## **Internal Erosion Detection at the Røsvatn Test Site**

Experiences from blind test using Resistivity, Self Potential, Temperature, and Visual inspection

**Rapport 05:42**

### **Part A - Assessment report**

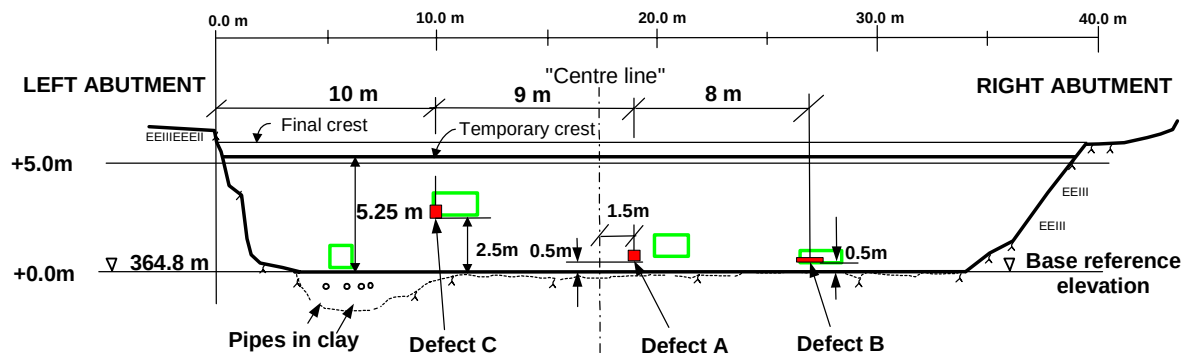
**Figure 5 Defect areas from temperature measurements (green) in comparison with actual locations (red).**

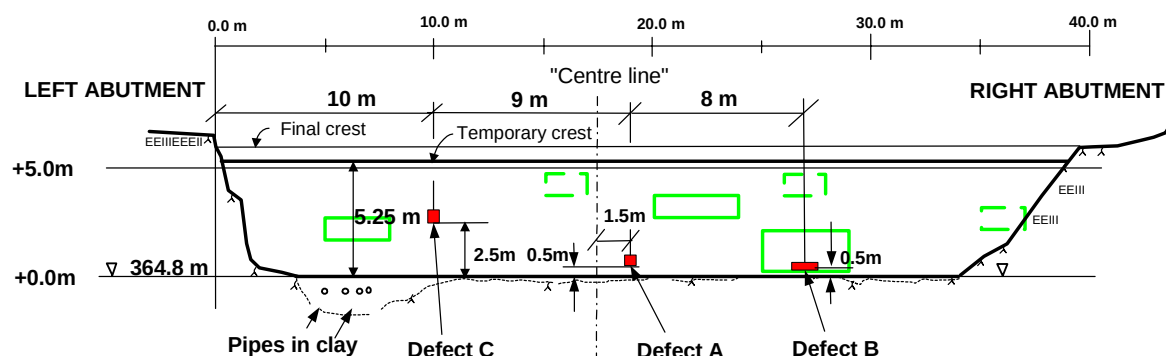
Two defect areas (around section 7 and 22m) were detected from initial measurements before filling (i.e. similar to an investigation). Three defect areas, including the two already mentioned, were detected based on several observations (i.e. similar to monitoring). Three other areas were classified as “possible, but less certain”, because these anomalies were just observed based on one or two weaker indications. All defect areas are indicated in green together with the actual locations marked in red (figure 6). According to the result in the pre-study none of these defects should be detectable. No attempt to correct for the 3D implication for the depth estimation was made by the monitoring group. The observed defects will therefore appear higher than the real defects.

**Figure 6** Defect areas from resistivity measurements (green line), “possible but less certain” areas (dotted green lines) in comparison with actual defect locations (red).

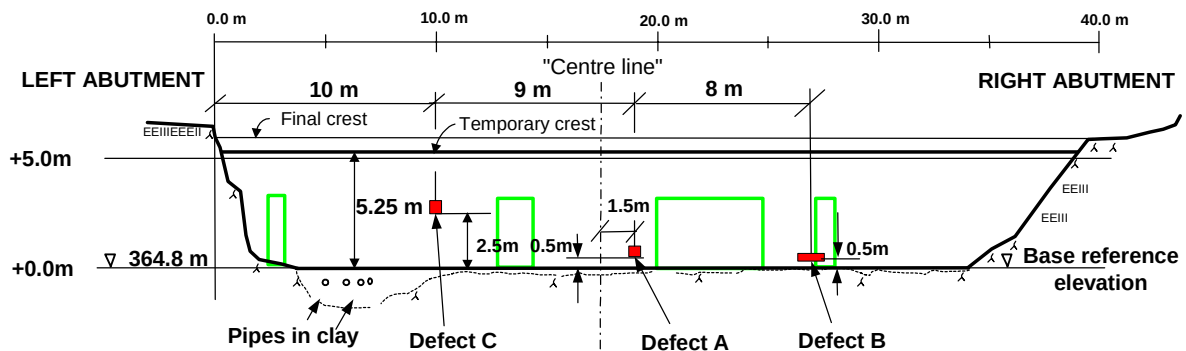
Only Defect B is detected by SP-measurements. However, the detection is weak, and should not have been reported as defect just based on the information from just SP-measurements. “There are also a number of weaker anomalies that one would not dare interpret as possible defects areas based on SP alone. Section 27.2-28m is one such example.” However, resistivity measurements should generally be used to at SP measurements to improve the interpretation.

Figure 7 Defect areas from SP Surveys (green) in comparison with actual locations (red).

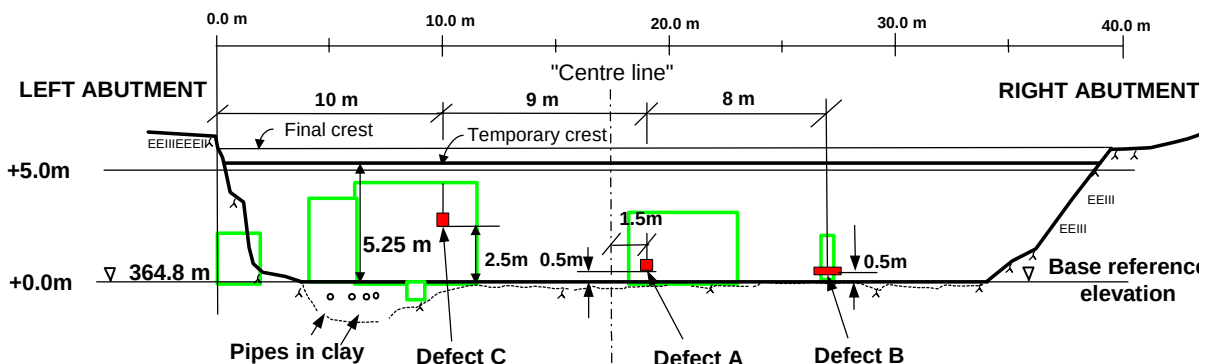
These areas are indicated in green together (using the inflow level as the upper limit and the outflow level as the lower limit). The real defect locations marked in red (**figure 8**).

**Figure 8 Defect areas from visual observations (green) in comparison with actual locations (red).**

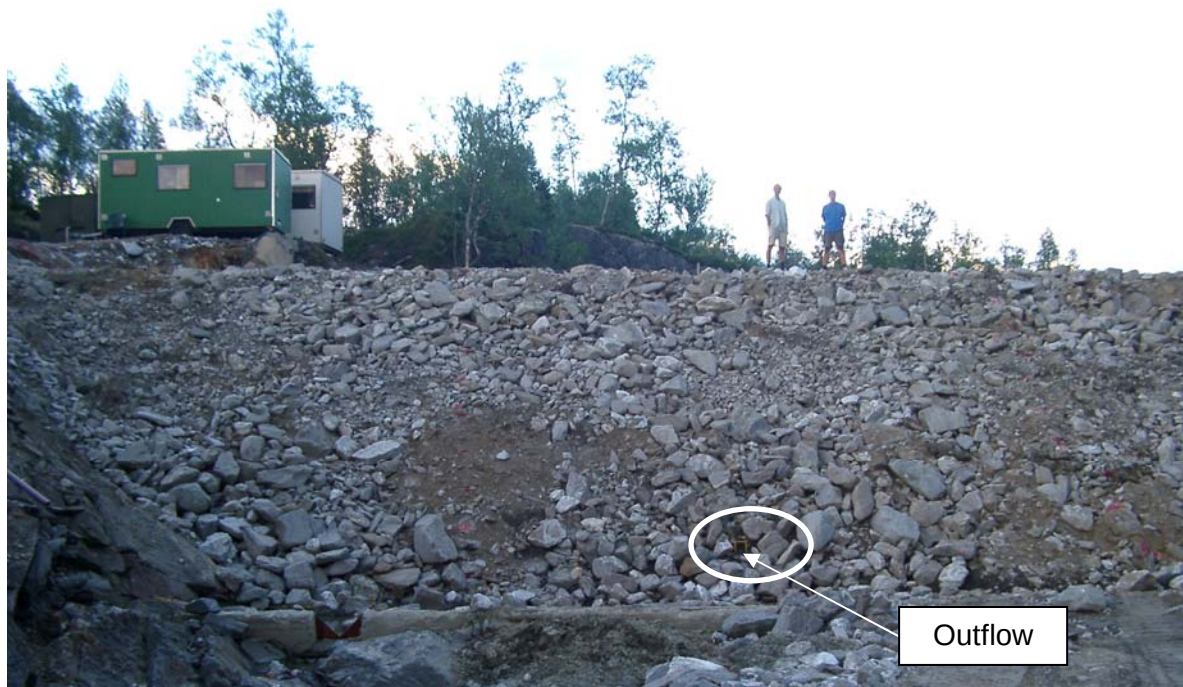
The temperature of the leakage water was also measured on the following day to 18.2°C, which was exactly the same temperature as the water in the reservoir. The leakage seems therefore to have a clear correlation with the upstream water. Other possible sources as rain or ground water outflow can also be excluded due to nice sunny weather, to high temperature of the leakage water, and not constant flow as expected from ground water outflow. This indicates that the water must come from the reservoir.

**Figure 9** Observed outflow at sec 27m, about 1m above the concrete sill. The high amount of fines in the support fill can also be seen.

It is reasonable to assume that the concentrated leakage outflow at sec 27m was connected to defect B. A reasonable explanation may be that the crushed rock downstream, in combination with the low permeable layer with fines between the boulders, could create a leakage path “in the upper part of the fines”, entering at a high level at the downstream toe (figure 10). Due to the low hydraulic conductivity, the infiltrated amount of water will be reduced. However, some water will also enter the dam toe, which was seen by the temperature measurements.

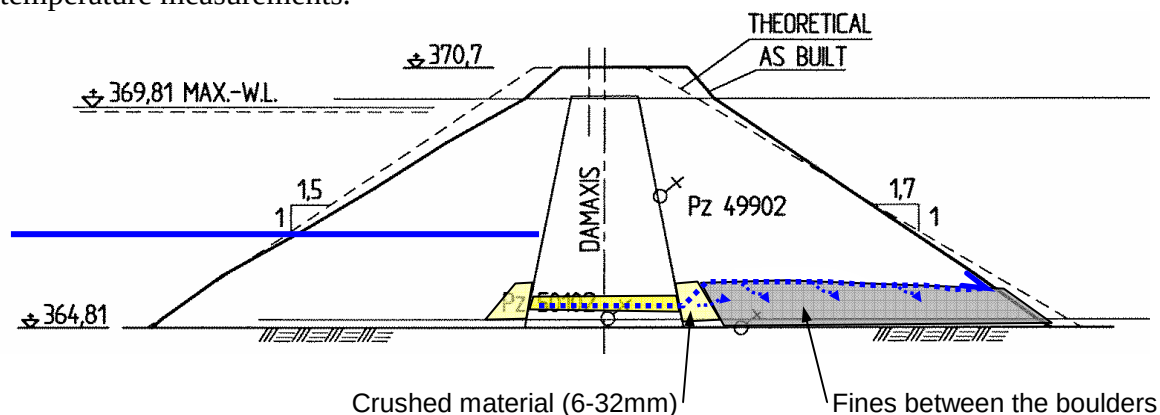
**Figure10 Possible explanation of the observed leakage at the dam toe at sec 27m.**

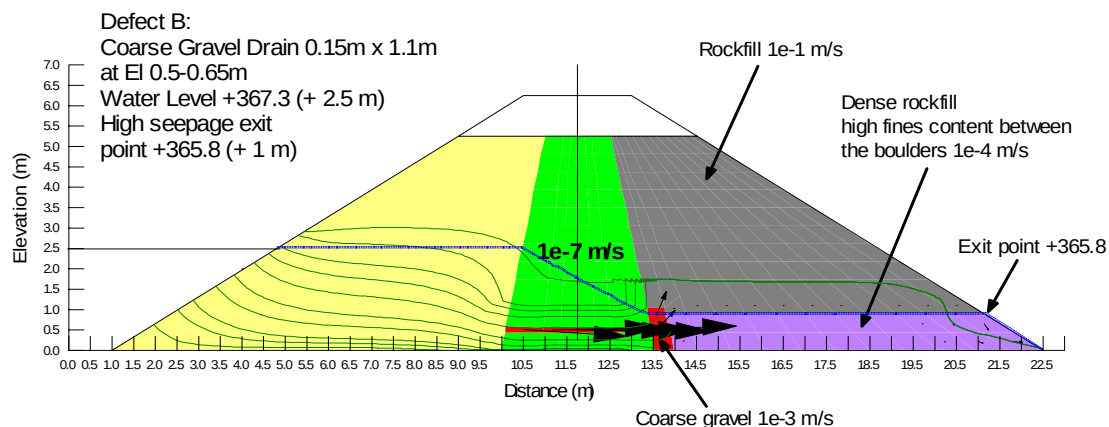
The hypothesis above has been tested by analysing the seepage through the section using different permeability in the lower portion of the rockfill in the downstream shell. A high seepage exit point of +365.8m can be obtained by assuming that the lower part of the downstream supporting fill does not exceed  $10^{-4}$  m/s. Should the permeability be higher than  $10^{-4}$  m/s it generates a lower exit point of seepage (figure 11 and 12).

**Figure11 Phreatic line assuming a permeability of  $10^{-4}$  m/s in the lower portion of the downstream shell.**

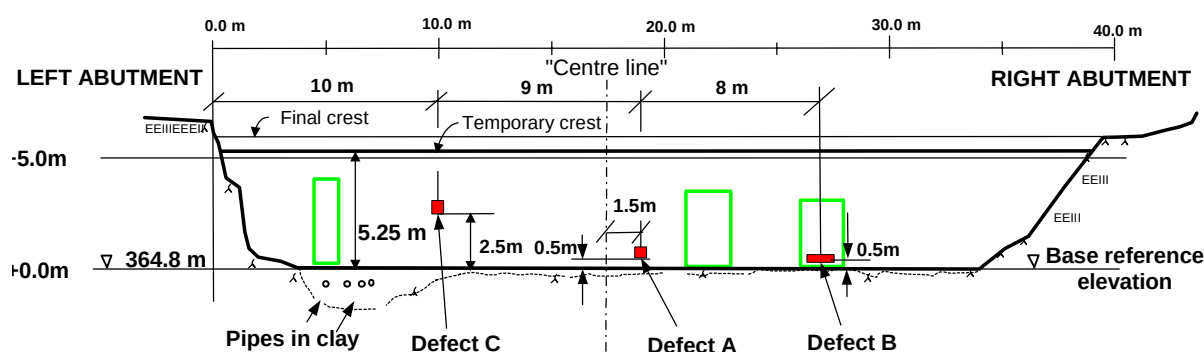
The above observations from the measurement report are indicated in green together with the real locations marked in red in **figure 13**.

**Figure 13** Defect areas according to the collected final information from all methods (green) in comparison with actual locations (red)

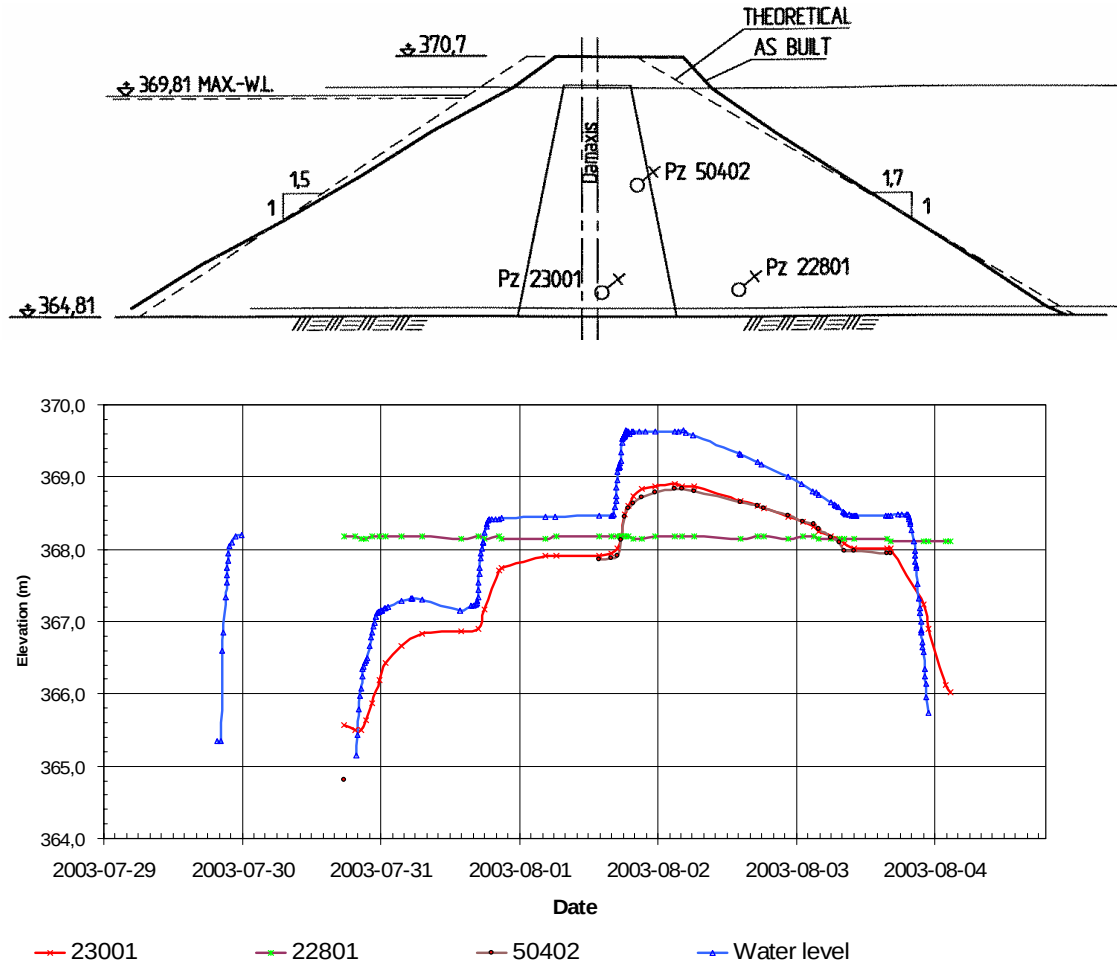
**Figure 26 Location of piezometers in Section II and measurements during the period of the geo-electric measurements**

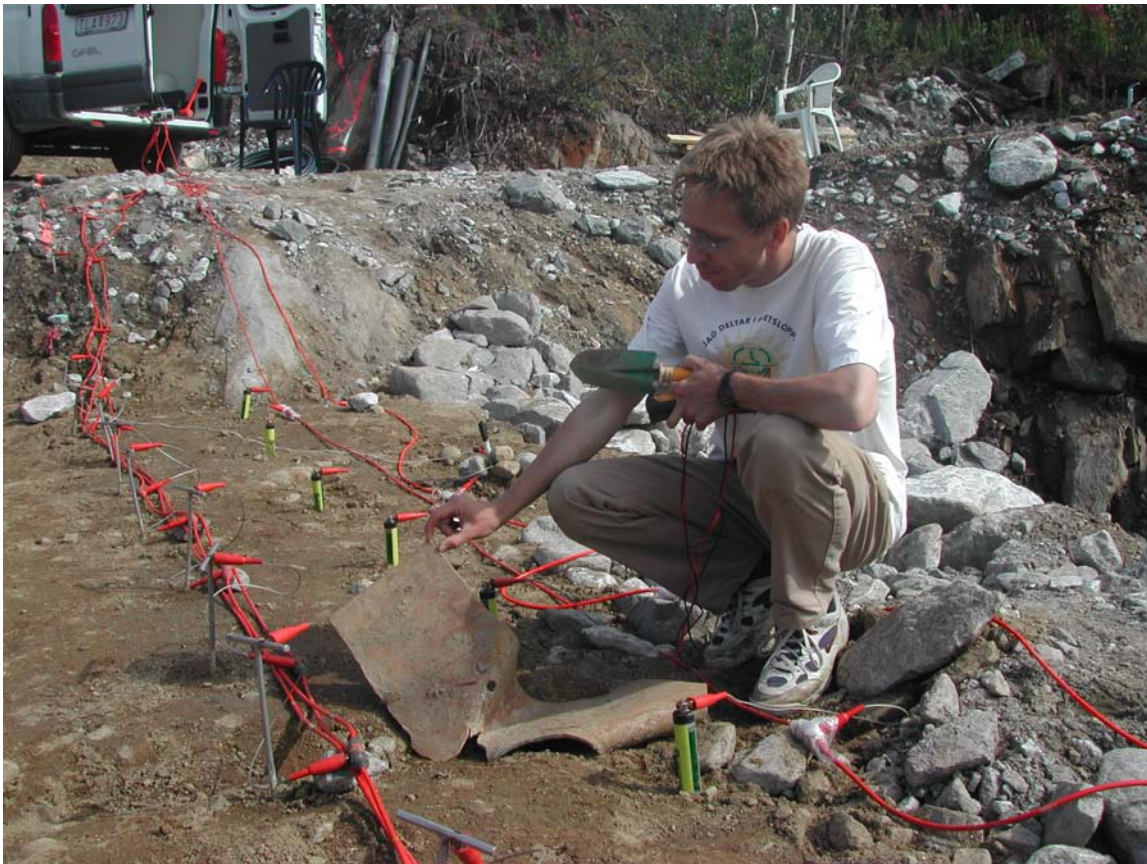
Figure 11-1 Steel plate found on the crest.
