## **DAMMSÄKERHET**

**Dam-Break Project in Norway,  
Slope Stability Analysis on Rockfill  
and Gravel Test Dams in correlation  
with test results**

**Rapport 05:13**

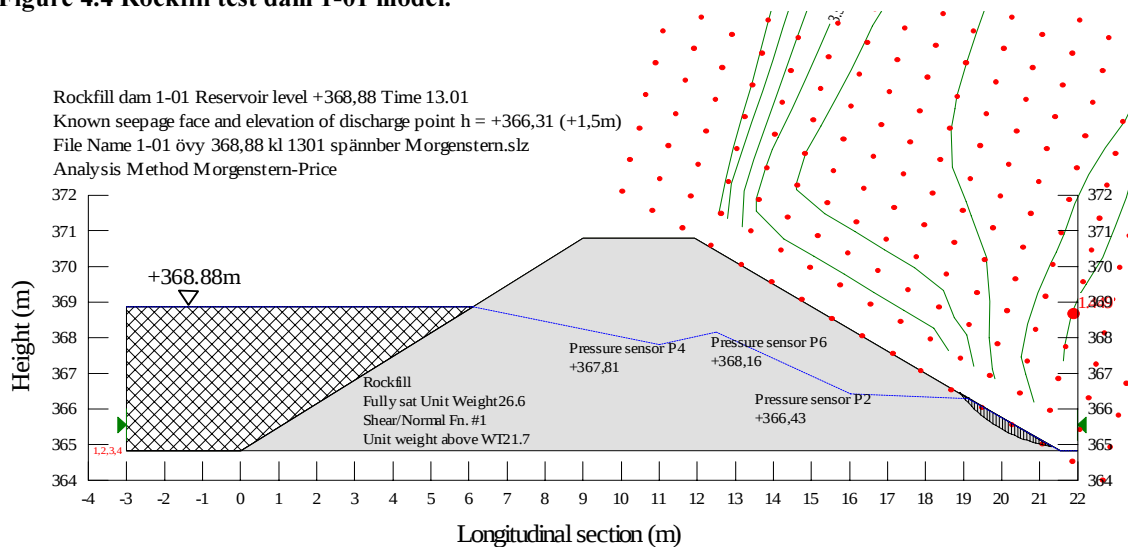
No breach was developed in this test, which correlates with the analysis result. The analysis show that superficial slides (thin failure plane, barely visible with a potentially small impact on the slope) have a factor of safety of approximately  $SF = 1,2$  which is just over stable conditions ( $SF = 1$ ) and these occur just below the seepage face as would be expected due to the effect of the pore pressure uplift.

Figure 4.5 shows a slightly larger slip surface, developed at the seepage point, with  $SF = 1,45$  (still one of slip surfaces with the lowest “safety”).

**Figure 4.5 Superficial slide just below the discharge point of the slope.  $F = 1,449$ .**

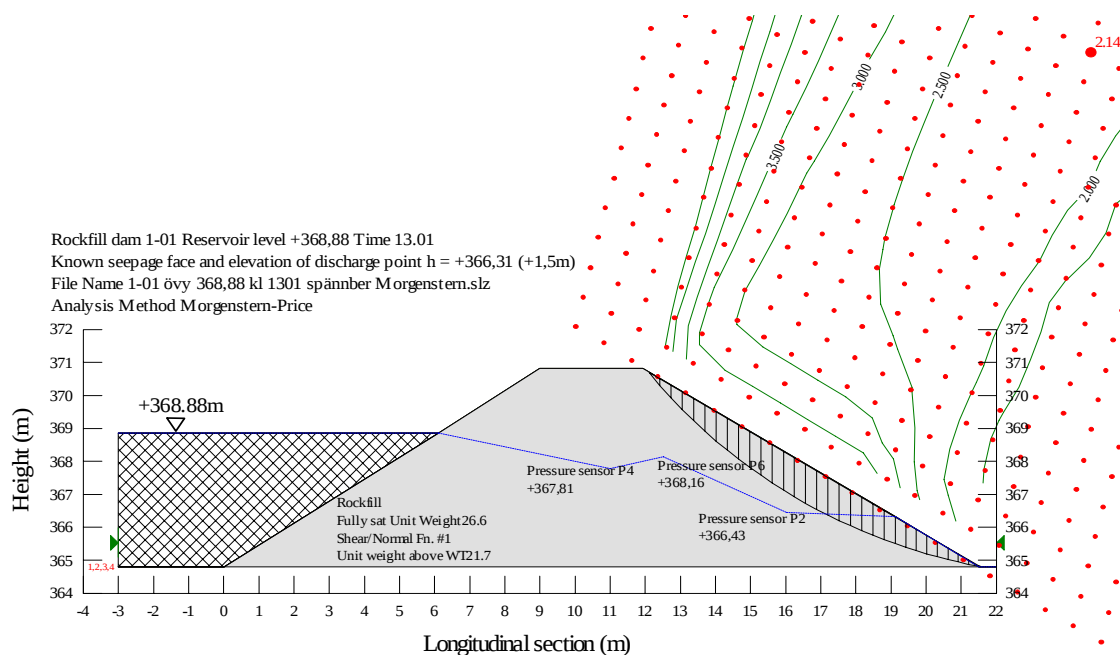
The factor of safety for a deep slip surface (see figure 4.6) with the scarp starting at the top of the slope and slip surface going down to the toe is  $SF = 2.145$ , which is well over stable conditions. This correlates well with actual conditions as a breach never initiated.

Figure 4.6 Deep slip surface from the top to the toe of the slope.  $F = 2.145$ .

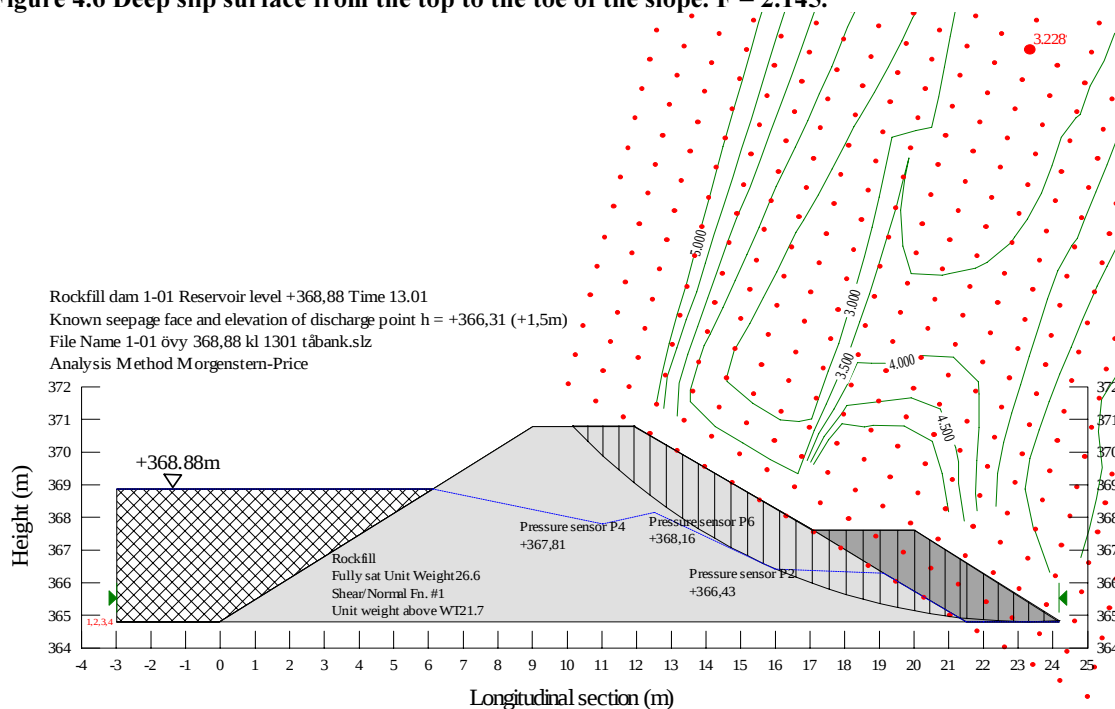
Figure 4.7 Deep slip surface with support of a toe berm.  $F = 3.23$ .

Under assumption that the reservoir level still is set at +368.88m and that such a toe berm will drain the upstream layer and lower the pore pressure at the interface, it will improve the factor of safety (increase the stability of the slope) of thin superficial slides, that without the berm had a factor of safety just over 1,2, with in excess of 100 % (SF = 2,4). The factor of safety for a deep slip surface with the support of a berm increases from SF = 2.145 to 3.23 (50 % improvement), see figure 4.7.

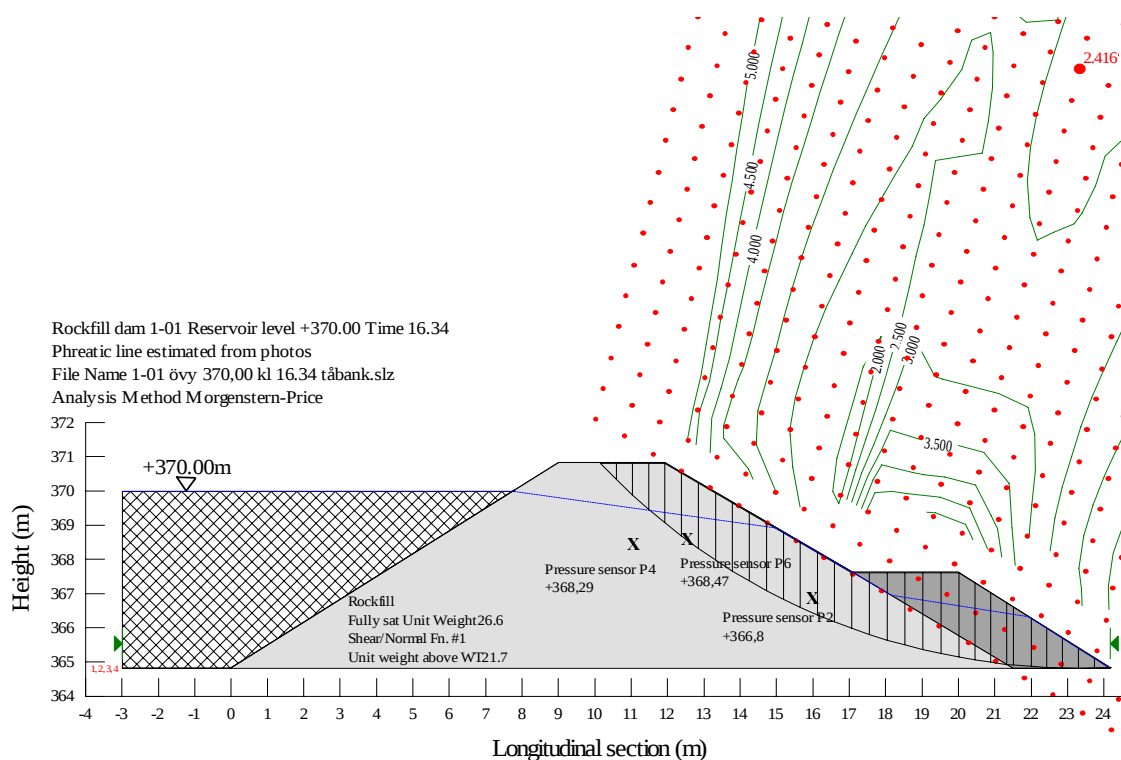
During the continuation of the test the upstream level was increased to +370.00m (Oct 31st 2001), roughly 0.8 m below the crest. According to photos taken this resulted in a heightening of the discharge face on the downstream slope, which lead to a seepage face above the berm, depicted by figure 4.8, with another point of discharge approximately at half of the berm height. This does not agree well with the pressure sensors, which measured lower head (displayed with X in figure 4.8). An explanation to this can be that the material had not had time to completely saturate during the increase in reservoir level, showing lower pressure or simply a measuring error. With regards to these circumstances the phreatic line in the dam has been estimated with basis on the photos taken and the pressure sensors are disregarded.

**Figure 4.8 Deep slip surface with support of a toe berm. Higher reservoir level with high pressure in the dam.  $F = 2.4$ .**

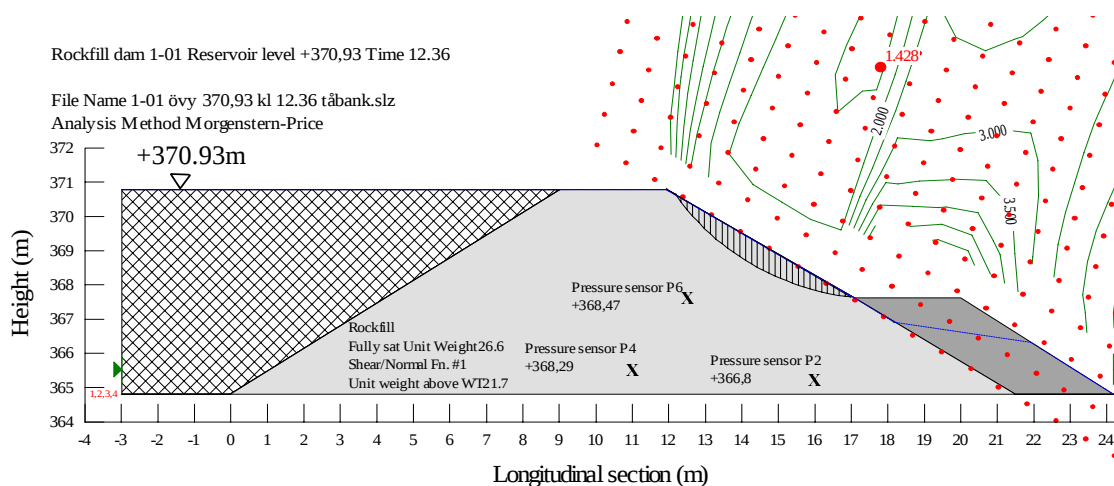
The dam was overtopped Nov 11th 2001 during which the pressure sensors measured unreasonable pore pressure (marked with X in figure 4.9), not taken into account in the following calculations. Similar to previous stability calculations thin slides (barely visible) occur with a factor of safety under stable conditions on the slope of the berm ( $SF = 0.9$ ) in agreement with the actual test where small erosion took place at the toe at

this point. Thin slip surfaces (with  $SF = 1.43$ ) develop above the toe berm on the upper, unprotected part of the test dam, see figure 4.9.

**Figure 4.9 Thin slip surface during overtopping on the upper unprotected part of the slope above the toe berm.  $F = 1.43$ .**

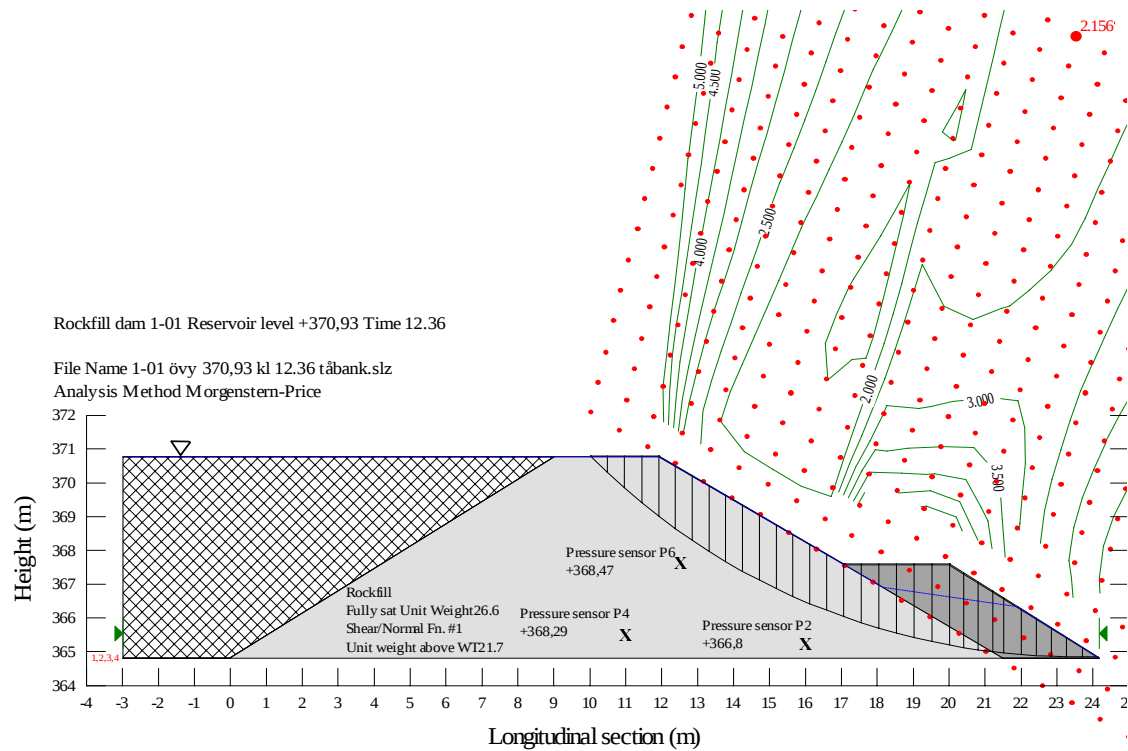
A deep slip surface during overtopping (and complete saturation) has a factor of safety of 2.15 (figure 4.10) with the support of a toe berm. The analysis shows that if the rockfill test dam overtops unsupported the factor of safety of a “deep” slip surface is  $SF = 1.3$ , which indicates a 65 % increase in the factor of safety and improvement of the stability when saturated and with through-flow.

Figure 4.10 Deep slip surface during overtopping with supporting toe berm.  $F = 2,15$ .

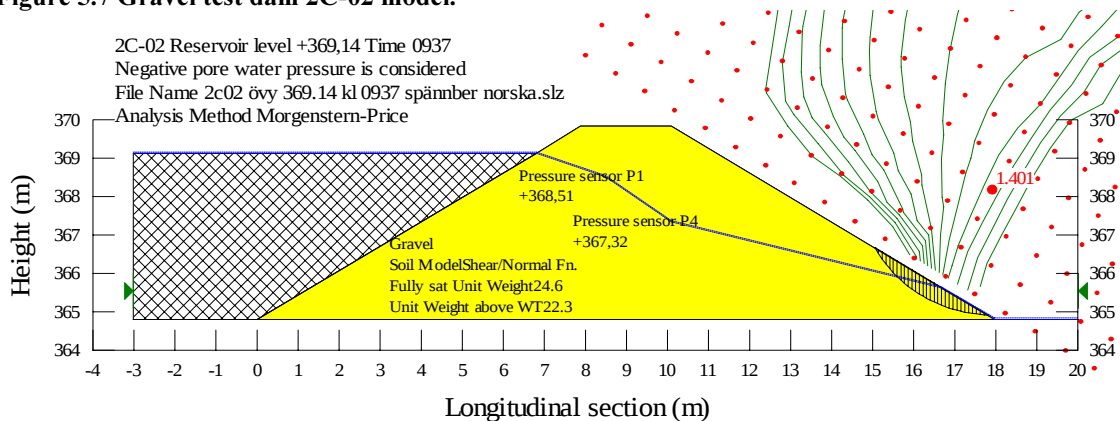
Figure 5.8 Thin slide on unprotected slope at +369.14.  $F = 1.4$ .

The analysis show that the factor of safety for thin barely visible slides is below stable conditions ( $SF = 1$ ) and these slides occur just below the seepage point under the influence of uplift. So according to this some erosion should have initiated under the seepage face during the first part of the test, this never happened. The influence of suction in this case is minimal because the failure occurred below the point of discharge. Maybe the erosion process would have started in the actual test dam if this case of load had continued for a longer time allowing the seepage situation to settle. A more tangible, but still small slip surfaces, has  $SF = 1.4$  (according to the analysis in figure 5.8). Without the influence of suction 1.33.

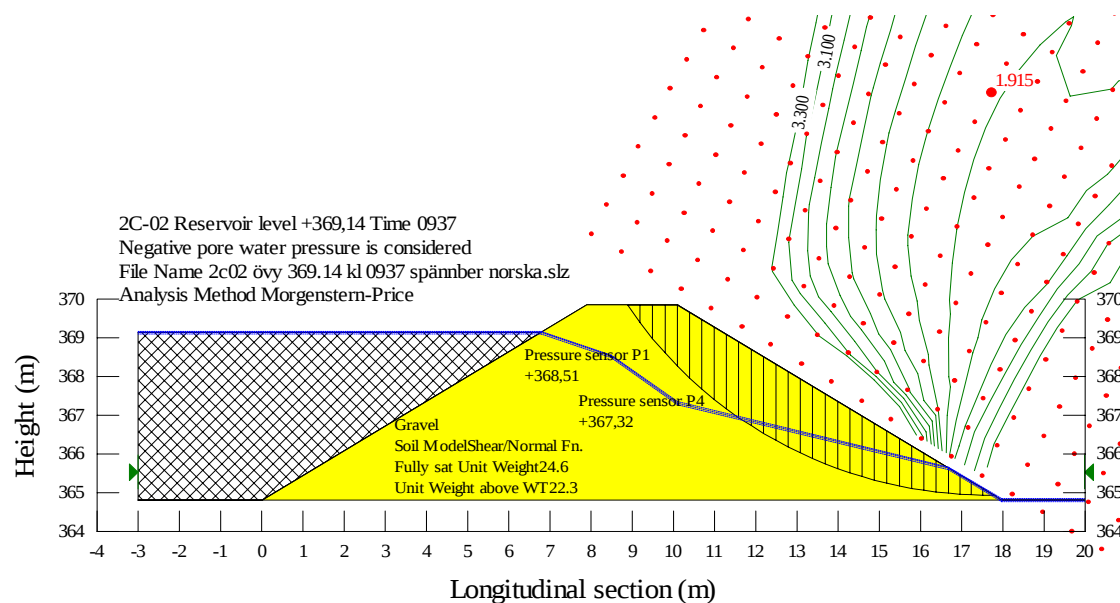
Figure 5.9 Deep slip surface on unprotected slope at +369.14.  $F = 1.92$ .

The factor of safety of a deep slip surface that probably would have resulted in a breach under these conditions is 1.92 (1.83 if negative pore water pressure is not considered, no suction), see figure 5.9. This is far above stable conditions.

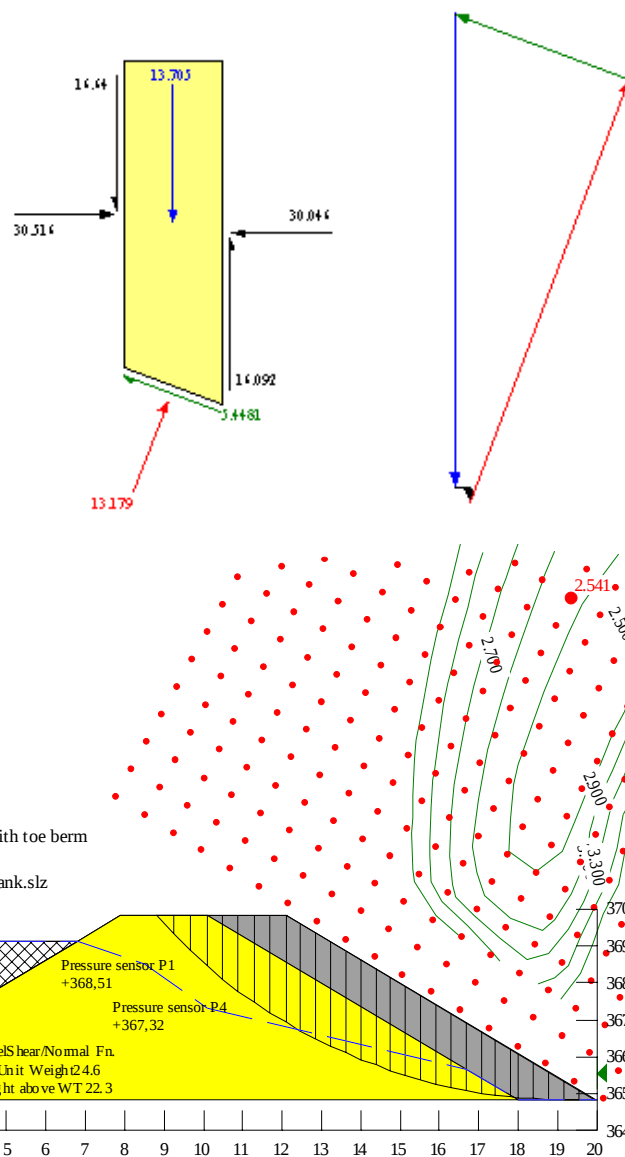
Figure 5.10 Deep slip surface with toe berm supporting the slope at a reservoir level at +369.14.  $F = 2.54$ .

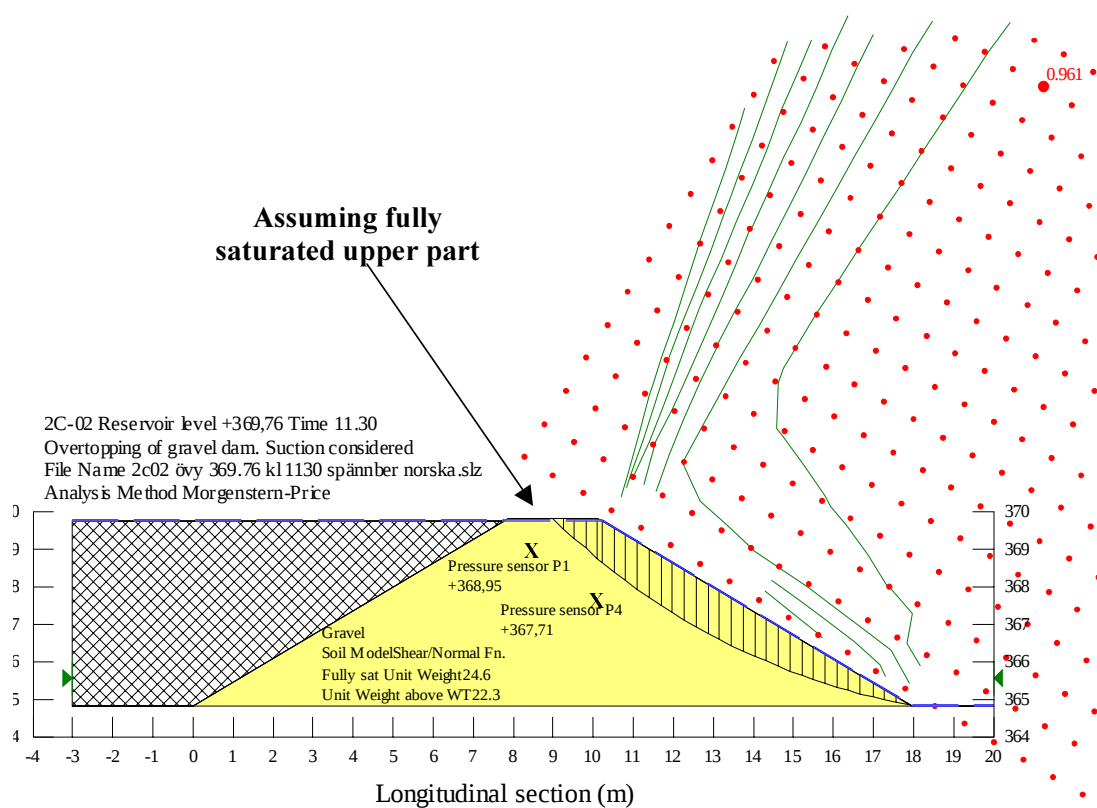
If the pore pressure readings are considered correct it means that the upper part of the dam is not fully saturated though overtopping is taking place and water is flowing freely down the slope. Under such conditions there can be a mobilized suction, which increases the shear strength of the unsaturated zone within the capillary reach rendering a factor of safety of 1.53, displaying a more realistic result comparable to the actual field test (figure 5.12). Assuming that this is the case then the submersion is continually increasing as the overtopping goes on, closing in on fully saturated conditions and by this the stability is gradually decreasing towards unstable conditions (see figure 5.11).

Figure 5.11 Deep slip surface during overtopping with unsupported slope.  $F = 0,961$ . Totally saturated material.

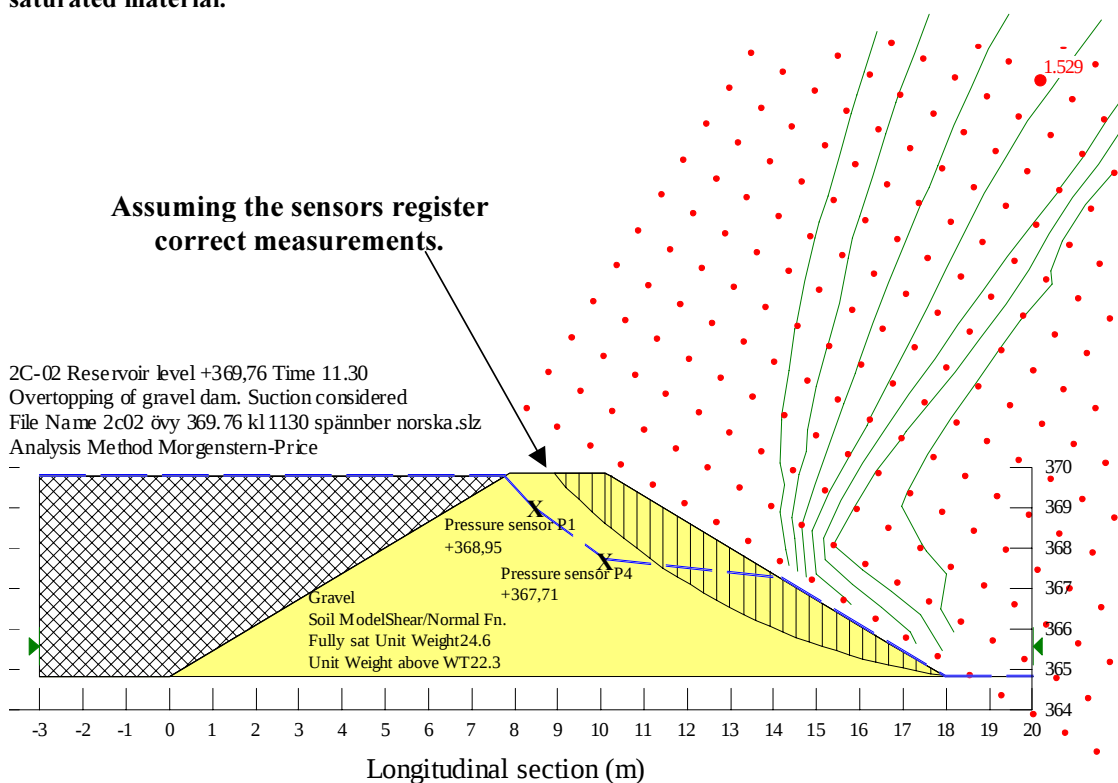
Figure 5.12 Deep slip surface during overtopping with unsupported slope.  $F = 1.53$ . The upper part has not yet been fully saturated permitting suction to mobilize.

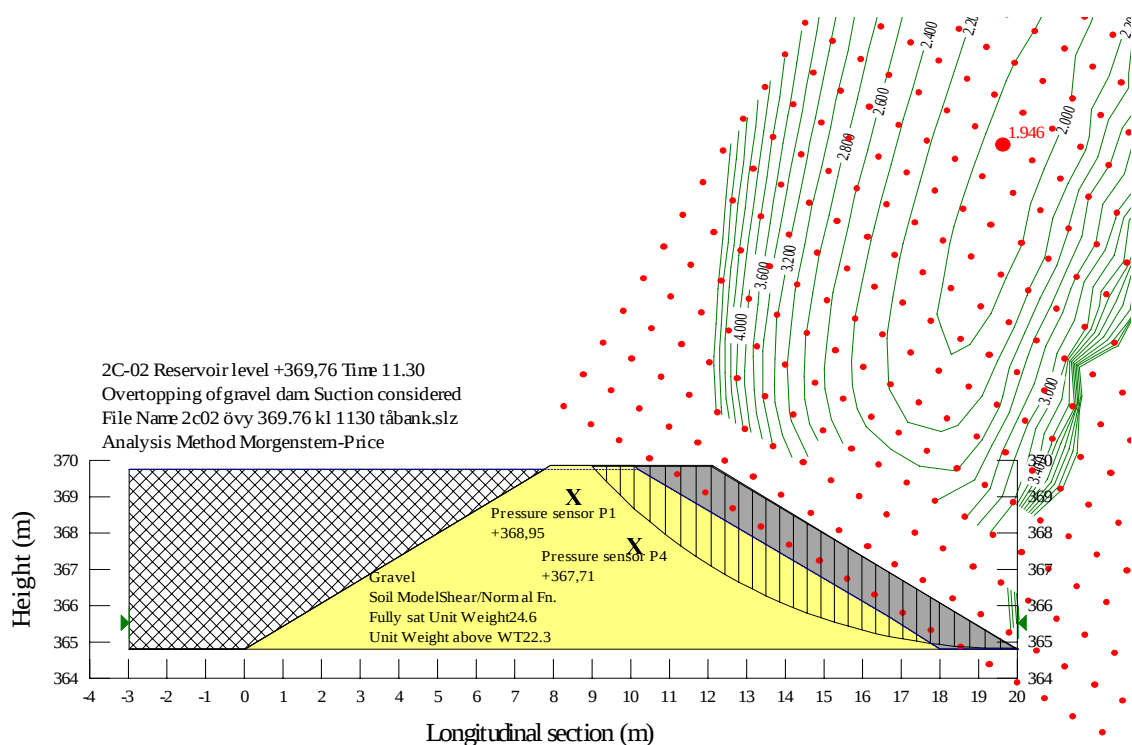
Figure 5.13 Deep slip surface during overtopping with toe berm.  $F = 1.94$ . Upper part fully saturated.

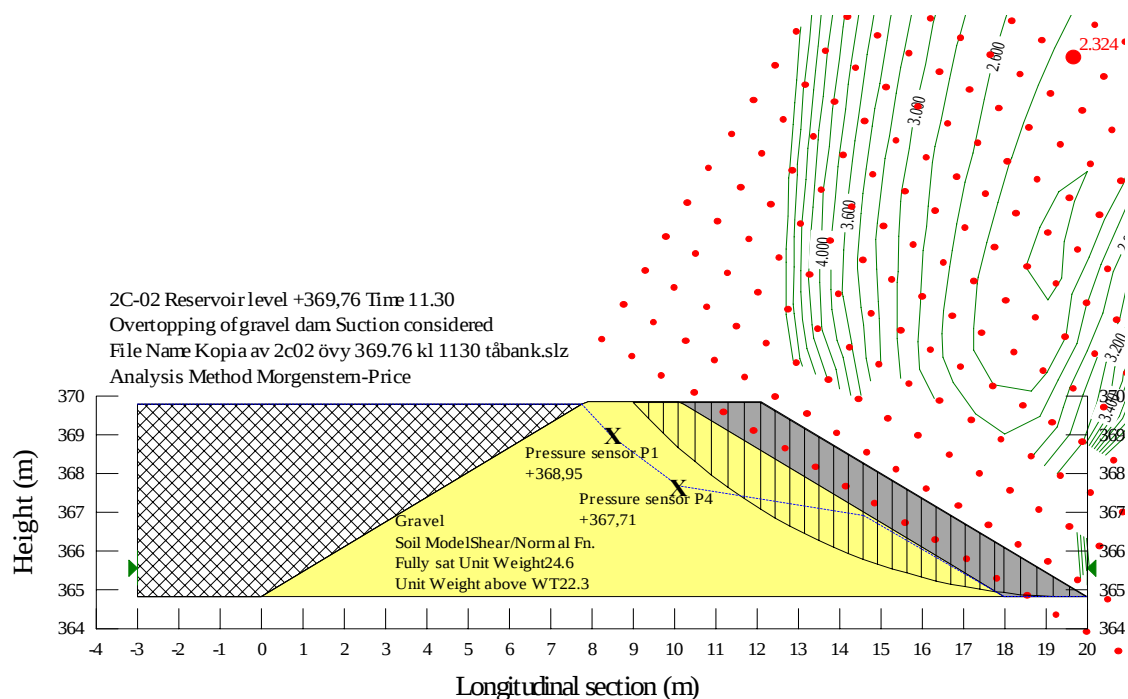
If the sensors are assumed to register pore water pressure correctly (analogous to previous case without toe berm) the influence of suction will increase the factor of safety to 2.32, which is a 51 % increase in comparison to unprotected conditions (see figure 5.14).

Figure 5.14 Deep slip surface during overtopping with toe berm and influence of suction.  $F = 2.32$ .
