# DAMMSÄKERHET

SAMARBETE MELLAN BC HYDRO OCH ELFORSK 1997 –  
1999

Rapport 00:03

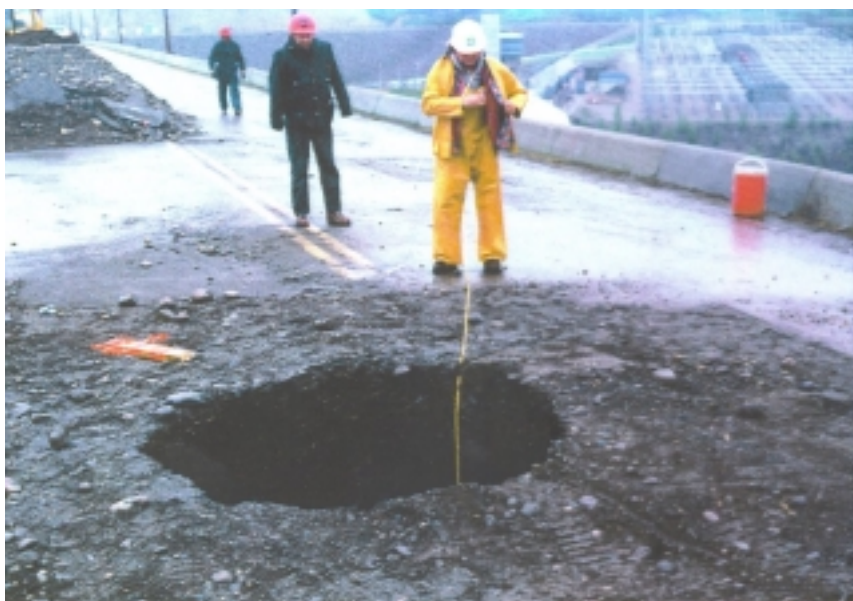
Den 14 juni 1996 uppstod ett hål i asfaltbeläggningen på dammens krön. Diametern var ca 50 cm. Hålet upptäcktes bara några timmar efter en detaljerad halvårsinspektion som ej rapporterat något onormalt. En första undersökning visade att hålet var ca 1.2 m djupt med en diameter på ca 2 m, se **figur 3**.

**Figur 4** Bennett Dam – Sjunkgrop i krön på dammen

Dammen är ca 115 m hög vid denna sektion. För att undersöka skadan startade man att borra med den så kallade Becker-metoden varvid en ytterligare 6 m djup sättning med en diameter på ca 2.5 m uppstod.

Inför åtgärdandet av sjunkgroparna har de tillgängliga metoderna för injektering utvärderats. Den metod som framstod som mest lämplig var kompakthinjektering. Denna metod går ut på att genom nedborrade injekteringsrör pumpa in en styv injekteringsmassa under relativt högt tryck i tät kärnan varvid man både tillför nytt material samt packar den omkringliggande jorden. Denna metod har inte använts tidigare för reparation av fyllningsdammar.

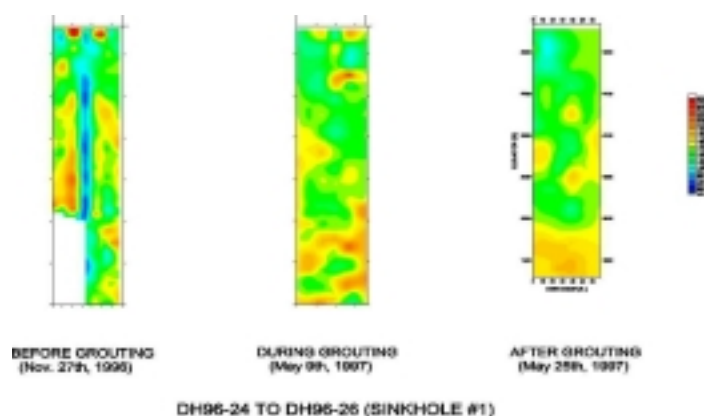
Figur 7 Bennett Dam – Exempel på tomografianalys från cross-hole mätningar. Ju varmare färg desto högre ljudhastighet och fastare material.

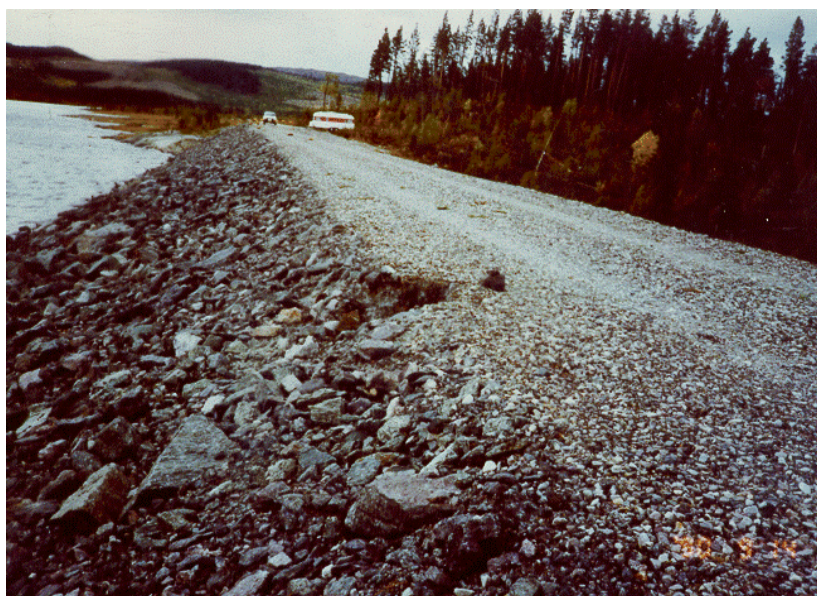
I rapporten konstateras att i de flesta av fallen med sjunkgropar bedöms orsaken vara inre erosion i dammkroppen eller undergrunden. Orsaken bedöms bero på otillfredsställande projektering eller byggande. I de flesta av fallen kan samband noteras med otillräcklig filterverkan.

Figur 9 Sjunkgrop – Grundsjöarna

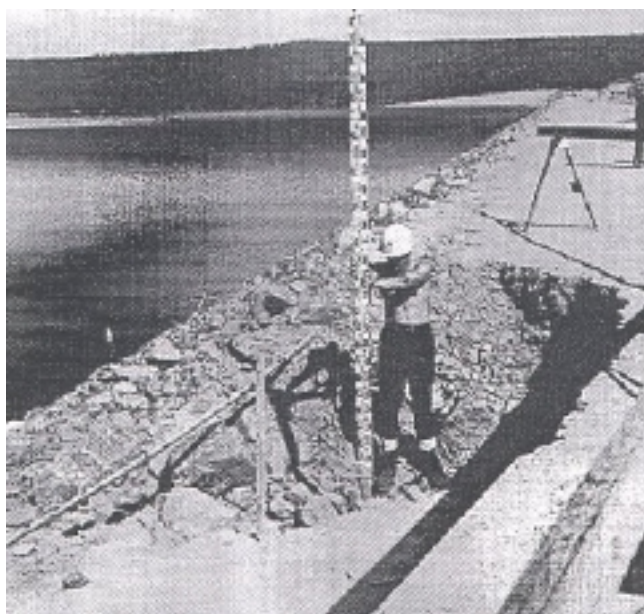
I samband med dämningssupptagningens slutfas 1963 uppstod två sjunkhål i dammkrönet i Messauredammen. I rapporten beskrivs skadeförloppet, gjorda observationer och undersökningar samt en bedömning av orsak till sjunkgroparna.

**Figur 10** Sjunkgrop i Messauredammen 1963

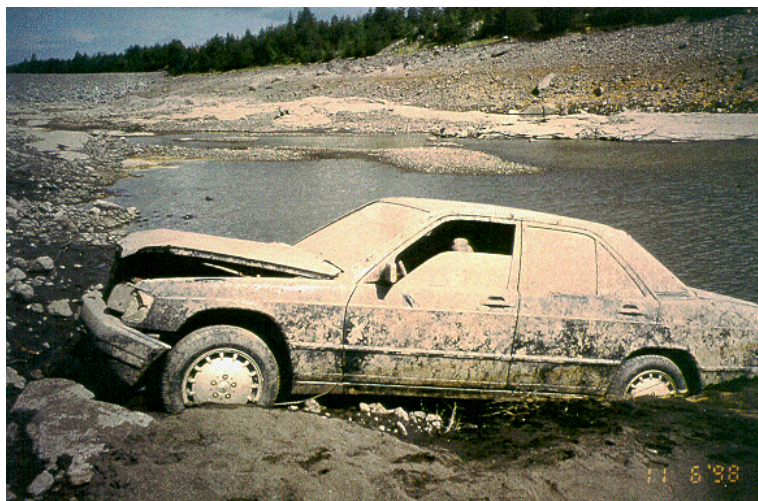
I Lövödammen uppstod sjunkgropar 1983 och 1986. Omfattande undersökningar har efter upptäckterna genomförts i och omkring det skadade området. Undersökningarna indikerade att inre erosion skett i tätkärnan och därför fattades 1997 beslutet att bygga om delar av dammen. I samband med utgrävningen dokumenterades alla upptäckter i dammen. Dessa redovisas i rapporten.

**Figur 11** Lövön – Ett fynd inte inne i dammen men väl i den torrlagda kanalen
