**Fibre-Optic System for Temperature Measurements  
at the Lövön Dam**

**Rapport 99:36**

**Sam Johansson  
Mahmoud Farhadiroushan**

**Dec 1999**

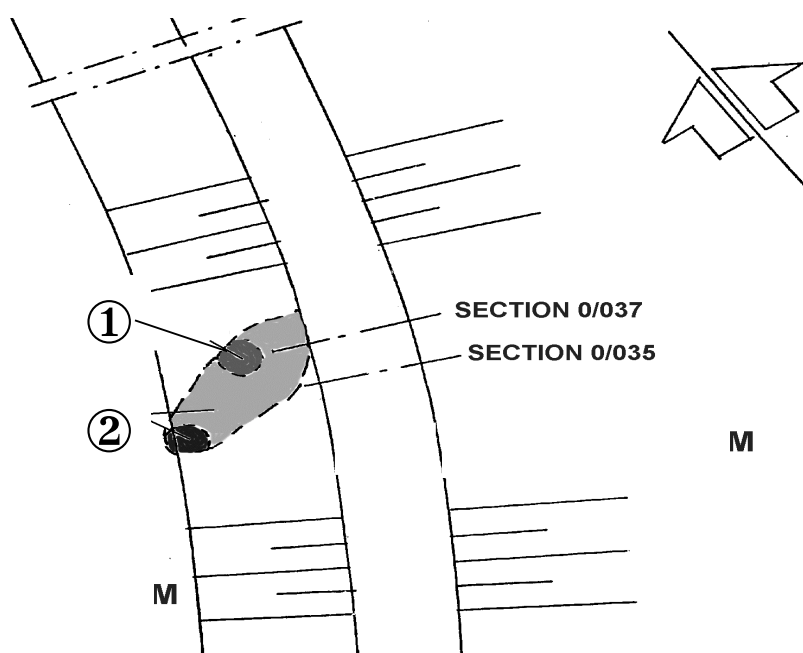
A sinkhole occurred in 1983 on the upstream face at 37m from the centre of the intake section (section 0/037). The volume was estimated to be  $6-8\text{m}^3$ . The sinkhole was backfilled and investigations started. The monitoring of piezometer levels was also extended in the new standpipes. In 1986 a wider sinkhole was observed at almost the same place (largest depth at section 0/034). This sinkhole had an extension of about  $20\text{m}^2$  and was about 1m deep, see Figure 3. After further investigations in 1986 and 1989 it was concluded that internal erosion was going on in the dam. Grouting was performed in 1992 in the bedrock and in the contact zone between the rock and the core. The total amount of cement grout in the contact zone was about 20 tonnes and about 20 tonnes in the bedrock. A stabilising downstream berm was also constructed in 1994 in order to achieve an acceptable safety margin against a dam break.

**Figure 3** Location and extension of the sinkholes in 1983 (①) and 1986 (②) on the upstream side.

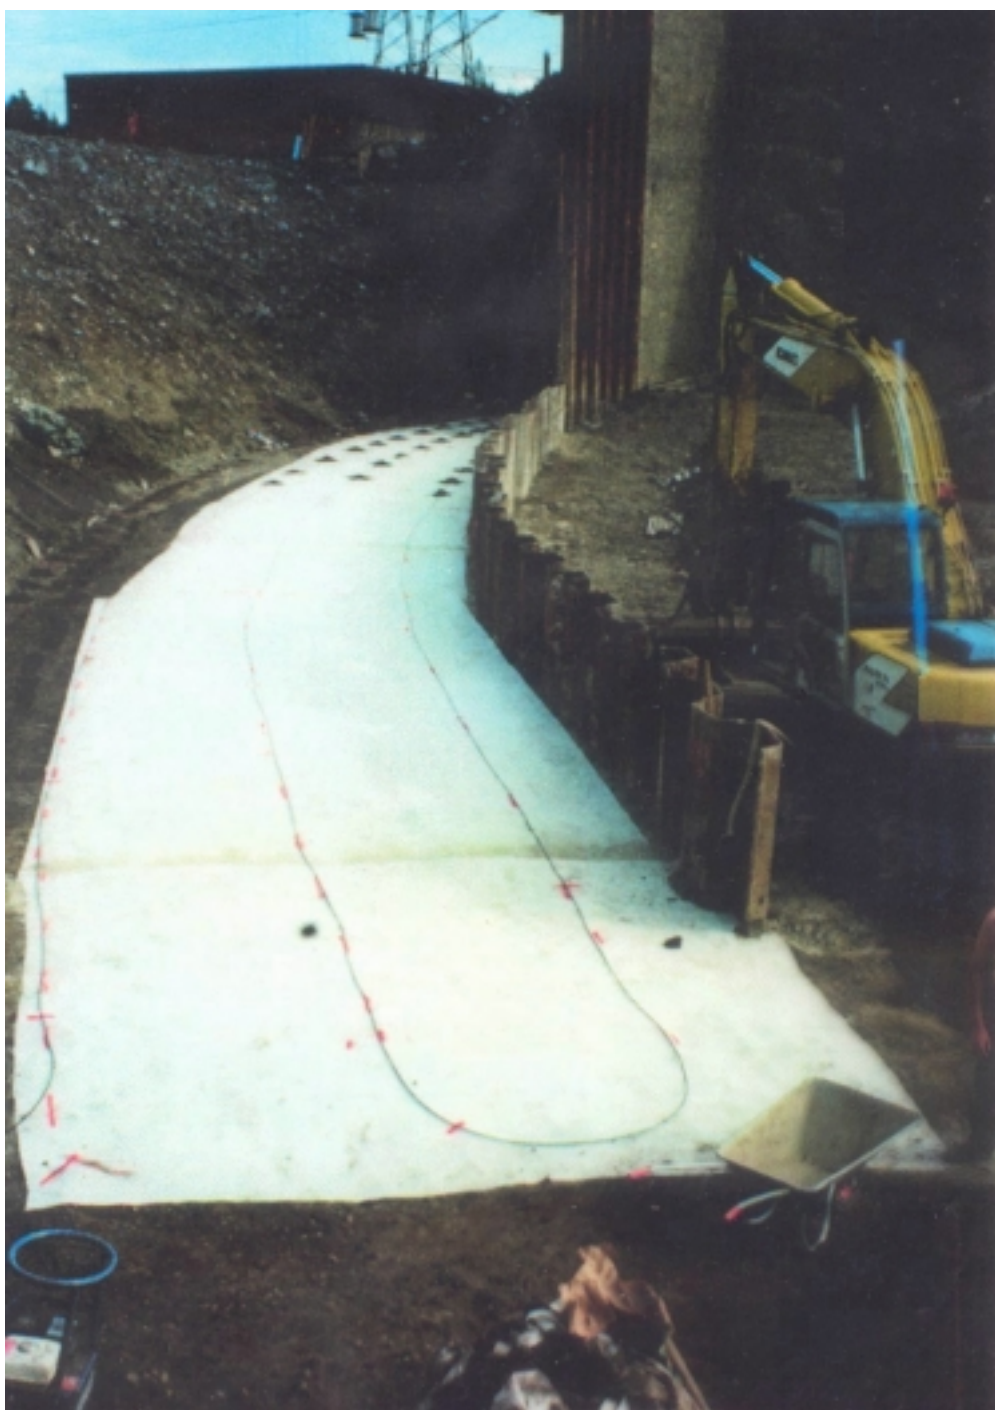
**Figure 4** Geomembrane connected to the sheet pile at El +274.0. Two fibre-optic cable loops can also be seen on the top of the geomembrane and on the downstream filter. (Photography by Graningverken AB)

A new core of moraine replaced the excavated part of the dam with proper downstream filters. The core was placed on a filter layer with a geomembrane on top that was sealed towards the sheet pile, see Figure 4.

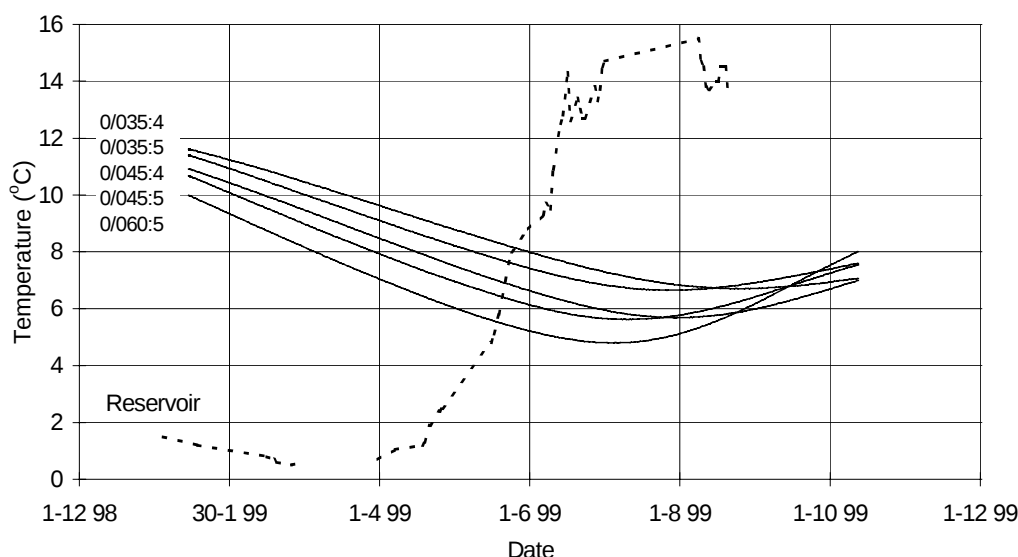
A general decreasing temperature trend in the core was observed for the first months, see Figure 9 until summer 1999, when the temperature increased. The linear decreasing temperature in the beginning was probably a consequence of the heat built-in during the summer, which slowly adjusts to the mean annual air temperature. Another reason for the decreasing temperature may be the drainage of the water from the precipitation from the construction time that also causes an advective energy transport.

**Figure 9** Temperature in the core in five sensors and in the reservoir. The location of the sensors (sec:1-3) is shown in Figure 5.

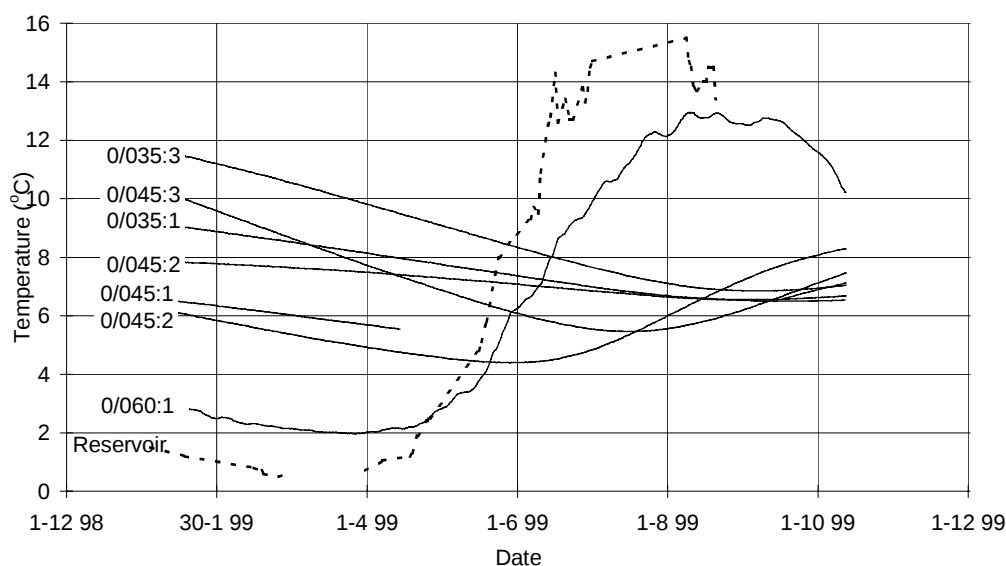
Measurements in the bedrock indicate a significantly lower temperature in section 0/060 than in the other sections. The temperature was about  $3^{\circ}\text{C}$  in the beginning of January and reached its lowest value (about  $1.9^{\circ}\text{C}$ ) in March. Some weeks after the temperature started to increase in the reservoir, a temperature increase followed in the bedrock. The low minimum temperature and the rapid thermal response indicate seepage through the bedrock.

**Figure 10** Temperature in the bedrock and the downstream part of the dam. The location of the sensors (sec:1-3) is shown in Figure 5.

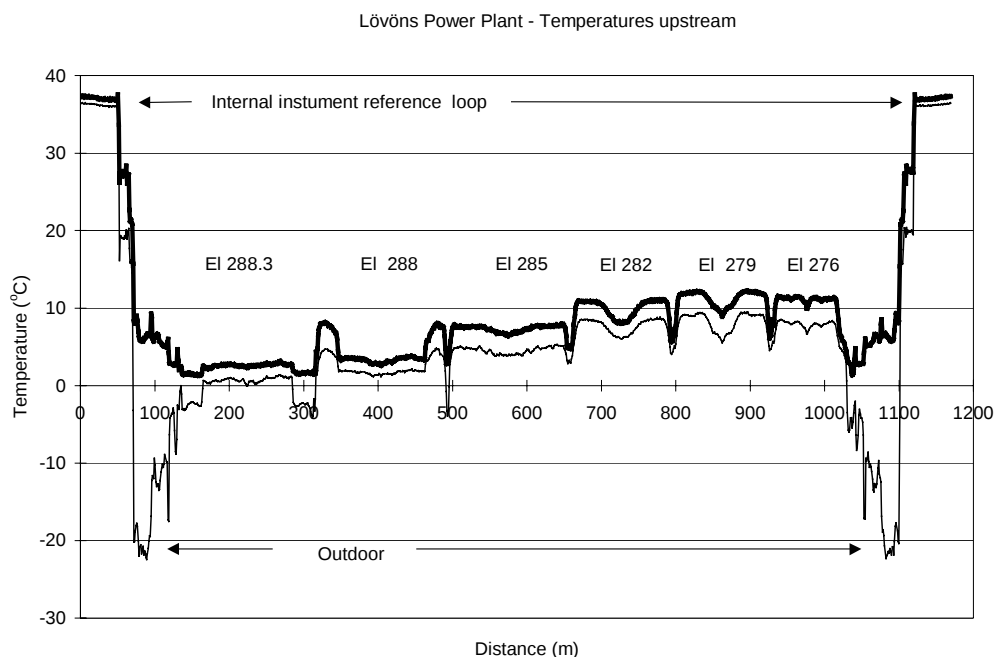
Basic output from the system is the temperature along the entire cable, as in Figure 11. The data clearly shows how the cable is installed. First it's an internal reference loop within the instrument, followed by some 10m inside the powerhouse. The fibre is then attached to an outdoor cable stage and comes to the dam after about 130m. Then the measurements start at the different levels in the dam. The return point can easily be seen because the temperature is lower at the end. A mirror image can also be seen on each elevation. After 1020m the fibre returns the same way to the instrument in the powerhouse. The temperature variation during the measuring period is  $0.9^{\circ}\text{C}$  in the reference coil, some degrees in the dam, and about  $28^{\circ}\text{C}$  in the outdoor part.

**Figure 11** Maximum and minimum temperature in the upstream fibre during the measuring period.

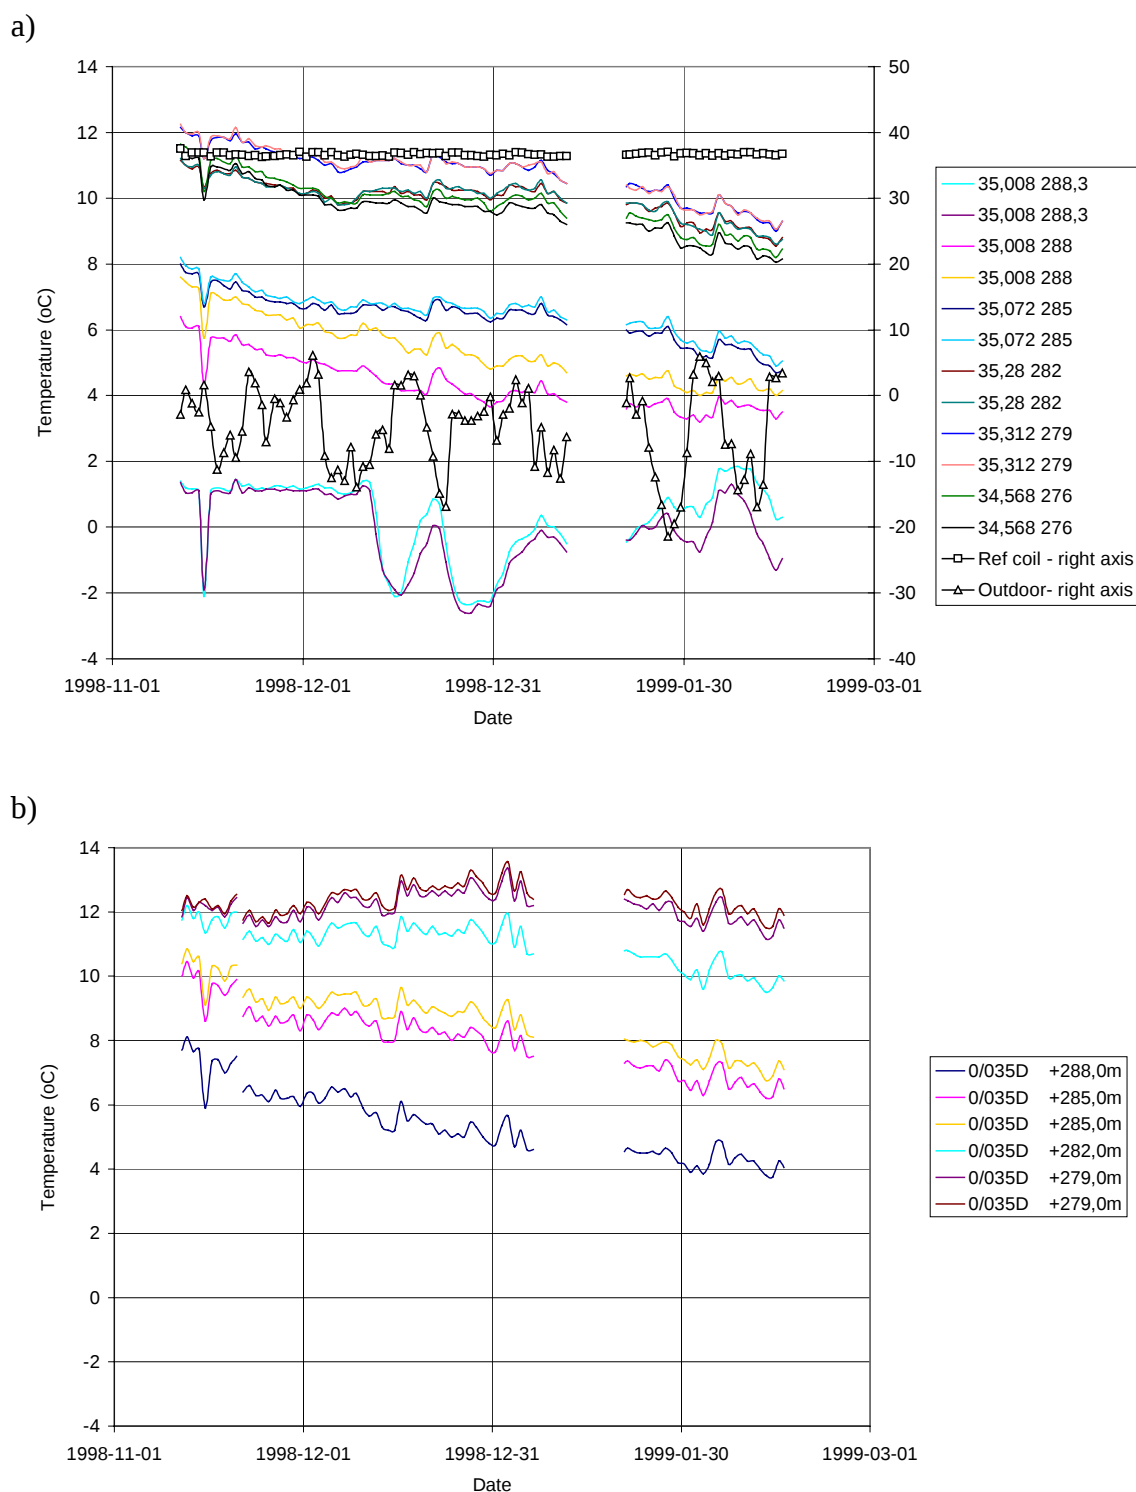
Some examples of data in section 0/035 in the upstream fibre illustrate the accuracy and repeatability of the system, see Figure 12. The forward and backward fibres are located very close to each other in the upstream face up to El 285m. The measured temperatures at El 285m and below can therefore be compared with each other. The system shows in this case a good agreement (a deviation  $<0.2^{\circ}\text{C}$ ) that might be a representative value for the relative accuracy.

However, several sudden dips and peaks all over the both fibres indicate some errors in the monitoring system, because any similar pattern cannot be observed for the vibrating wire temperature sensors. These errors are sometimes short, as in November 1998 with a dip of two degrees for one day. Errors occur also at several days as the one-degree dip around January/February 1999.

These errors are thought to be resulted from the temperature variations of the internal reference oven. The reference oven houses a 50m section of optical fibre that is used to evaluate the coefficients of the backscattered light and to calculate the temperature profile along the entire length of the sensing fibre. The temperature of the reference oven is controlled and assumed to be constant but it is not measured. However, if the temperature of the reference section changes, say due to sudden temperature change of the control room, then this will appear as a temperature change through the whole length of the sensing fibre. One solution to avoid this possible error is to measure the actual temperature of the reference oven and use this rather than the assumed value.

**Figure 12** Measured temperatures in the onward and backward fibre in section 0/035 at different elevations upstream (fig a) and downstream (fig b).

The unexpected temperature peaks and dips are thought to be due to the temperature variations of the internal reference oven. This error can be eliminated by measuring the actual temperature of the oven. In addition, using a section of the sensing fibre at a known temperature, we could eliminate any common errors caused by the instrument.

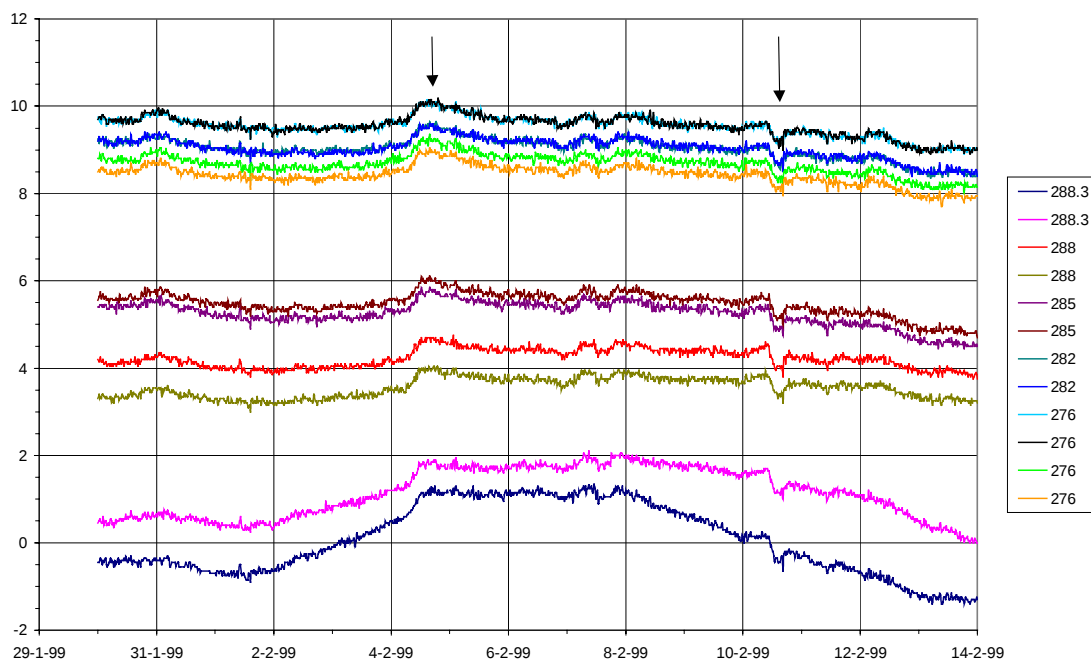
All data presented above are daily data stored at noon. However, the result from the last period with measurements each 20 minutes gives similar result, see Figure 13. Shorter peaks and dips can also be found on this time-scale. These are larger than the normal noise that is about  $\pm 0.2^{\circ}\text{C}$ . If those large dips and peaks could be eliminated the accuracy should be improved.

**Figure 13** Measured temperatures each 20minutes in sec 0/035 at different locations on the upstream side. The arrows indicate a short-time peak and a dip.

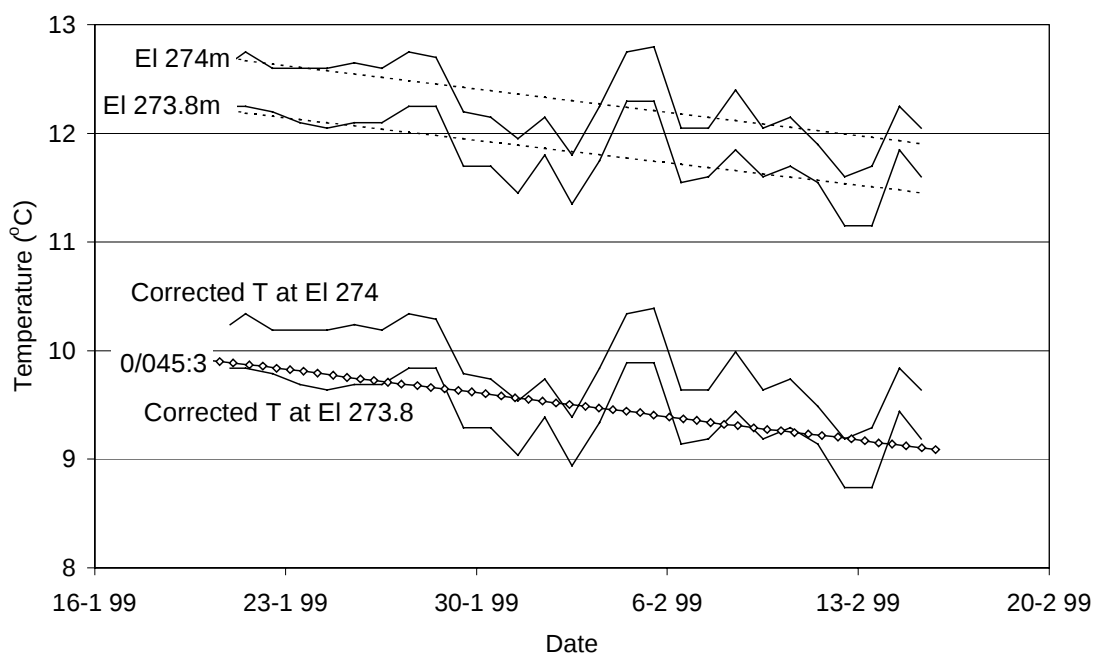
The two piezometers 35:3 and 45:3 are located in the downstream filter under the new core where the optical fibre is also located. The results from the two temperature monitoring systems can therefore be compared. The difference, about  $2.5^{\circ}\text{C}$ , is much larger than expected (accuracy better than  $0.5^{\circ}\text{C}$ ), see Figure 14. Comparison was done at two locations (section 0/035 and 0/045) where the temperature was measured both inside (with the DTS-system) and outside the optical fibre (with the vibrating wire temperature sensor). Based on those data an adjustment of about  $2.41^{\circ}\text{C}$  was obtained, based on best-fit linear approximation for both calibration points.

**Figure 14** Measured temperature in piezometer 0/045:3 (El. +273.65m) and in the optical fibre at El. 273.8 and 274m in section 0/045. The piezometer is located between and below the optical fibres. The dotted lines show the best-fit linear approximation to the measured temperatures.

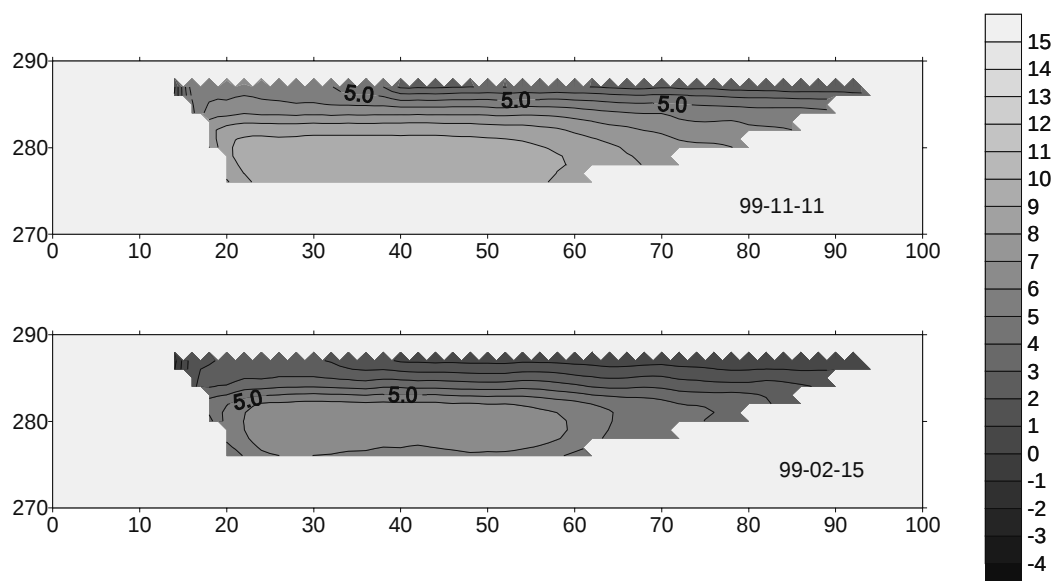
Longitudinal sections over the temperature field have been made with about one week interval. Two of those are shown in Figure 15. The pictures indicate clearly the location of the isolation that was installed up to about section 0/030. The temperature was still above the freezing point in the dam, but the cold will continue to penetrate into the dam until April/May at those depths. Another observation is that the area above the slurry trench was warmer than outside section 0/058. The colder temperature was probably caused by a higher seepage in this part of the dam, may be below the excavation/lowest measuring level.

**Figure 15** Temperature in the upstream filter at the beginning and at the end of measuring period (longitudinal section).

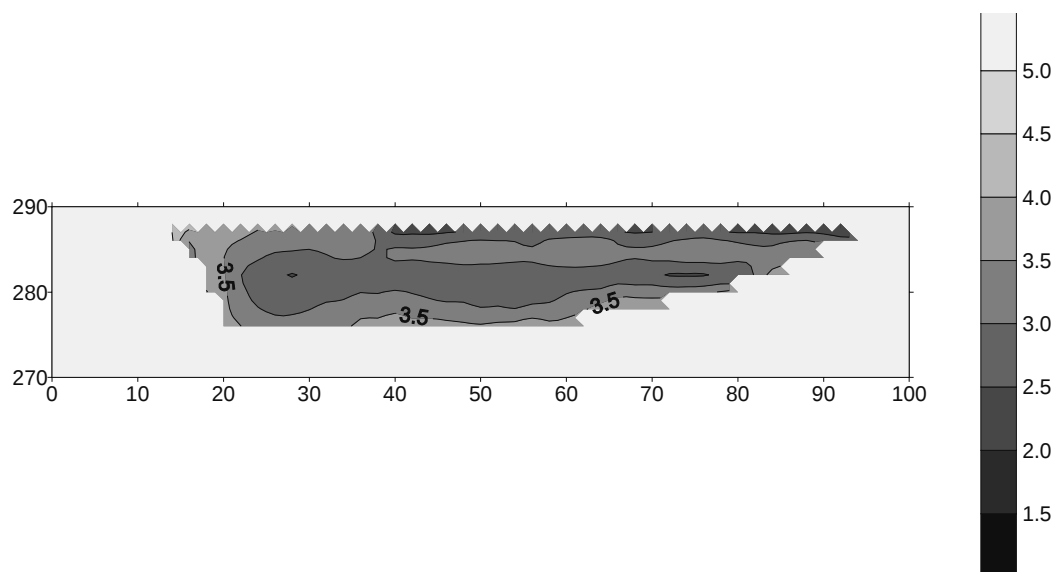
The largest temperature difference during the measuring period is in the lowest part in the dam at El. 276m and close to intake (at the left side of the Figure 16). The low temperature as well as the larger temperature difference close to the intake section can be explained by heat conduction from water and air. The large temperature difference at El. +276m cannot currently be explained.

**Figure 16** Temperature difference in the upstream filter between 1998-11-20 and 1999-11-15 (longitudinal section).

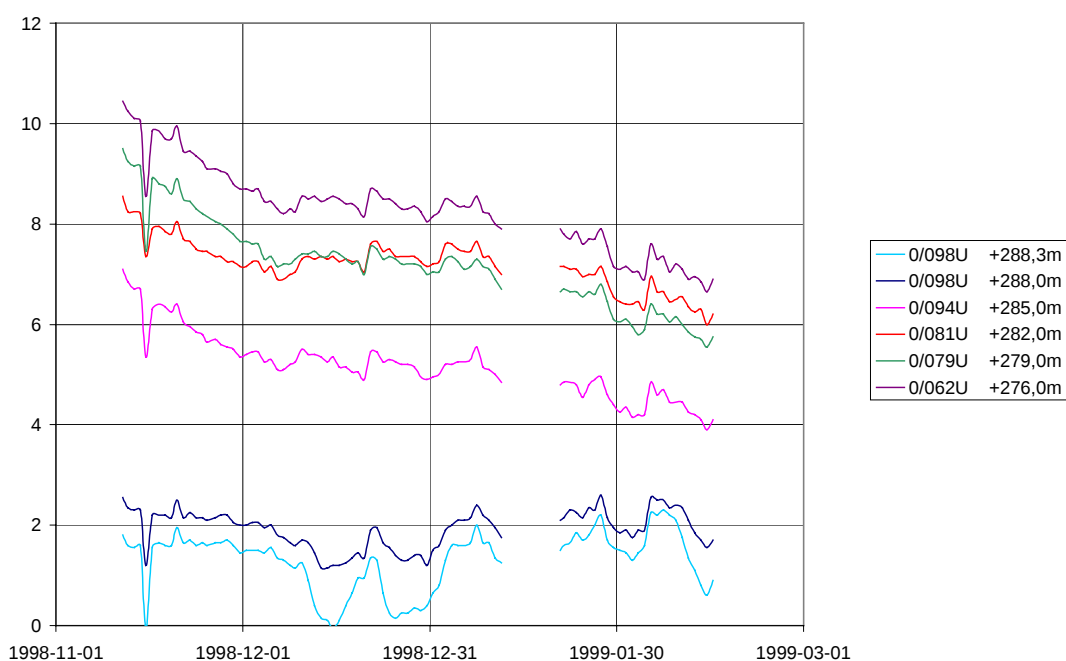
The temperature variation in the outer parts the repaired area where it connects to the old core gives some indications of the seepage. As discussed above (see Figure 11) all temperatures are lower at the turning point of the fibres. This depends probably on a slightly higher seepage in the old core, which gives a more rapid temperature decrease. The temporal temperature variation in the endpoints (see Figure 17) is although similar to the other sections (as shown in Figure 12).

**Figure 17** Measured temperature at different elevations in the upstream cable at the end of the monitoring section.

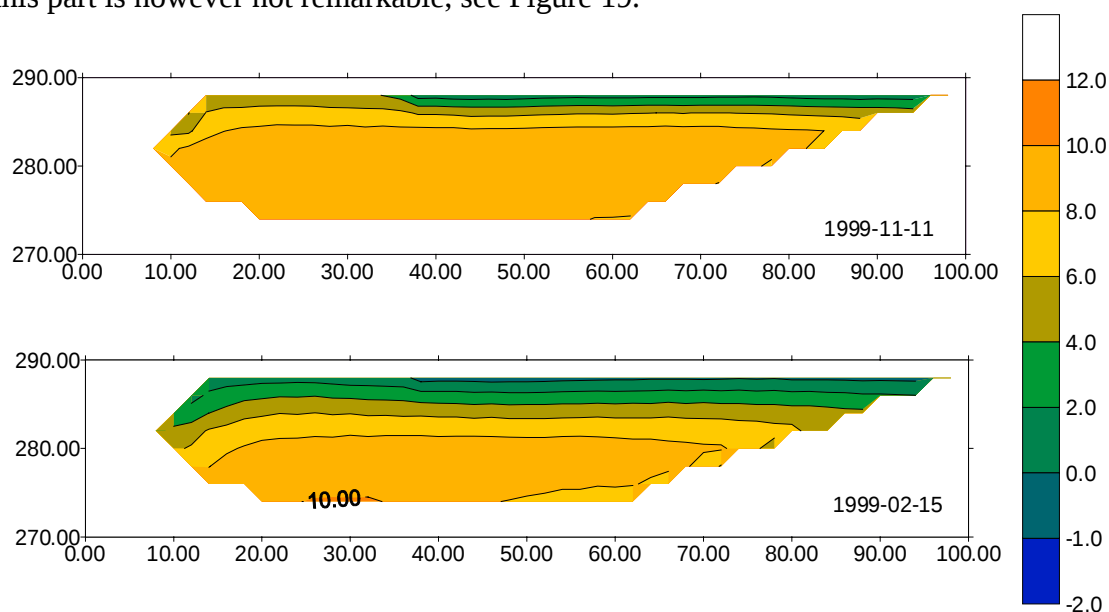
The measured temperature in the downstream filter was similar to that in the upstream part. The influence of the isolation is clearly seen, see Figure 18. The extent of the warmer area is however larger and is extended almost over the entire repaired region. The exception is in the lower part from about section 0/045 where a lower temperature occurs, especially in the last part of the measuring period. The temperature difference in this part is however not remarkable, see Figure 19.

**Figure 18** Temperature in the downstream filter just outside the core at the beginning and at the end of measuring period (longitudinal section).

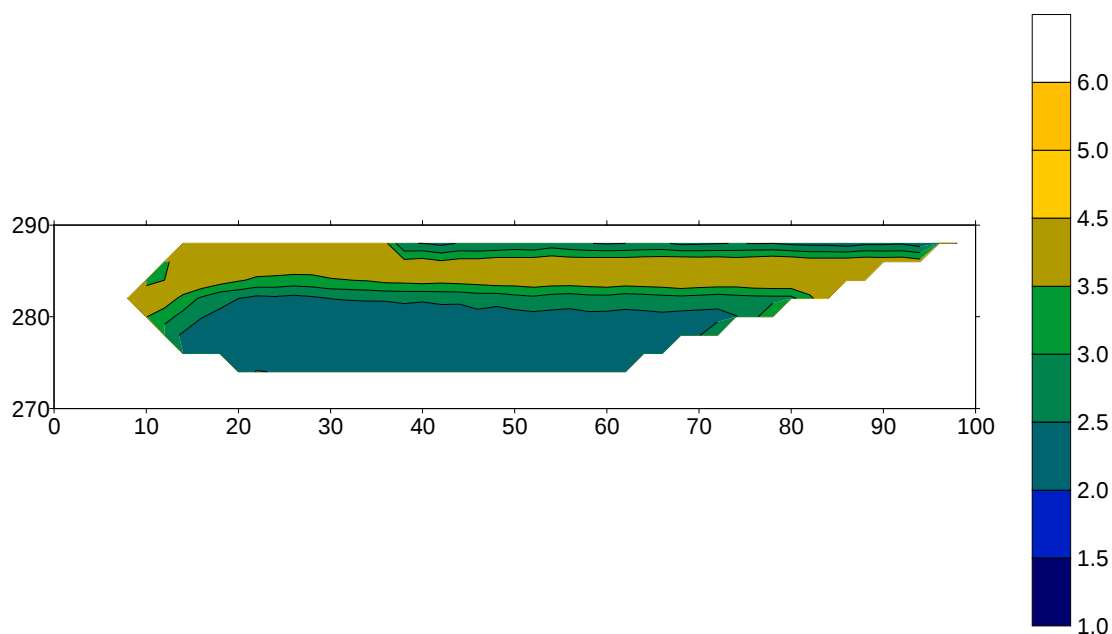
**Figure 19** Temperature difference in the downstream filter between 1998-11-20 and 1999-11-15 (longitudinal section).

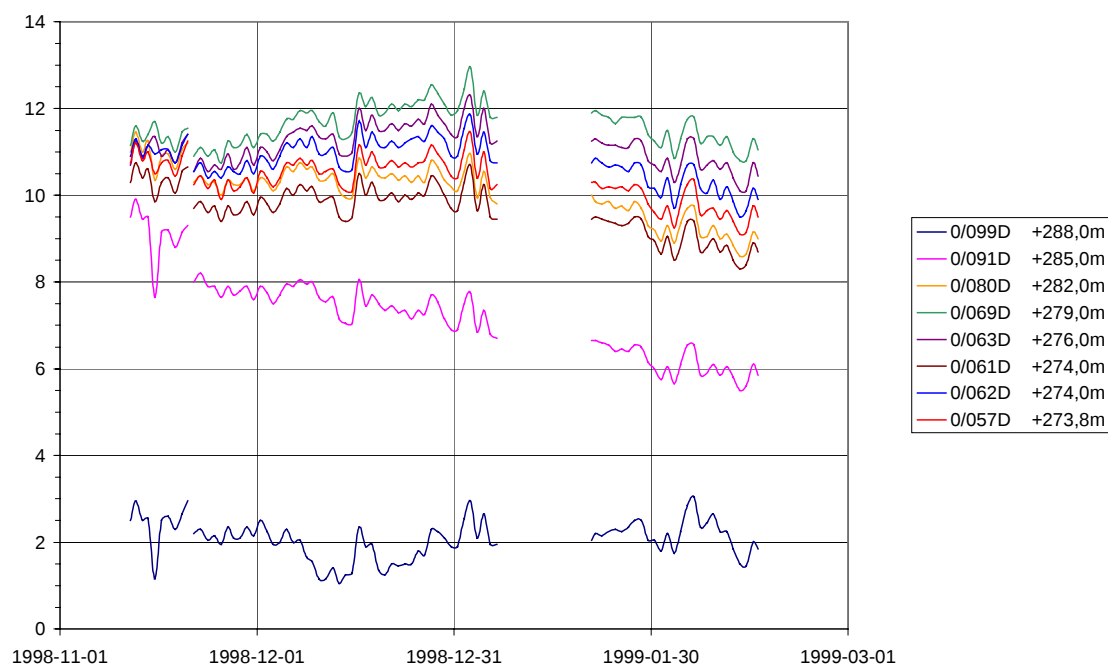
Temperature variation with time exhibits a similar pattern as showed in the upstream fibre. Peaks and drops occur over the entire fibre at same time. This further indicates that they must be caused by the monitoring system. The general trend in the downstream cable in the end of monitoring section shows however a temperature maximum in December/January. This can be compared with the upstream fibre, where a constant temperature decrease was found.

**Figure 20** Measured temperature at different elevations in the downstream cable at the end of the monitoring section.
