# SAMPO Workshop 27 – 28.11.2019

## New "Lining" in Tanks on Ringhals AB

22-11.2019 Stjepan Jagunic

Expiriens – Leakage in PTFE pipe on  
Ringhals AB

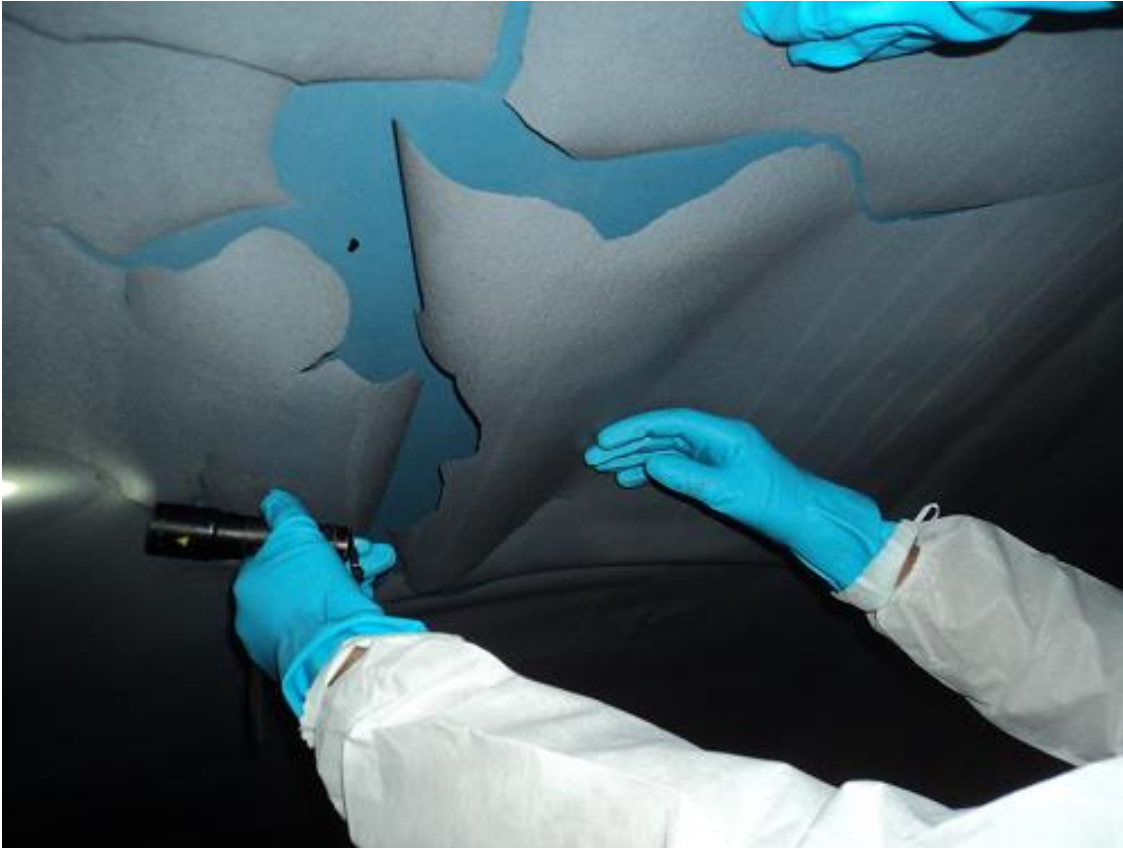
On the south side of the tank roof, an area of about 0.5 m<sup>2</sup> was noted where the upper inner composite layer has dropped from the underlying composite layer. However, nothing has fallen into water.

The reason was hot days and exceeded time span for application of the second composite layer. The underlying layers were intact.

4 m<sup>2</sup> of the bad adhesive layer was removed before repair.

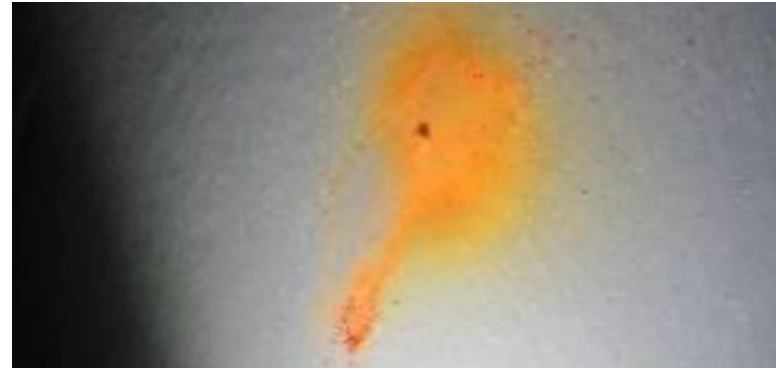
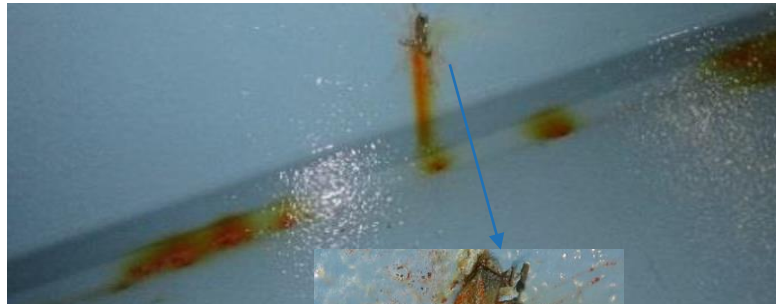
After scrape  
with knife

Several smaller corrosion deposits have been found.

These were located mainly along the edge of the floor and mostly in one half of the tank and about 2 m up on the walls.

A few were going through.

Most of the corrosion particles were embedded in epoxy layers without contact with the underlying tank steel.

The reason for corrosion deposits is poor cleaning after blasting before painting 2017.

All locations were restored by grinding and repainting

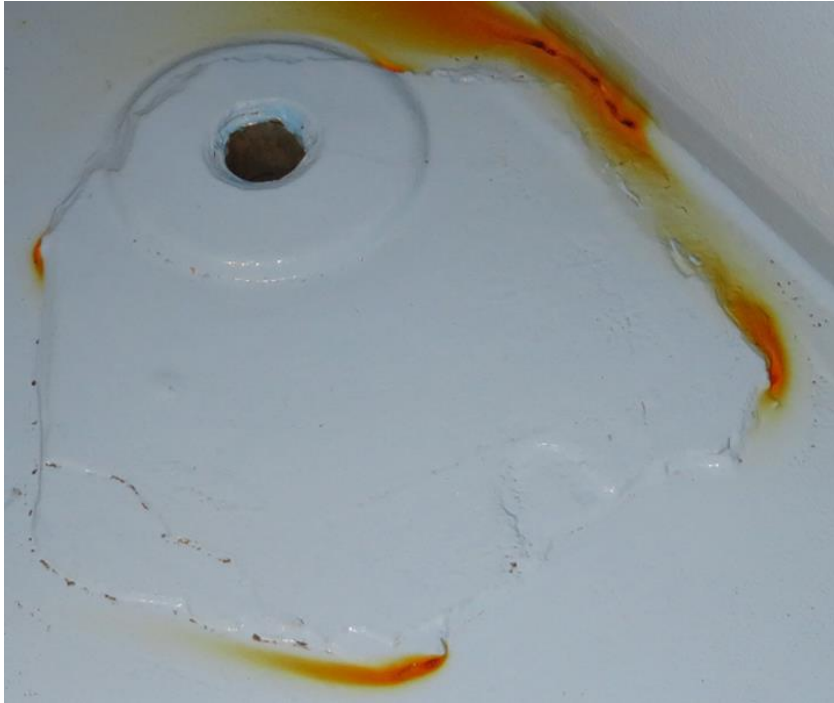
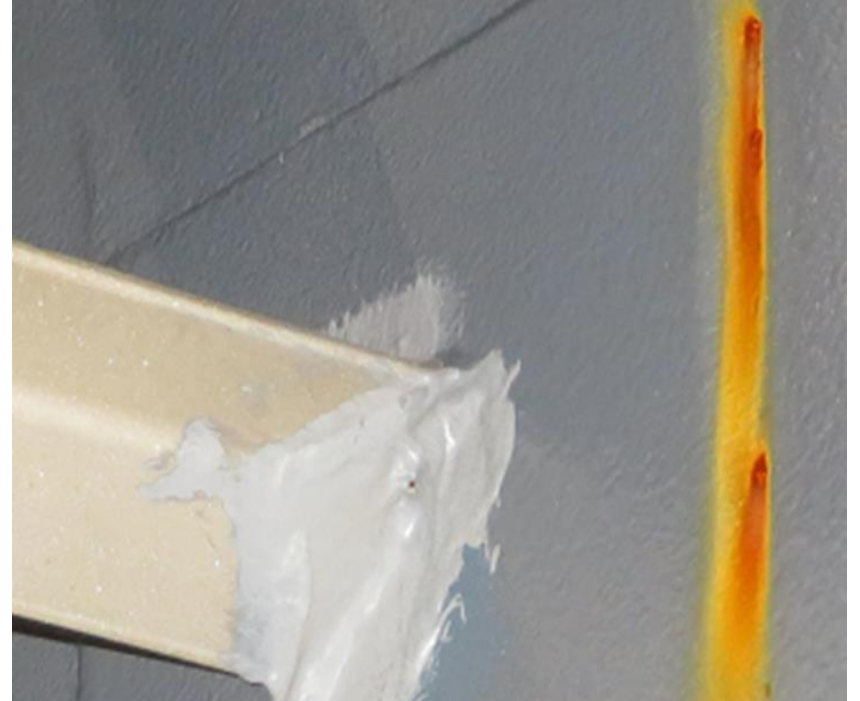
- Corrosion deposits around left old rubberized and welded steel plates. The reason is moisture that has not been dried before painting in 2017.
- Adhesion tests showed very good adhesion and the breakage occurs in the glue between the dolly and epoxy composite. Mean value 11,6 MPa

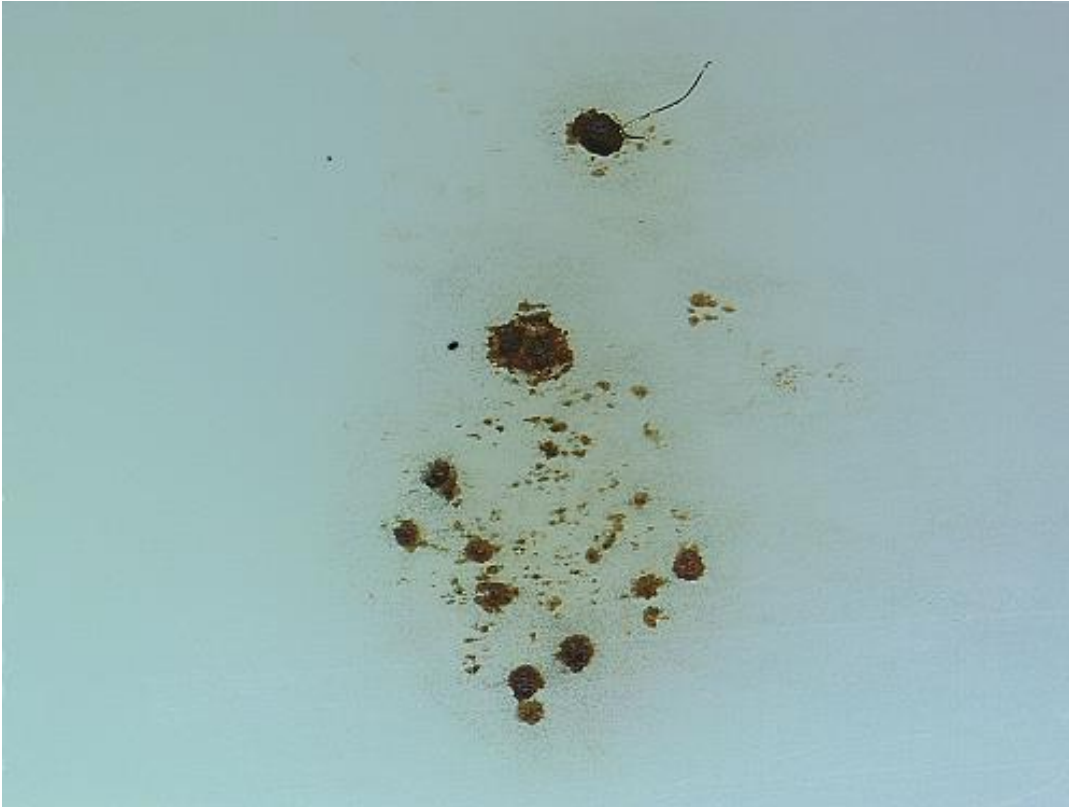
# Colling tube for generator R1

The cooling pipes in the new generator on Ringhals 1 are manufactured in PTFE (Ø30 mm). In one of these, the leak occurred.

The reason for the leak was poor purity at the manufacturer during manufacture. Small carbon steel particles have fallen into the pipe material. When these have corroded, the leak has occurred.

This type of error is difficult to catch with receive control. The example show that purity is always important.
