Measurement and analysis of piping vibrations in turbine feed-water systems

Vibrations in nuclear applications 2020

Thomas.Probert@OKG.Uniper.Energy

Applying the methodology to damage in system 462

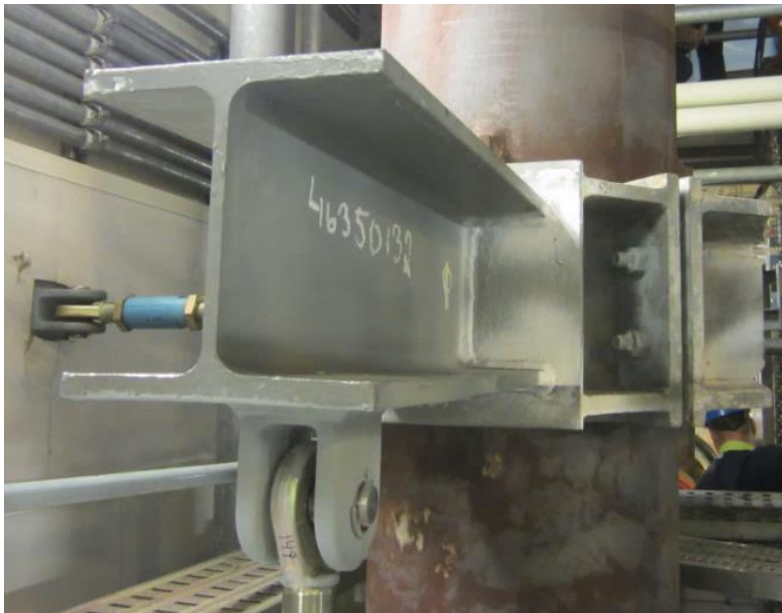
Large piping & large supports

Heavy and hard to handle

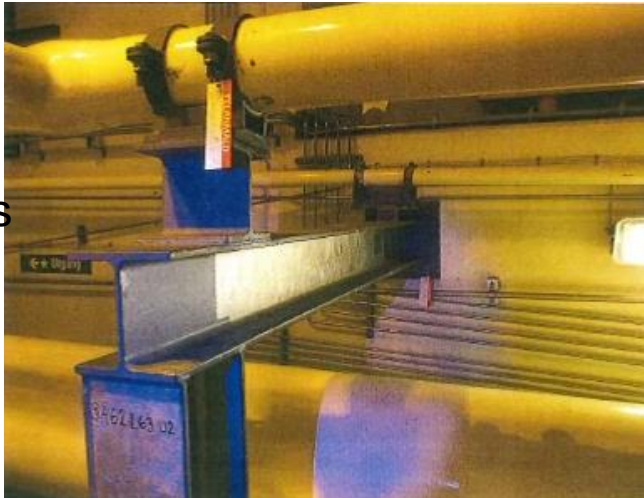
462L63/U2
Vibrations
and
displacements
(loose
expanders)

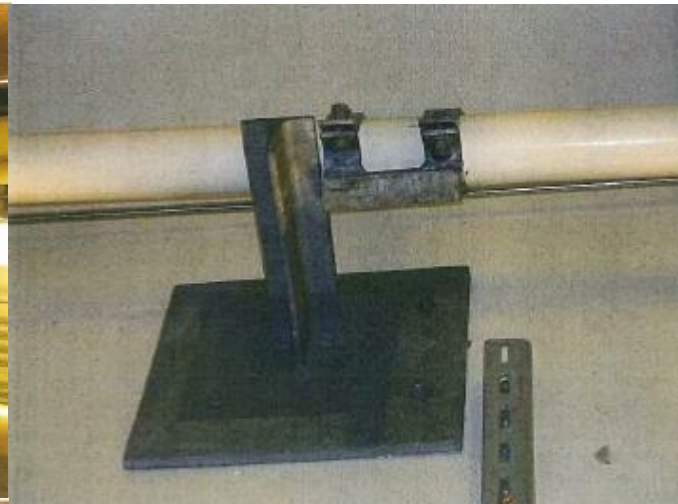
462L151/U14
Displacement

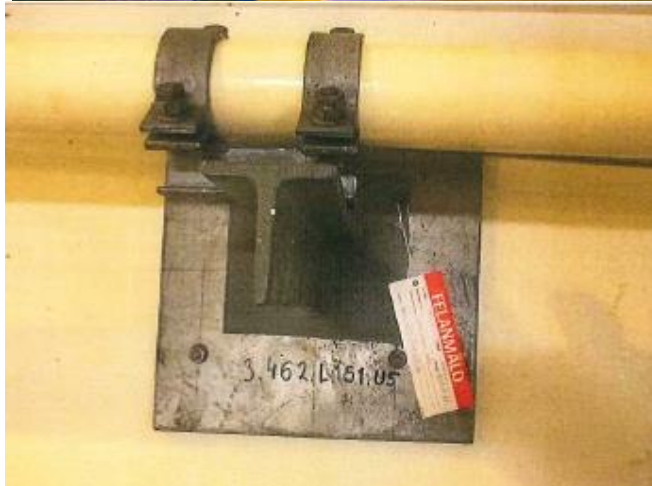
462L151/U5
Vibrations
(loose
expanders)

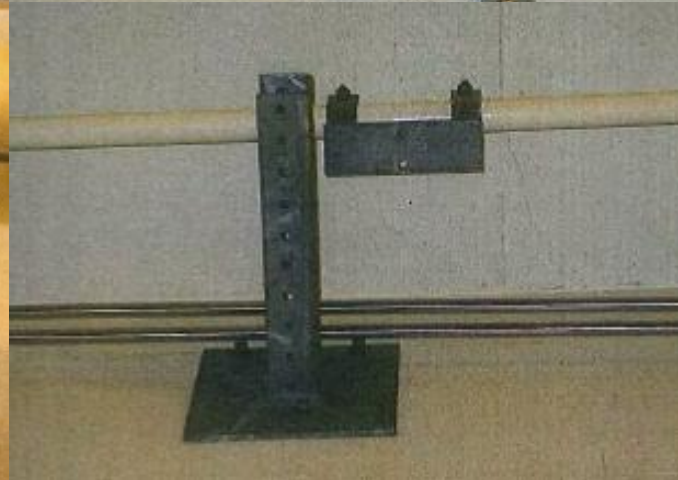
462L152/U1
Displacement

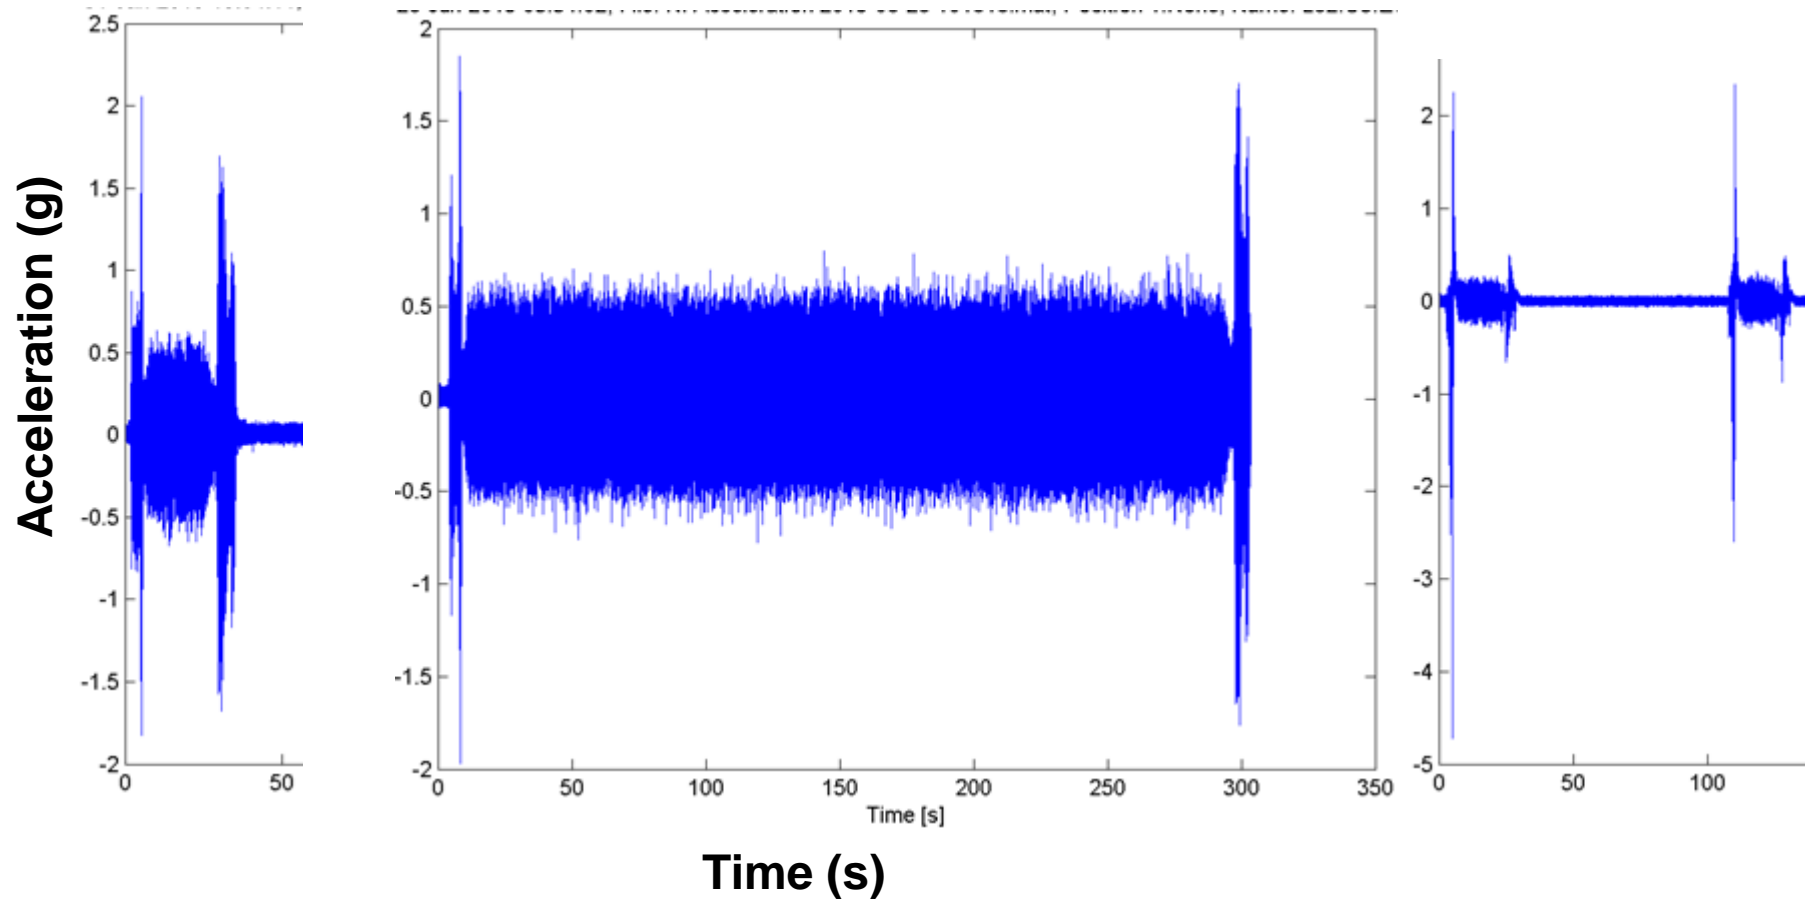
Accelerations on the supports

“Triggered” every Friday night

- **The valve 462VA35 for cooling the dump-drums is opened and closed every Friday night according to DRUS**
- **According to the night shift’s instructions the valve must be opened and closed every Friday night to ensure its function**

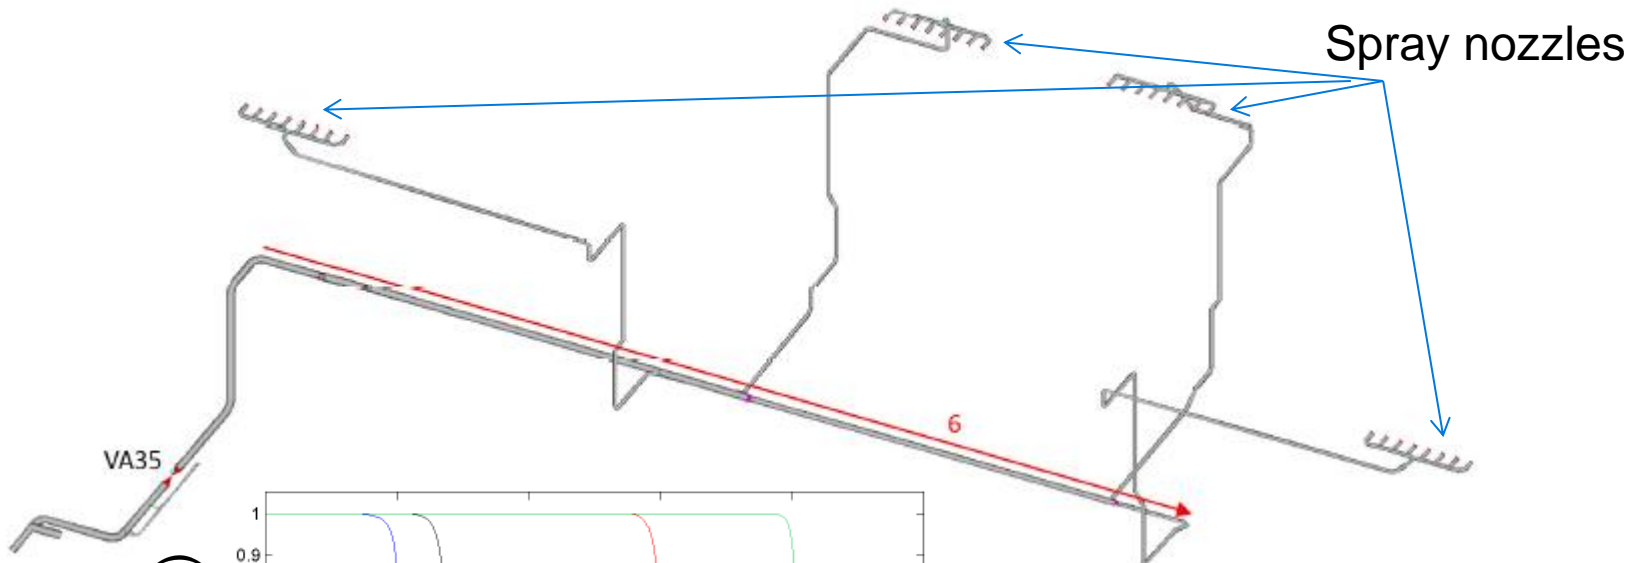
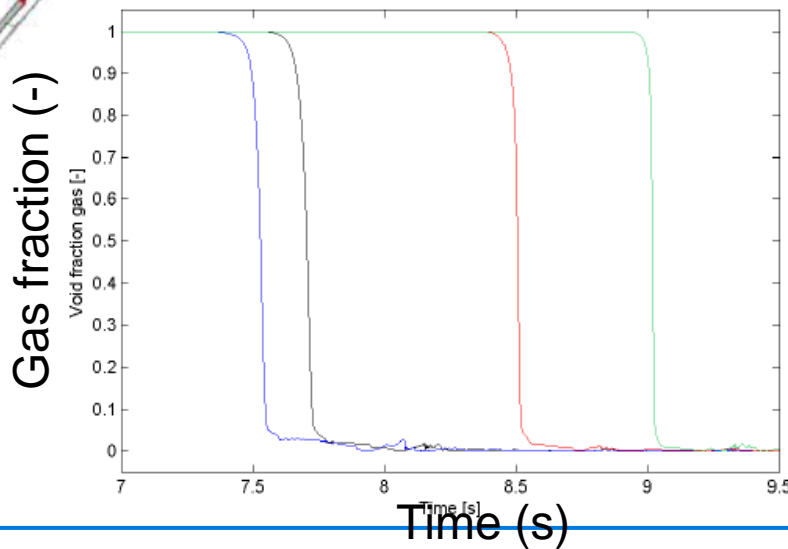
The piping leading to the dump-drums

The time when the gas has been pushed out of the piping via the nozzles. This is when the water front impacts the nozzles and causes loads

- At shut-down before the outage in 2018 462VA35 was opened/closed when the condenser pressure was roughly 1,2 kPa
- The temperature of the condensate was 13,5°C
- At 1,2 kPa the saturation temperature is 9,7°C
- It is probable that 462VA35 opened when some of the water in the piping had evaporated which caused the damage (vibrations & displacements)
- Work is on-going to avoid this scenario in the future
