PM Comments regarding measurements with DAS at the Experimental dam at Älvkarleby

This PM is written upon request from Energiforsk. It complements the two reports written about the Distributed Acoustic Sensing (DAS) measurements made in 2020 at filling (Phase 1) and 2021 at lowering (Phase 2) the reservoir at the dam at Älvkarleby (Johansson et al., 2021; Johansson et al., 2022). It also includes comments regarding the ability to detect defects, revealed after the reports were written.

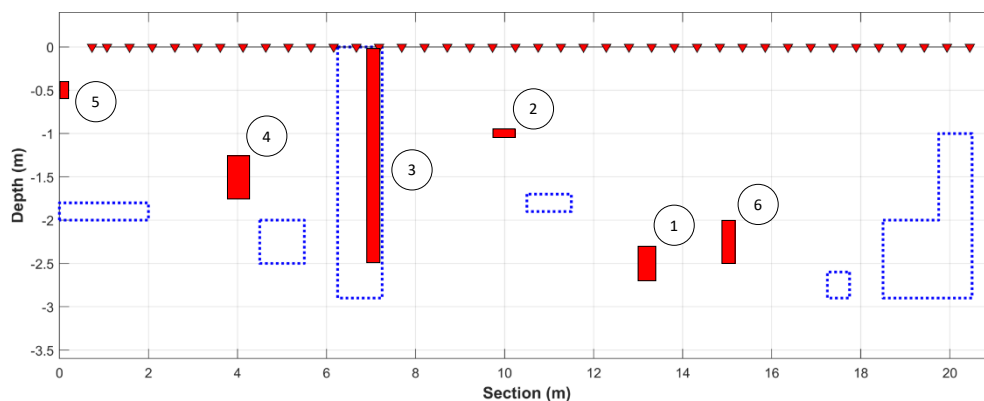
Figure 1 shows high-velocity zones corresponding to potential defects identified by the imaging method of Phase 2. There are high-velocity zones in Figure 1 in the vicinities of defects 3 and 4. Also defects 2 and 5 can be considered identified if section is regarded. Defect 6 should not give significant deviations from the surroundings. The two remaining right-most zones must be caused by other irregularities. It is possible that they are due to the unintended higher seepage flow in this area.

Figure 1 Location of potential defects identified by imaging in Phase 2 (Johansson et al., 2022). Red squares indicate locations of revealed dam defects, with numbers corresponding to Table 1 (Lagerlund et al., 2022).
