# INCREASED FUEL FLEXIBILITY AND PERFORMANCE FOR BOILERS WITH CHALLENGING FUELS

RAPPORT 2023:928

# Increased fuel flexibility and performance for boilers with challenging fuels

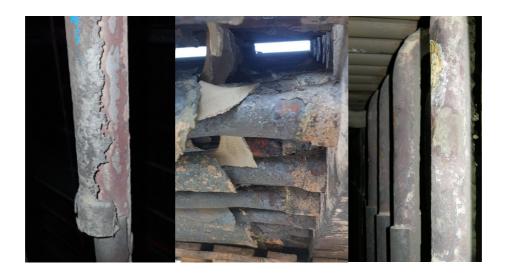
Leaks in the tubes is the most common reason for unscheduled stop in the boilers. Some of the leaks have been recently observed in the superheaters (P15) or close to the cyclone (Värtaverket). The leaks are caused by erosion and corrosion of tubes. Maintenance of the tubes and tube sheets for the superheaters include overlay welds, removal of slag and replacement of tube shields (every 2 years in P14). The corrosion rates of tubes and tubes shields have been considerably reduced with ChlorOut additions in Jordbro boiler (see Figure 3).

Figure 3 Corroded and eroded tubes with tube shield in P15 (left), SH3 in P14 (middle) and SH2 with ChlorOut additions in Jordbro.

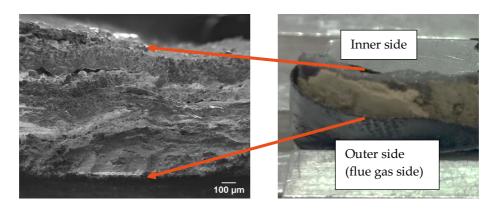
Figure 4 SEM image of cross section of deposit collected from boiler P6 at Mälarenergi (left) and its corresponding photograph showing the inner side of the deposit and the outer side (exposed to flue gas).

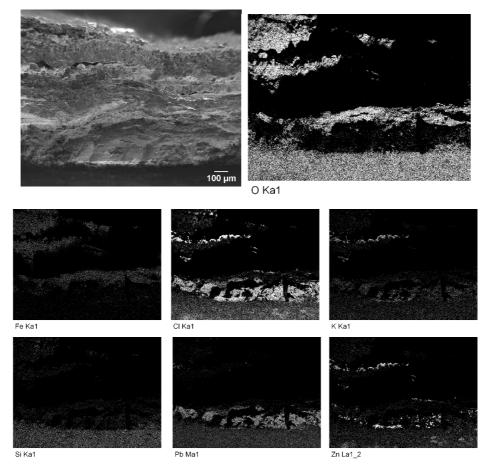
Figure 5 SEM image and its corresponding elemental maps (EDS) of deposit collected from boiler P6 at Mälarenergi (empty pass). Upper side corresponds to the inner side of the deposit/scale, while the bottom side is the outer side that was exposed to flue gas. O, Fe, Cl, K, Si, Pb and Zn maps are depicted. The maps of Pb and Na are indicative only, since the signals overlap with S and Na, respectively.

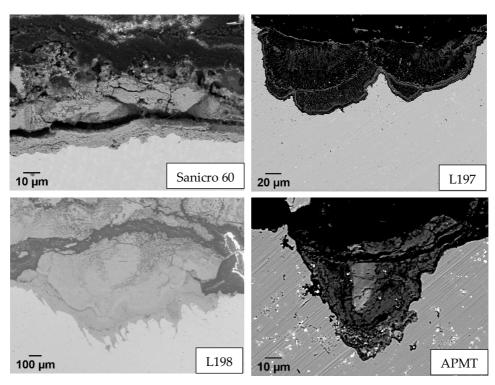
Figure 13 SEM images of the typical corrosion attack morphology exhibited by the overlay weld materials for tube shields after a 6-month exposure in a waste-fired plant.

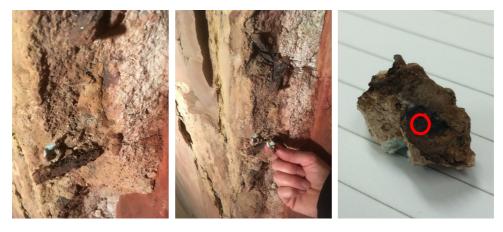
Figure 15 shows a piece of studding (refractory anchor) from the boiler Händelö P14, retrieved from the cyclone inlet. The composition of the corrosion products and deposits in the specimen was analysed using SEM/EDS. The encircled area in the right-most picture of Figure 15 shows where the analysis was attempted. Figure 16 and Table 3 show the corresponding SEM image and chemical analysis results. The specimen exhibited low conductivity which resulted in high uncertainty, which is related to its composition, indicating that extensive corrosion has occurred. The composition suggests the presence of iron-based oxides and segregated areas containing Na, S and Ca.

Figure 15 Retrieved studding from boiler Händelö P14. The encircled area corresponds to the chemical analysis shown in Table 3.

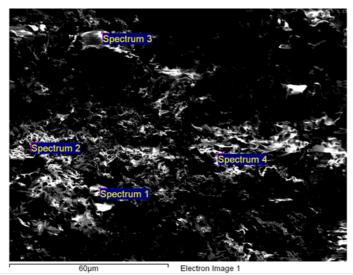
Figure 16 EDS map corresponding to the encircled section in Figure 15. Table 3 shows the corresponding results in weight %.

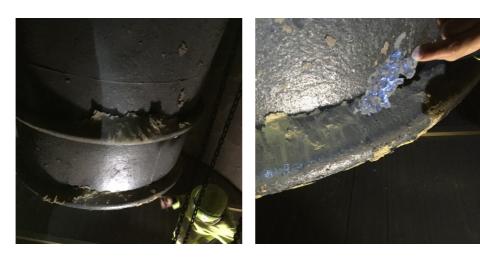
Figure 17 shows the localization at the cyclone vortex finder of Händelö P14 boiler system, where flakes were collected to inspect using SEM/EDS. The examined flake is shown in Figure 18 and exhibits extensive corrosion. The EDS results in Table 4 show localized chromium-containing oxides (Spectrum 1) and the widespread presence of iron-containing oxides.

Figure 17 Cyclone vortex finder in Händelö P14 boiler. Flakes from this area were retrieved for SEM/EDS analysis.

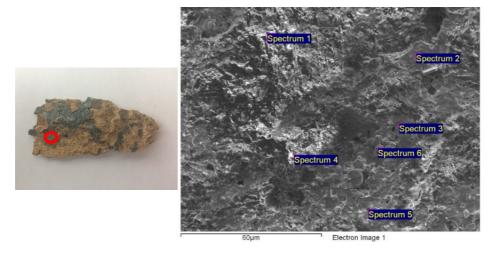
Figure 18 Flake retrieved from the cyclone vortex finder in the Händelö P14 boiler system. The circle in the left picture indicates the analysed area by SEM/EDS. The rightmost SEM (secondary electrons) image indicates the EDS point analyses (Spectrum 1 to 6) showed in Table 4.

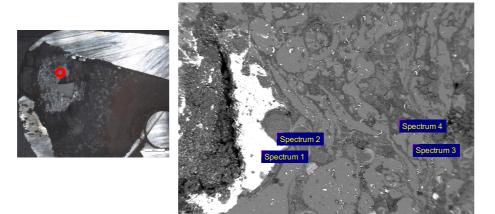
Figure 20 The left image shows a cross section of retrieved primary air nozzle. The encircled area was investigated using SEM/EDS. The rightmost image is the secondary electron SEM image with point analysis (Spectrum 1 to 4) shown in Table 5.

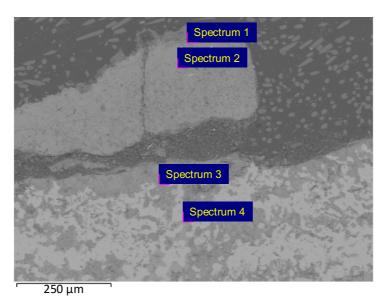
Figure 26 SEM image corresponding to the cyclone vortex finder sample retrieved from Mälarenergi P6. The corresponding compositions for the spectra are shown in Table 9.

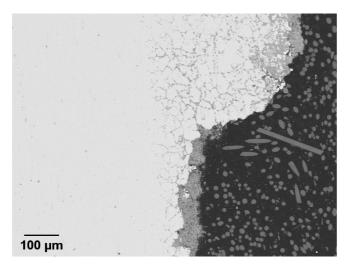
Figure 29 SEM image (Backscattered electrons) of the cross section of a studding from Mälarenergi P6 boiler.

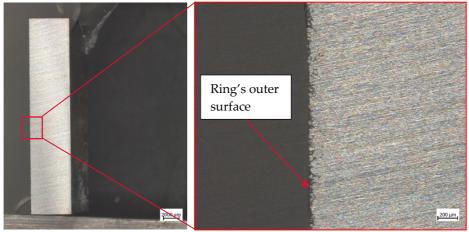
## • #1 253 MA (reference)

Figure 36 Specimen #1 corresponding to the alloy 253 MA (reference) after exposure. The zoomed in picture to the right shows an indication of internal corrosion attack (about 0.1 mm deep).

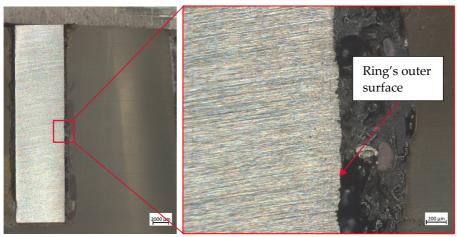
# #2 Solid Kanthal® APMT<sup>TM</sup>

Figure 37 Specimen #2 corresponding to the alloy solid Kanthal® APMT™ after exposure. The zoomed in picture to the right shows negligible corrosion attack.

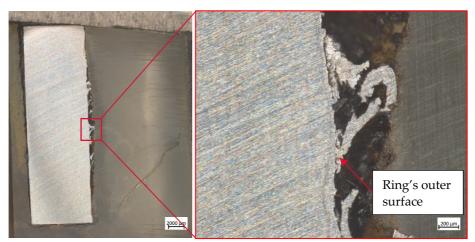
Figure 38 Specimen #3 corresponding to the welded alloy Kanthal® APMT™ after exposure. The zoomed in picture to the right shows remaining welded coating and no signs of internal attack.

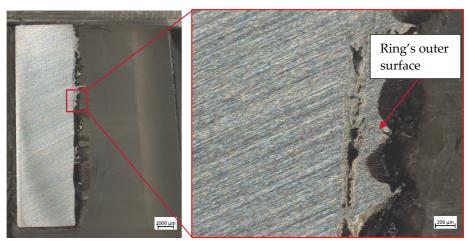
Figure 39 Specimen #4 corresponding to the welded alloy Kanthal® EF100 after exposure. The zoomed in picture to the right shows remaining welded coating and no clear signs of internal attack.

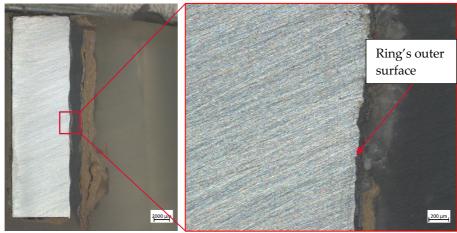
Figure 40 Specimen #5 corresponding to the welded alloy Kanthal® EF101 after exposure. The zoomed in picture to the right shows no signs of internal attack.

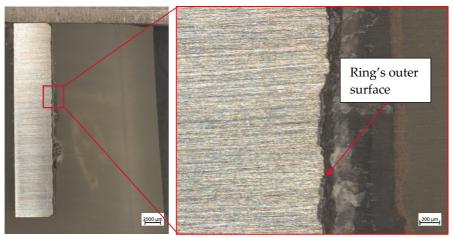
Figure 41 Specimen #6 corresponding to the alloy solid 625 after exposure. The zoomed in picture to the right shows an uneven surface and a thin corrosion layer.

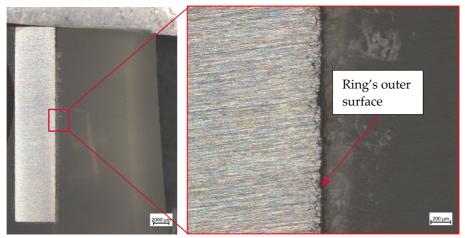
Figure 42 Specimen #7 corresponding to the alloy 253 MA (reference) after exposure. The zoomed in picture to the right shows a similar microstructure as specimen #1 (253 MA), with an internal corrosion attack of about 0.1 mm depth.

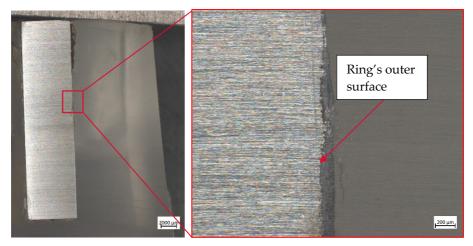
Figure 43 Specimen #8 corresponding to the alloy solid Kanthal® APMT™ after exposure. The zoomed in picture to the right exhibits a thin corrosion/deposit layer.

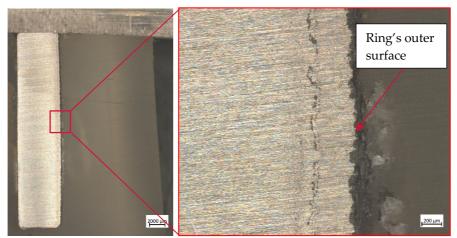
Figure 44 Specimen #9 corresponding to the coating CorrEr on a 253 MA substrate after exposure. The zoomed in picture to the right shows remaining coating (about 0.4 mm thickness) with a thin corrosion/deposit layer on top.

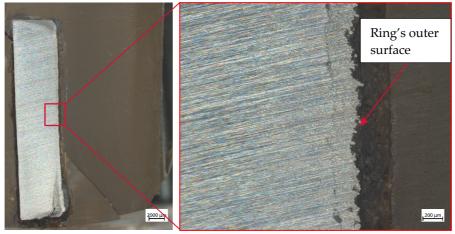
Figure 45 Specimen #10 corresponding to the coating Amdry 365-4 on a 253 MA substrate after exposure. The zoomed in picture to the right shows remaining coating (about 0.25 mm thickness) with a thin corrosion/deposit layer on top. This specimen exhibited some undermining at the edges.

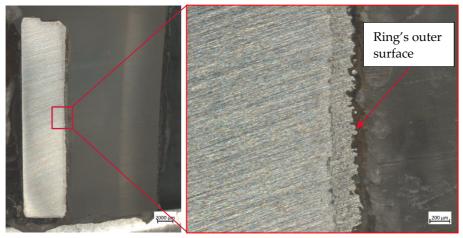
Figure 46 Specimen #11 corresponding to the coating Amdry 510 on a 253 MA substrate after exposure. The zoomed in picture to the right shows remaining coating (about 0.25 mm thickness) with a thin corrosion/deposit layer on top.

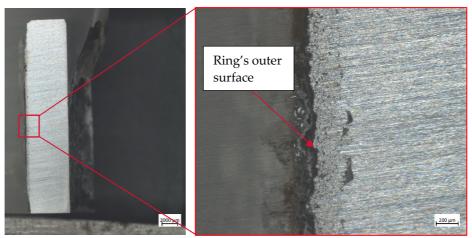
Figure 47 Specimen #12 corresponding to the coating Amdry 9700 on a 253 MA substrate after exposure. The zoomed in picture to the right shows remaining coating (about 0.25 mm thickness) with a thin corrosion/deposit layer on top. In between the coating and the substrate, some areas seem to have become detached.

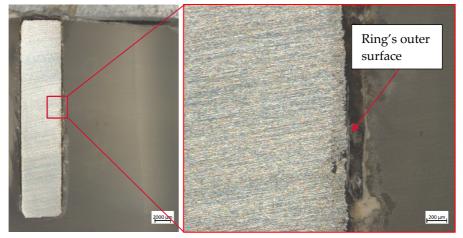
Figure 48 Specimen #13 corresponding to the coating Keram on a 253 MA substrate after exposure. The zoomed in picture to the right shows no signs of ceramic coating. However, an undefined possibly metallic layer of about 0.1 mm thickness is seen.

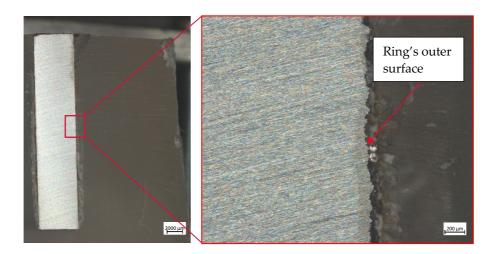
Figure 49 Specimen #14 corresponding to the alloy 253 MA after exposure. The zoomed in picture to the right shows an irregular surface but no internal corrosion attack.

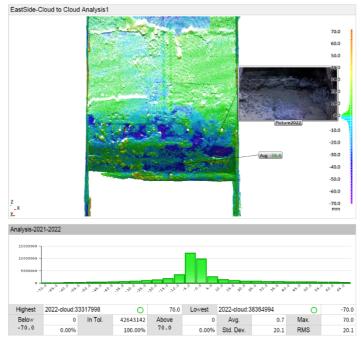
Figure 55 3D scan cloud has been used to indicate varying lining thickness due to spalling, slag build-up etc.

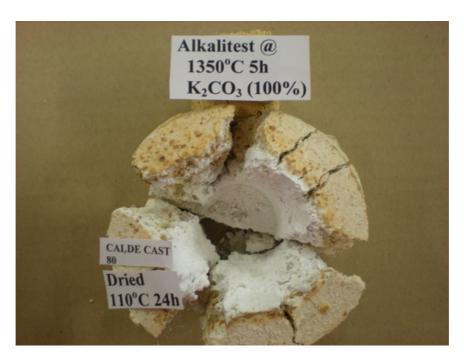
Figure 73 Photos of a high-quality refractory without the proper alkali resistance needed.
