Photogrammetry of Kalhovd dam

Kalhovd Dam

Case study of Stable Dams (2015-2019)

Pillar 49: condition assessment

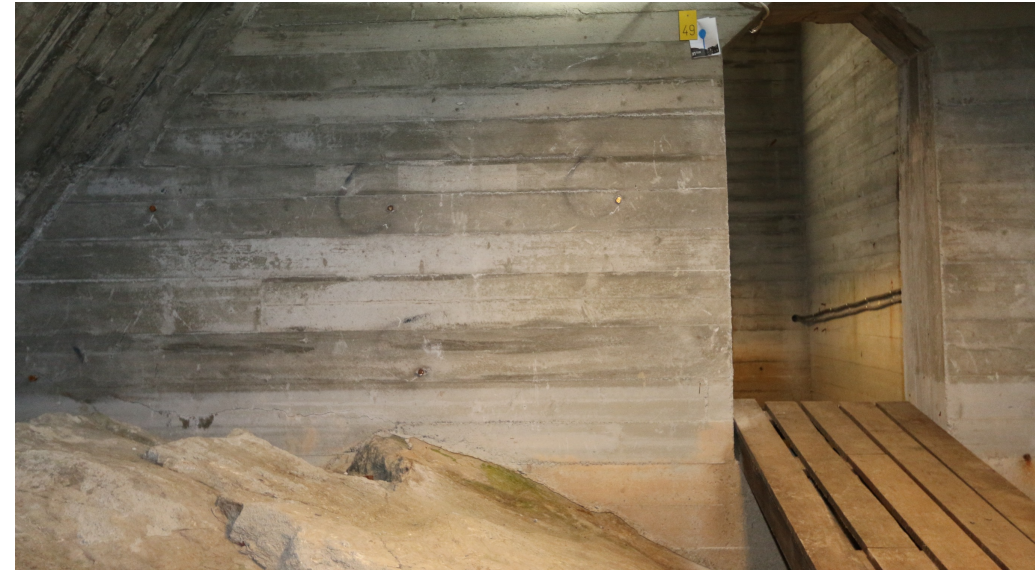
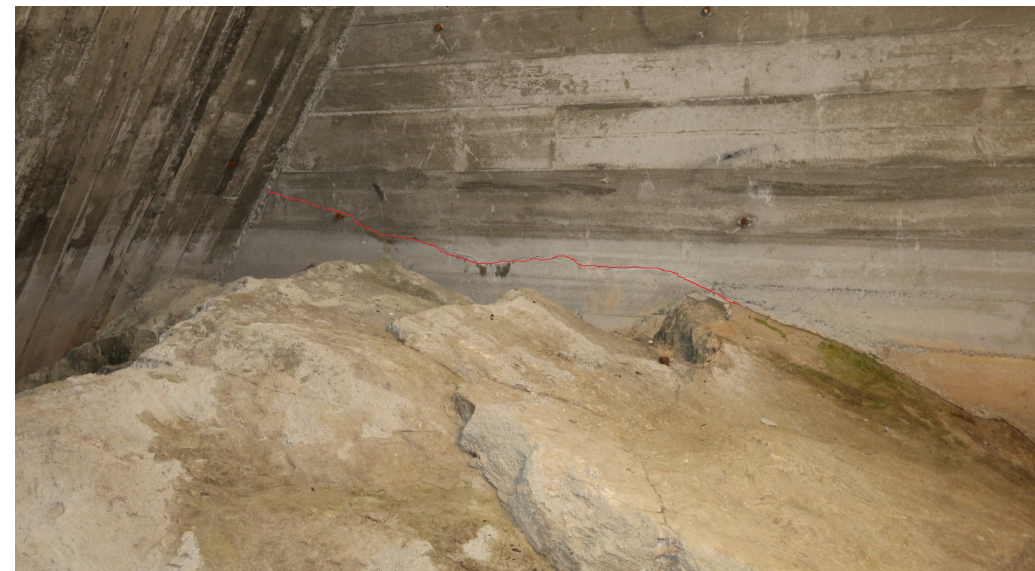
1. What caused the crack in concrete and the crack at interface ?
2. Is the process still active?

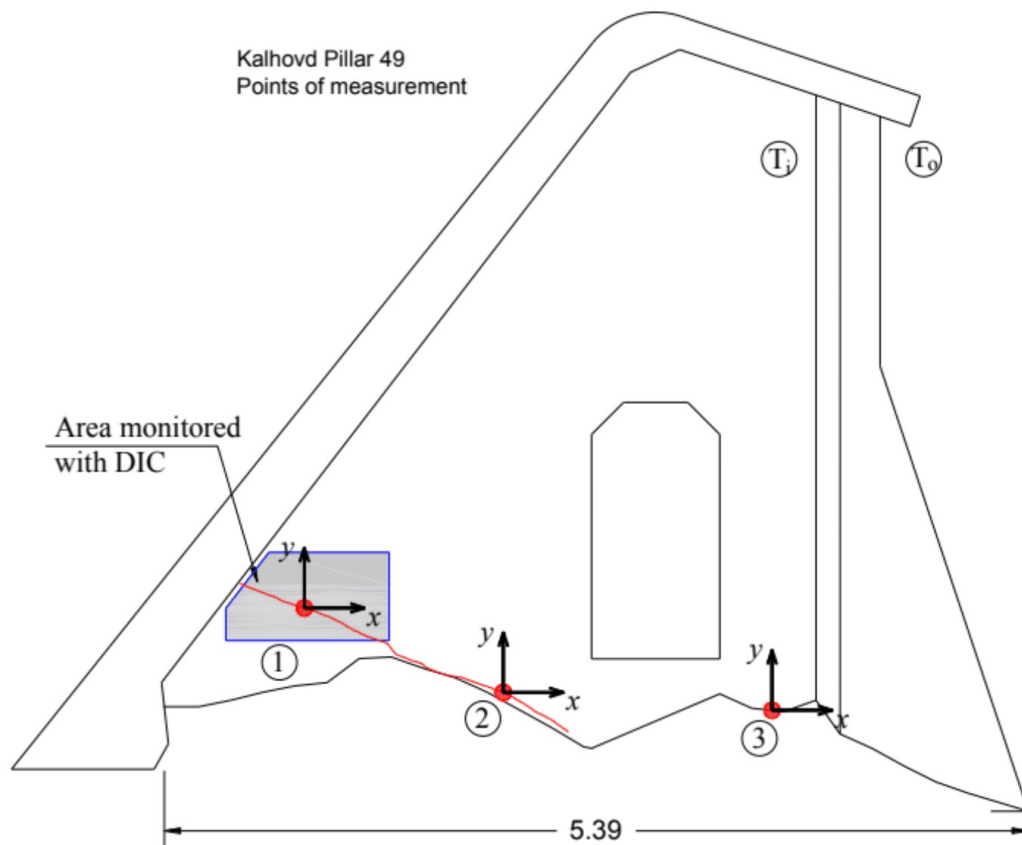
Pillar 49: Long term - monitoring plan

- Displacements:
3 points along the interface
- Crack evolution:
Photogrammetry -DIC
- Temperature:
inside & outside

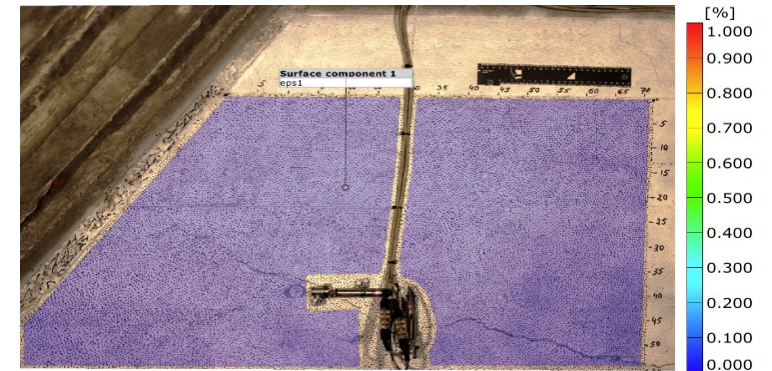
Max water level #1 (2017.11.11) - dx

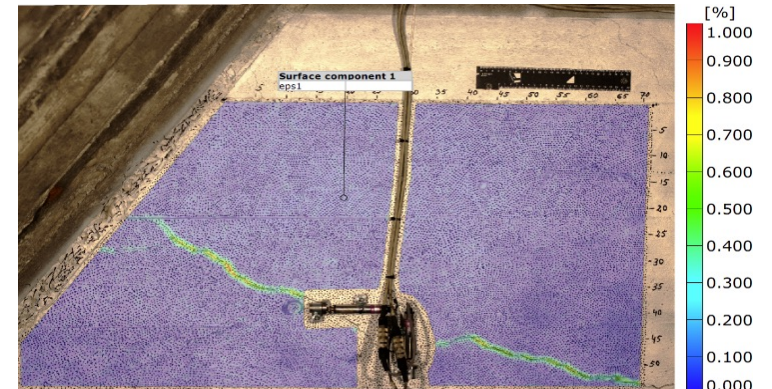
Max water level #1 (2017.11.11) - eps

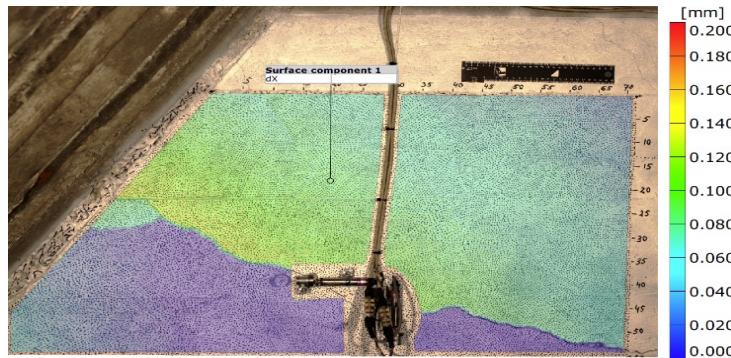
1st "peak" ice fracture (2018.02.02) – dx

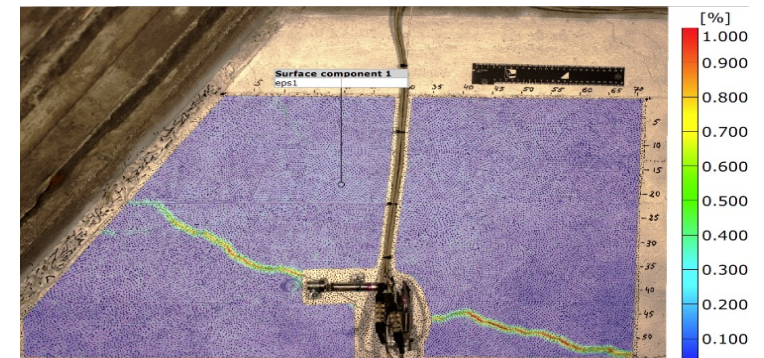
1st "peak" ice fracture (2018.02.02) – eps

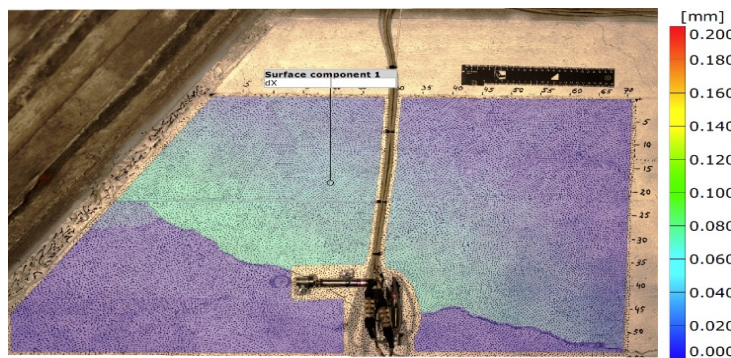
1st "peak" ice load (2018.02.05) – dx

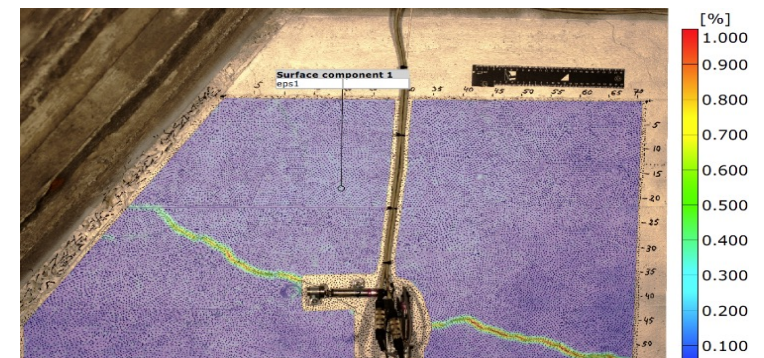
1st "peak" ice load (2018.02.05) – eps

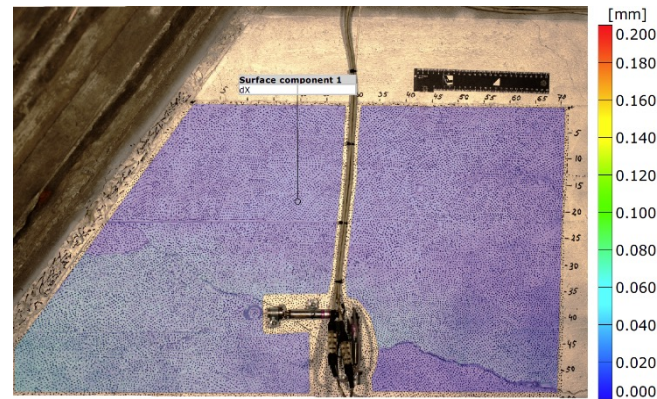
Min water level (2018.05.06) – dx

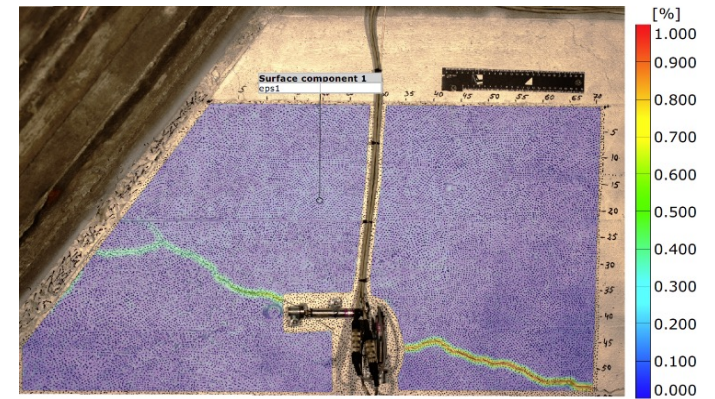
Min water level (2018.05.06) – eps
