# EARTHING GRID STATUS

REPORT 2024:1047

# Earthing grid status

INGRID STENHOLM, SWECO SVERIGE AB

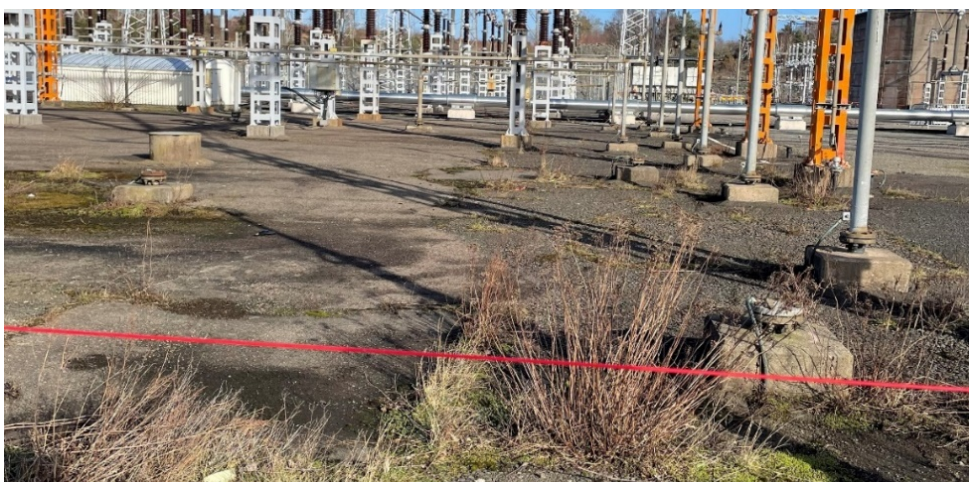
Figure 1 Ground at site with asphalt and foundations

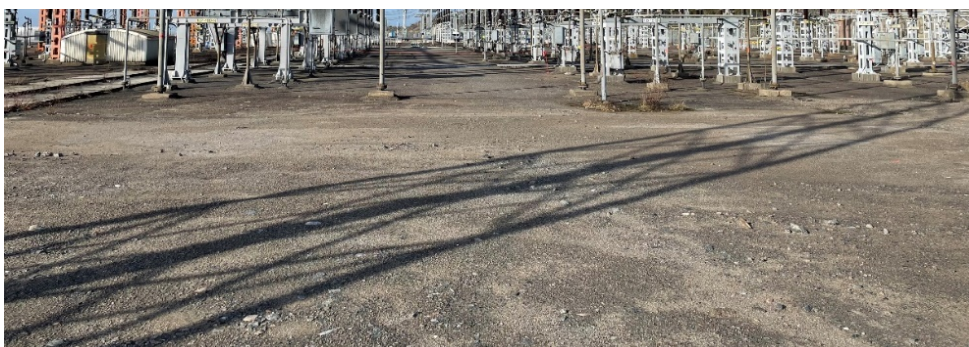
Figure 2 Ground at site with asphalt and foundations

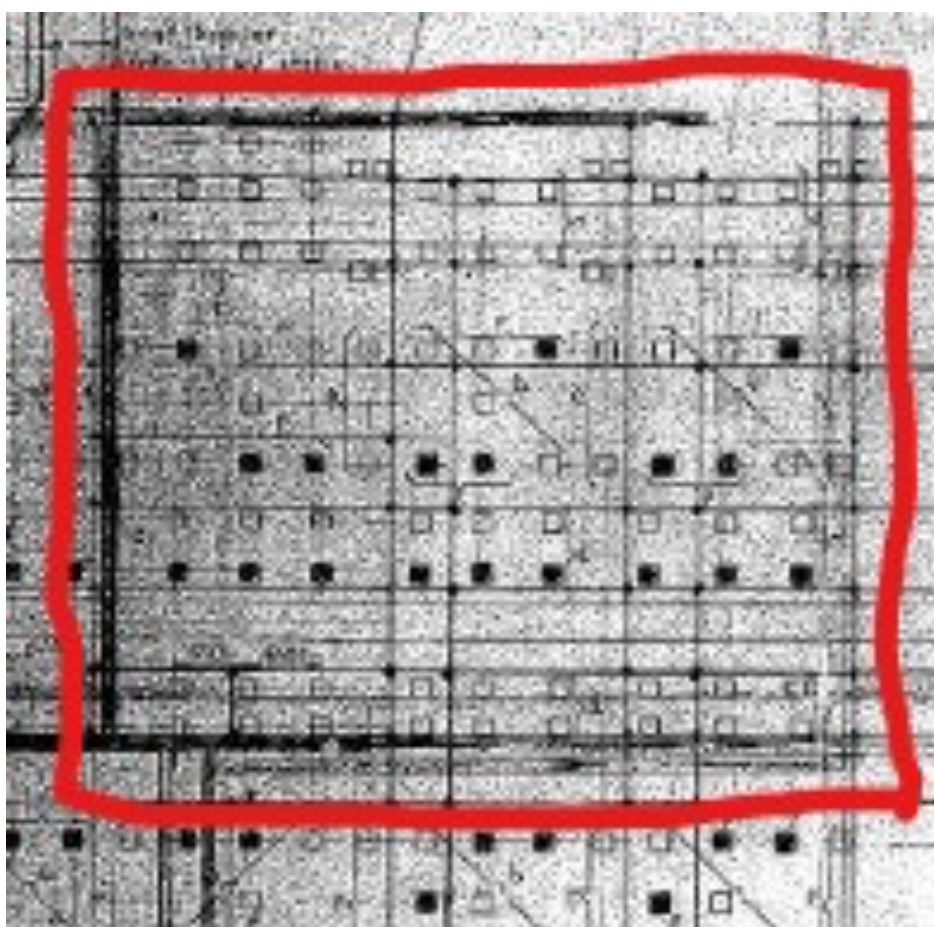
The part that could be tested was approximately 50 x 50m and it was out of operation. However, it was part of a larger grid, that was still in operation. See Figure 3.

**Figure 3** Affected part of drawing of the on-site earthing grid ~50x50m

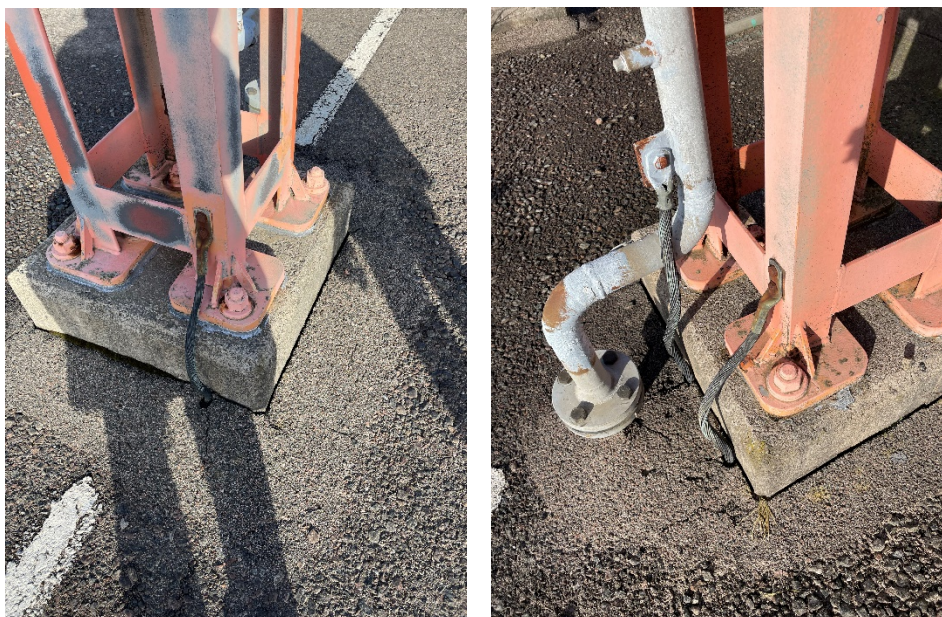
Figure 4 Connections to earthing grid

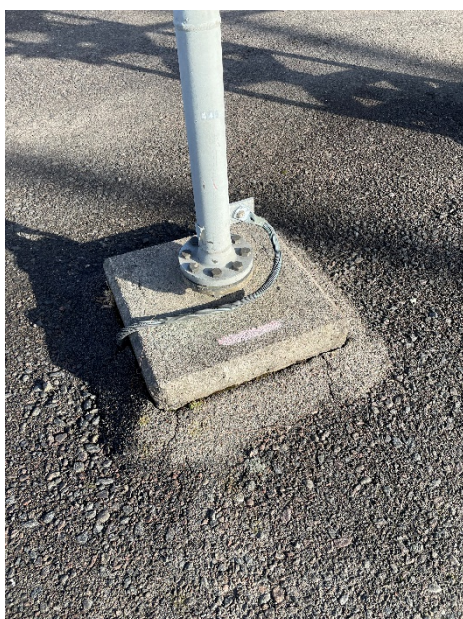
Figure 5 Connection to the earthing grid
