TESTING OF ACOUSTIC CAMERAS TO DETECT LEAKAGE THROUGH A CONCRETE STRUCTURE

REPORT 2026:1189

Testing of acoustic cameras to detect leakage through a concrete structure

Testing performed during a leak rate test of Vercors

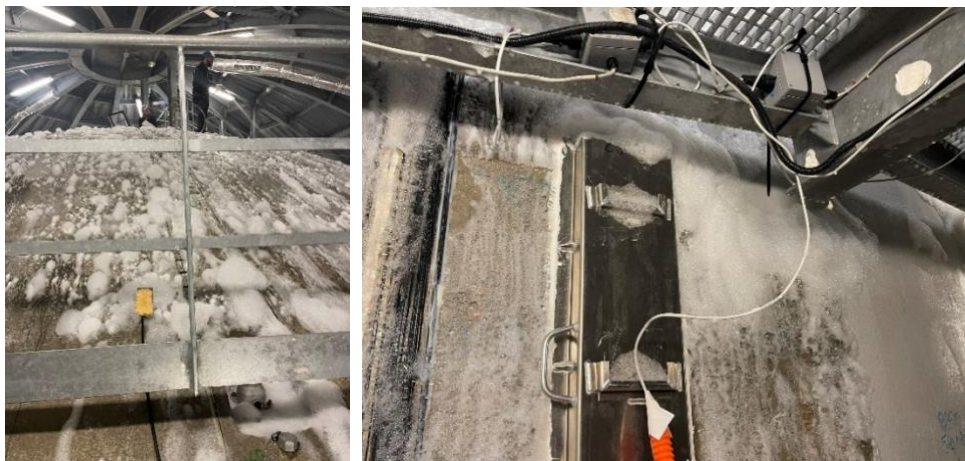
Figure 4 Dome and wall covered by leakage spray

During the first visit, EDF already started their activities in the area. To detect leakage they shower the containment with leakage spray, see Figure 4. This meant that the larger parts of the containment was covered with leakage spray before the test of the cameras started. During the second time. At 4.8 bar, it was possible to perform the test before the leakage spray was applied.

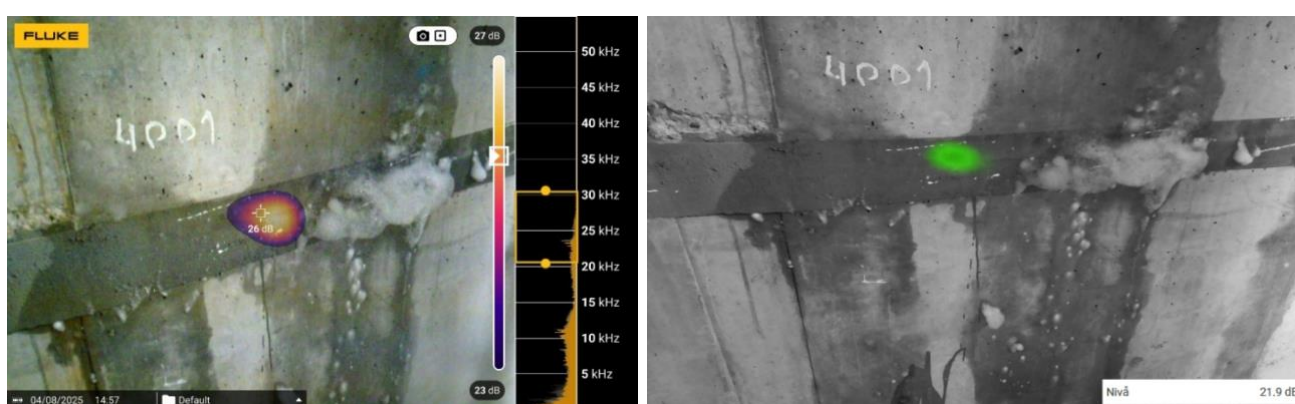
Figure 6 Pictures from the cameras of the leakage at reference point 1. On the left FLUKE ii910 and on the right NL ACOUSTICS

Reference point 1 was selected as an example with a smaller leakage. In this area there is a joint in the construction with a deviation of the used material.

At this reference point, leakage spray was applied. In this location there is a small leakage that all cameras can identify. Photos with leakage indications from two different cameras are found in Figure 6.

At this occasion FLUKE measured a leakage of 26 dB and NL ACOUSTICS measured a leakage of 21,9 dB.

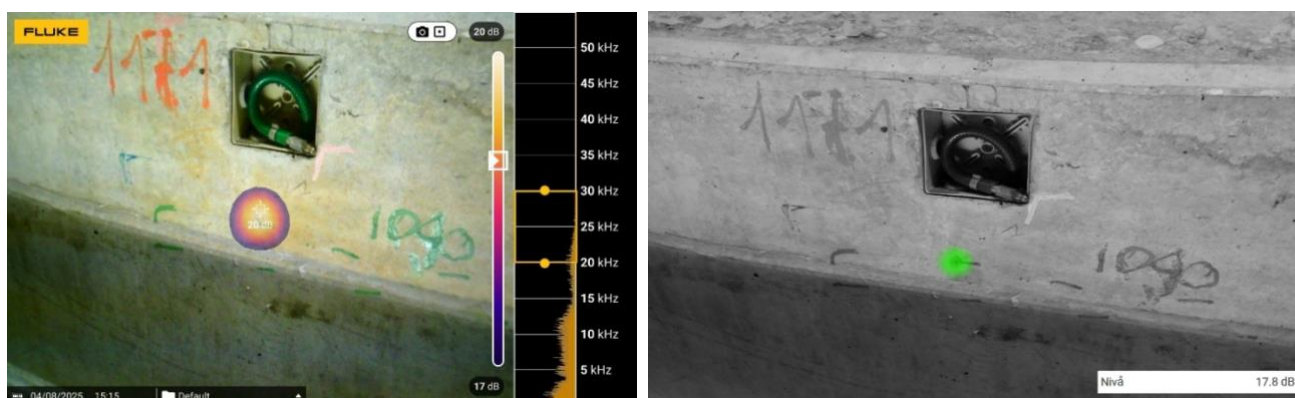
Figure 7 Pictures from the cameras of the leakage at reference point 2. On the left FLUKE ii910 and on the right NL ACOUSTICS

Reference point 2 was selected as an example where leakage could be found in an area without leakage spray added during the first visit.

At this reference point, leakage spray has not yet been applied. This reference point has a small leakage that can be detected by both cameras. Photos with leakage indications from two different cameras are found in Figure 7.

During this occasion FLUKE measures a leakage of 20 dB and NL ACOUSTICS measured a leakage of 17,8 dB.

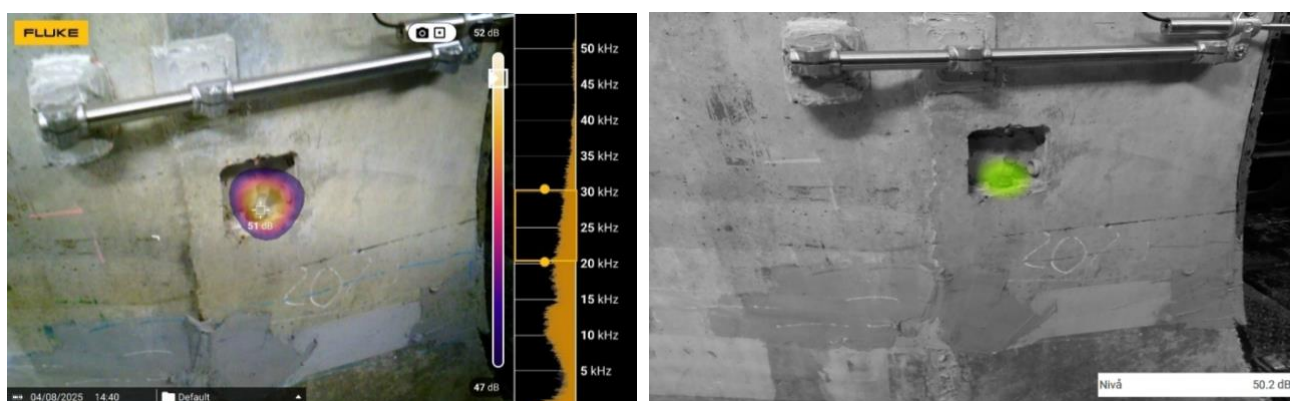
Figure 8 Pictures from the cameras of the leakage at reference point 2. On the left FLUKE ii910 and on the right NL ACOUSTICS

Reference point 3 was selected as an example where the leakage is detected next to a detail that is embedded in the concrete.

A smaller penetration with a hose was selected as a reference point; this was a large leak that all cameras identified. At this point, leakage spray has not yet been applied. This is a rather large leakage that can be heard by ears and felt by the hand. Photos with leakage indications from two different cameras are found in Figure 8.

During this occasion FLUKE measures a leakage of 51 dB and NL ACOUSTICS measured a leakage of 50,2 dB.

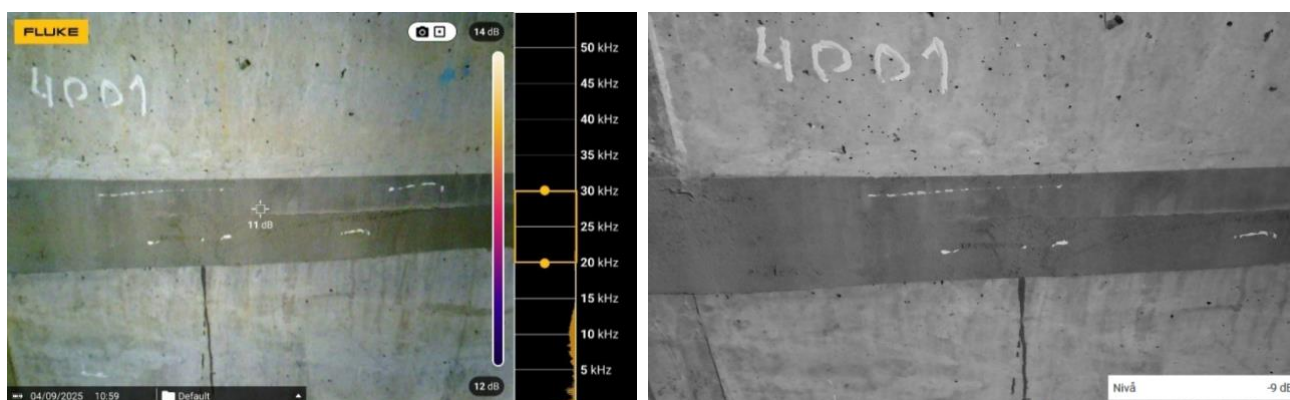
Figure 9 Pictures from the cameras of the leakage at reference point 1. On the left FLUKE ii910 and on the right NL ACOUSTICS

No leakage was identified by any of the cameras, see Figure 9. Both cameras give a value in this area but it is not possible to see if it is the leakage or a reflection of other sounds.

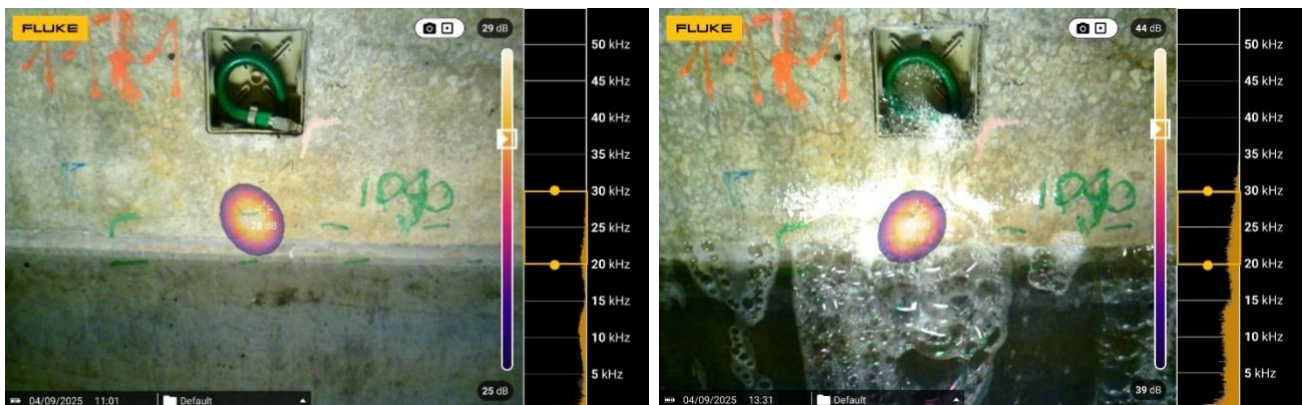
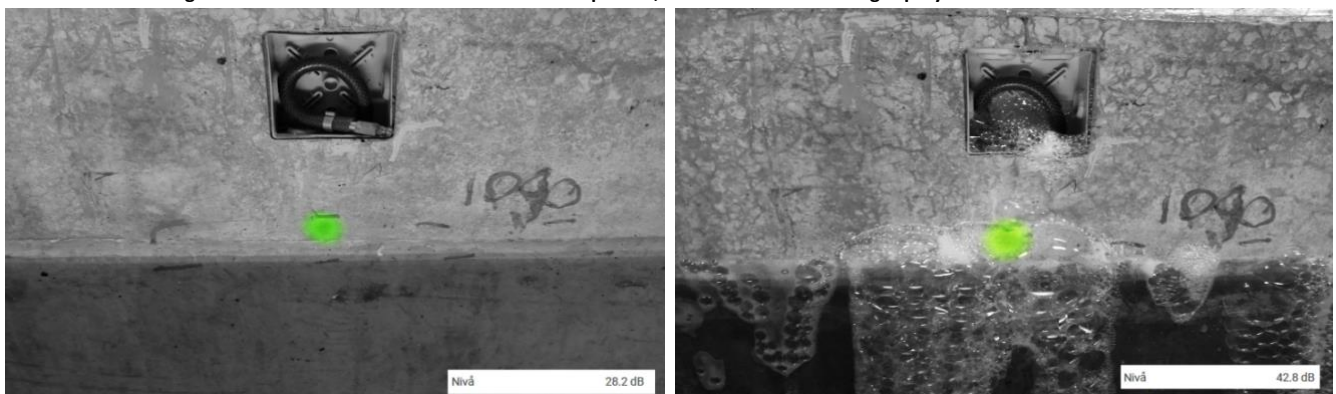
In reference point 2 all cameras identifies leakage, both with and without leakage spray, see Figure 10 and Figure 11. The cameras indicates a slightly higher leakage than during the first test.

During this occasion FLUKE measures 28 dB without leakage spray and 48 dB with.

NL ACOUSTICS measures 28,2 dB without leakage spray and 42,8 dB with.

Figure 10 Picture from FLUKE ii910 at reference point 2, with and without leakage spray

Figure 11 Pictures from NL ACOUSTICS at reference point 2, without and with leakage spray.

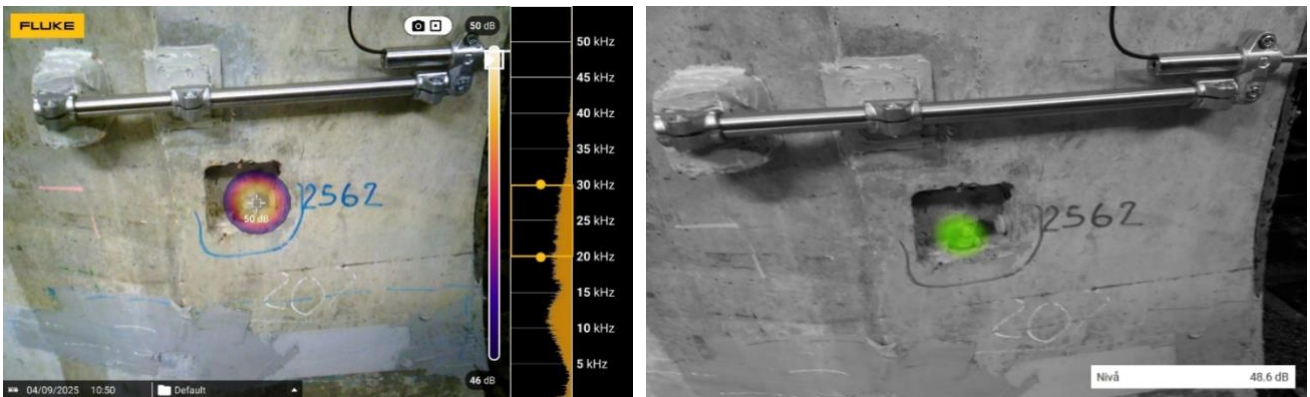
Figure 12 Picture from the cameras of the leakage at reference point 3. On the left FLUKE ii910 and on the right NL ACOUSTICS

In reference point 3 the amount of leakage is equal to the leakage during the first test.

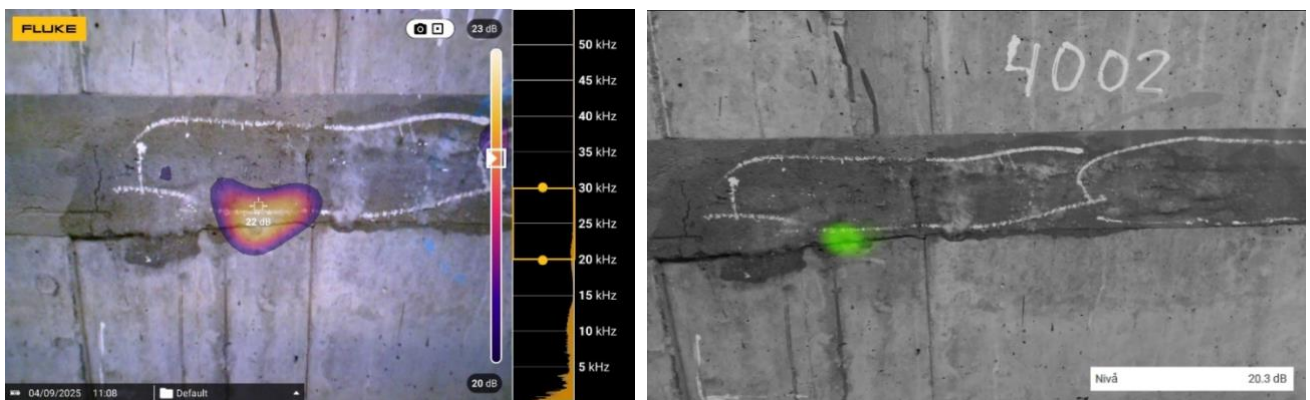
Figure 13 Picture from the cameras of the leakage at reference point 4. On the left FLUKE ii910 and on the right NL ACOUSTICS

Reference point 4 was selected as an example where the camera is not able to detect leakage but other methods are. This location was only investigated during the second occasion.

At reference point 4, none of the cameras could identify any leakage, but you can feel a leakage with your hand. Leakage spray was applied over the surface and the bubbles from this allow the cameras to capture the leakage.

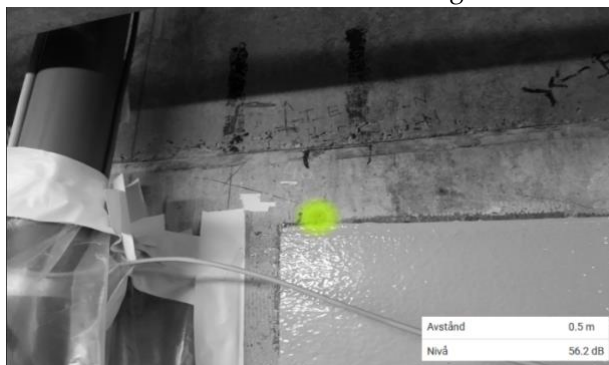
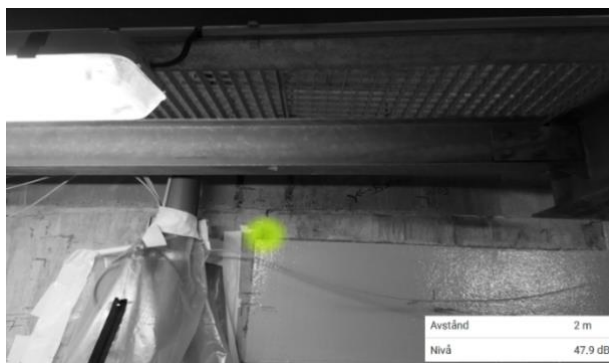
At this reference point, the amount of leakage given by the camera was tested at different distances. The leakage value is dependent of the distance which implies that the value for the amount of leakage should not be taken as "true".

Figure 15 Picture from NL ACOUSTICS of the leakage at reference point 5 – Short distance

Figure 14 Picture from NL ACOUSTICS of the leakage at reference point 5 – Long distance

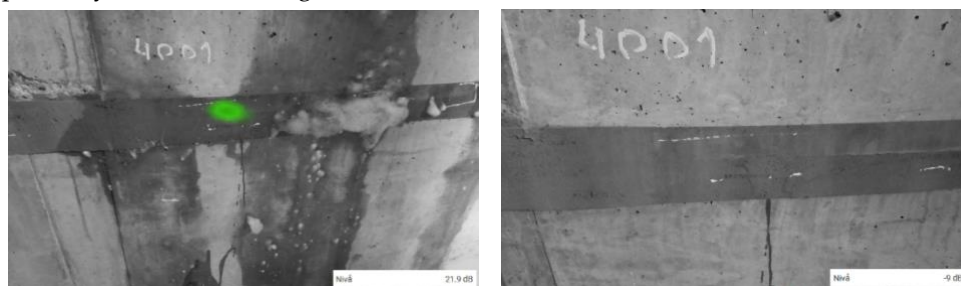
Figure 16 Comparison of Reference Point 1 during the first and second occasion

During the test at 4.3 bar a leakage was identified in this location. During this next test, none of the cameras identified a leakage. The difference was that during the first test leakage spray was applied but during the second the area was dry. When leakage spray was applied during the second test the leakage was detected by the cameras. When leakage spray is applied, bubbles bursts which gives a sound. It is probably this sound that gives an indication in the cameras.

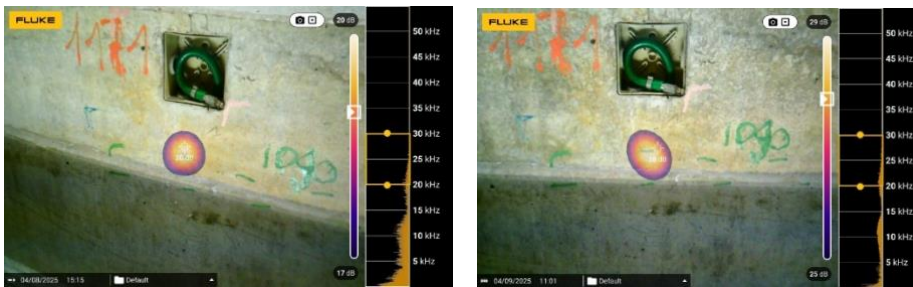
Figure 17 Comparison of Reference Point 2 during the first and second occasion

A leakage was detected in this area at both occasions. During the first occasion FLUKE measured a result of 20 dB and at the second 28 dB, see Figure 17. A similar difference was detected with NL ACOUSTIC that indicated a leakage of 17,8 dB during the first occasion and 28,2 dB during the second. Because of the higher pressure inside the containment during the second occasion it is expected that the leakage will be higher.

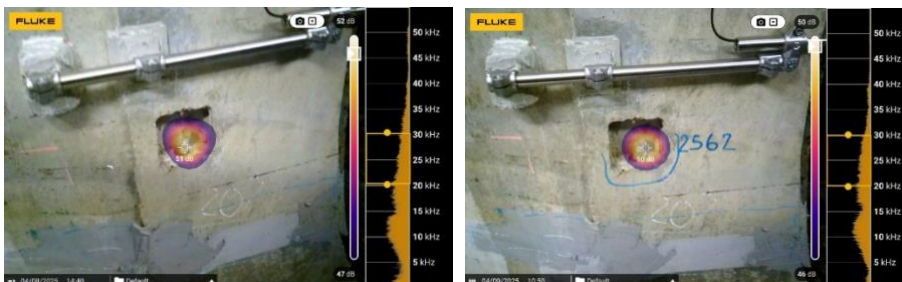
Figure 18 Comparison of Reference Point 3 during the first and second occasion

This leakage is found next to a smaller penetration with a hose. The leakage was found at both occasions. Even if there was a higher pressure during the second occasion, the leakage rate stayed at the same level.

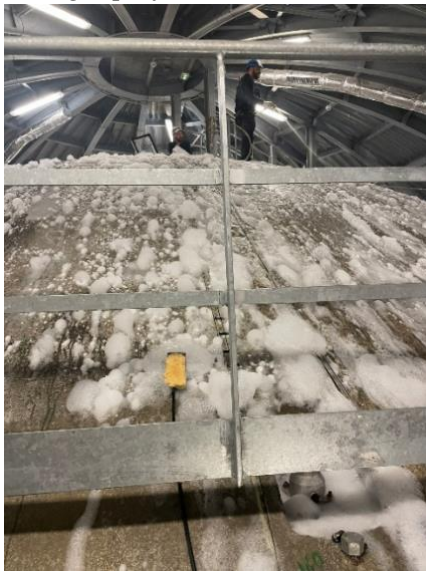
Figure 19 Applying leakage spray to the containment

When going into the containment during the first occasion, leakage spray was already applied over large areas. Roof and walls were showered by leakage spray, see Figure 19. It was therefore hard to know if the sound that was measured by the cameras was the sound of leakage or if it was the sound of bubbles from the leakage spray that burst. In some cases bubbles burst in areas without leakage.
