# INCREASED STEAM TEMPERATURE IN GRATE FIRED BOILERS

RAPPORT 2018:551

# Increased Steam Temperature in Grate Fired Boilers

Steamboost

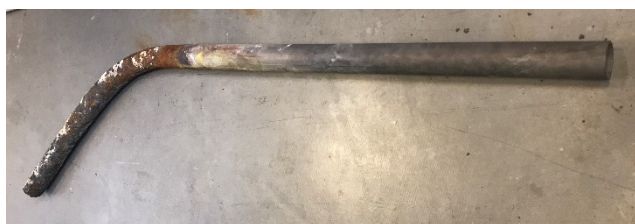
During each corrosion probe test the FeCrAl tube was removed and then after the test inserted again in the Steamboost region. After 12000h the material failed and was removed for analysis. Figure 12 shows the tube after being removed due to failure.

Figure 12. FeCrAl tube after being removed

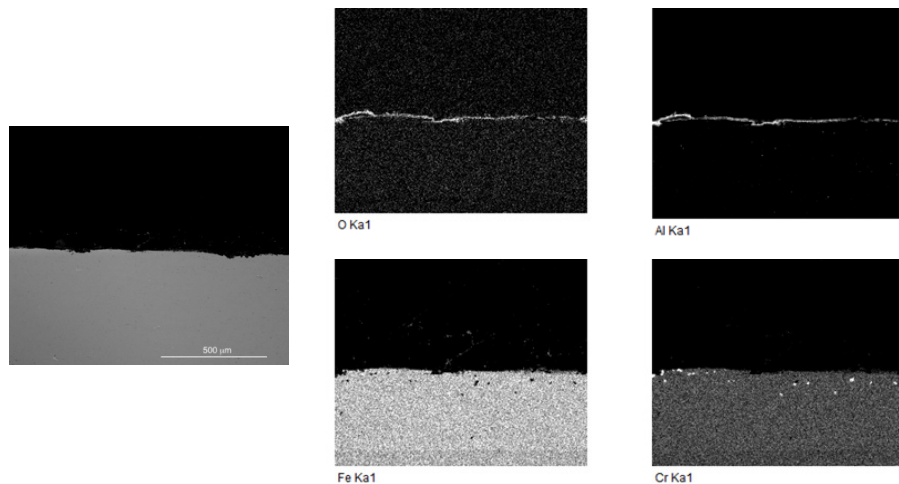
**Figure 40.** Backscattered SEM image and EDX analysis of the FeCrAl tube placed at Steamboost area 4500h. This area represents the 50% of the tube where the protective alumina was not damaged

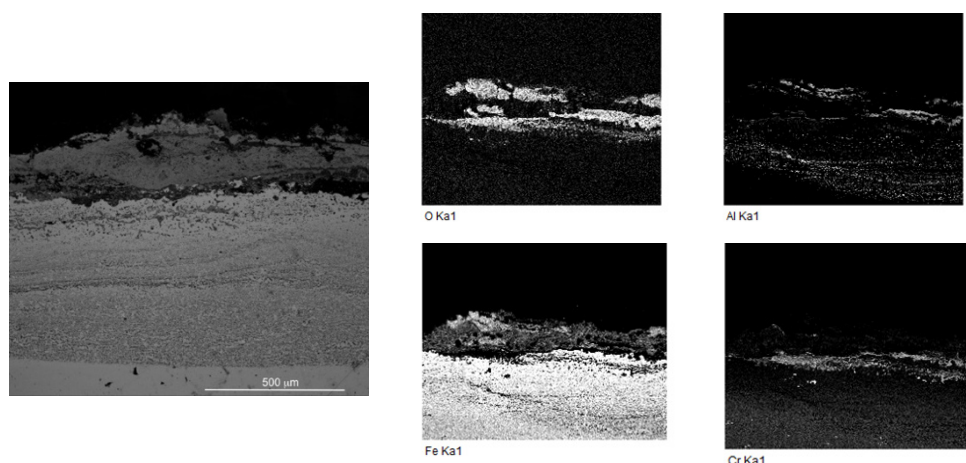
**Figure 41.** Backscattered SEM image and EDX analysis of the FeCrAl tube placed at Steamboost area 4500h. This area represents the 50% of the tube where the protective alumina was cracked and corrosion occurred

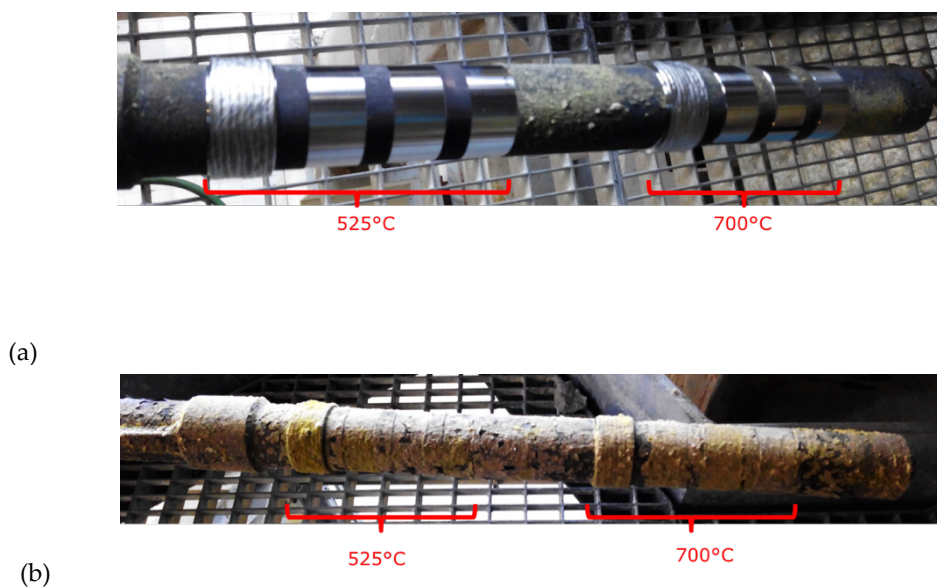
Figure 44. (a) Probe with the samples before exposure (b) Probe with the samples after 24 h exposure in the Steamboost region

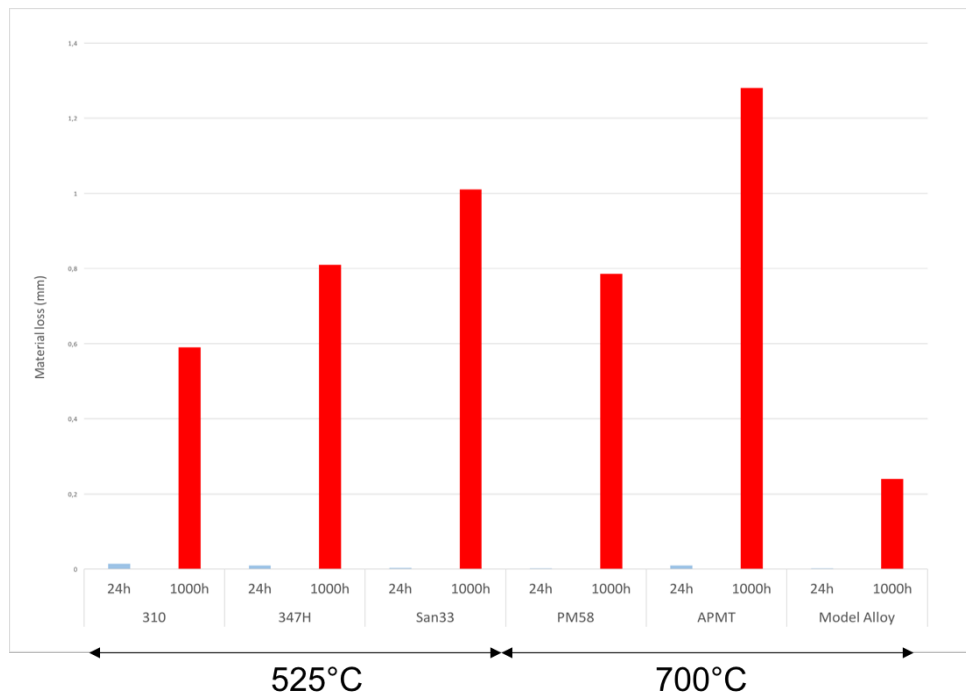
Figure 52 shows the material loss calculated for the materials exposed 1000h in the Steamboost region compared to the 24h exposure. The analyses were carried out as described in 3.2.6.3. The over welded materials were not included in the material loss measurements due to the high error that the shape of the weld seam introduces. It should be pointed out that the temperature control of the 700 °C temperature zone was lost for about 100h of the exposure. The corrosion rates are high and in line with the fast-initial corrosion attack observed on the 24 h samples. The two alumina forming alloys represent the highest material loss (Kanthal APMT) and the lowest material loss (Model alloy).

Figure 52. Material loss of the different materials exposed 24h and 1000h in the Steamboost region.

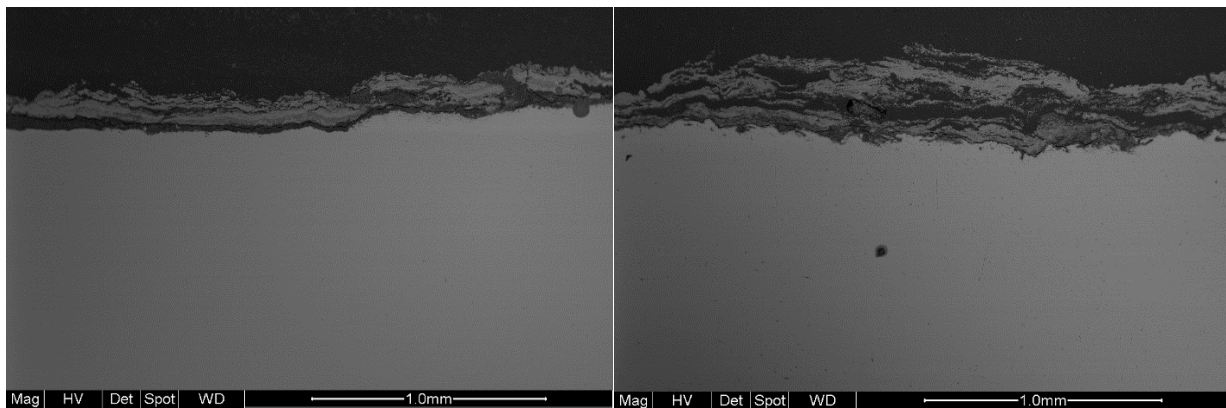
Figure 66: SEM cross section images of the most severely corroded (right, flue gas side) and one of the less corroded (left) points of the Inconel overweld sample ring.

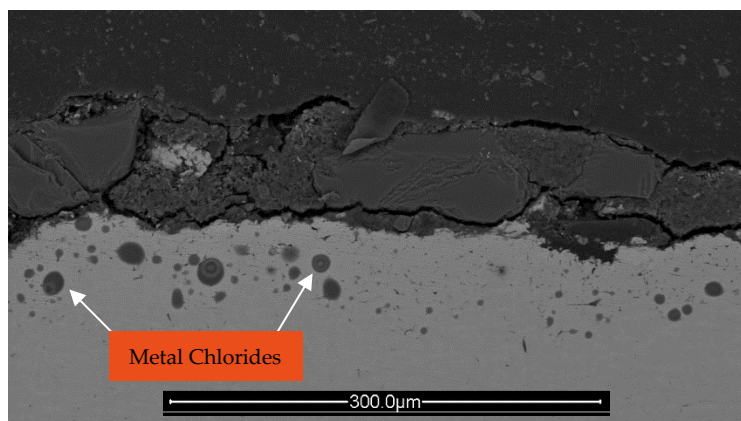
Figure 67: SEM cross section image of Inconel 625 overweld sample ring showing the formation of metal chlorides.

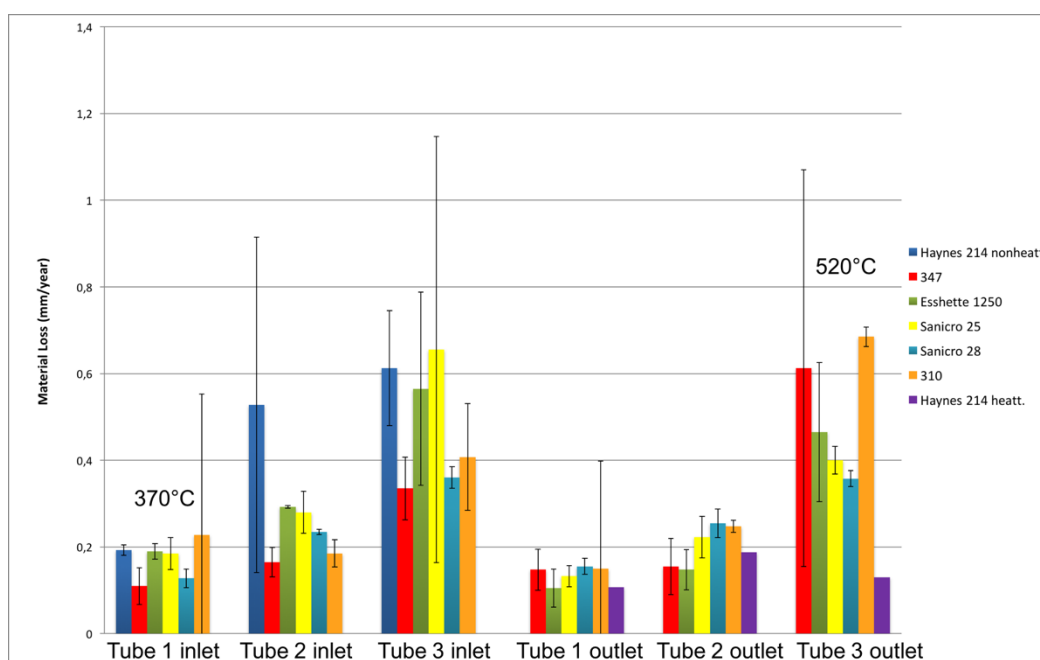
Figure 68: Material loss of the different material of the Steamboost for the different tubes (2015)

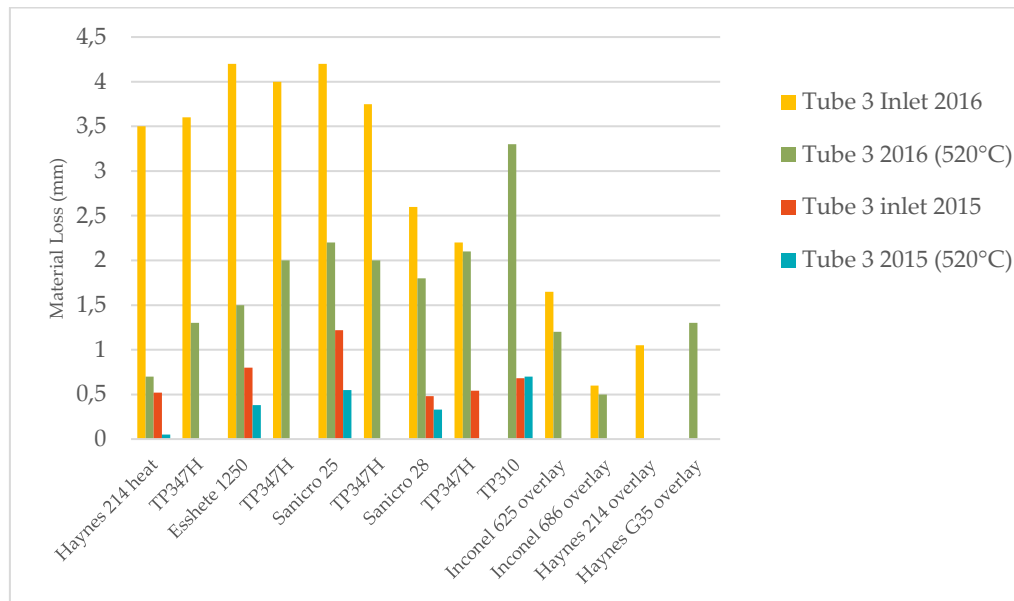
Figure 69. Material loss of the different materials in the tube 3 (520°C) 2016

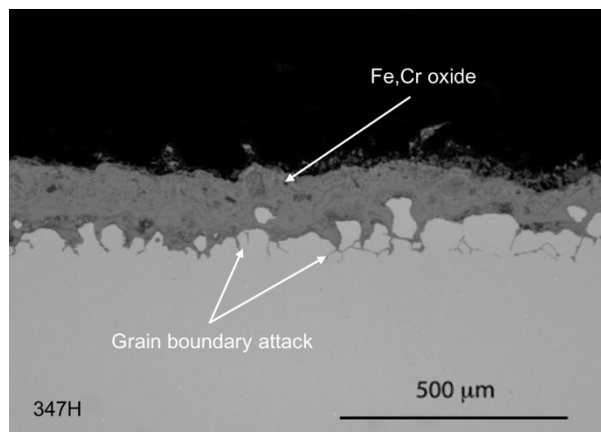
Figure 70: Scanning Electron Microscopy Backscattered image of 347H material exposed 8000h at the Steamboost
