# New Materials and Oxygen Carrier Aided for improved competitiveness of FB plants using renewable fuels

Julien Phother, Hampus Lindmark, Loli Paz & Jesper Liske

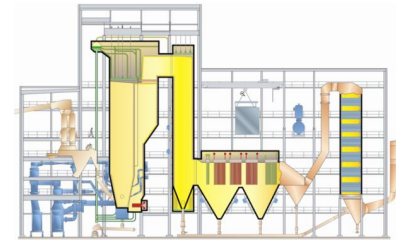
## Händelö P15

- A section of the empty pass has been coated by means of metal spray (HVOF).
- The corrosion results of this test section will be compared to water walls overlay welded with Alloy625.

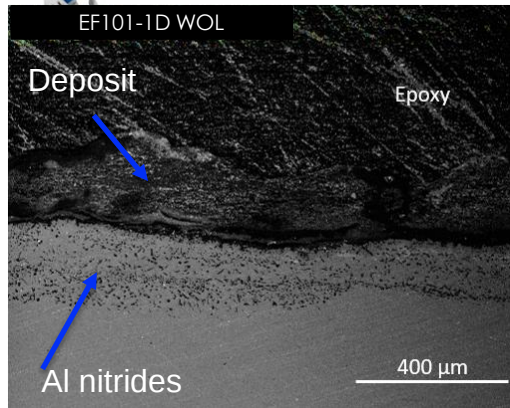
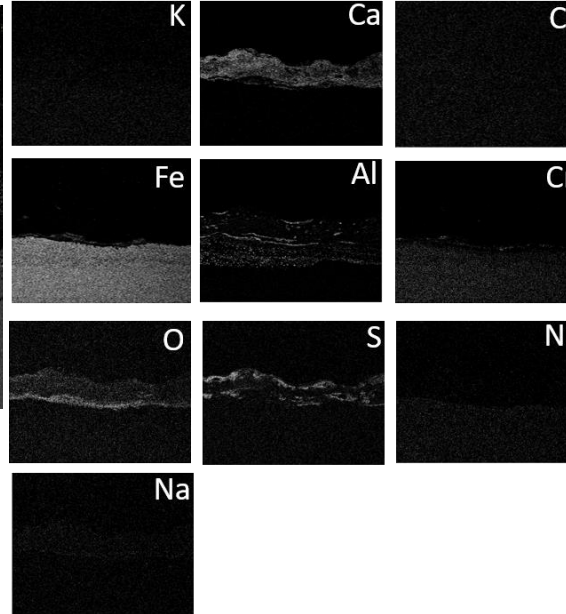
# Kanthal® EF101-1D WOL

| Materials | Position | Time |
|---|---|---|
| Kanthal®<br>EF101-1D WOL | SH2 | 6month |

- Internal oxidation (Al nitrides)  $\approx 200\mu\text{m}$
- Deposit thickness  $\approx 200\mu\text{m}$
- Oxide thickness:  $\approx 40\mu\text{m}$
- Thin and adherent oxide

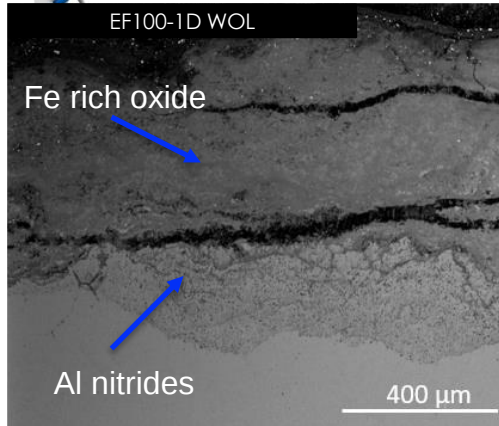
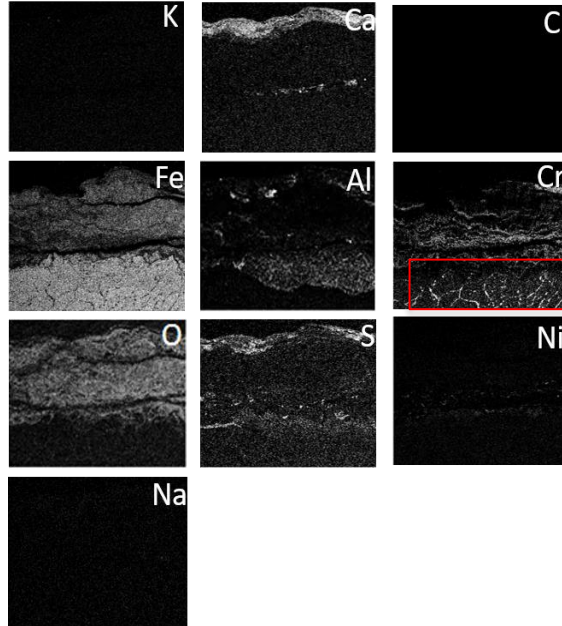
# Kanthal® EF100-1D WOL

| Materials | Position | Time |
|---|---|---|
| Kanthal® EF100-1D WOL | SH2 | 6month |

- Internal oxidation (Al nitrides)  $\approx 230\mu\text{m}$
- Deposit visible
- Cr enrichment in G.B
- Oxide thickness:  $\approx 500\mu\text{m}$

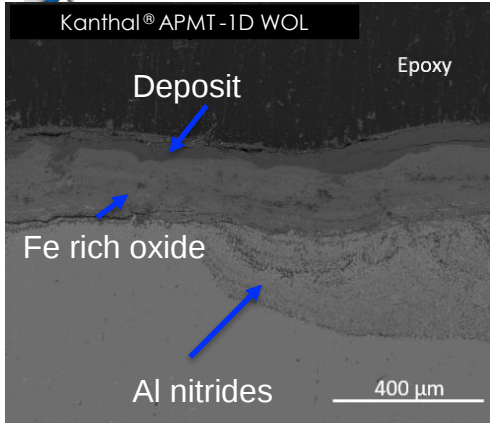
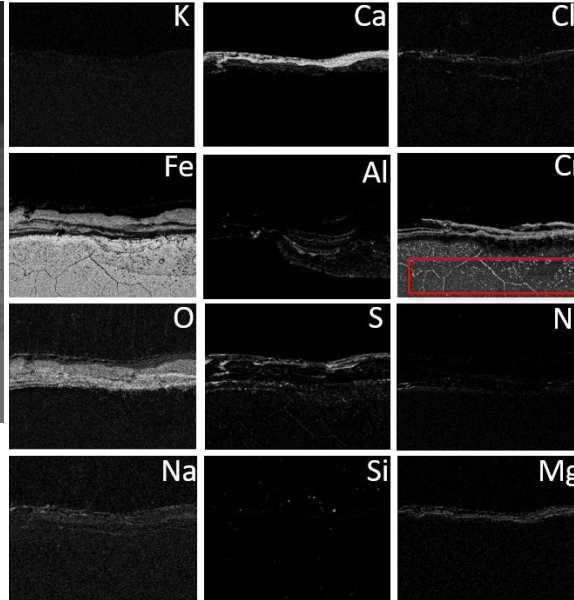
# Kanthal® APMT-1D WOL

| Materials | Position | Time |
|---|---|---|
| Kanthal® APM1-1D WOL | SH2 | 6month |

- Internal oxidation (Al nitrides)  $\approx 220\mu\text{m}$
- Deposit visible
- Cr enrichment in G.B
- Oxide thickness:  $\approx 260\mu\text{m}$
- Adherent oxide
