# NON-DESTRUCTIVE TESTING OF CONCRETE STRUCTURES IN NUCLEAR APPLICATIONS

REPORT 2016:245

# **Non-destructive testing of concrete structures in nuclear applications**

Evaluation and follow up on the CONMOD project, Part I

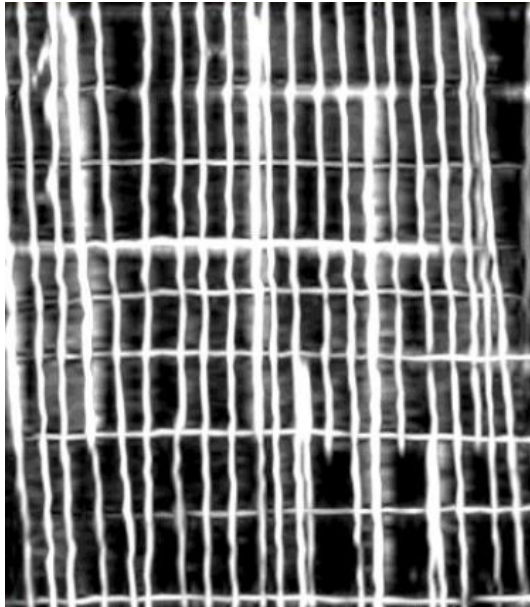
Below two examples of 3D scans performed by BAM at Barsebäck in 2014 is given. The illustrations are taken from (CONSAFESYS, 2015). The first example shows a section of the above mentioned 10m<sup>2</sup> survey field. The scan shows the distribution of the reinforcement at a depth of 80 mm. The picture clearly shows the position, spacing, direction and overlaps.

Figure 8: Examples of combined radar scan lines (3D measurements). Measurements at a section of the containment at Barsebäck 1.
