Crack propagation in buttress dams

Application of non-linear models – Part II

Elforsk report 10:69

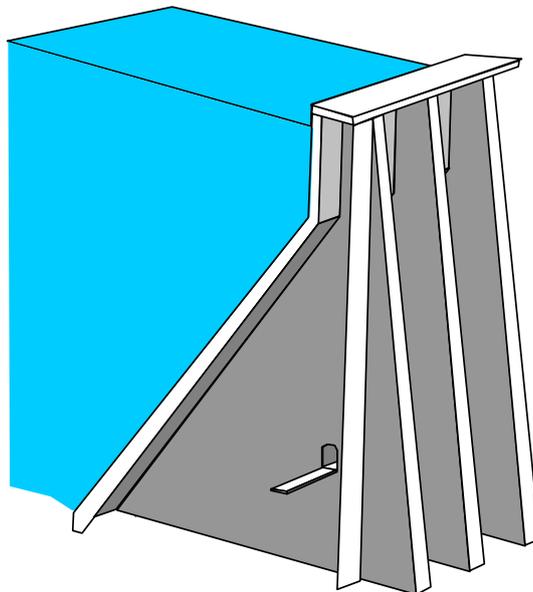
Figure 2.1 A section of a concrete buttress dam. From Malm and Ansell (2010).

A typical, large buttress dam can consist of up to 70–100 concrete monoliths that are up to 40 m high. Each supporting buttress can be 2 m thick and about 30–35 m wide near the bedrock. The section of the front-plate supported by one buttress is 8–10 m wide and has a varying thickness of about 1–2 m, where the thickest part of the front-plate is found near the bedrock.

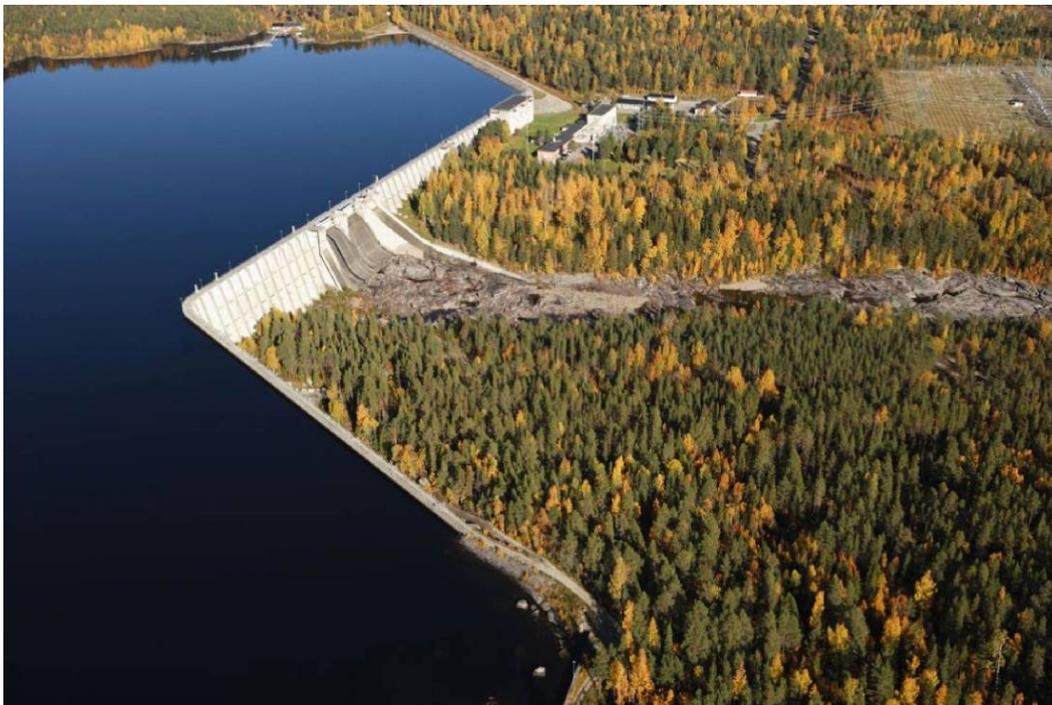
**Figure 2.2 Storfinnforsen hydropower plant in the Faxälven River.
Photo from P. Stenström, WSP.**

There are approximately 25 major concrete dams in Sweden (FOI, 2000) of which about 15 are buttress dams and the remaining are gravity dams and arch dams. The largest Swedish buttress dam is a part of Storfinnforsen hydropower plant that was built between 1949 and 1954, located in the Faxälven River in northern Sweden. The entire dam is about 1200 metres long with a concrete part that is about 800 metres, here shown in Figures 2.2–4. The dam consists of 66 concrete monoliths, excluding intakes, spillways and a concrete support wall dam. The tallest monolith is about 40 m high and consists of an 8 m wide front-plate with a downstream supporting block, the buttress. Each buttress is 2 m thick and the width near the bedrock is about 34 m in the largest monolith. The front-plates are about 2.5 m thick near the bedrock and 1.2 m at the top of the dam. The gap between the front-plates of two adjacent monoliths has a water tight seal.

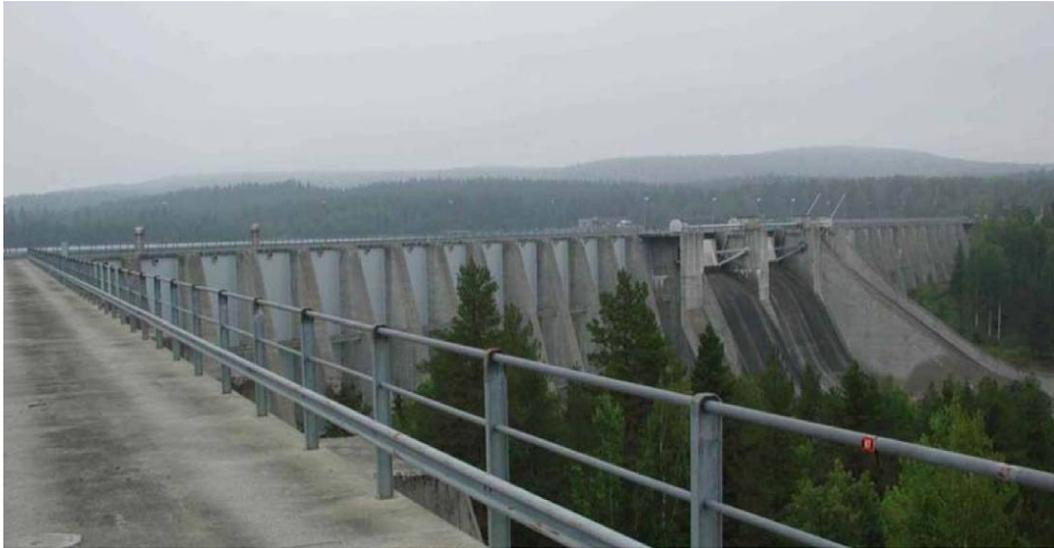
Figure 2.3 The concrete dam of Storfinnforsen hydropower plant. From Ansell et al (2008).

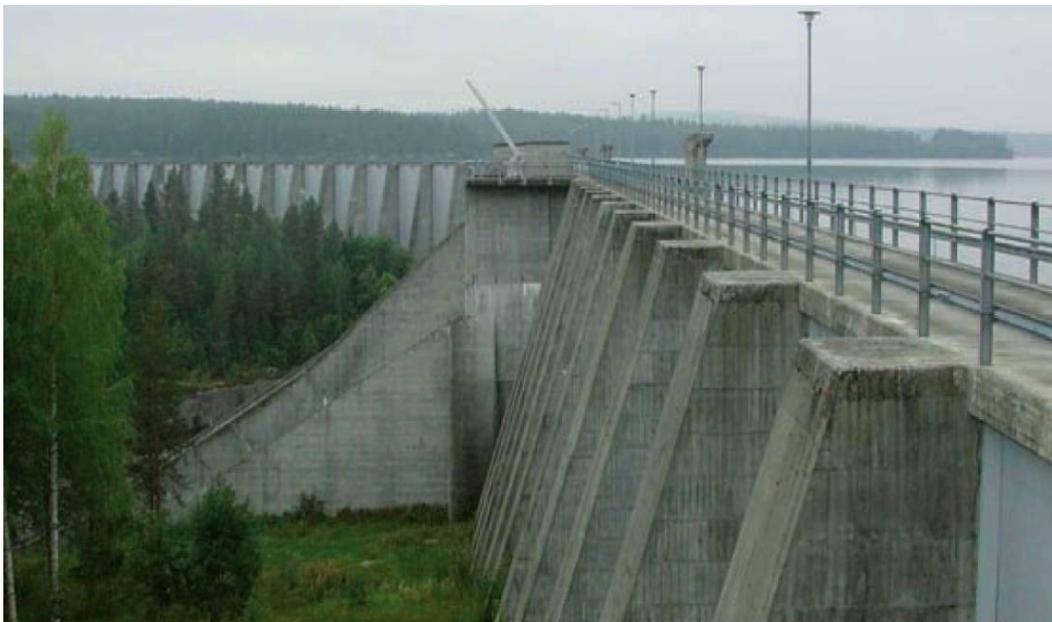
Figure 2.4 The crest of Storfinnforsen hydropower dam. Photo from T. Ekström, Energoretea.

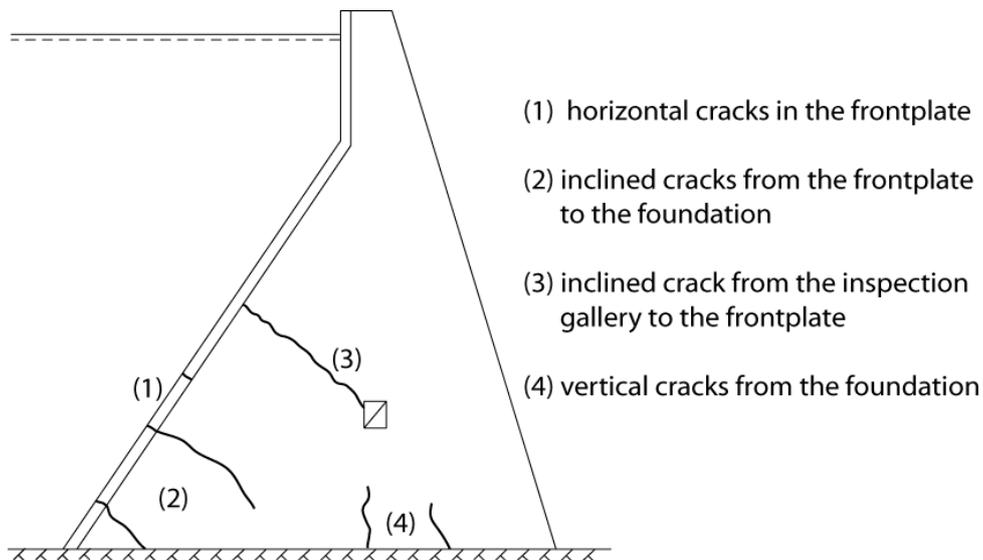
A summary of typical observed cracks are here given in Figure 2.5. The cracks are classified as four different types where type 1 is horizontal cracks in the front-plate. The type 2 is inclined cracks from the front-plate that has propagated in the buttress towards the foundation. The type 3 is an inclined crack that has propagated from the inspection passage towards the front-plate and the type 4 is vertical cracks originating from the foundation. A typical crack in the monolith starts at the front-plate, from a horizontal crack, and continues diagonally downwards in the downstream direction. Such a crack often goes through the entire concrete cross section.

Figure 2.5 Location of cracks observed in situ. From Malm and Ansell (2010).

The calculated results show that all four types of cracks observed in situ were obtained in the non-linear analyses. Horizontal cracks in the front-plate, type (1) according to Figure 2.4, occur due to high tensile stresses during the summer, which can be seen in Figure 5.1. The winter temperatures results in cracking of type (1) and (2) on the downstream side of the front-plate and in the lower part of the buttress respectively, as can be seen in Figure 5.4. These cracks of type (2) are probably caused by a combination of static load from the water and restrained shrinkage due to low temperatures. The third type of cracks (3) goes diagonally from the rectangular opening orthogonally towards the front-plate. Such a crack is clearly visible in Figure 5.3 and a crack propagating in the opposite direction is also found, caused by extreme summer temperatures following the instalment of the insulating wall. This can be seen when comparing Figures 5.1 and 5.3. A detailed analysis showed that the diagonal cracks propagate when the temperature within the space enclosed by the front-plate and the insulating wall is colder than approximately $+10^{\circ}$ C at the same time as the outside temperature exceeds approximately $+25^{\circ}$ C. Cracks from the concrete-rock interface, type (4), are caused by restrained movement due to low temperatures, and possibly also concrete shrinkage. High tensile stresses and possible concrete damage in this area are visible in the winter temperature-results in Figures 5.4 and 5.6. The magnitude of the stresses within the area close to the concrete-rock interface depends on the rigidity of the rock underground.

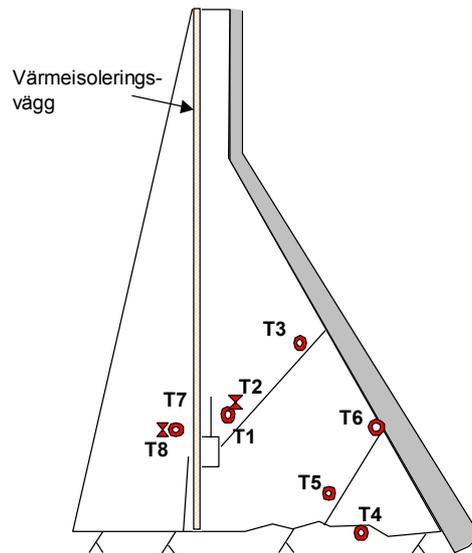
Figure 2.6 Set-up of transducers for temperatures. The symbols \diamond denote surface mounted transducers and \circ transducers 50 mm into the concrete. From Ansell et al (2008).

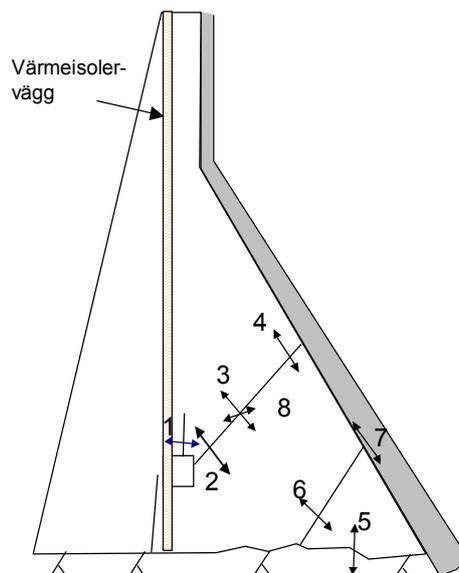
Figure 2.7 Set-up of transducers displacements. LVDT transducers marked with \leftrightarrow . From Ansell et al (2008).

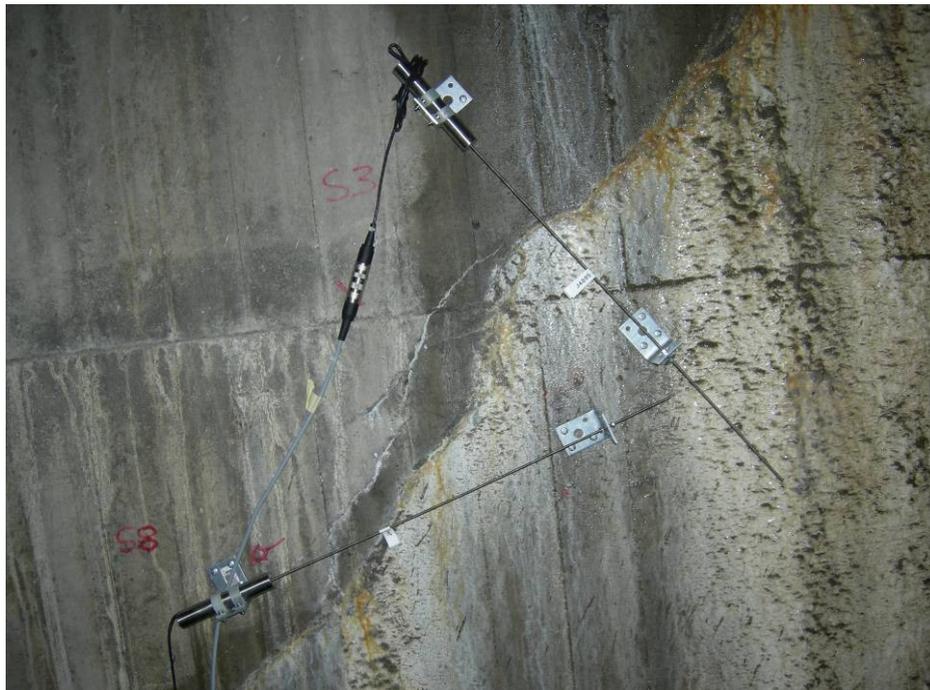
Figure 2.8 Displacement LVDT transducers on the buttress of the Storfinnforsen dam. From Ansell et al (2008).

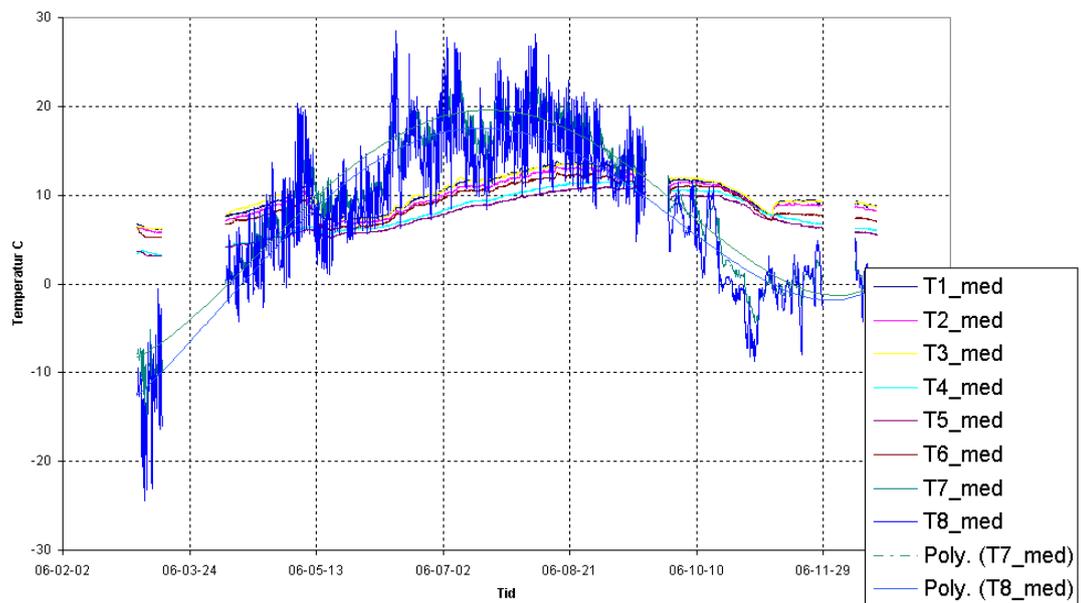
Figure 2.9 Temperatures monitored during 2006. Transducers mounted on monolith 43 of the Storfinnforsen dam. From Malm and Ansell (2010).

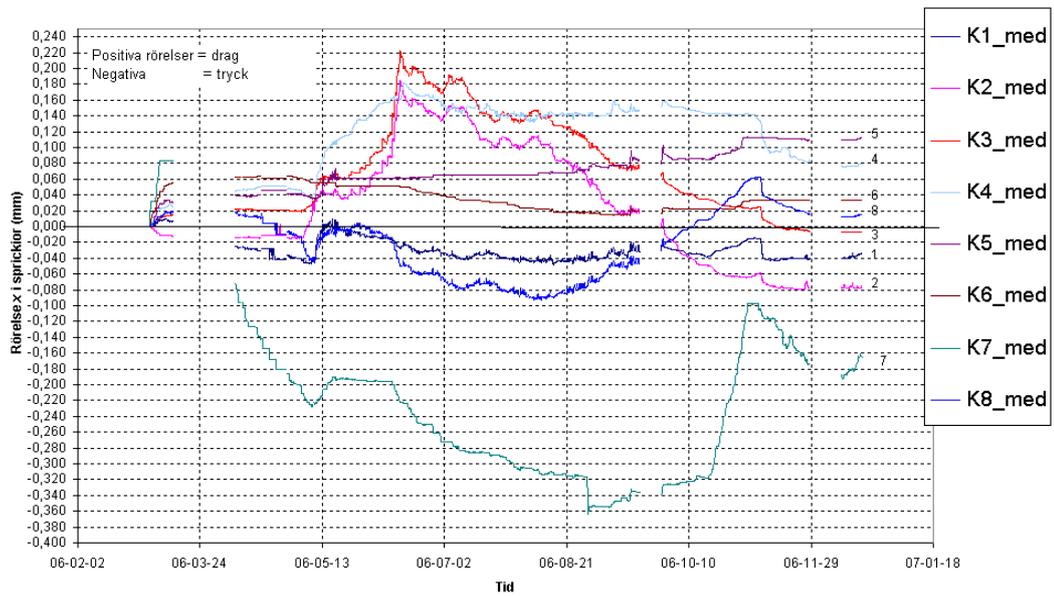
Monitored displacements are shown in Figure 2.10. The displacements vary during the period, probably as a result of the seasonal variation in temperature. Note that the transducer 7 is placed on the downstream side of the front-plate and that the transducer 5 is placed between the rock and the

buttress. The crack movement recorded by this transducer is large and varies during the period in spite of a rather small variation of the water temperature at that level.

Figure 2.10 Displacements monitored during 2006. Transducers (LVDT) mounted on monolith 43 of the Storfinnforsen dam. From Malm and Ansell (2010).

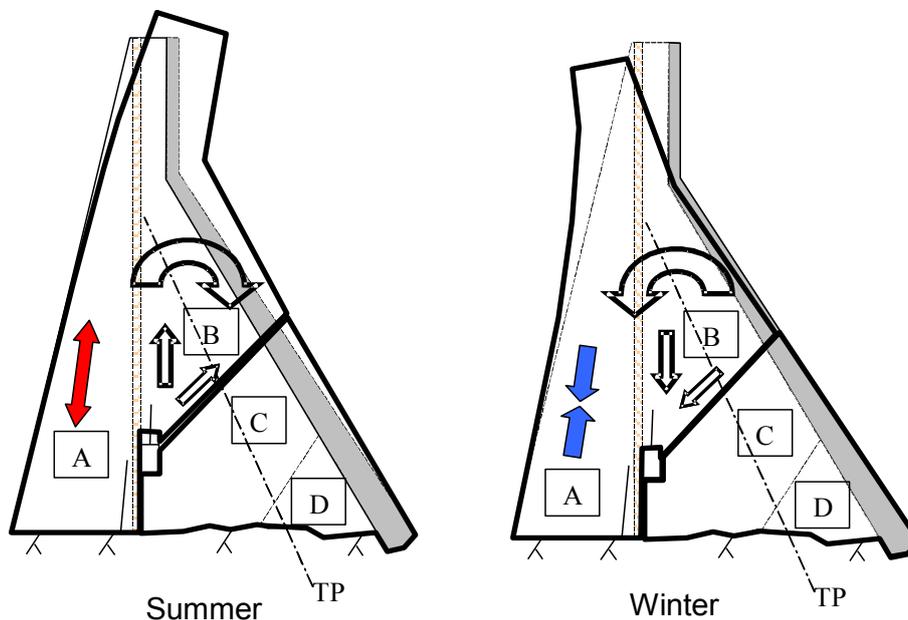
Figure 3.1 Geometry of the analysed concrete monolith. From Ansell et al (2009).

The principles of the structural behaviour are described by Björnström et al (2006) and Ansell et al (2008) and here shown in Figure 3.1. It can be seen that when the ambient air temperature increases, the part A of the buttress expands and forces part B to follow. The front-plate thus becomes subjected to compression when the air temperature increases. The opposite situation is to be expected during the winter, when the ambient air temperature decreases.

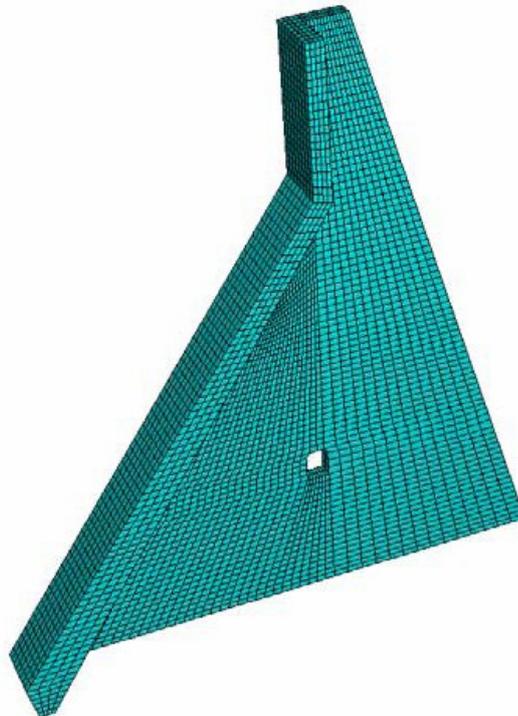
Previous numerical modelling of the dam behaviour verified that the variation in seasonal temperature together with the water pressure is important mechanisms behind the observed crack pattern. A first step was taken by Björnström et al (2006), through linear elastic analysis aiming at showing whether or not deformations and stresses caused by seasonal variation of temperatures could initiate cracks in a concrete dam. The main purpose was to demonstrate the finite element method (FEM) as a tool for analysis. The results revealed areas of stress concentrations and high stress levels in parts of a dam from where cracks could initiate. The analysis was performed with a large three-dimensional model of solid elements that however could not be efficiently used in a non-linear analysis. The model consisting of approximately 9,000 brick-elements are here shown in Figure 3.2.

Figure 3.2 Three-dimensional finite element model with 9,000 brick-elements. From Björnström et al (2006).

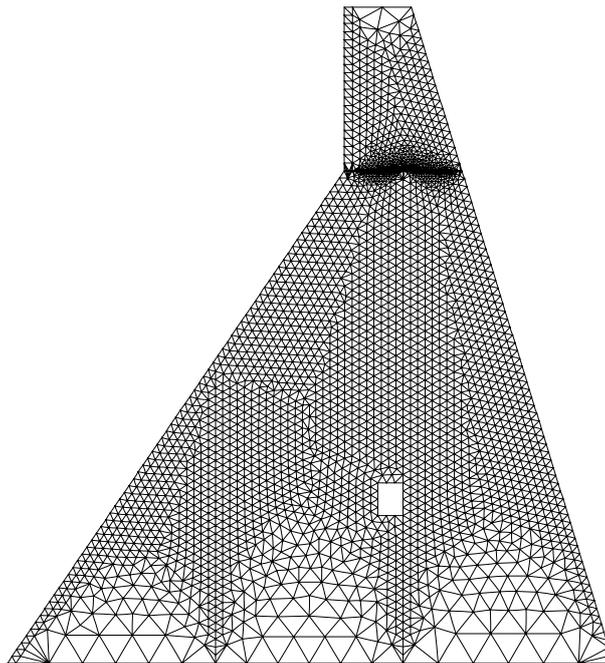
In a following project, Ansell et al (2008) tested two-dimensional models of triangular continuum elements and non-linear material properties for the concrete. A fictitious buttress dam structure is studied, with measurements typical of large buttress dams in Sweden. The front-plate and the buttress were relatively thin in comparison with the height and width of the analysed dam and therefore plane stress conditions were assumed, in contrast to plane strain conditions that are often used for two-dimensional models of massive structures, such as gravity dams. For the combined analysis of displacements, stresses and temperatures thermally coupled elements were chosen. A typical model of the dam consisted of nearly 6,000 triangular elements with almost 53,000 degrees of freedom, as shown in Figure 3.3. The depth (thickness) of buttress was 2 m with a 8 m deep, 2m wide band representing the front-plate. The monolith was assumed to be rigidly connected to the underground. The effect of reinforcement was not included in this case. The analyses focused on the determination of the direction and the extension of thermally induced cracks. The results showed that it is possible, by means of numerical non-linear analysis, to describe and follow the initiation and propagation of cracks found in situ on the studied type of concrete buttress dams.

Figure 3.3 Two-dimensional finite element model with 5,800 triangular elements. From Ansell and Malm (2008).

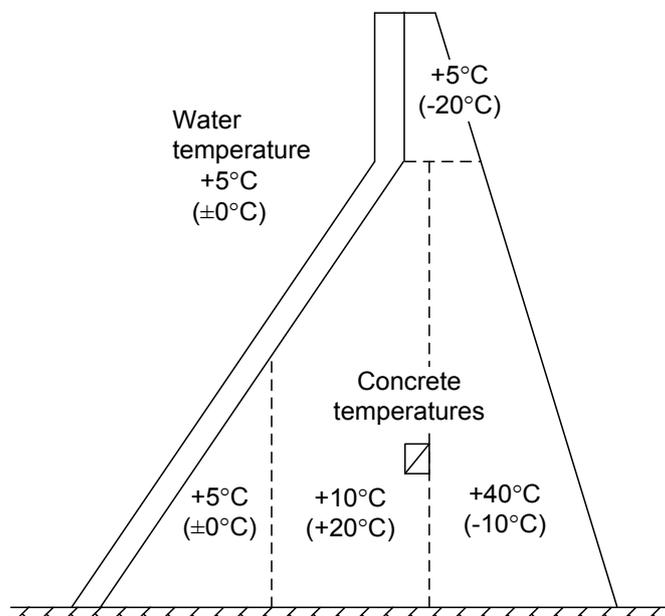
Figure 3.4 Example of previously assumed extreme temperatures in water and concrete during summer (and winter). From Ansell and Malm (2008).

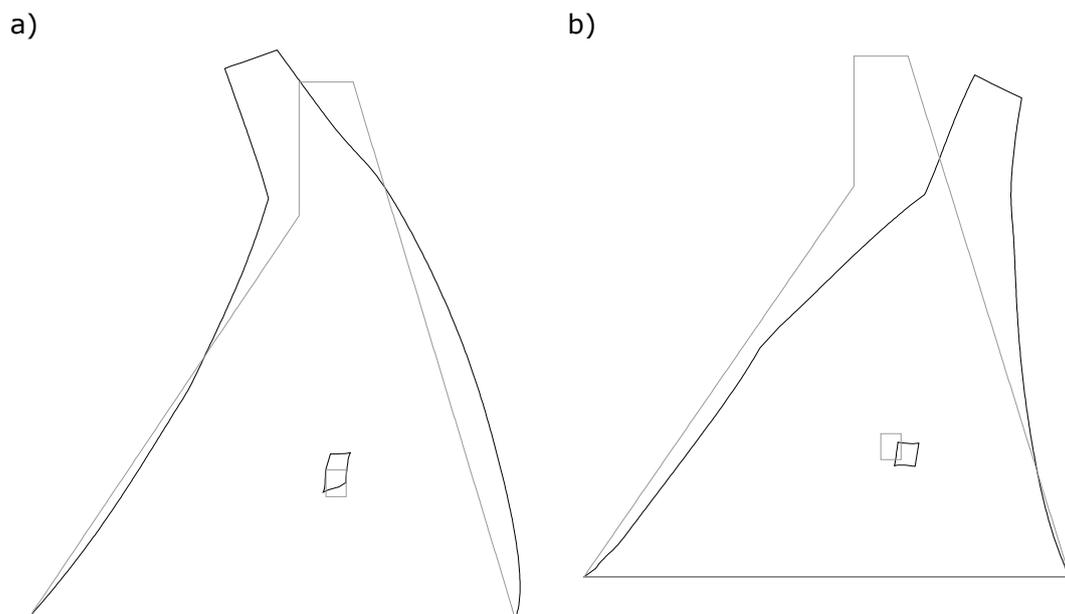
The tests with the two-dimensional model showed that the extreme temperatures, positive and negative, must be applied to parts of the structure before cracks were initiated. The extreme summer temperatures gave rise to large stresses in the buttress and tensile cracks propagated from the opening towards the front-plate, and towards the lower right corner of the structure. For the winter conditions there were low or zero stresses within the interior (insulated) zone with temperatures close to the initial temperature of the concrete, i.e. $+10^{\circ}\text{C}$ which corresponds to zero temperature strain. A vertical band of stresses appeared along the interface between positive and negative temperature zones. There were also high stresses along the front-plate. The assumed full coupling to the underground in both cases gave rise to large stresses and some damage at the lower corners of the structure. The deformed shapes are shown in Figure 3.5 where it is evident that the buttress deforms towards the side with extreme temperatures, towards the relatively cold water during the summer and vice versa during the winter. The horizontal displacement of the crest was in this case approximately 5 mm during summer and 9 mm during winter.

Figure 3.5 Deformation due to extreme (a) summer and (b) winter temperatures. Deformation scale factor 1000. From Ansell and Malm (2008).

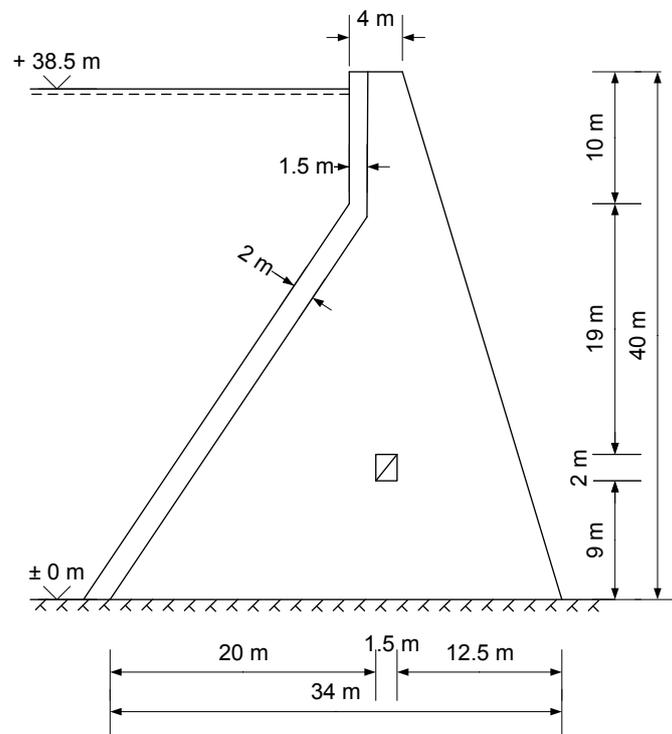
One concrete monolith with dimensions similar to that of the Storfinnforsen buttress dam was analyzed. The analysed structure is a 40 m high section of a buttress dam, as shown in Figure 4.1. It consists of a 2 m thick and 8 m wide front-plate facing the water and a 40 m high triangular supporting buttress. The upper 10 m of the front-plate is vertical while the lower part is inclined, with an angle of 56.3° versus the horizontal axis. The downstream edge of the buttress slopes 68.2° versus the horizontal. The dam crest, the horizontal upper part of the buttress and front-plate, has a width of 4 m and the water surface is assumed to be situated 1.5 m below this level. The front-plate is rigidly connected to the buttress, but free at its outer ends that are in contact with the front-plates of the adjacent monoliths. The buttress is 2 m thick and rigidly connected to the rock underground, which is assumed to be of good quality granite. A slab of granite is included in the model which represents the elasticity of the bedrock. This slab is 2 m thick with an $8 \times 34 \text{ m}^2$ base. There is an inspection passage through a $2 \times 1.5 \text{ m}^2$ rectangular opening in the buttress, situated 9 m above the ground.

Figure 4.1 Geometry of the analysed concrete monolith.

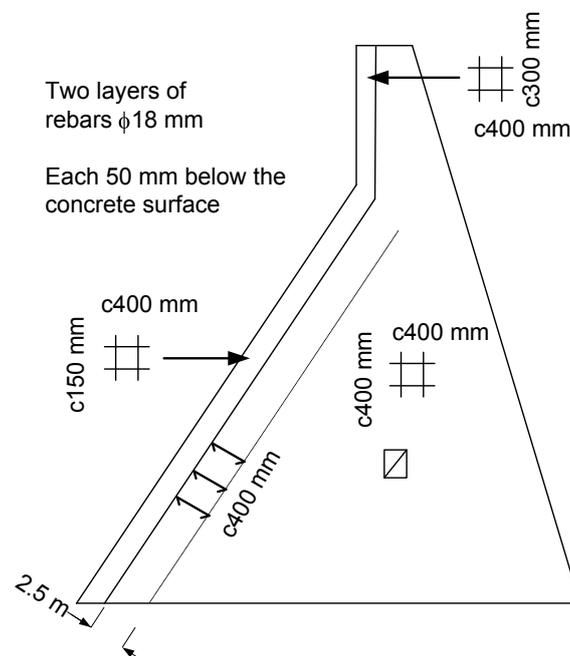
It is assumed that only one quality of concrete have been used in all parts of the monolith, corresponding to concrete C25/30. The effect of steel reinforcement was included assuming steel reinforcement of standard ribbed steel bars of Swedish type Ks40, all with a diameter of $\phi 18$ mm. Two layers of horizontal and vertical reinforcement bars were placed in the entire monolith, as shown in Figure 4.2. In the construction joint, the segment between the front-plate and the buttress, two additional layers of bars were added perpendicular to the front-plate. Physical and mechanical material parameters for steel, rock and concrete included in the analysis are given by Ansell and Malm (2008) and Malm and Ansell (2010).

Figure 4.2 Arrangement of steel reinforcement in the analysed concrete monolith.

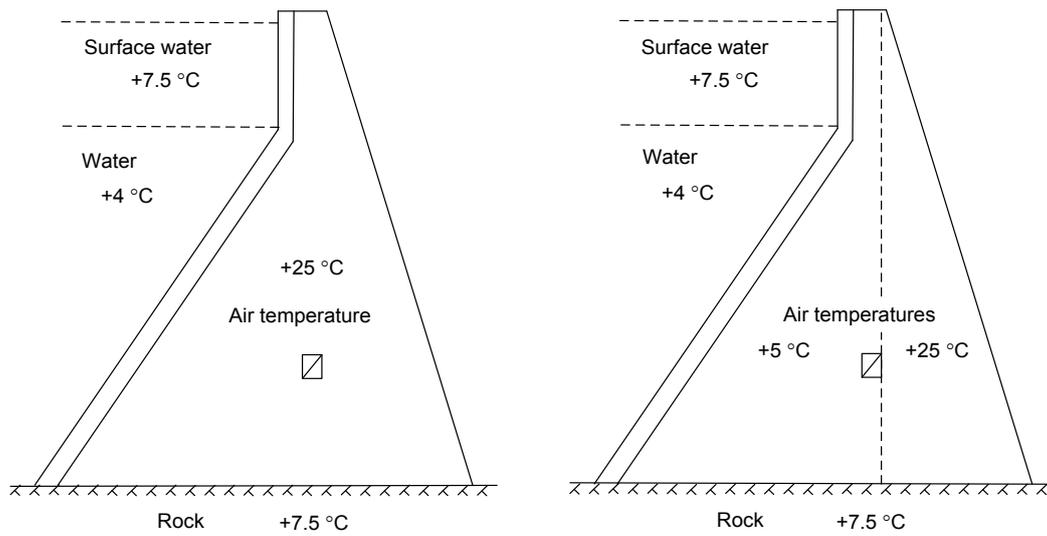
Figure 4.3 Maximum temperatures in air, water and rock during summer for a monolith with and without an insulating wall.

Tensile stresses and deformations due to maximum summer temperatures as given to the left in Figure 4.3 are shown in Figure 5.1. The summer temperatures give rise to high tensile stresses in the front-plate but only minor in the buttress, as seen in Figure 5.1(a). The plate is cracked (b) at the lower 15 m, with a vertical crack along the connection to the buttress, ending with a horizontal crack across the plate. There are also large tensile stresses at the connection between the upper vertical and the lower parts of front-plate. The maximum crack width (crack opening displacement, COD) for the horizontal crack in the front-plate is approximately 0.75 mm and its development with the outside air temperature can be seen in Figure 5.2.

The inclusion of the insulating wall results in a division of the surfaces of the buttress into two temperature zones, as shown to the right in Figure 4.3. The sharp limit between the moderate temperatures between the wall and the front-plate and high outside temperatures result in large tensile stresses in the buttress, as seen in Figure 5.3. In this case the summer temperatures will also initiate cracks at the rectangular opening which propagates diagonally towards the front-plate and in the opposite direction, as seen in Figure 5.3(b).

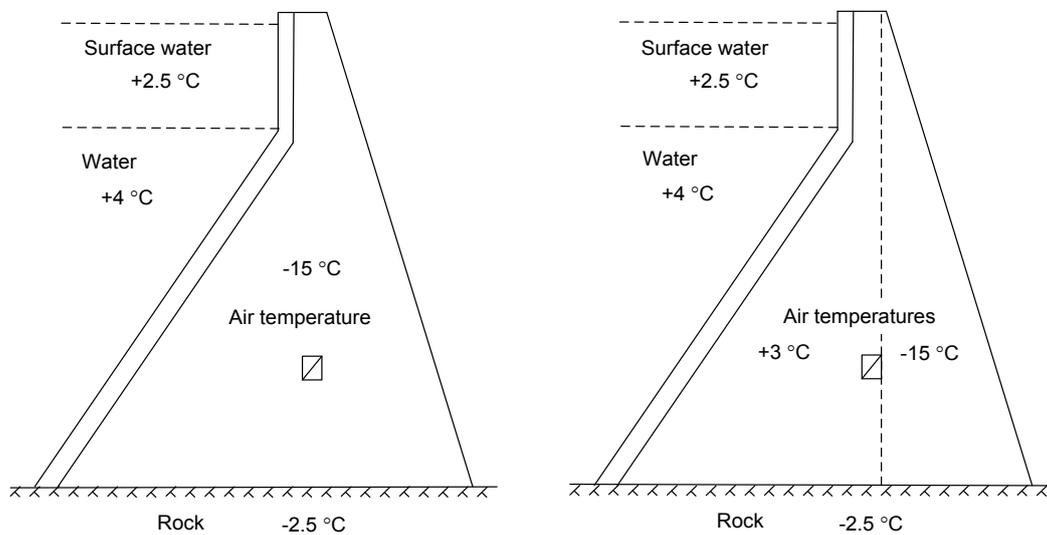
Figure 4.4 Maximum temperatures in air, water and rock during winter for a monolith with and without an insulating wall.

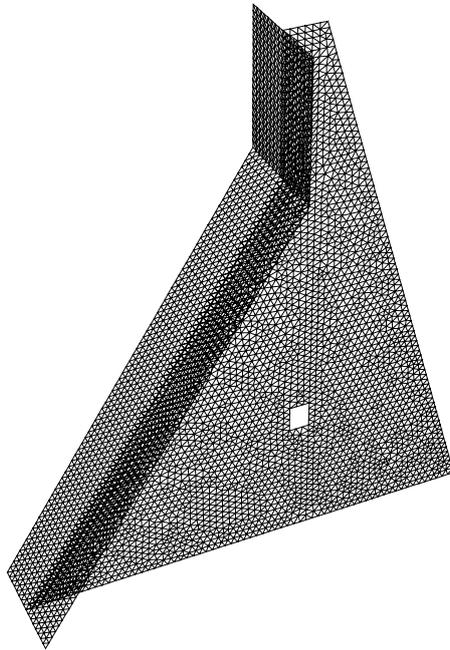
The three-dimensional model was built up with approximately 9,400 triangular shell elements with 33,000 degrees of freedom, as seen in Figure 4.5. The rock is here modelled as an elastic 2 m thick plate, with material properties as given by Ansell and Malm (2008) and Malm and Ansell (2010). This will lead to less stress build-up at the concrete-rock interface, compared to a case where the rock is un-deformable. In this way, an elastic coupling to the ground is obtained, which approximates the function of anchorage of dam structures in situ. Reinforcement bars were included in the model, coupled to the shells as embedded elements.

Figure 4.5 Finite element model with 9,418 triangular shell elements.

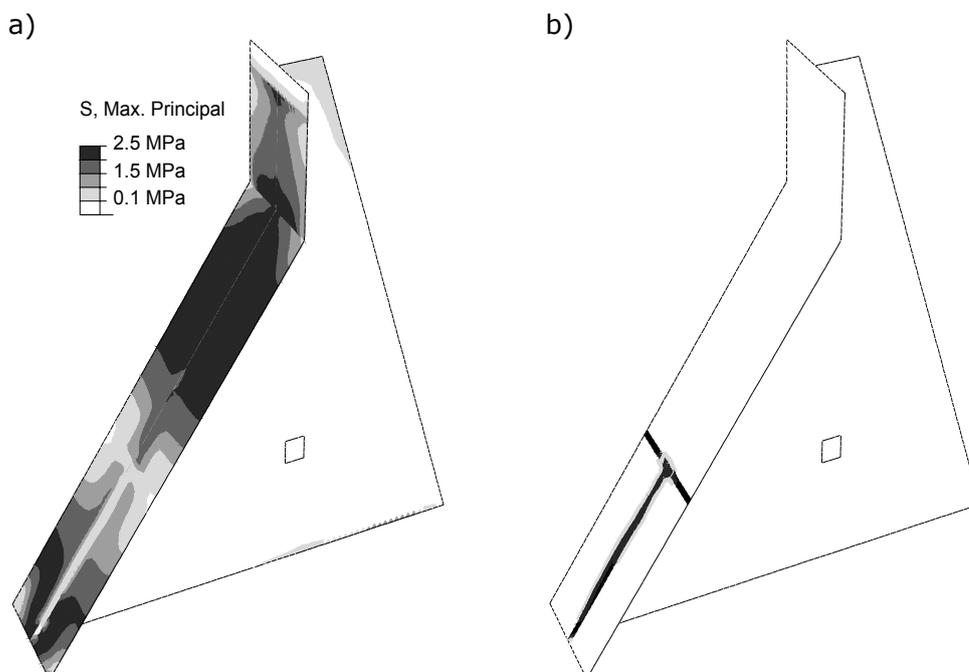
Figure 5.1 Maximum principal tensile stresses (a) and damaged concrete (b), due to summer temperatures.

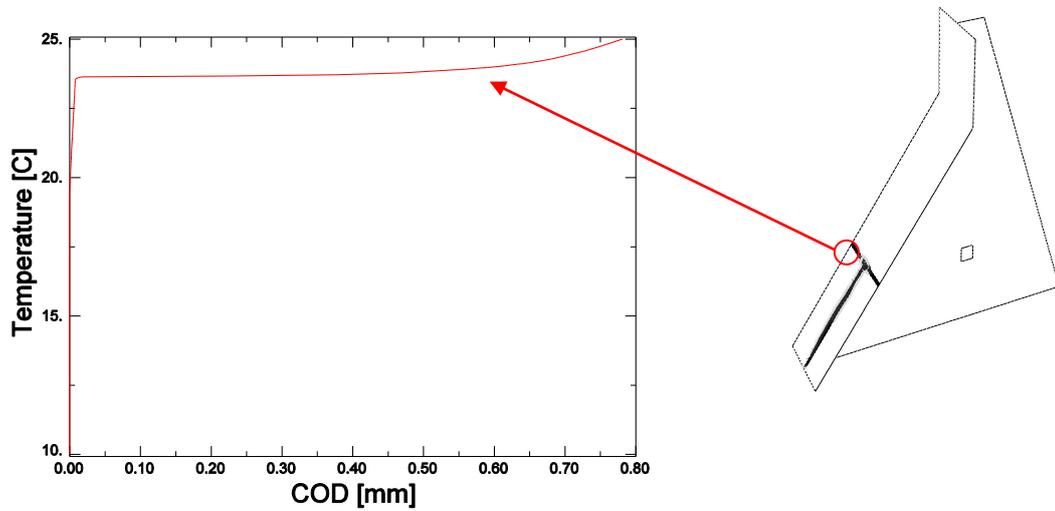
Figure 5.2 Temperature vs. crack opening displacement for the horizontal crack in the front-plate due to summer temperatures.

The cracks are initiated when the outside air temperature is about $+20\text{ }^{\circ}\text{C}$, but will propagate first when this has reached approximately $+25\text{ }^{\circ}\text{C}$.

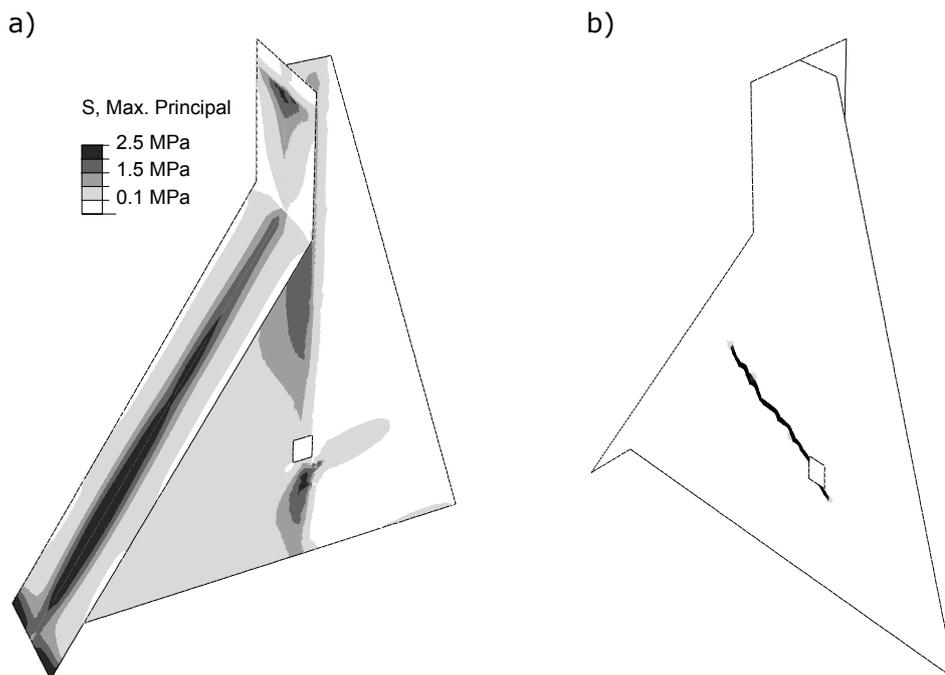
Figure 5.3 Maximum principal tensile stresses (a) and damaged concrete (b) due to summer temperatures, with insulating wall.

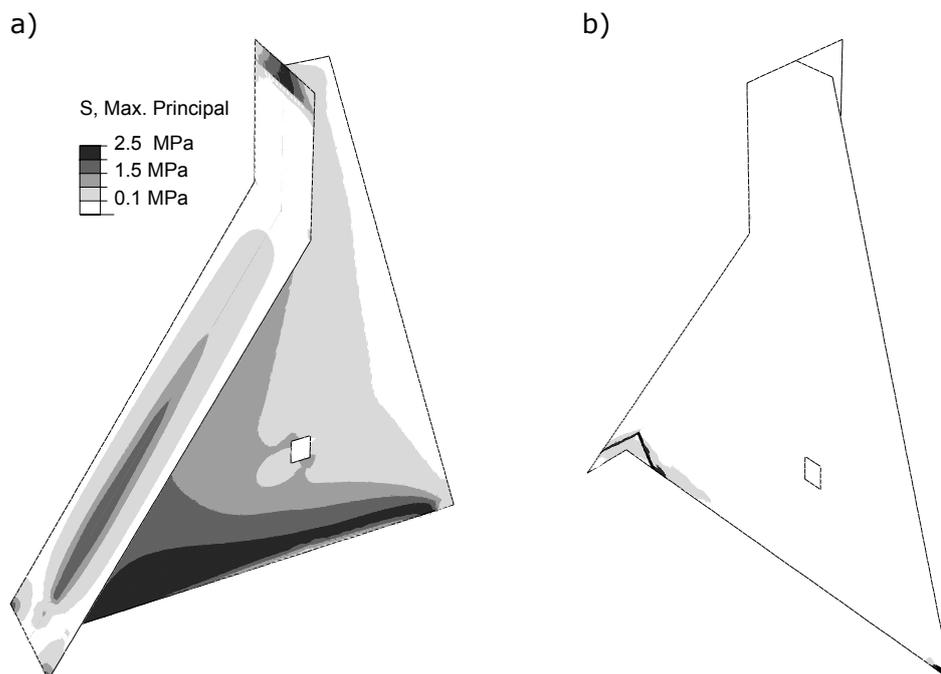
There are low stresses in the front-plate but high stress fields in the lower part of the buttress. There are also in this case large tensile stresses at the centre of the front-plate. These stresses do not initiate cracking, apart from the edges of the concrete at the concrete-rock interface as shown in Figure 5.4(b). The maximum crack width (COD) for the inclined crack in the buttress is approximately 0.17 mm , as can be seen in Figure 5.5.

Figure 5.4 Maximum principal stresses (a) and damaged concrete (b) due to winter temperatures.

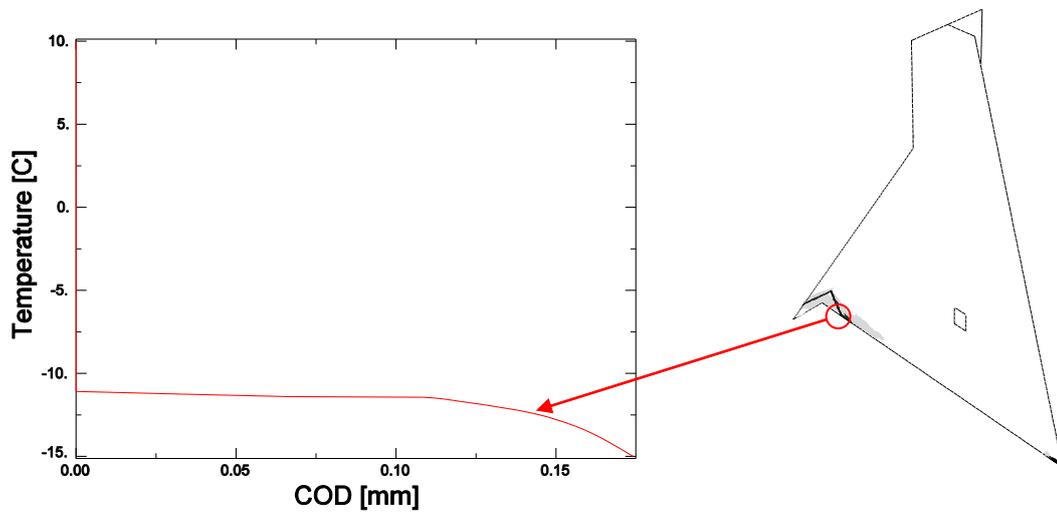
Figure 5.5 Temperature vs. crack opening displacement for the inclined crack in the buttress due to winter temperatures.

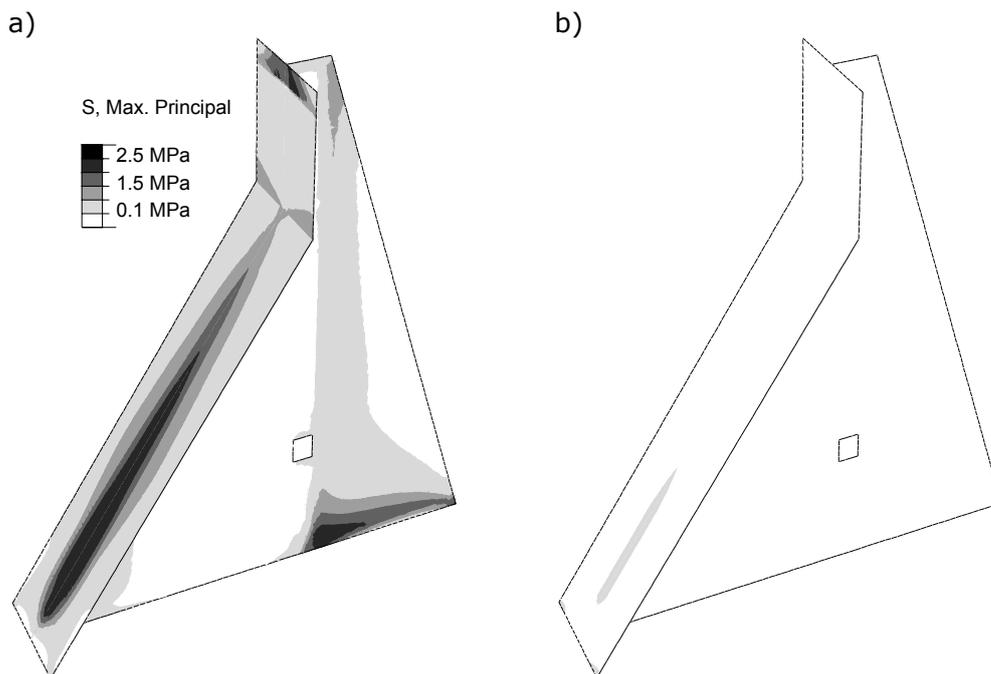
The inclusion of the insulating wall here only results in micro-cracks in the front-plate, as shown in Figure 5.6. The cracks at the concrete-rock interface do not, however, appear in this case. The sharp line between the moderate temperatures between the wall and the front-plate and low outside temperature give rise to large stresses in the buttress, in the zone with the lowest temperatures.

Figure 5.6 Maximum principal tensile stresses (a) and damaged concrete (b) due to winter temperatures, with insulating wall.

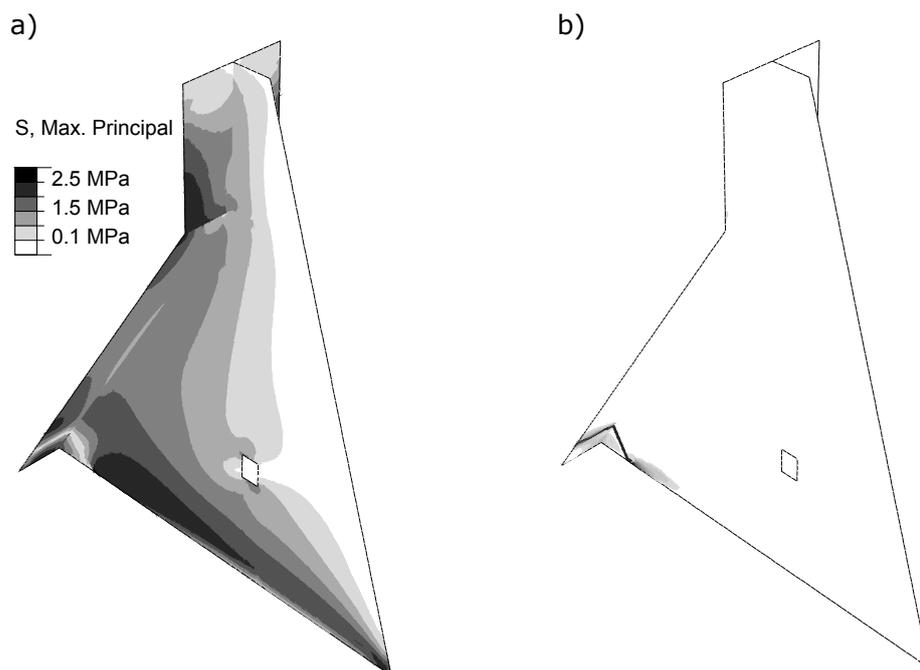
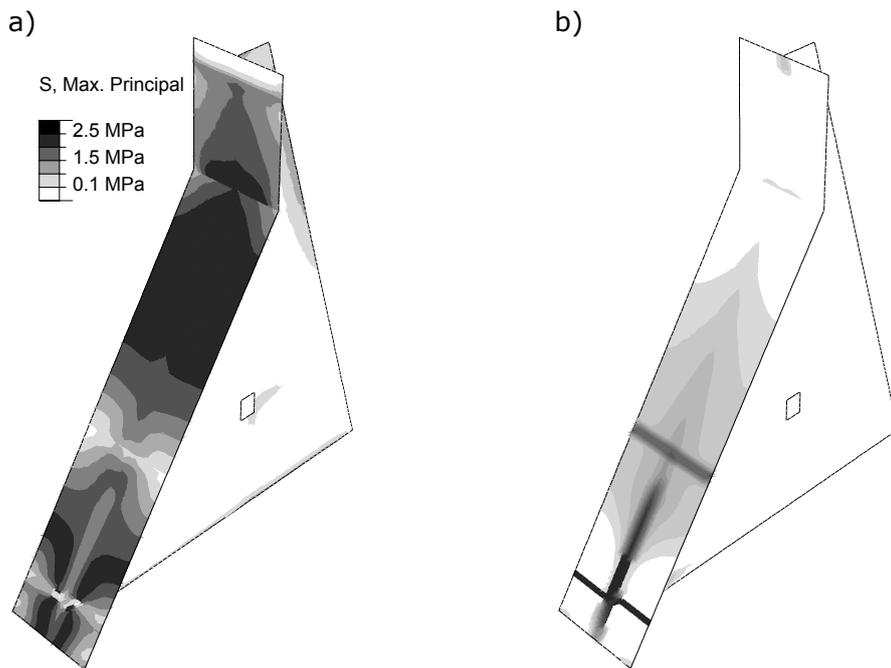
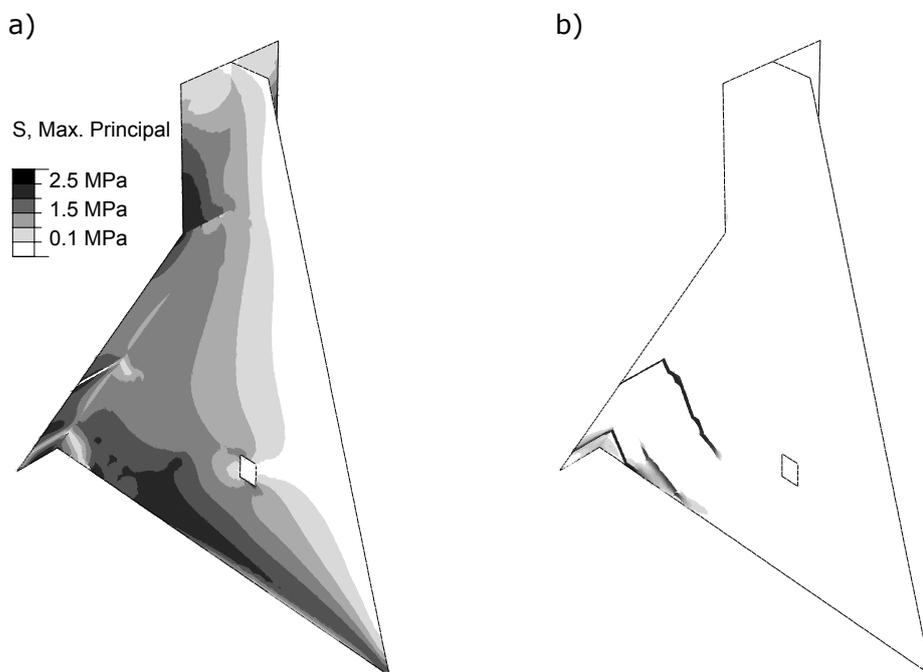
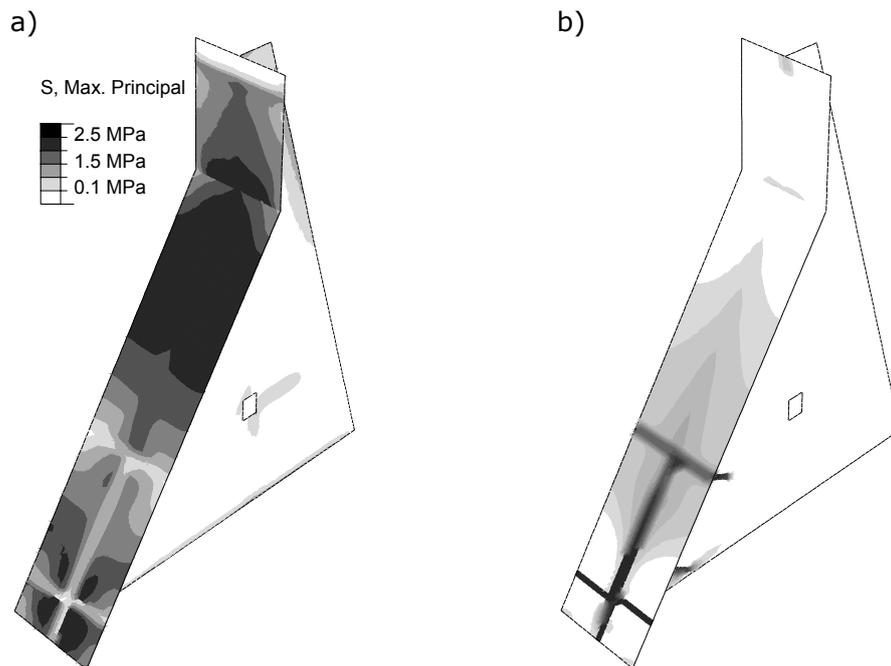
The formation of concrete cracks depends on whether the first season experienced by the un-cracked dam is summer or winter. Subsequent steady-state calculations, with alternating summer or winter temperatures, will be affected by the previous since a more cracked structure is weaker which may affect the initiation of new cracks. After two seasons with cyclic seasonal temperature the dam reaches a constant crack pattern where new cracks only form if the extreme temperatures increase. The crack pattern after two years becomes identical irrespective of which season the analyses start with. The cracks that occur during the two first years in the analysis, without the heat insulation wall, are shown in Figures 5.7–10, starting with winter conditions that lead to some cracking in the lower part of the buttress. As seen, the front-plate is severely cracked already during the first summer season. The maximum principal tensile stresses are also shown in Figures 5.7–10. It can be seen that large tensile stresses occur on the downstream side of almost the whole front-plate. During the winter season large tensile stresses occur in the lower part of the buttress. If the cyclic seasonal analysis is started with summer conditions, one additional year is needed to obtain the results in Figures 5.9–10.

Figure 5.7 Year 1: Maximum principal tensile stresses (a) and damaged concrete (b) due to winter temperatures, without insulating wall.

Figure 5.8 Year 1: Maximum principal tensile stresses (a) and damaged concrete (b) due to summer temperatures, without insulating wall.

Figure 5.9 Year 2: Maximum principal tensile stresses (a) and damaged concrete (b) due to winter temperatures, without insulating wall.

Figure 5.10 Year 2: Maximum principal tensile stresses (a) and damaged concrete (b) due to summer temperatures, without insulating wall.

The simulation of five years of seasonal variation shows that cracks of type (1) and (2) appear already during the first year, as seen in Figures 5.7–10. Diagonal cracks in the buttress are visible from the second winter. A crack of type (3) appears during the first summer following the instalment of the insulating wall and this crack was also found to propagate in the opposite direction during the subsequent winter season, as seen in Figures 5.11–12. A crack of type (4) appeared during the fifth winter season where the inclined crack from the inspection passage has propagated into a vertical crack at the concrete rock interface, which can be seen in Figures 5.13–16.
