Crack propagation in buttress dams

Application of non-linear models – Part II

Elforsk report 10:69

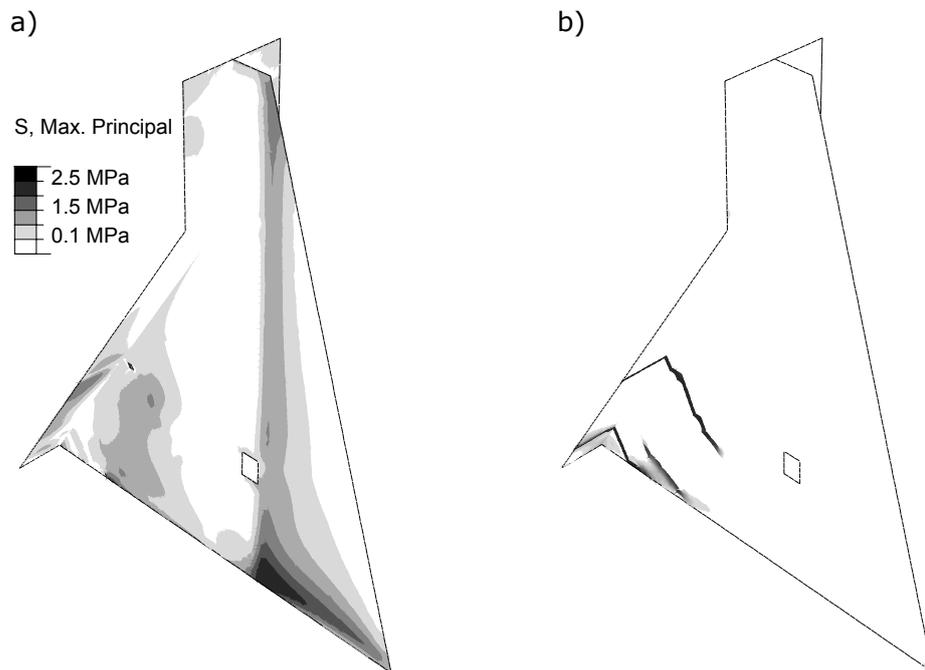
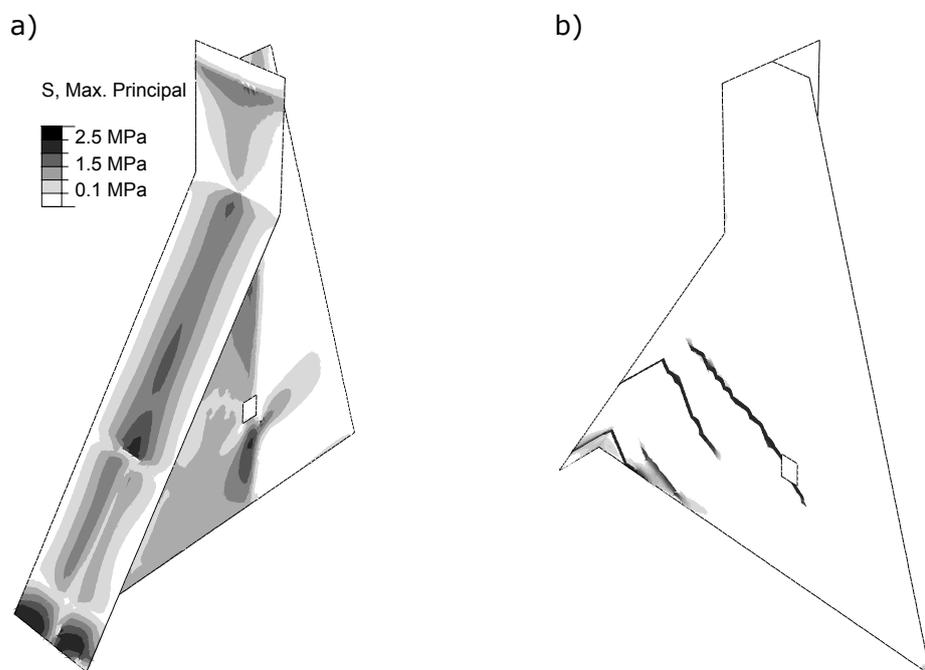
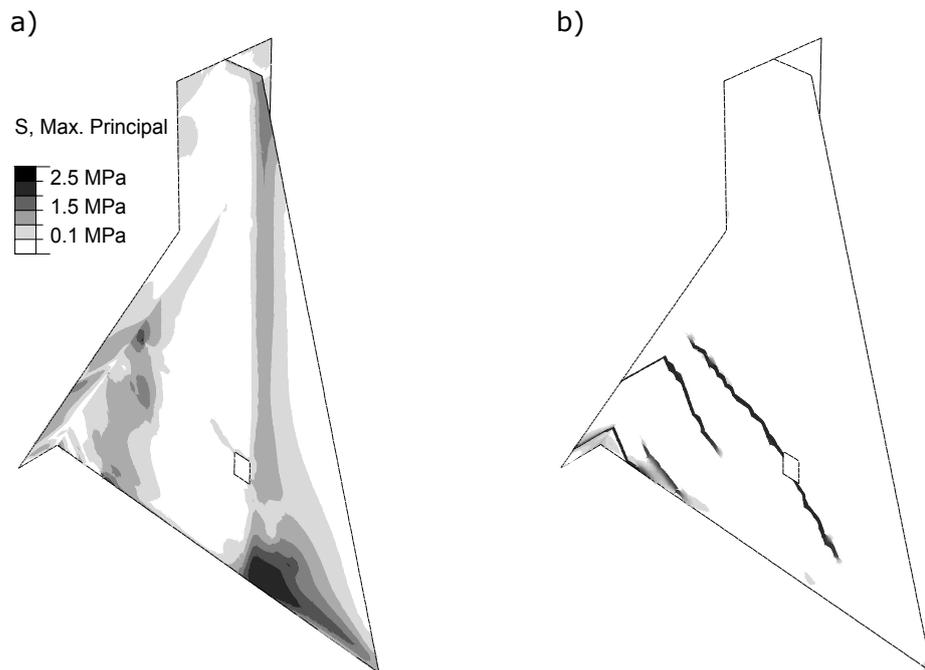
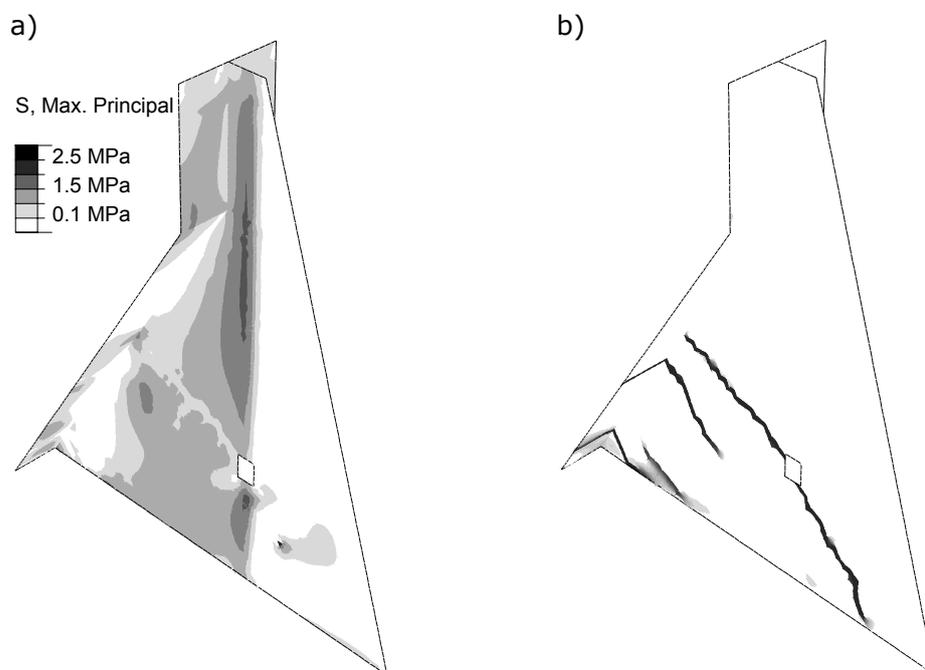
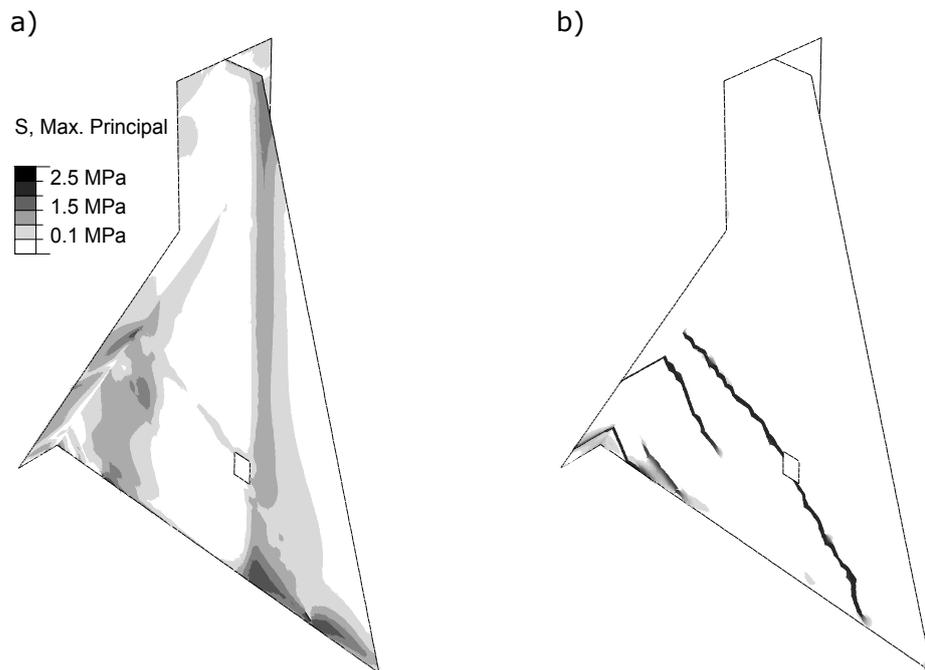
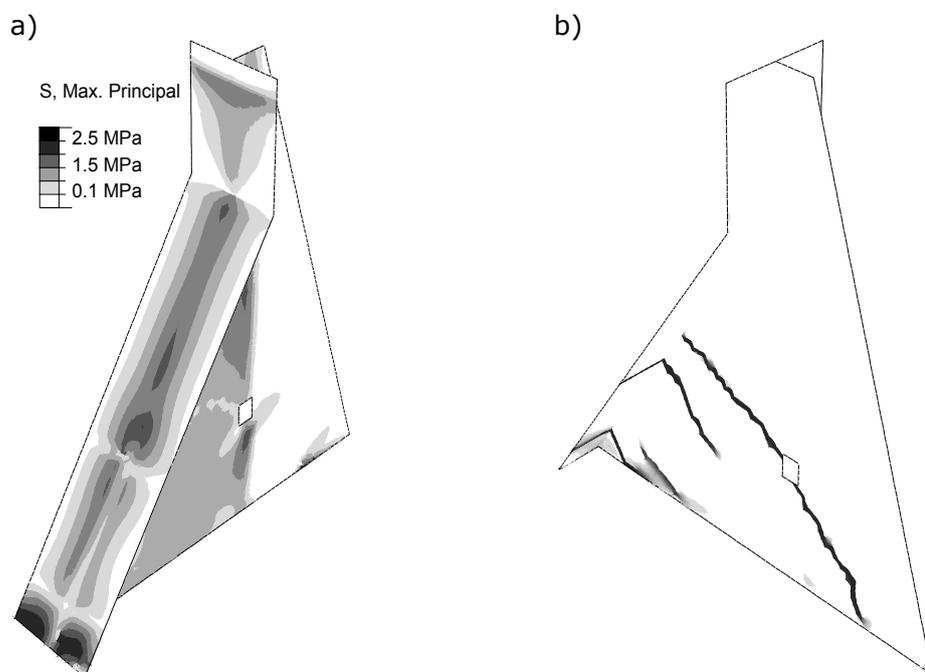
From the third year of the analysis the presence of an insulating wall is accounted for, resulting in the concrete damage shown in Figures 5.11–12. The results from the fourth and the fifth year are presented in Figures 5.13–16. These results, from the last three years of the analyzed time span, also show possible damage caused by this modification of the original structure. The first new cracks developed during the summer, an inclined crack that initiated at the inspection passage and propagated swiftly towards the front-plate. During the following winter analysis step, year 4, this crack propagated from the opposite side of the inspection passage towards the downstream base of the buttress. After this point the dam with the insulating wall has reached a constant, stabile crack pattern where additional cracks or crack propagation will not occur unless higher extreme temperatures appear. It can be seen when comparing Figures 5.7–16 that the tensile stresses in the front-plate are reduced after inclusion of the insulating wall. Large stresses do, however, appear in the buttress during the summer, as can be seen in Figure 5.12. The insulating wall results in a division of the surfaces of the buttress into two temperature zones, resulting in a distinct line in the buttress in the stress figures, where high stresses occur on the colder side.

Figure 5.11 Year 3: Maximum principal tensile stresses (a) and damaged concrete (b) due to winter temperatures, with insulating wall.

Figure 5.12 Year 3: Maximum principal tensile stresses (a) and damaged concrete (b) due to summer temperatures, with insulating wall.

Figure 5.13 Year 4: Maximum principal tensile stresses (a) and damaged concrete (b) due to winter temperatures, with insulating wall.

Figure 5.14 Year 4: Maximum principal tensile stresses (a) and damaged concrete (b) due to summer temperatures, with insulating wall.

Figure 5.15 Year 5: Maximum principal tensile stresses (a) and damaged concrete (b) due to winter temperatures, with insulating wall.

Figure 5.16 Year 5: Maximum principal tensile stresses (a) and damaged concrete (b) due to summer temperatures, with insulating wall.

The simulation of five years of seasonal variation shows that cracks of type (1) and (2) appear already during the first year, as seen in Figures 5.7–10. Diagonal cracks in the buttress are visible from the second winter. A crack of type (3) appears during the first summer following the instalment of the insulating wall and this crack was also found to propagate in the opposite direction during the subsequent winter season, as seen in Figures 5.11–12. A crack of type (4) appeared during the fifth winter season where the inclined crack from the inspection passage has propagated into a vertical crack at the concrete rock interface, which can be seen in Figures 5.13–16.

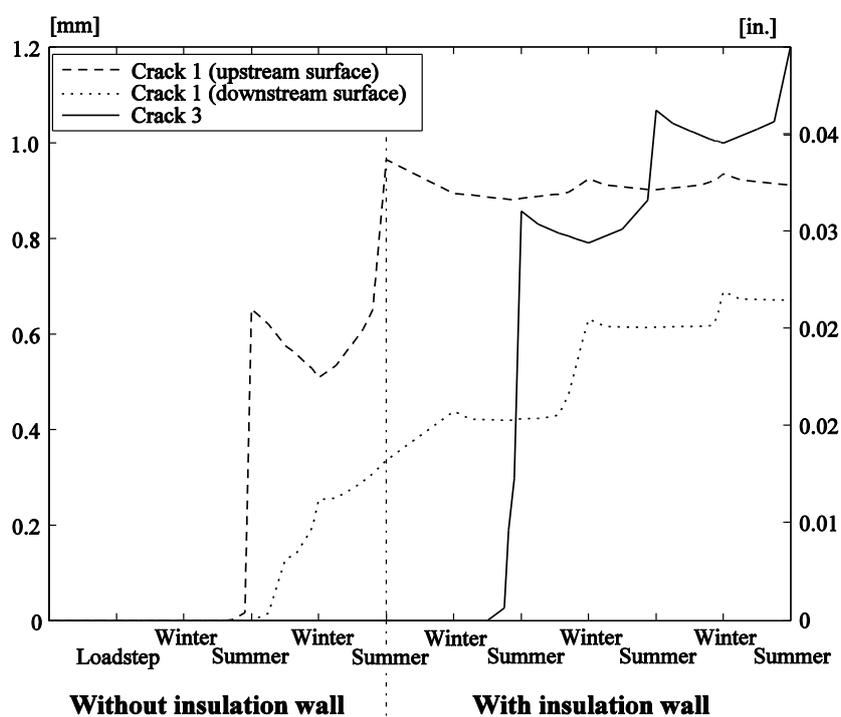
The variations of crack widths during the analysis are presented in Figure 5.17. The two largest cracks in the dam are shown, a horizontal crack in the front-plate (type 1) and the inclined crack in the buttress starting from the inspection passage (type 3). The variation of the displacement of the dam crest is shown in Figure 5.18. The displacements have been normalized to remove the permanent displacement from the gravity load and the external water pressure. Movement upward is defined as a positive vertical displacement and a horizontal movement in the downstream direction is defined as a positive horizontal displacement.

Figure 5.17 Seasonal variation in crack width. From Malm and Ansell (2010).

It can be seen in the Figure 5.17 that the crack width on the upstream side of the crack in the front-plate continuously increases until the insulating wall is inserted. This crack stabilizes thereafter, and for the remaining seasons in the analysis this crack has a maximum width of 1.0 mm. However, on the downstream side of the front-plate this crack continues to increase. The crack with the largest width is the inclined crack of type (3) that originates from the inspection passage, with a maximum width of 1.2 mm. The maximum observed crack width observed on the monitored Storfinnforsen dam is about 2.0 mm (Fahlén and Näslund, 1991), but most of the observed cracks have widths within 0.3 to 1.0 mm.

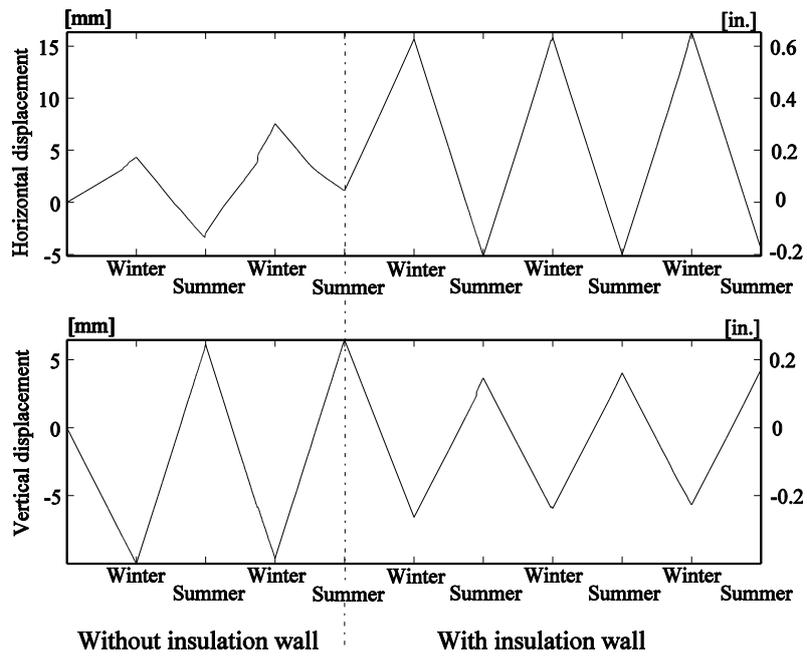
Figure 5.18 Seasonal variation of horizontal and vertical displacement. From Malm and Ansell (2010).

the other hand increased after the insulating wall was included. The analysis showed that both the horizontal and the vertical displacement are slowly increasing due to the crack propagation. The calculated crack patterns, crack types and crack widths shows good agreement with the ocular observations on the Storfinnforsen dam. Some cracks were most probably also formed, during the cooling phase when the dam was built, in the contraction joint between pillars and front-plates and vertically in the pillars near the rock. These first cracks have facilitated the further formation of the cracks described above.

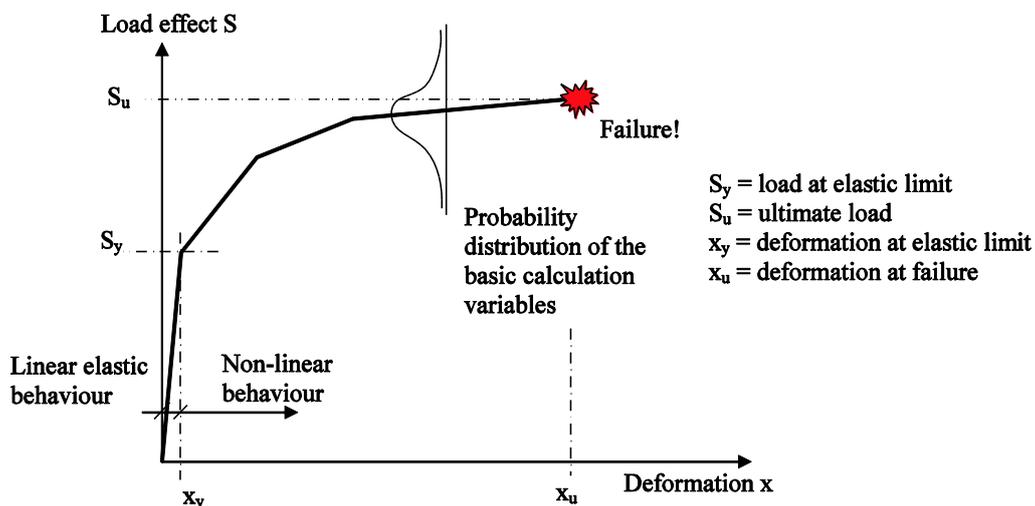
It is also very important to be able to predict the final, global failure of a monolith. To do this a global load-deformation-curve as in Figure 6.1 has to be calculated. The deformation of the dam crest is a suitable measure. After appearance of the first crack the monolith will behave non-linearly, with the formation of more cracks leading to global failure. The load-deformation curve is however not deterministic, but probabilistic due to variations in basic variables, such as for the Young modulus of elasticity, strength, etc. The model may therefore be refined also with probabilistic calculations.

Figure 6.1 Principles of a load-deformation curve showing failure of a concrete monolith.
