**EXPERIENCES FROM DISTRIBUTED STRAIN  
MEASUREMENTS IN FIVE EMBANKMENT DAMS  
2004-07**

**Sam Johansson and Dan Watley**

**Rapport 07:52**

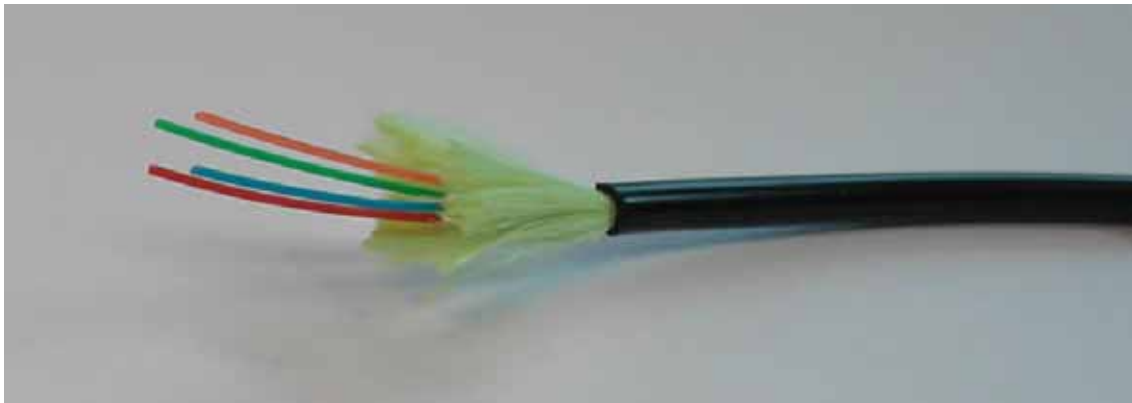
The first DamSens cable (Figure 2), was designed by Sensornet/HydroResearch for dam monitoring. The first installation of the cable was made at Ajaure in 2001. This cable has also been installed in other dams, although some minor changes have been made in order to further improve its durability. The cable contains two single mode fibres for use with the DTSS system, and two multimode fibres for use with the Sensornet DTS system (which measures only temperature along a length of fibre), if the user should wish to use a DTS system at some time. Each system only requires one fibre (they take single-ended measurements) – the second fibre was added for redundancy. The specifications for the cable and the fibres are shown in Table 1 and Table 2.

Figure 2 - DTSS cable breakout.

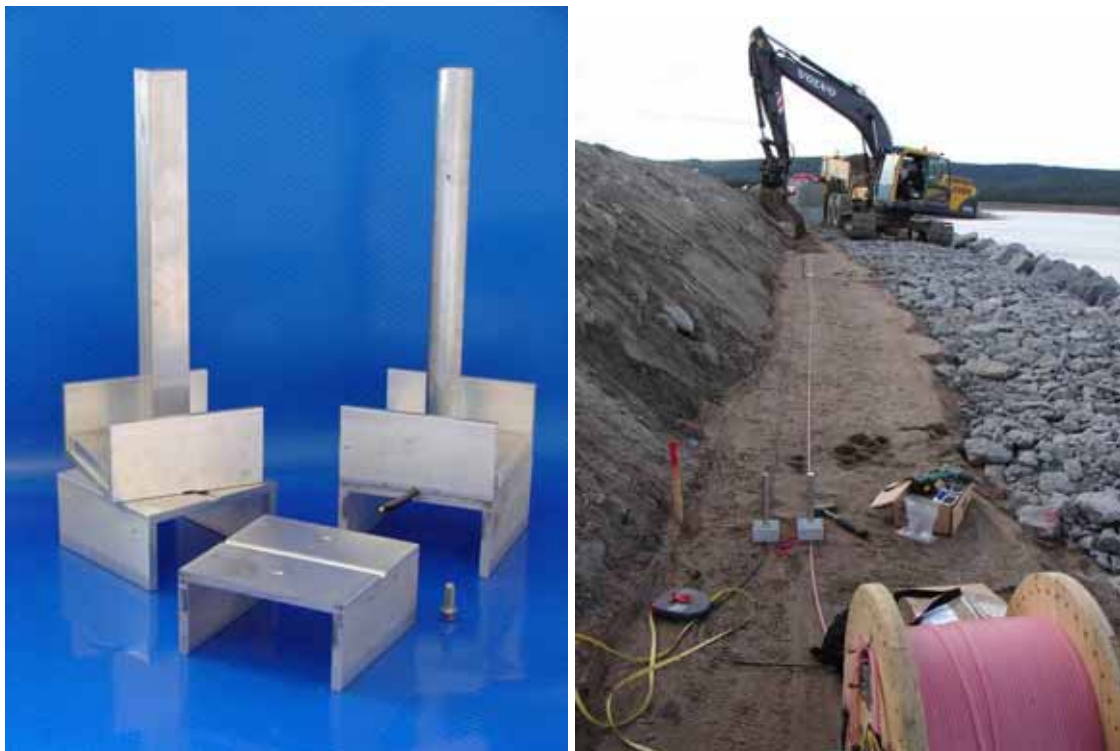
If the friction is expected to be low (as is the case with the thin SMARTprofile Cable) it can be increased using clamps (Figure 9). These clamps were designed to obtain a 1 dm<sup>2</sup> in all three directions using a u-beam of aluminium. Surveying poles were also added to a few clamps to verify measured movements. The clamp was made in two versions to fit both cables.

Figure 9 – Clamps used for the SMARTprofile cable and the DamSens cable, with additional surveying poles (left), and installation of the clamps at Seitevare dam.

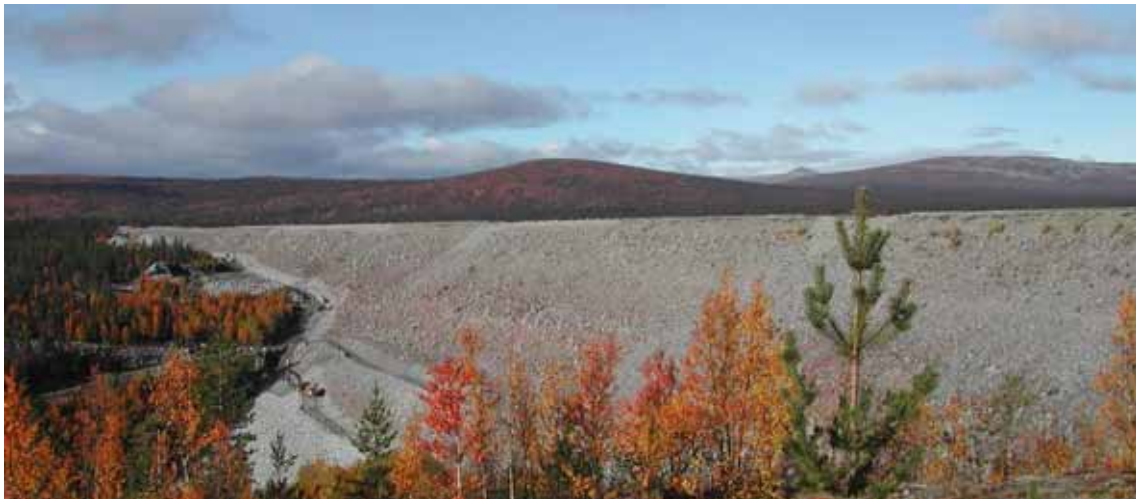
Figure 27 – The Seitevare dam

The Seitevare dam is located in the Lilla Luleälven River, in the northern part of Sweden. With a length of 1450km and maximum height of 106 m, the dam is among the largest dams in Sweden. The main purpose of measurements taken at the dam was to evaluate the seepage flow at the toe, and movement detection on the crest.

The first distributed measurements of strain and temperature in the crest were carried out at Seitevare dam in September 2005, followed by measurements in May 2006, September 2006 and May 2007.

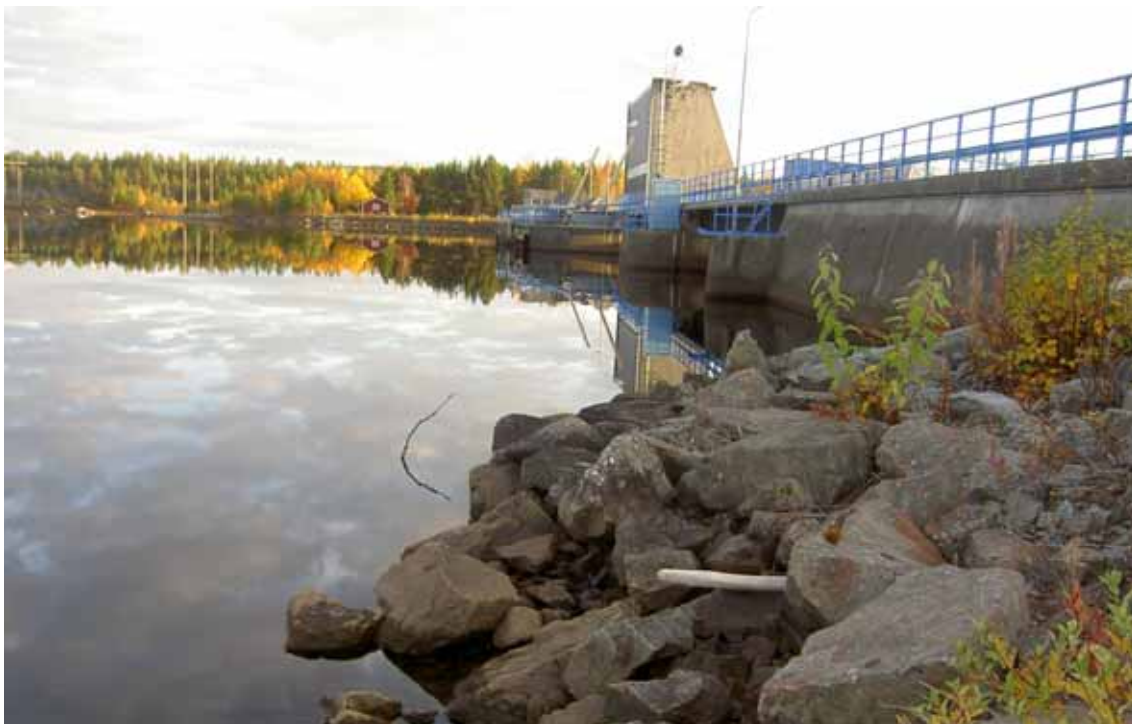
**Figure 54 – Hällby Dam.**

Hällby consists of two dam sections, referred to as “Left” and “Right” with the power station between the two dam sections (Figure 54). The optical monitoring cable has been installed in the crest of the dam, running outwards from the power station, where also the terminations are made in each of the abutments. The cable was installed in 2005 in connection to dam safety upgrading work including a new toe berm and increased core crest.

The optical cable that has been installed is the standard DamSens cable, providing two multimode fibres (for temperature monitoring) and two singlemode fibres (for strain monitoring). The cable was placed on the core crest.

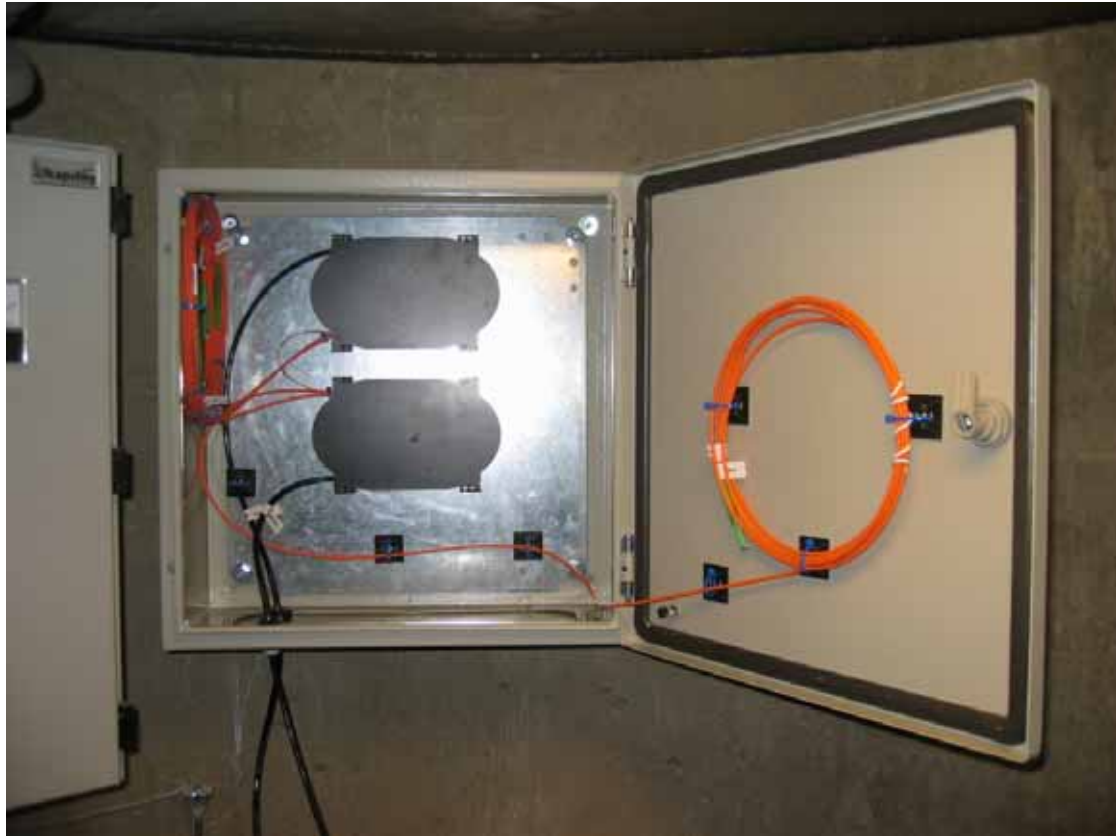
Figure 65 - Junction box installed in 2006.

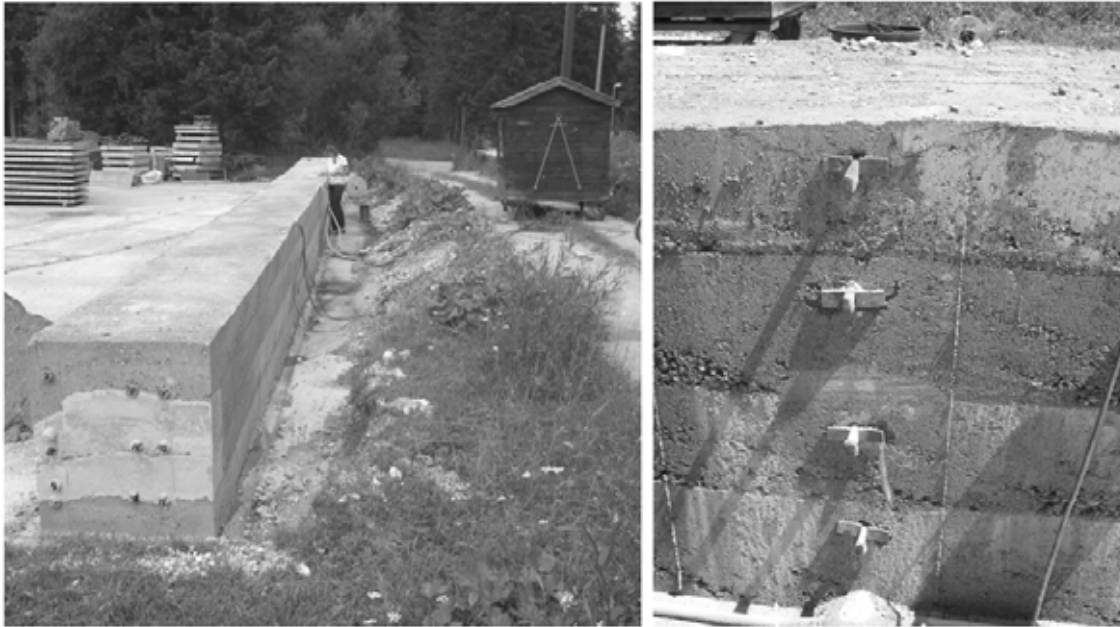
The closest representation to this that has been tested is the cracking of a concrete slab in which was embedded a strain sensing cable (Figure 69). Tests were carried out using

Sensornet's DTSS by the Technical University of Munich (Moser et al). A cable was installed in a RCC block, where the fibre was laid back and forth along the block in 9 different lengths. Some steel pins were driven into the block to create a crack through the block approximately 1mm in magnitude. This crack ran perpendicular to the cable lengths.

**Figure 69 - Photos of the RCC block with the strain sensing cable embedded within it (Moser et al).**
