# CORROSION IN EARTHING NETWORKS IN NUCLEAR POWER PLANTS

REPORT 2017:397

# **Corrosion in Earthing Networks in Nuclear Power Plants**

Literature study

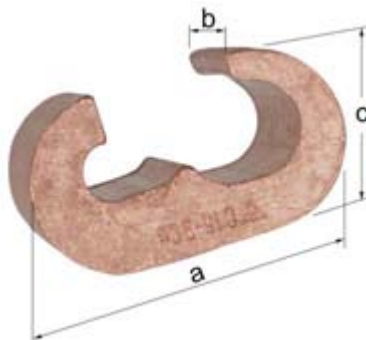
The crimp connection type specified by Svenska Kraftnät is Elpress C-sleeve [9] which is a C-shaped crimp “sleeve” with a ridge providing the required deformation of the conductor, see Figure 6. Besides design, the material in the

Figure 6 - Elpress C-sleeve ([www.elpress.se](http://www.elpress.se))
