# FROST-INDUCED DETERIORATION OF CONCRETE IN HYDRAULIC STRUCTURES

REPORT 2017:437

Interactions between water absorption, leaching and  
frost action

DIVISION OF BUILDING MATERIALS | FACULTY OF ENGINEERING | LUND UNIVERSITY

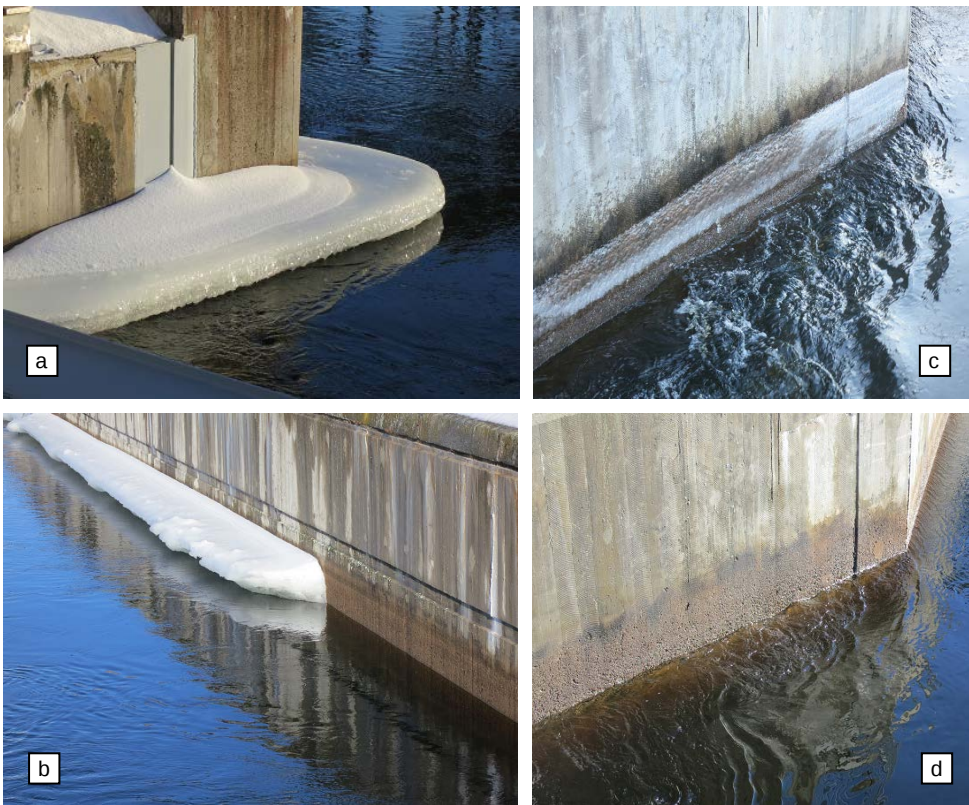
**Figure 2-3. In winter, a band of ice frozen solid to the concrete surface can be seen at the waterline of hydraulic structures (a). In spring, the band of ice falls off when the air temperature rises (b). In both spring and autumn, the air temperature frequently crosses the freezing point of water. A small band of ice can therefore be seen at the waterline in the morning (c) while it has been melted away in the evening (d).**

The band of ice falls off when the air temperature starts to rise in spring (Figure 2-3 b). However, as previously mentioned, the air temperature frequently crosses the freezing point of water in spring and autumn. Depending on the air temperatures, the band of ice can be re-formed during the nights and later melted away during the days (Figure 2-3 c–d).

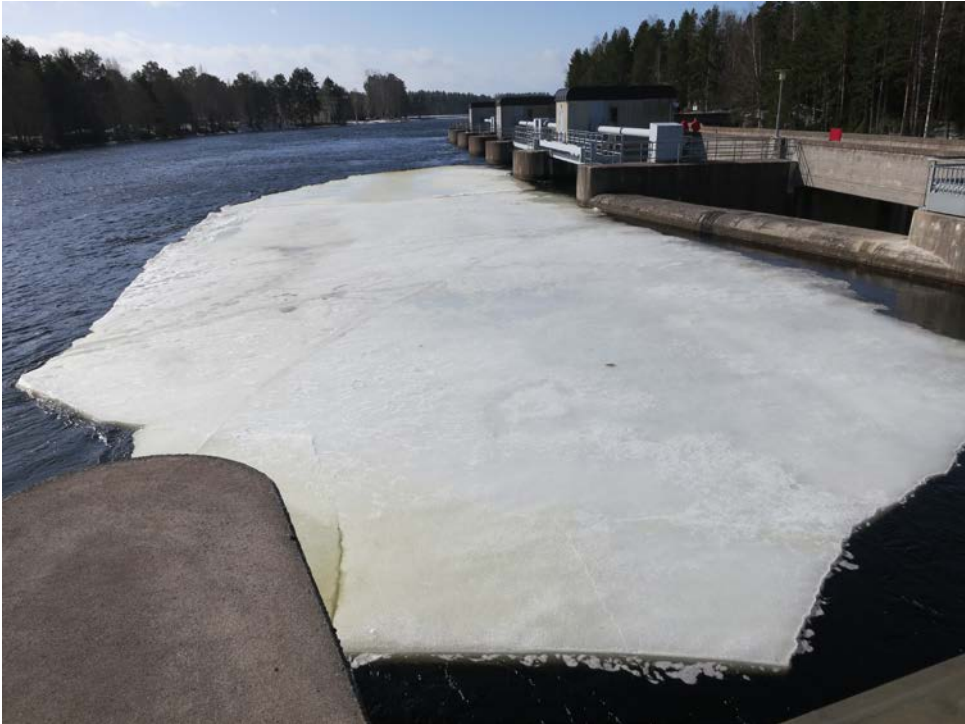
**Figure 2-5. Ice floe pushing against the dam and a bridge pile.**

ICOLD (1996) stated that the ice cover tends to melt in place in small and medium sized lakes and reservoirs. In rivers fully utilised for power production, the ice tends to melt in place or will at least be strongly weakened before it breaks up into ice floes of different sizes during spring. The ice floes are then slowly brought downstream by the river current. If the ice floes do not melt away until they reach the dam or any other hydraulic structure, the ice floes push against the structure until they break apart into smaller pieces or melt away (Figure 2-5).

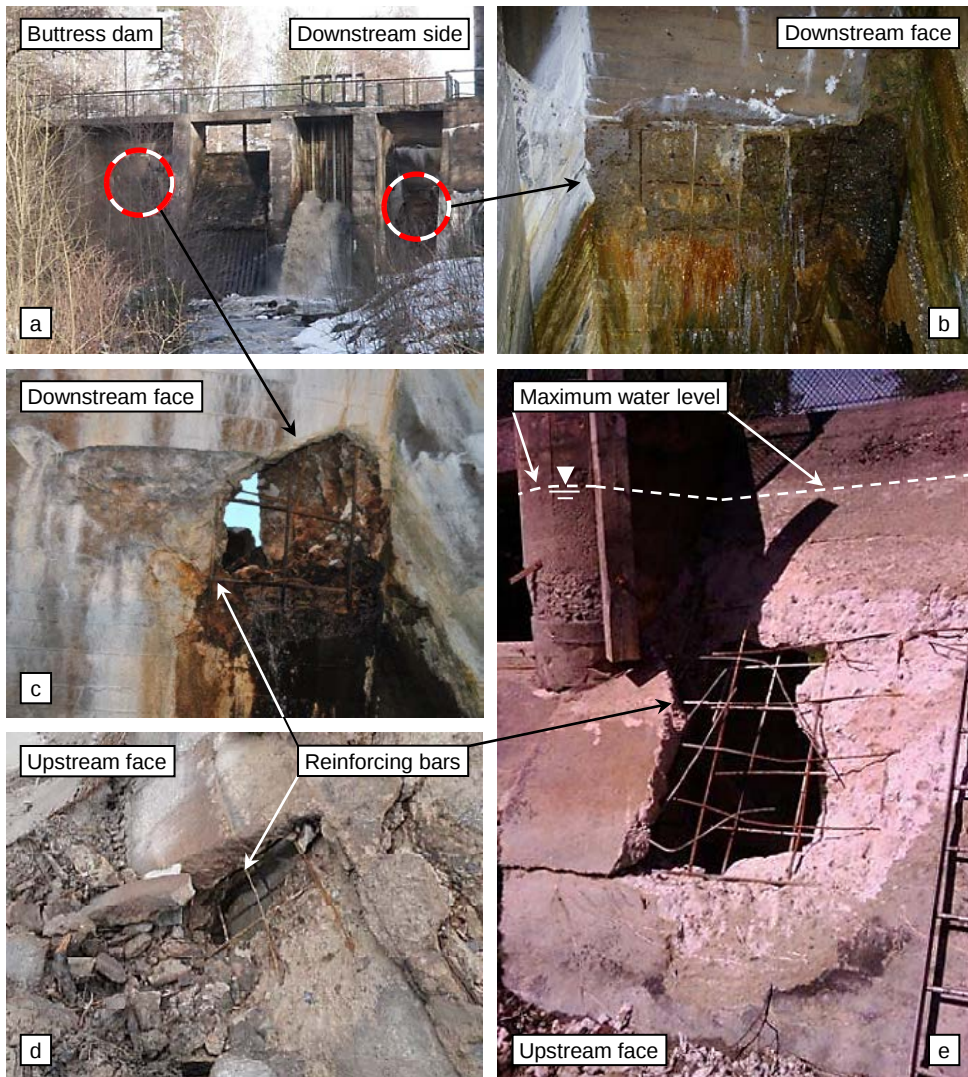
**Figure 2-11. A severely damaged buttress dam (a). Concrete cover missing in some places in the vicinity of water leakage through cracks on the downstream face (b). A hole appeared in the flat slab in another place and water escaped flushing away loose pieces of concrete (c–e). Only the reinforcing steel was left. Photos provided by Fortum AB.**
