ANALYSIS OF LOAD AND RESPONSE ON LARGE HYDROPOWER DRAFT TUBE STRUCTURES

REPORT 2019:567

Analysis of load and response on large hydropower draft tube structures

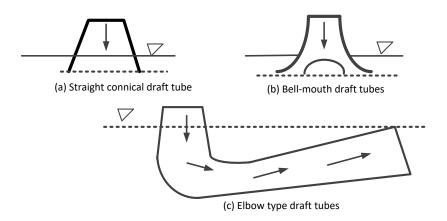
Figure 1.3: Schematic diagram of different types of draft tubes (Abbas & Kumar, 2015)

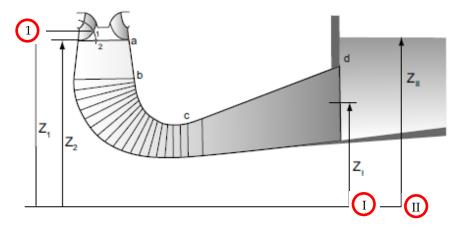
Figure 1.3: Schematic of a draft tube (Mauri, 2002)

The role of the draft tube can be described by considering the energetic balance ΔE between sections 1 and II with and without the draft tube (see Figure 1.3):

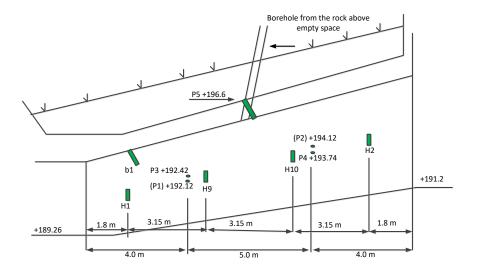
Figure 2.1: Sensor position in right-hand draft tube central wall and roof (H: strain gauges, P: pressure sensors and b1: crack-opening meter) (Holmström, 2010).

As illustrated in **Figure 2.1**, the position of the sensors is P1 at upstream/left side of the wall, P2 at downstream/left side of the wall, P3 at upstream/right side of the wall, P4 at downstream/right side of the wall and P5 at roof/right side of draft tube. It should be noted that sensors P1 and P3 unfortunately failed during the monitoring campaign.

To measure the concrete structure's response to variations in the water pressure, 10 strain gauges have been placed in the right section of the draft tube, central wall and roof of the draft tube. Four strain gauges were mounted on the central wall, as well as six sensors in the roof to follow any deformation of the draft tube structure under load. To measure the change of crack width in the crack between the roof and central wall, a crack-mouth opening gauge was mounted. This gauge failed directly after filling the draft tube. The strain gauges on the central wall located along the draft tube from upstream to downstream are denominated as H1, H3, H10 and H2, respectively, see Figure 2.1. The strain gauges on the roof and along the draft tube from upstream to downstream are denominated as H4, H6, H8 and H9, respectively, see Figure 2.2. Two strain gauges have also been placed on the roof and across the draft tube, H5 and H7 but the former failed from the beginning. The strain gauges were installed on a dog bone shape plate with three different lengths: 300 mm, 160 mm and 132 mm for stain gauges H1-H4, H5-H8 and H9-H10, respectively. The direction of dog bones plates has been shown in Figures 2.1 and 2.2.

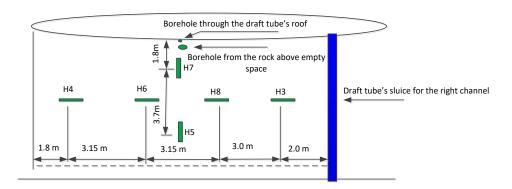
Figure 2.2: Sensor position on the right-hand side of the draft tube roof (H: strain gauges) (Holmström, 2010).

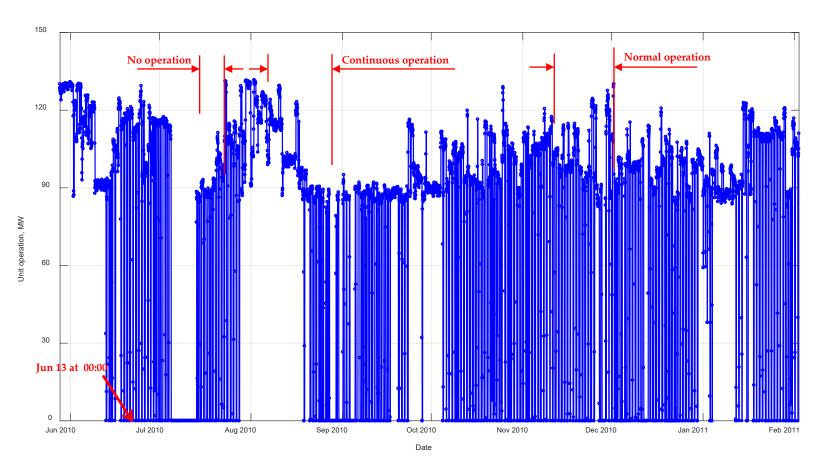
Figure 3.1: Unit operation during one-year measurement

It is nowadays common to see turbines being operated over the whole range, with many start/stops, instead of continuous close to peak operation as in the former days. Measurement of unit operation for one year indicated that for normal operation the unit production in daytime is almost between 80-130 MW, see Figure 3.1. It should be noted that the capacity of the unit is 150 MW, but it was restricted to operate not more than 130 MW. It can be seen from Figure 3.1 that the unit had been stopped for a certain time during the summer time; i.e. from July 05 at 01:00 to July 12 at 17:00. Figure 3.2 -3.3 show the unit operation and downstream level as moving average for ten months.

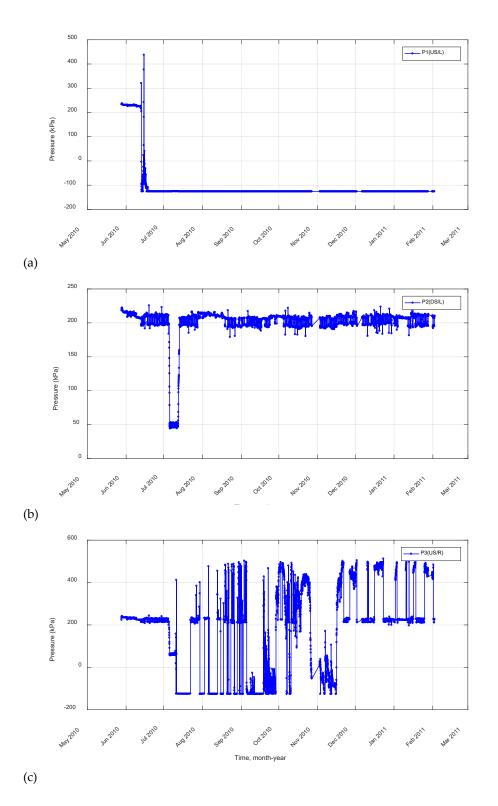
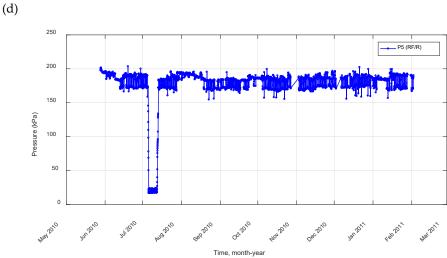
Figure 4.1: Pressure measurement during one year for (a) P1 (US/L), (b) P2 (DS/L), (c) P3 (US/R), (d) P4 (DS/R) and (e) P5 (RF/R).

(Cont.) Figure 4.1: Pressure measurement during one year for (a) P1 (US/L), (b) P2(DS/L), (c) P3 (US/R), (d) P4 (DS/R) and (e) P5 (RF/R).

The pressure measurements of all five sensors are shown in Figure 4.1. The pressure measurements from 28^{th} May 2010 to 28^{th} February 2011 were recorded. It can be seen that P1 was no longer working in the early stage of measurements on 13^{th} June at 00:00 when the first stop event occurred, i.e. see Figure 2.1 (a). The cause of such failure may occur due to the connectors were broken, or the cable insulation was damaged because of the fluctuation of the water during the start of the operation unit. Whereas, P3 failed during the stop event of the unit on 10^{th} July at 00:00 but in some periods the reading could be considered for example during 19^{th} to 25^{th} January , see Figure 4.1(c). It can also be seen that P2, P4 and P5 have the same behaviour pattern with minor differences. By excluding P1 and P3, Figure 4.2 shows the minor differences in the measurements of P2, P4 and P5.

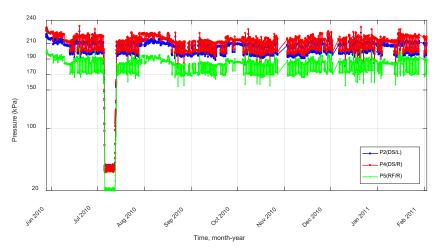
Figure 4.2: Pressure measurement during one year for P2 (DS/L), P4 (DS/R) and P5 (RF/R).

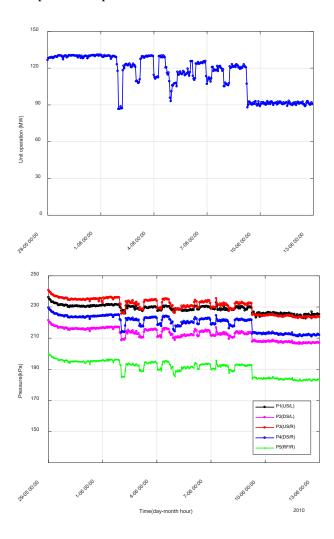
Figure 4.3: The pressure measurement of five sensors from 29th May at 00:00 to 13th June at 00:00.

However, the pressure measurements of five sensors for two weeks form 29th May at 00:00 until 13th June at 00:00 are shown in Figure 4.3. In this period, all five sensors work very well. Also, it can be seen that the measured pressure follows the unit operational pattern.

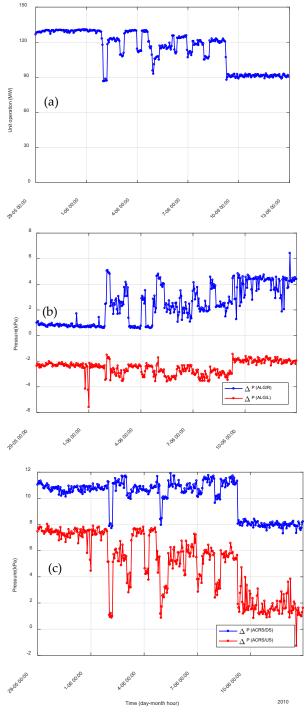
Figure 4.4: The variation of the pressure during (a) unit operation, (b) across and (c) along the central wall for two weeks.

The variation of the pressure across the central wall at the downstream and upstream sides of the draft tube can be calculated by using Eq. 4.1-4.2 for the same period from 29^{th} May at 00:00 to 13^{th} June at 00:00 and is shown in Figure 4.4 (b). The variation of the pressure along the central wall at right and left sides of the central wall are calculated by using Eq. 4.3-4.4 for the same period and illustrated in Figure 4.4 (c).

It can be seen in Figure 4.4 that a drop of the output of 40 MW gives a relative increase of the pressure with approximately four kPa on the upstream position, whereas this reduction gives a decrease of the pressure on the right-hand side with approximately six kPa. A higher relative difference in pressure across the wall can be observed in the downstream position due to even lower values on left-hand side downstream.

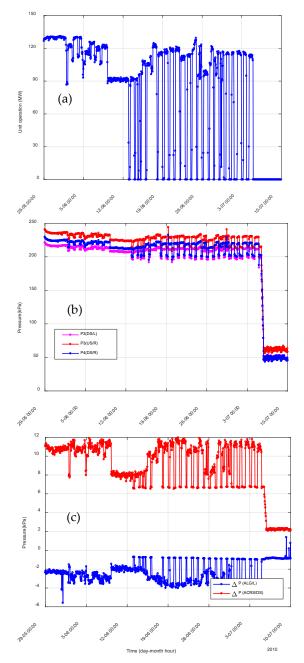
Figure 4.5: The variation of the pressure during (a) unit operation, (b) across and (c) along the central wall during a month.

For one-month measurements, the variation of the pressure of only three sensor P2, P3 and P4 can be achieved by excluding P1 and illustrated in Figure 4.5 (b). Also, the variations of the pressure across the central wall at the downstream side and along the central wall at right side of the central wall are shown in Figure 4.5 (c).

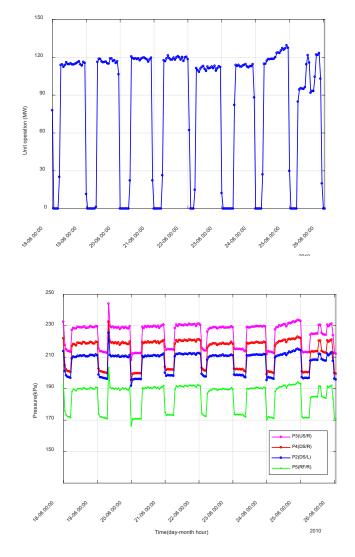
Figure 4.6: Variation of measured pressure in a week for normal operation by producing the power of about 120 MW.

In this section, the pressure measurement for normal operation by producing the effect of about 120 MW during daytime is described. Figures 4.6 – 4.7 illustrate a variation of measured pressure for one week and 24 hours, respectively. As shown in these figures, pressure on the right side of the central wall (P3 (US/R) and P4 (DS/R)) is higher than the left side of the central wall (P2 (DS/L)). Pressure on the roof is less than for other sensors. It should be noted that when the unit is off, sensors show hydrostatic pressure. As seen from these figures, the maximum pressure during operation is for sensor P3 (US/R) with a value of almost 230 kPa. The minimum pressure during operation is for sensor P5 (RF/R) with a value of 190.5 kPa.

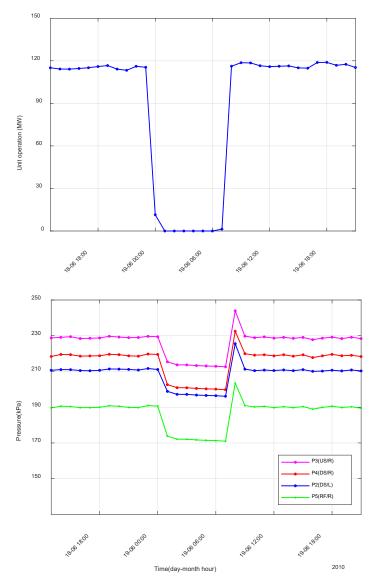
Figure 4.7: Variation of measured pressure in 24 hours for normal operation by producing the effect of about 120 MW.

In Figure 4.7 it can be seen there is pressure reduction from daytime (operation of 120 MW) to night-time (no operation) of about 20 kPa in all sensors.

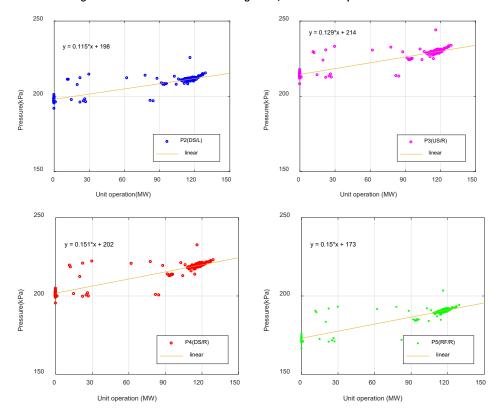
Figure 4.9 illustrates a linear correlation between pressure measurement and unit operation for one week. As seen from this figure for sensors P2-P5 with increasing effect, the measured pressure is increased.

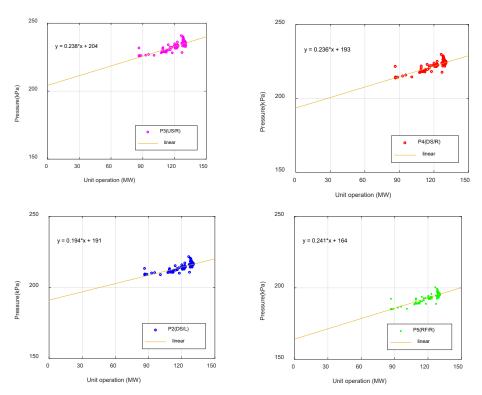
Figure 4.18: Correlation between pressure measurement and unit operation in a week for continuous operation with producing power between 85-130 MW

A linear correlation between pressure measurement and unit operation can be found for one-week occasion and shown in Figure 4.18. As seen from this figure for all sensors with increasing the unit operation power, the measured pressure is increased. Figure 4.19 shows the correlation between unit operation and pressure along and across the central wall. It is observed that with the increasing effect the pressure difference across and along the central wall is increased. The behaviour regarding pressures along and across the wall show a good correlation with the unit operation.

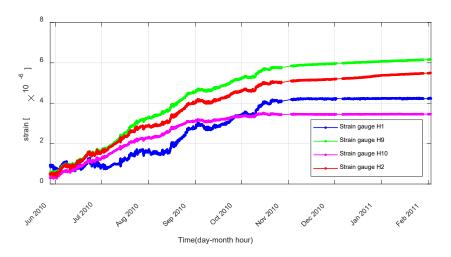
Figure 5.1 Measured strain of H1, H9, H10 and H2 on the right side of the central wall.

Figure 5.1-5.3 illustrates pressure measurements of all ten strain gauges during one year starting from 28 May 2010. The measured strain along the right side of the middle wall in the draft tube is presented in Figure 5.1. Whereas, the measured strain under the roof is presented in Figure 5.2-5.3. It can be seen from these figures that after July the measurement of H1-4 and H6-10 had drifted while H5 was failed from the beginning.

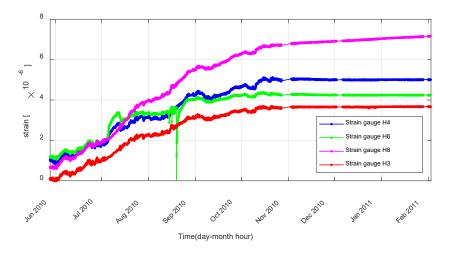
Figure 5.2 Measured strain of H4, H6, H8 and H3 along the roof.

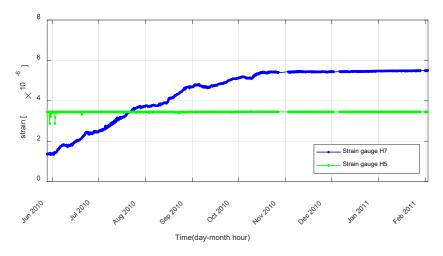
Figure 5.3 Measured strain of H7 and H5, across the roof.

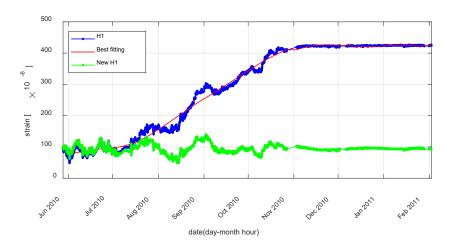
Figure 5.4: Trend removal process from strain measurement

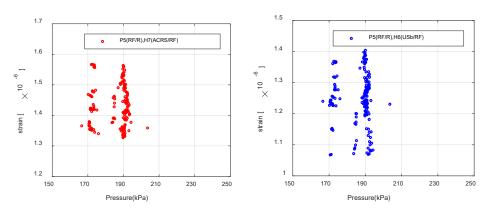
Figure 5.10: Correlation between pressure and strain measurement on the roof for normal operation with production of 110 MW in a week. Y-axis scale is 0.5 µstrain.

Figures 5.10-5.12 show a correlation between pressure and strain measurement on the roof, central wall and across the wall, respectively. Correlation has been shown for the closest strain sensor to the pressure gages.

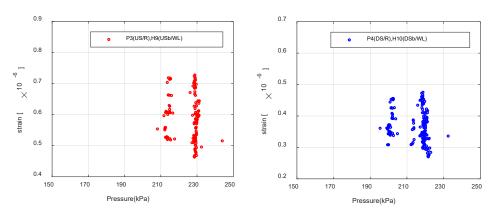
Figure 5.11: Correlation between pressure and strain measurement on the wall for normal operation with production of 110 MW in a week. Y-axis scale is 0.5 µstrain.

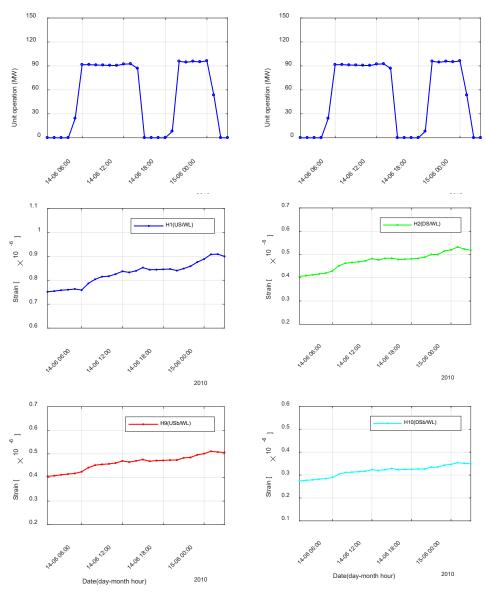
Figure 5.24: Variation of measured strain on the wall in 24 hours for normal and quick start and stops

Figures 5.24 and 5.25 show variations of strain measurement during a sequence of start and stops on central wall and roof, respectively. Three start/stop events are observed in 12 hours in the morning and afternoon. As seen from these figures for the second start/stop, except sensors H1 (US/WL), H3 (USb/WL) and H7 (ACRS/RF) variation of strain on this time interval are insignificant. While, for all sensors, strain corresponding to the zero MW operation is higher than, other strain measurement corresponding to zero MW operation. This shows the effect of fast stop/start. Table 5.11 and 5.12 summarize measured strain during this time interval for sensors on the central wall and roof, respectively. It should be noted that strain measurement for this time is higher than strain during normal operation of 110 MW, see Tables, 5.3-5.4.

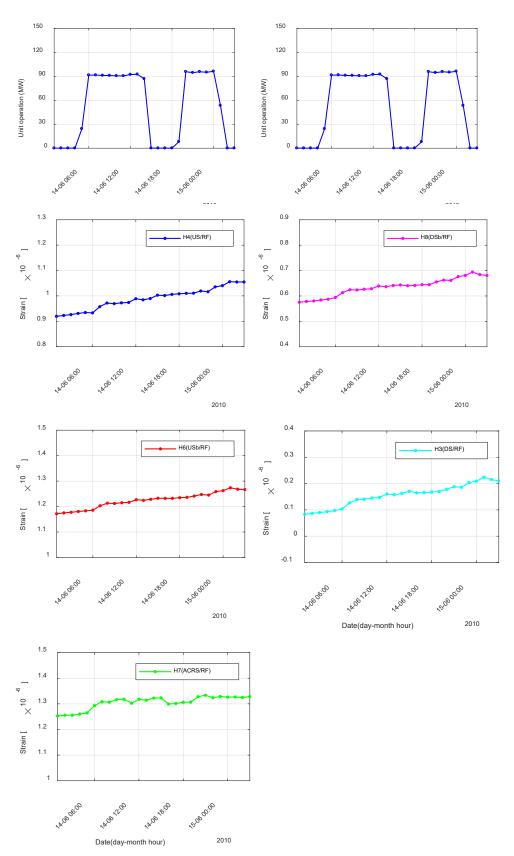
Figure 5.25: Variation of measured strain on the roof in 24 hours for normal and quick start and stops

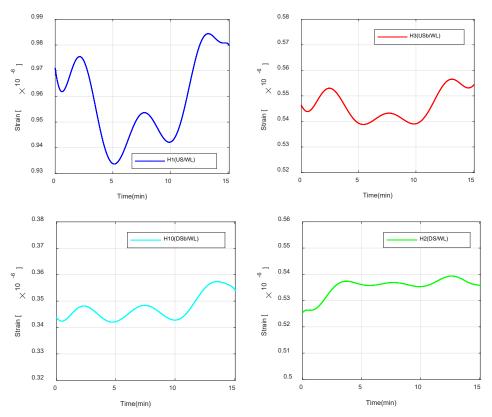
Figure 5.26: Variation of measured strain on the wall in 15 min during stop- reducing effect from 19.15 MW to 0 (2010-12-20 12:23). Y-axis scale is $0.025~\mu strain$.

Figures 5.26-5.27 show variation of measured strain in 15 min during stop-reducing effect from 19.15 MW to 0 (2010-12-20 12:23) for central wall and roof, respectively. Strain measurements indicate peaks that significantly are higher than the measured value from 1 min reading at time 12:00, see Tables 5.11-12. Compared to Figure 5.29-30, strain measurement during stop-reducing effect from 8.68 MW to 0, Variation of strain significantly is high. This can be due to fast stopping the unit. It should be noted that pressure and strain measurement from time 12:00 to 13:00 was increased while the operation was reducing from 19.15 MW to zero.

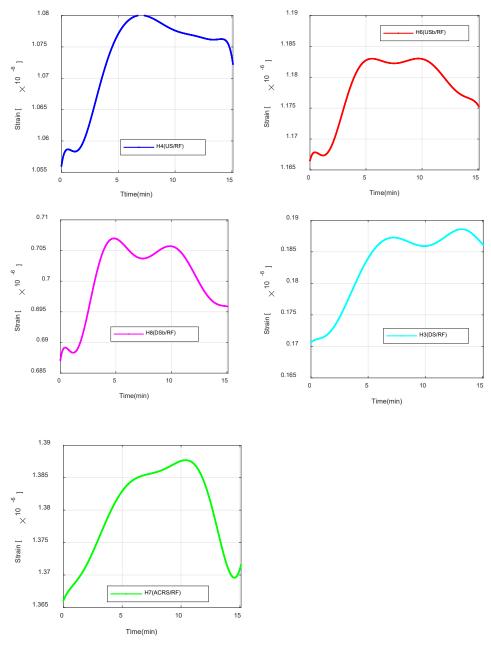
Figure 5.27: Variation of measured strain on the roof in 15 min during stop- reducing effect from 19.15 MW to 0 (2010-12-20 12:23). Y-axis scale is $0.025~\mu strain$.

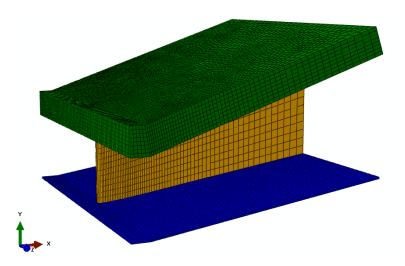
Figure 6.1: Finite element model of draft tube.

In this chapter, a simplified three-dimensional FE model of the draft tube with the central wall is presented, where FE modelling, boundary conditions, material properties and applied load are described. Furthermore, structure response from FEM is compared with the strain measurements.

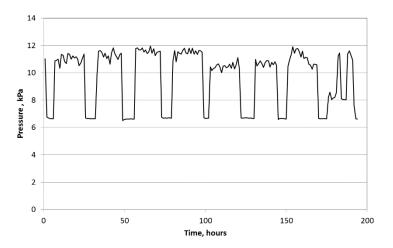
Figure 6.1: The applied load on the central wall.

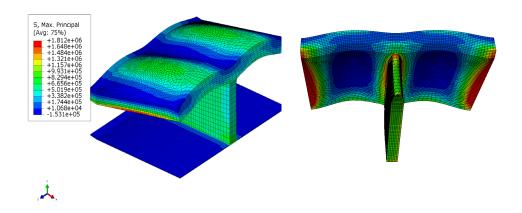
Figure 6.3: Distribution of maximum principal stress on the draft tube.

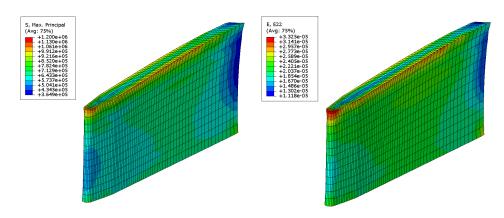
Figure 6.4: Distribution of maximum principal stress and strain in the vertical direction on the central wall.

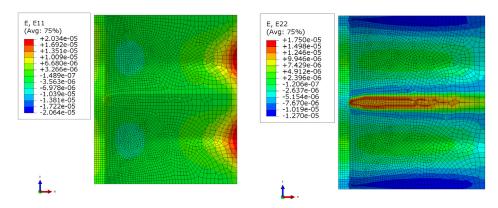
Figure 6.5: distribution of strain along (E11) and across the wall (E33).

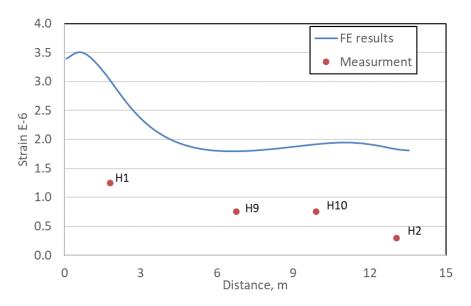
Figure 6.6: Comparison between strain measurement and strain from FEM for the central wall.

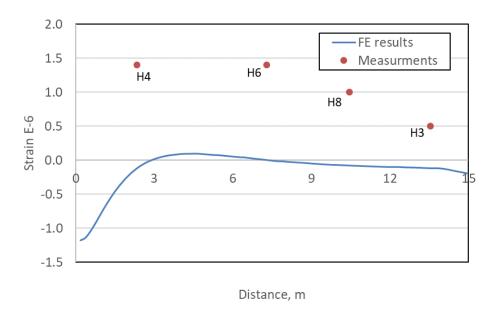
Figure 6.7: Comparison between strain measurement and strain from FEM.

It can also be seen that the structure response along the roof from FEM has the same trend as the measured results.
