DETECTION AND ANALYZATION OF BEARING CURRENT ON THE MAIN SHAFT OF WIND TURBINE

PHD-STUDENT: JIAN ZHAO
ELECTRIC POWER ENGINEERING

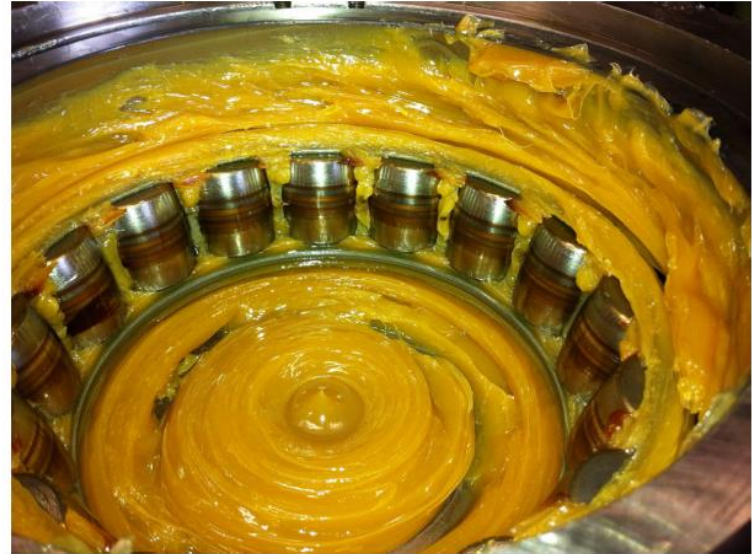
Effect of current, visible in laboratory tests (#1)

Test
result
from
SKF

8h lab test

Thrust load scaled to
replicate turbine conditions

Similar κ ratio to turbine

2A current

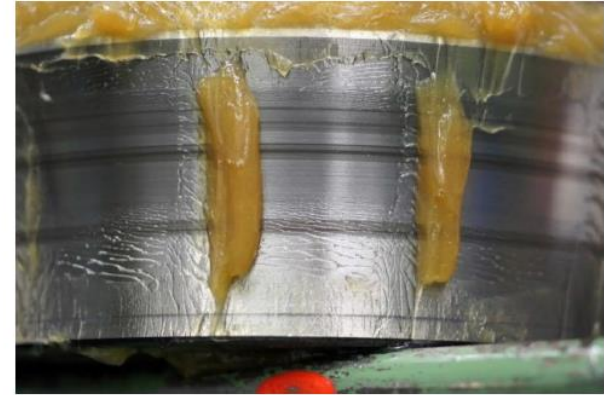
24 h more same conditions + Current

Grease color changed & roller race damaged

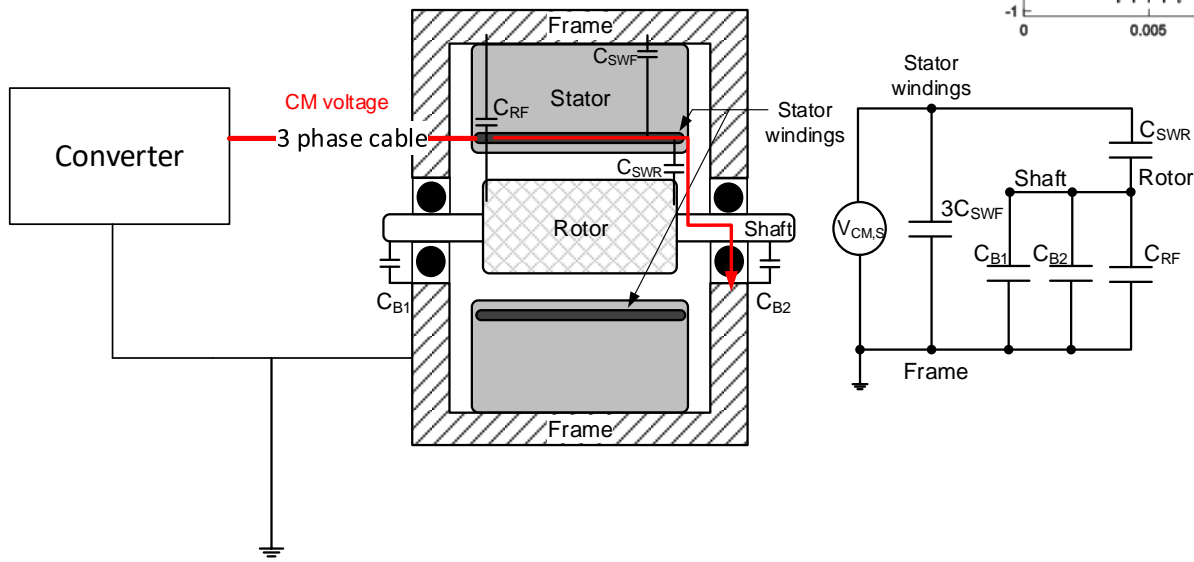
Common mode voltage

$$V_{CM} = \frac{V_{AG} + V_{BG} + V_{CG}}{3} = \pm \frac{V_{DC}}{2}, \pm \frac{V_{DC}}{6}$$

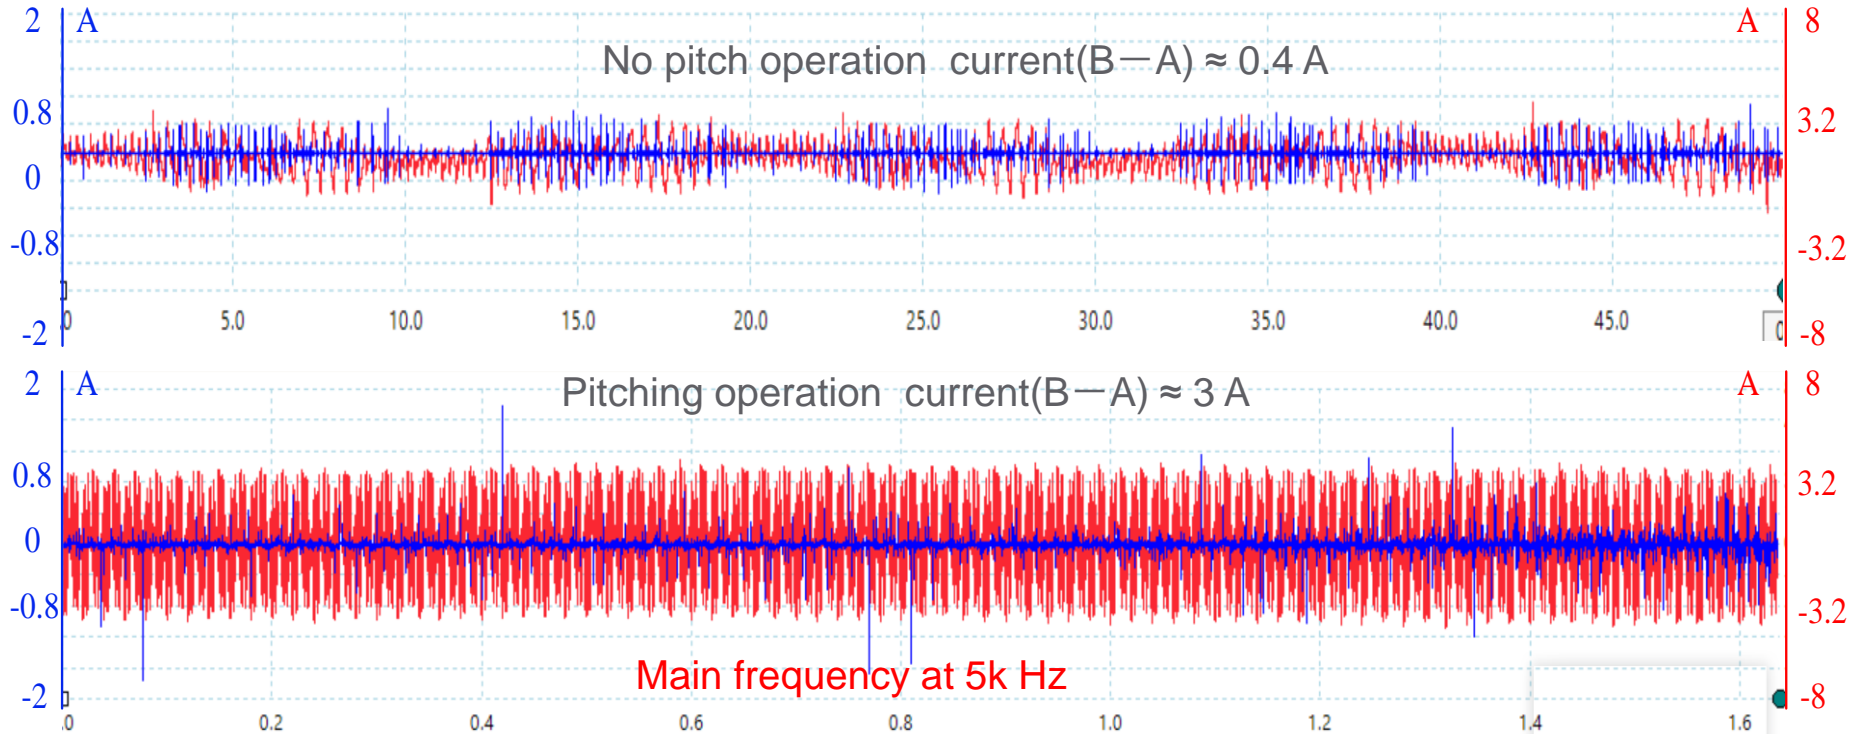
Bearing Current during pitching

- Electrical pitching system generate CM voltage
 - CM voltage damage the main bearing
