# Nordic Nuclear Power Generator Stator Vibrations

Energiforsk seminar 2019, Espoo  
Kent Engvall, Gabor Csaba  
Fortum Turbine and Generator Services

- This paper is generally focused on vibrations in turbo generator stators in the Nordic nuclear power plants in Ringhals, Forsmark, Oskarshamn and Olkiluoto. The purpose of the project is to provide a background and basic knowledge of the generator stator structure, design requirements and various vibration conditions.
- Authors are Kent Engvall senior consultant and Gabor Csaba, Generator Product Line Owner at Fortum Turbine and Generator Services.
- The study has been carried out within the Energiforsk Vibrations in nuclear applications research program. The stakeholders of the program are Vattenfall, Uniper, Fortum, TVO, Skellefteå Kraft and Karlstads Energi.

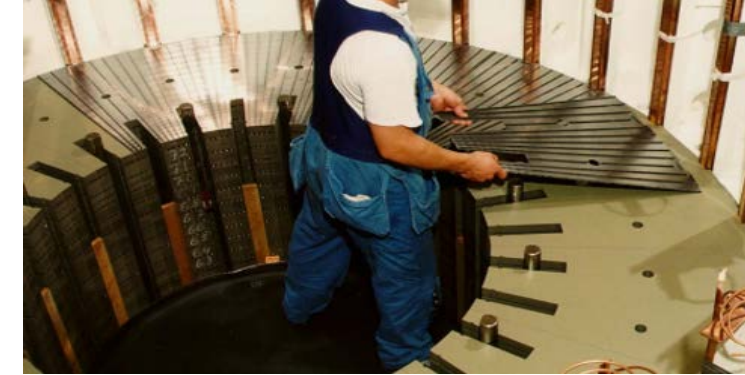
- Lead magnetic flux
- Place for stator bars
- Guide cooling air

*Stacking of core*

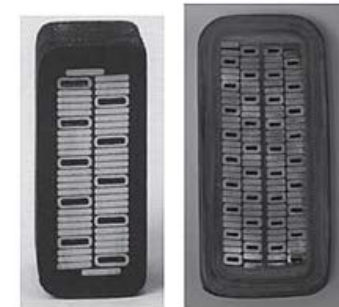
- Induce electrical energy from rotating magnetic
- Fixed in slots in core
- Withstand short circuit forces

*H<sub>2</sub>O-cooled stator bars*

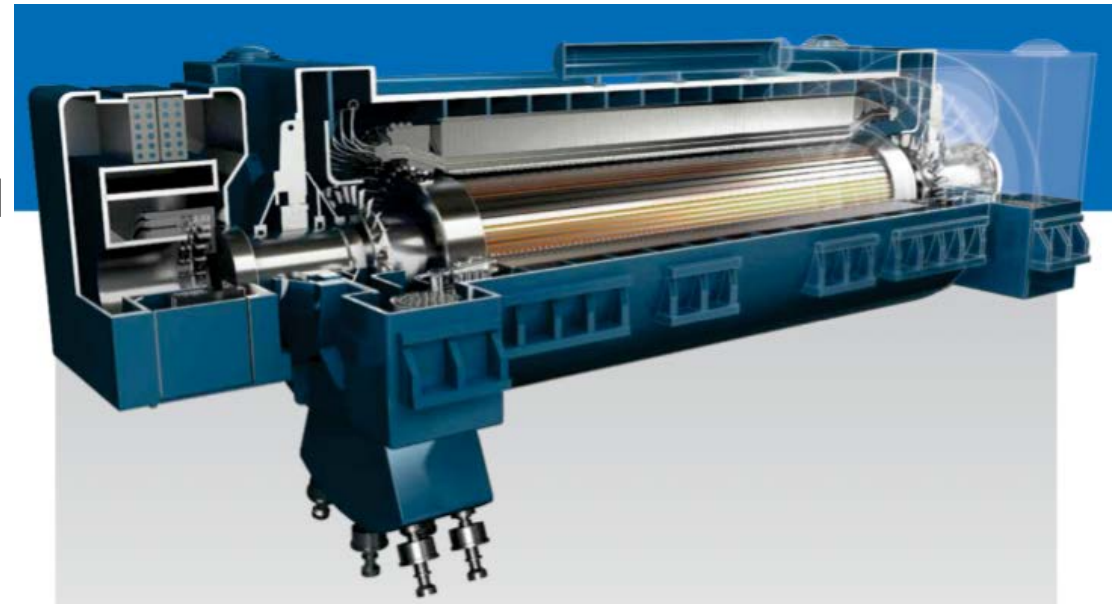
- Gigatop at Oskarshamn 3 and Forsmark 3
- Siemens SGen 4000W at Olkiluoto 3
- Rotor and core H<sub>2</sub>-cooled, stator winding H<sub>2</sub>O-cooled
- End winding 8-node mode well above excitation freq.
- In F3/O3 22 vib. sensors, in OL3 12 sensors
- Typical stator vibrations at F3:
  - End winding 1 – 2 mm/s
  - Connection bar braids ~4 mm/s
  - Stator core ~2 mm/s
- One can expect stable vibration conditions over time.
- If trend shows deviations, investigation is recommended even if absolute values are low.

*GE Gigatop 4-pole turbo generator*

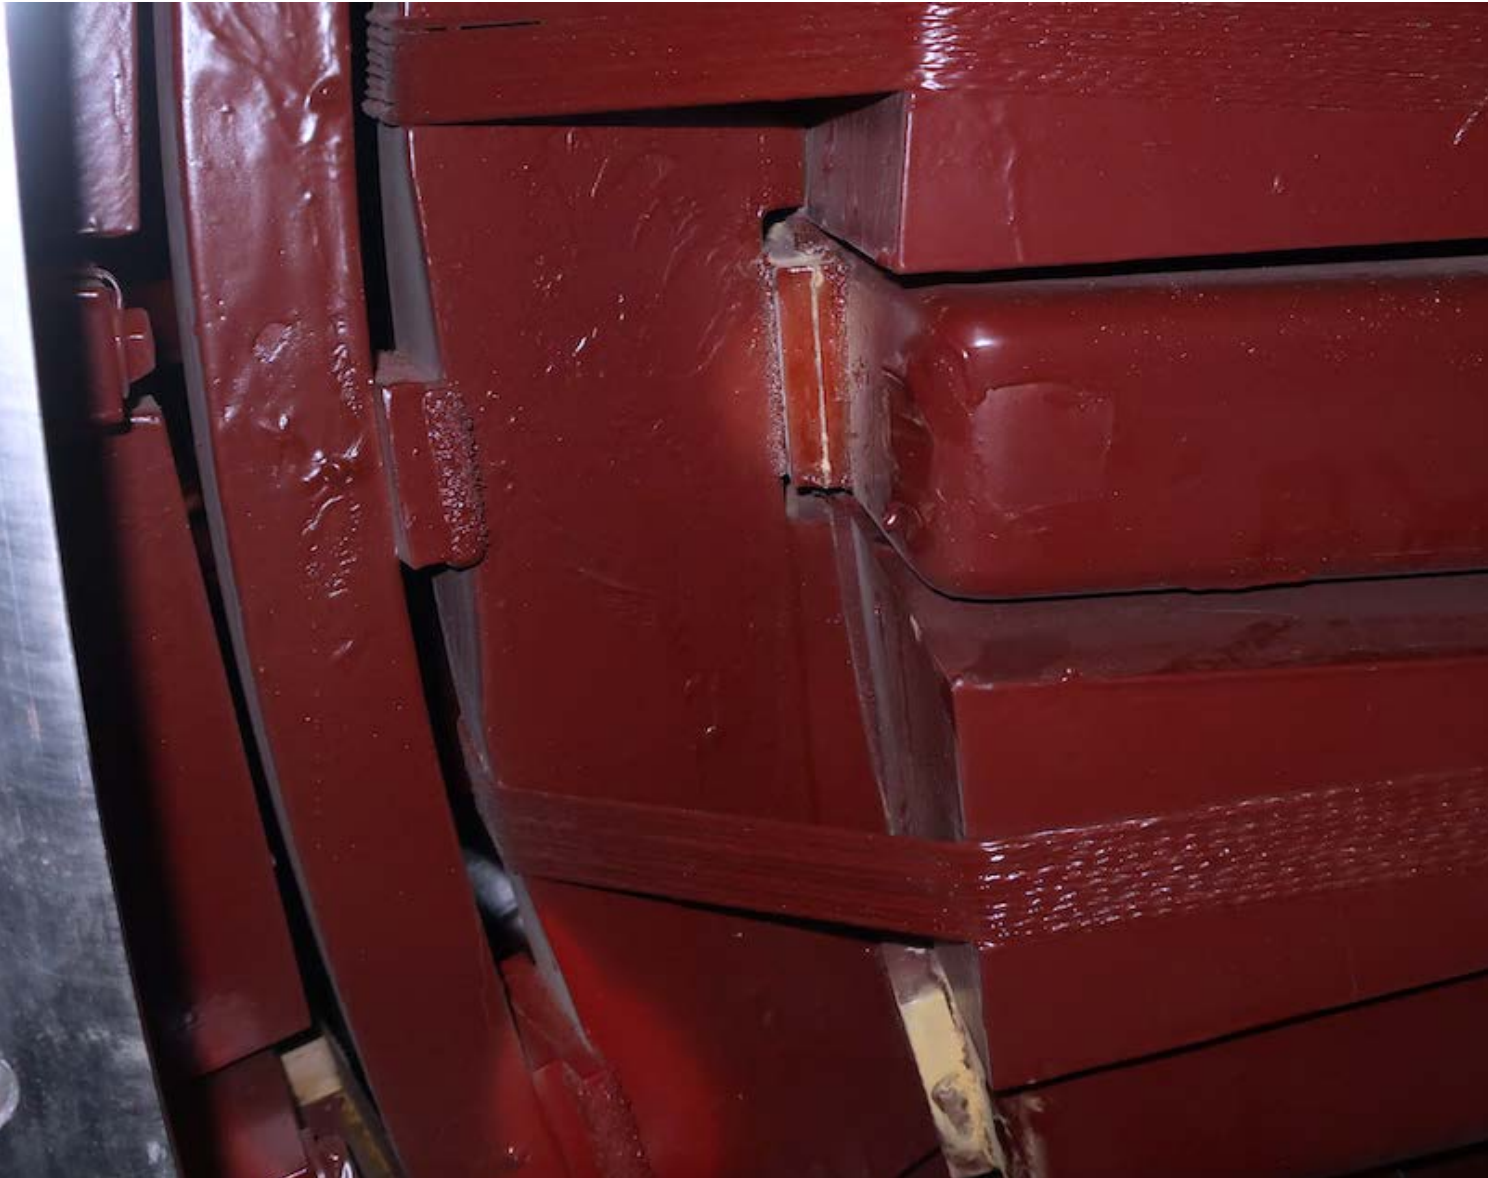
# Case from Forsmark with changed end-winding vibrations.

Ärvkorgsgivare TS och MS 2xN (mm/s rms /grad)

K911 S57	K912 S58	K913 S59	K914 S60	K915 S61	K916 S62
503 MW	DS18/19				
9/168	10/84	7/345	6/162	5/40	6/348
510 MW	DS18/19				
18/158	9/119	5/337	12/169	7/27	2/330
514 MW	DS18/19 <b>Decision to stop and inspect</b>				
28/186	3/167	8/305	17/196	11/13	6/269
515 MW	DS18/19 <b>After reconditioning</b>				
8/202	14/82	8/335	5/167	4/66	8/345
518 MW	DS18/19				
7/205	15/96	7/338	6/162	5/60	7/343

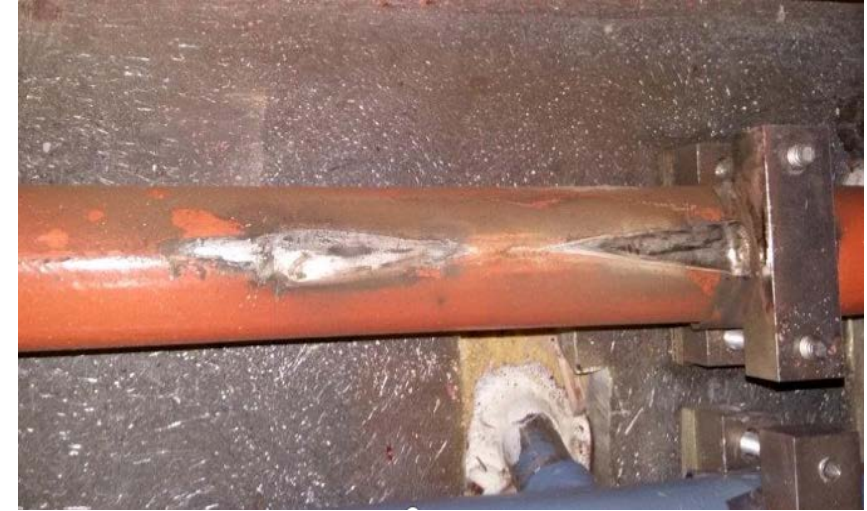
Wear marks on manifold

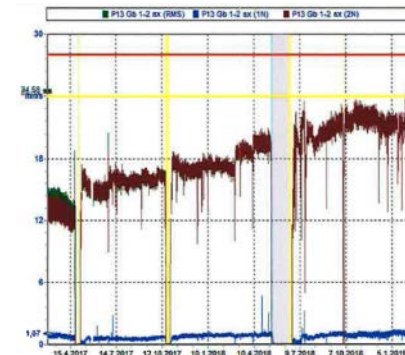
Axial  
in core packet 80 & 13  
2017-2019

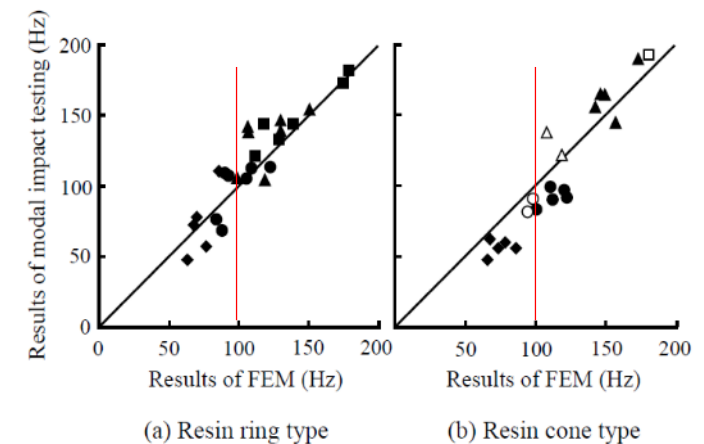
Modal shape	2-pole	4-pole
2 node	◆	-
4 node	●	○
6 node	▲	△
8 node	■	□

2-pole have larger potential to create scenarios to analyze
