# New Materials and Oxygen Carrier Aided for improved competitiveness of FB plants using renewable fuels

# Overall aim

# **Preliminary Results of the Clamps Exposures In Händelö**

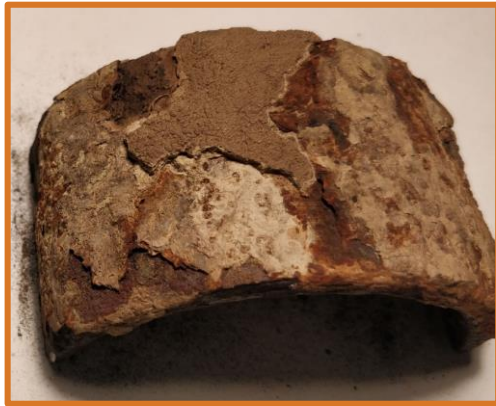
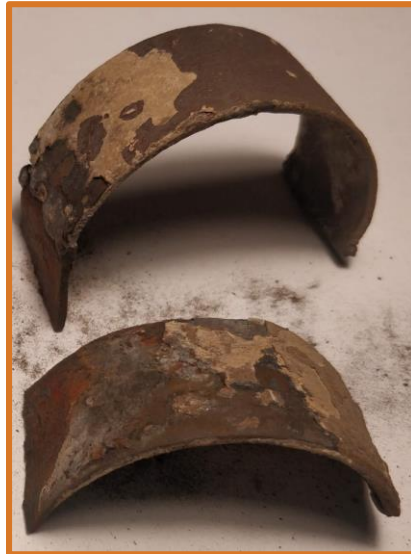
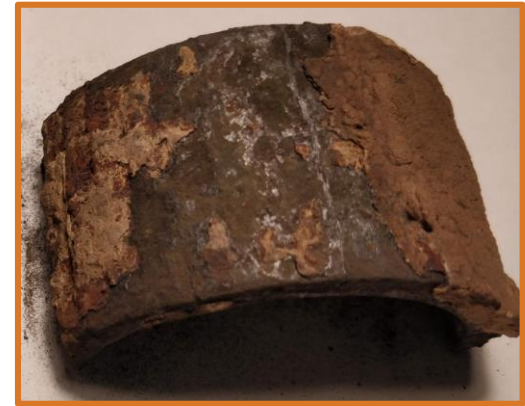
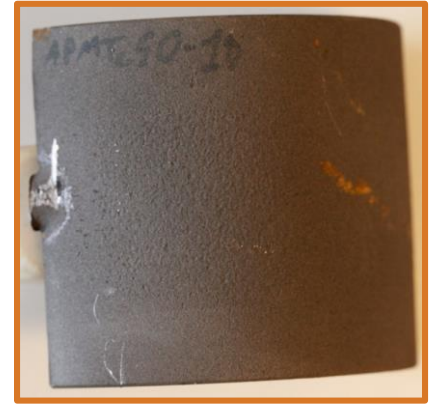
## Visual Inspection

# Results of the Clamps Exposures In Händelö
