## WP1 SAMPO Task 1.3 Setting up safety margins for O-rings 2020

RISE Report : 9P03241-02

# Background and aim

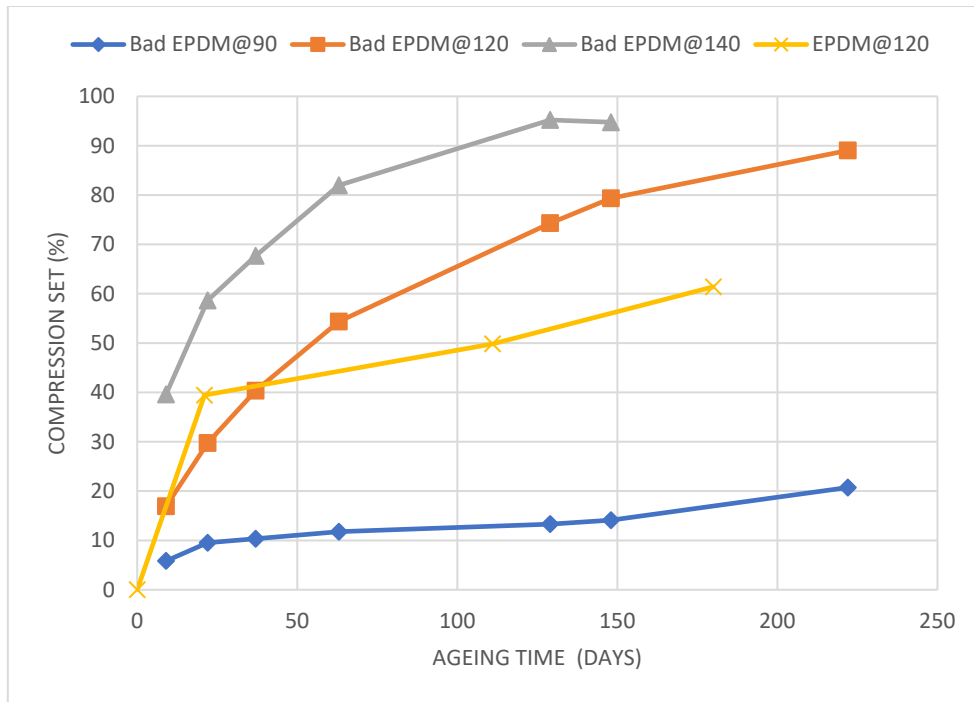
Figure 1. Data of compression set for model 'bad' material, and one set of data of top-level material at 120 °C for comparison.

Figure 1 depicts a result from 2019 (120 °C EPDM) compared with 2020 results upon this model 'bad' material. For the comparable 120 °C one can observe the 'bad' performing worse than the top-level material, with, as far as the data goes, ~60 vs. ~85 % respectively. This is a good sign, and the data follows the trend that we would expect.

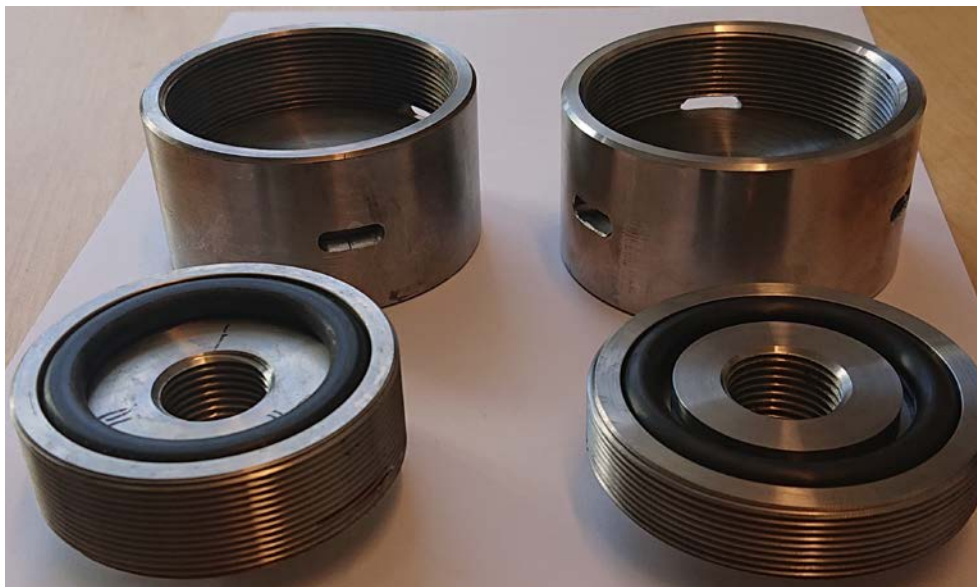
Figure 2. O-ring test rigs. Left: old test rig from COMRADE. Right: new test rig re-designed for SAMPO.

Experimentation moved on to compression set within leak test rigs, having verified compression in this manor is appropriate. During a symposium summarising 2019 data for stakeholders, it was brought to our attention that the 'old' test rigs may not be deemed satisfactory enough for duplicating the environment that O-rings find themselves in inside a power plant. Thus, the rigs were redesigned as per figure 2, where one can see a groove has been cut out for the ring to sit within, compared to the 'old' test rig with much more empty space in the centre.

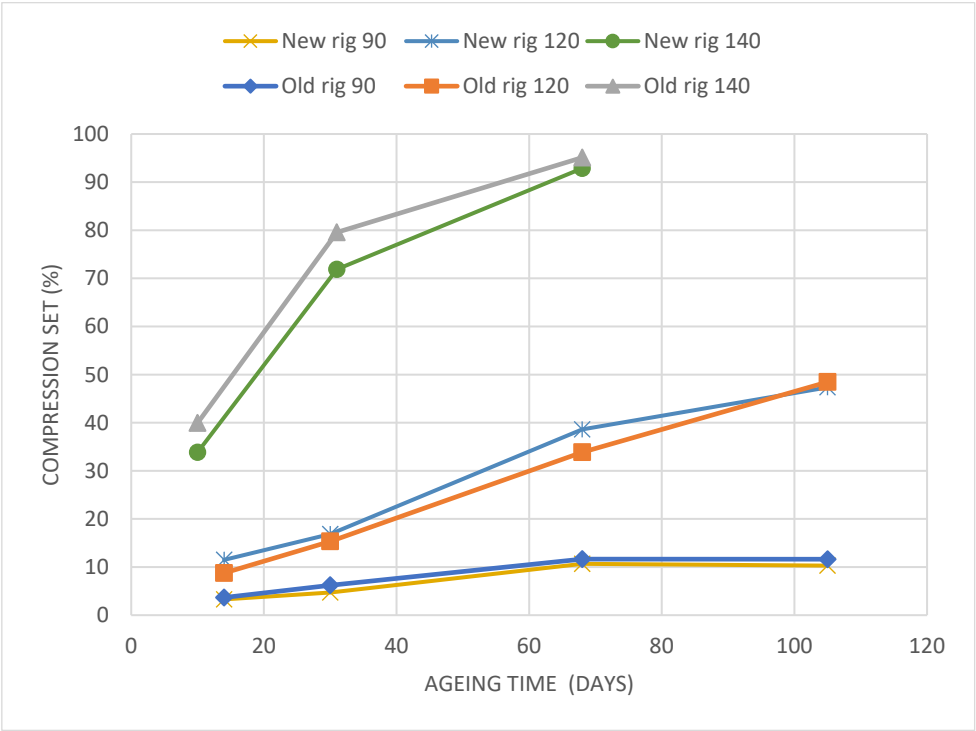
Figure 3. Compression set of model 'bad' EPDM material within test rigs, both 'old' and redesigned.

Compression set is underway for EPDM material within both leak test rig designs, and the data can be found in figure 3. The data follows the expected trend, with raising temperature, a higher compression set is attained. The testing will continue to attain more data points. Note that leak testing has been

performed at the 2 latter time points as per figure 3, no leaks were detected except for the 'old' rig, at 140 °C. For the first of the two time points the leak was detected under low pressure (~5 Bar) and once the operating pressure for the test was attained (~60 Bar), the leak was no longer detected. It could be deduced that the higher pressure allowed the O-ring to attain a tighter seal within the test rig. For the last point, the rig was leaking continuously and could not hold any higher pressure.
