# INFRARED THERMOGRAPHY FOR DETECTING DEFECTS IN CONCRETE STRUCTURES

REPORT 2021:762

# Infrared Thermography for Detecting Defects In Concrete Structures

DIMITRIOS BOUBITSAS, LARS OLSSON AND FREDRIK STÅHL

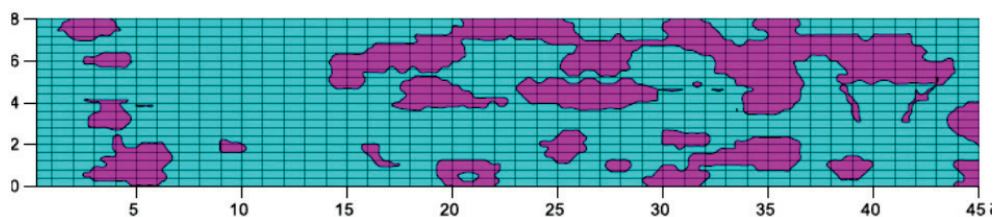
The vehicle was driven at low speed over the centre of the bridge deck, and a total of 392 thermal and digital images were collected, which covered the entire bridge deck. The total time of data collection was about two hours. Multiple software tools were used to enhance the captured IRT images and making it possible to differentiate delaminated areas from other surface features (discoloration, oil stains, sand and rust deposits, etc.). The max thermal contrast of the recorded data was  $7.7^{\circ}\text{C}$ . The selected threshold value for the calculated thermal contrasts that could indicate where delamination was likely to be detectable was chosen to  $1^{\circ}\text{C}$ . The pixels with a higher temperature than this threshold value were highlighted because delamination appear with a higher temperature. Figure 1 illustrates the created map from the IRT measurements of the surveyed bridge deck.

Figure 1. IRT condition map indicating delaminated areas in the surveyed bridge deck [8].

As can be seen in Figures 1 and 2, despite the different mechanisms of both techniques and their capabilities of detecting different deterioration types, the condition maps in both figures are comparable. It must be noted that both methods require extensive post-processing analysis of the acquired data to reveal subsurface anomalies.

The authors concluded that IRT testing produces visual delamination images with good location accuracy. However, as a surface temperature method, its detection capability is depth limited and that its effectiveness can be reduced in the presence of overlays. Also, IRT testing requires adequate solar radiation and weather conditions to produce the required temperature differentials.

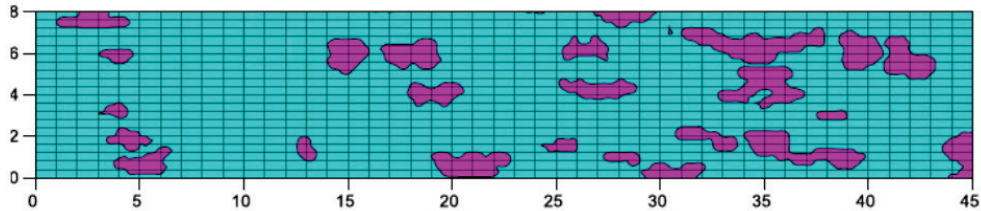
As a comparison Figure 2 illustrates the corresponding GPR condition map indicating location of corrosion in the surveyed bridge deck.

**Figure 2. GPR condition map indicates location of corrosion in the surveyed bridge deck [8].**

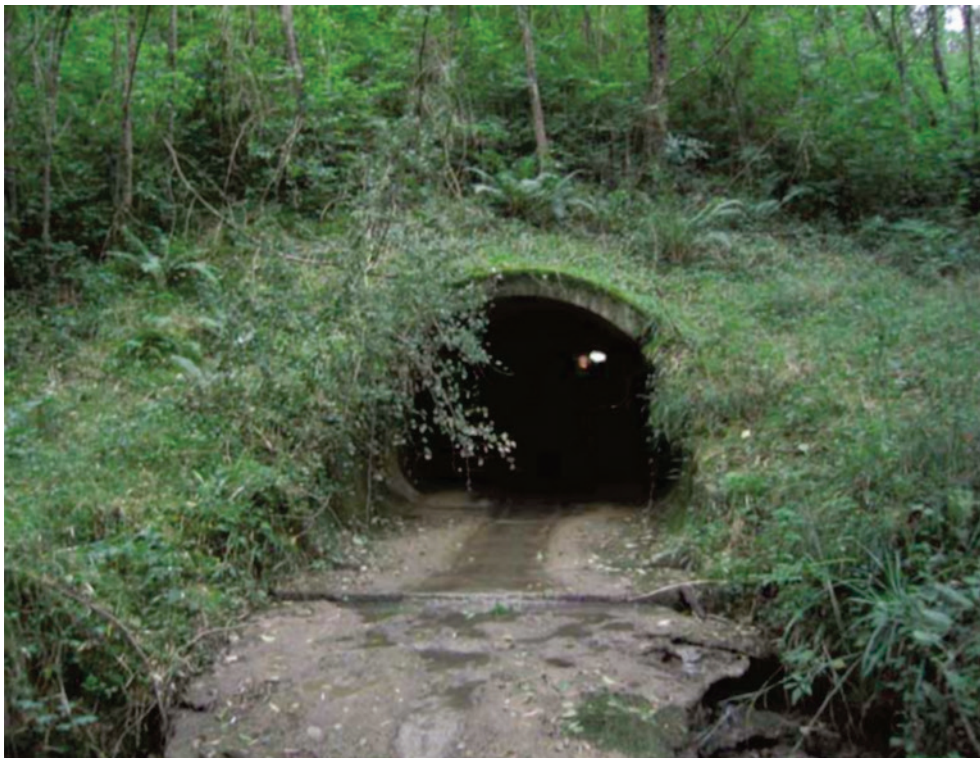
Sirieix et al. [9] examine a precast concrete culvert (Figure 3) for defect identification using different NDT methods, one of which was passive IRT. The other methods evaluated include electrical resistivity and capacity methods.

**Figure 3. Entrance of the concrete culvert [9].**

The concrete culvert consisted of 55 precast pipe segment each 3 m long, and the total structure is 165 m. The pipe segment shape was ovoid with a height of 1.7 m and a width of 1.8 m and the concrete thickness was about 20 cm. Only the internal surface of the duct could be inspected and showed some damage, such as cracks, which sometimes contained calcite and, in some cases, visible corroded rebars (Figure 4).

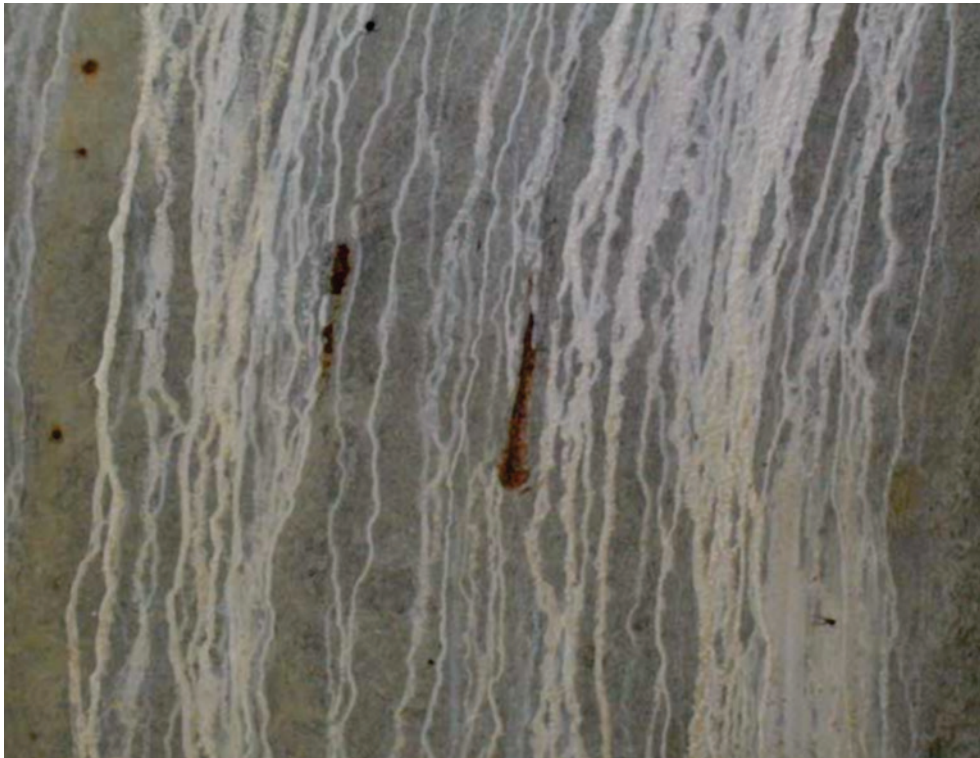
**Figure 4. Calcite in cracks and visible corroded rebars [9].**

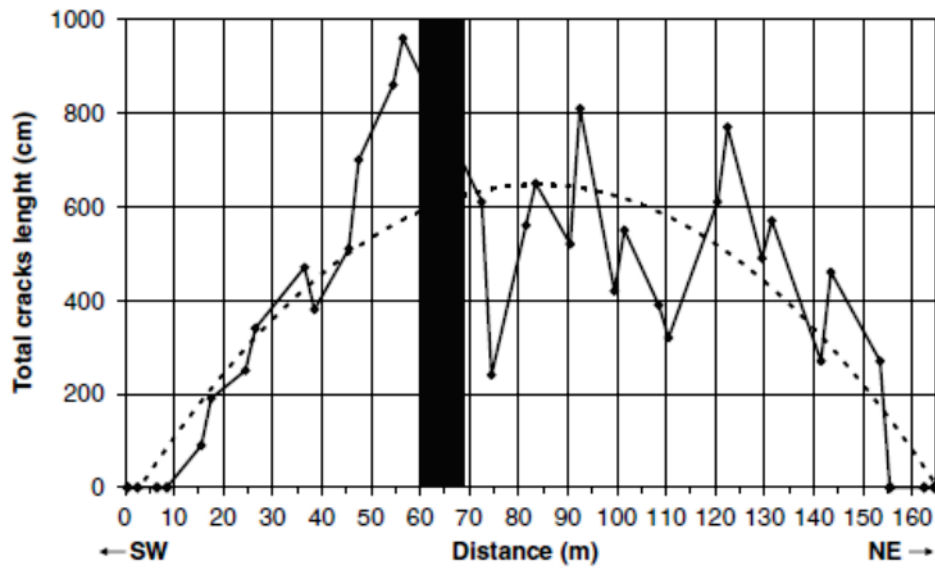
Based on a visual inspection, the damage pattern of the pipe segments was previous recorded, and the overall dimensions of the cracks had been evaluated for each 3-m-length segment. The cracks were mainly concentrated to the upper part of the culvert. Figure 5 shows the total crack length for each segment. Three segments, between 60 and 69 m had been repaired previous, so these segments were excluded from the investigation.

Figure 5. Profile of total cracks length for each segment [9].

The results in Figures 5 and 6 suggest a correlation between the measured total crack length and the surface temperature of the upper part of the culvert.

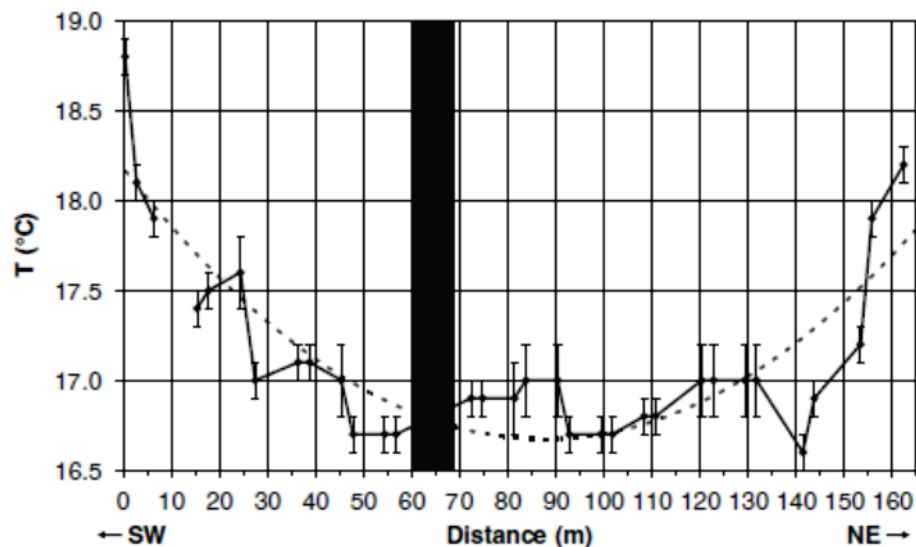
Because the investigated structure in this work was a culvert, there is no reflection, no solar radiation nor any artificial source of heat, and the emissivity will be constant and high (more than 0.93). Therefore, in this case it was concluded that, a variation of surface temperature would be dependent on thermal diffusivity or evaporation. The results from the IRT measurement are shown in Figure 6, as the average surface temperature of the keystone (upper part of the culvert) for each pipe segment.

Figure 6. Average surface temperature of the keystone for each pipe segment as measured by IRT [9].

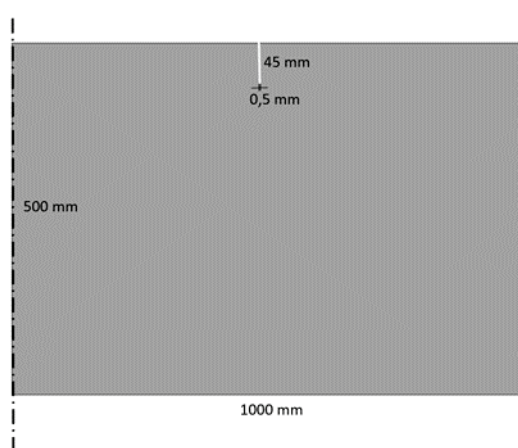
- A crack (width 0.5 mm and depth 45 mm) perpendicular to the wall, see Figure 7.
- Delamination (500 mm wide and 45 mm thick delamination with a crack width of 0.5 mm) of wall, see Figure 9

Figure 7. A crack in a concrete wall. Simulated section (not to scale).

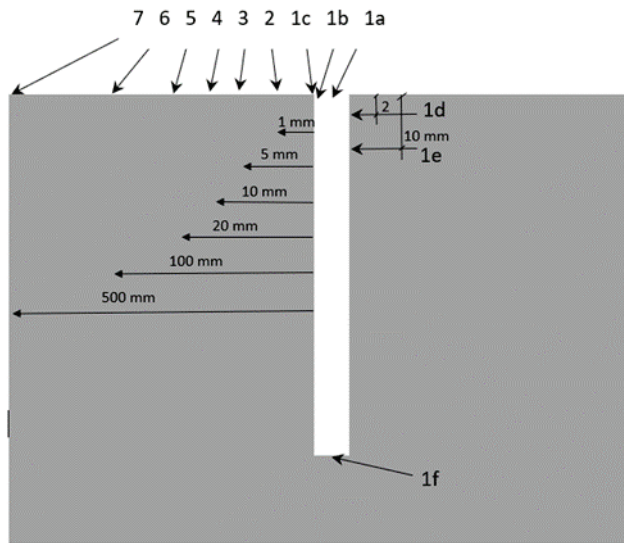
Figure 8. A crack in a concrete wall. Position of calculation points in relation to the crack (not to scale). Calculation points 1a and 1b are either in the air or at the water surface. The other points are on the concrete surface.

The humidity and temperature simulations have been performed using WUFI 2D 4.3, a 2-dimensional heat and moisture simulation program. The result is reported for specified points, see Figure 8 and Figure 10. The simulation starts when the water (assumed temperature 35°C) in the concrete tunnel is replaced by outdoor air. The concrete tunnel is assumed to be ready for inspection immediately after the water has been removed.

The surface temperature of the concrete tunnel is decreasing after the tunnel has been emptied of water. The surface temperature close to a crack is decreasing faster compare to the surface temperature further away from the crack. Figure 11 shows the surface temperature difference between a point 0.5 m from the air-gap (point 7 in Figure 8) and several points (point 1c, 2, 3, 4 and 5) closer to a crack filled with air. The change of temperature difference is shown during the first 24 hours after the tunnel has been emptied of water. The surface temperature at point 7 is used as a reference and the surface temperature at this point is assumed to be unaffected by the air-filled crack. The greatest simulated temperature difference occurs between point 7 and point 1c (at the edge of the crack, see Figure 8) at the beginning (0.5h) of the process.

In a similar way, Figure 12 shows the surface temperature difference between a point 0.5 m from the air-gap (point 7 in Figure 8) and several points (point 1a, 1c, 2, 3, 4 and 5) closer to a crack that, in this case, is filled with water.

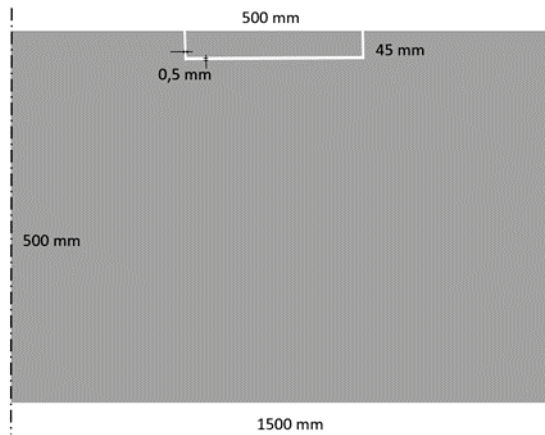
Figure 9. Delamination in concrete wall. simulated section (not to scale).

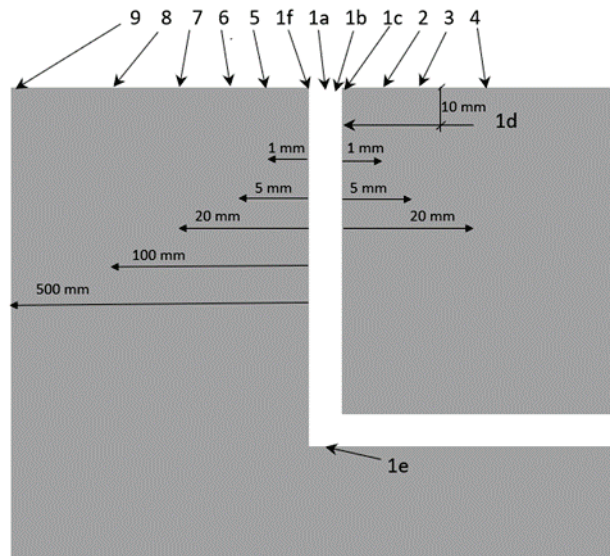
**Figure 10. Delamination in concrete wall. Location of calculation points in relation to the crack / delamination (not scaled sketch). Calculation points 1a and 1b are situated in air. The other points are situated on the concrete surface.**

Figure 13 shows the surface temperature difference between a point far away from a delamination crack (point 9 in Figure 10) and several points (point 1c, 2, 3 and 4, see Figure 10) closer to the air-filled delamination crack. In this case, the surface temperature difference is greatest around 2 hours after the tunnel has been emptied of water.

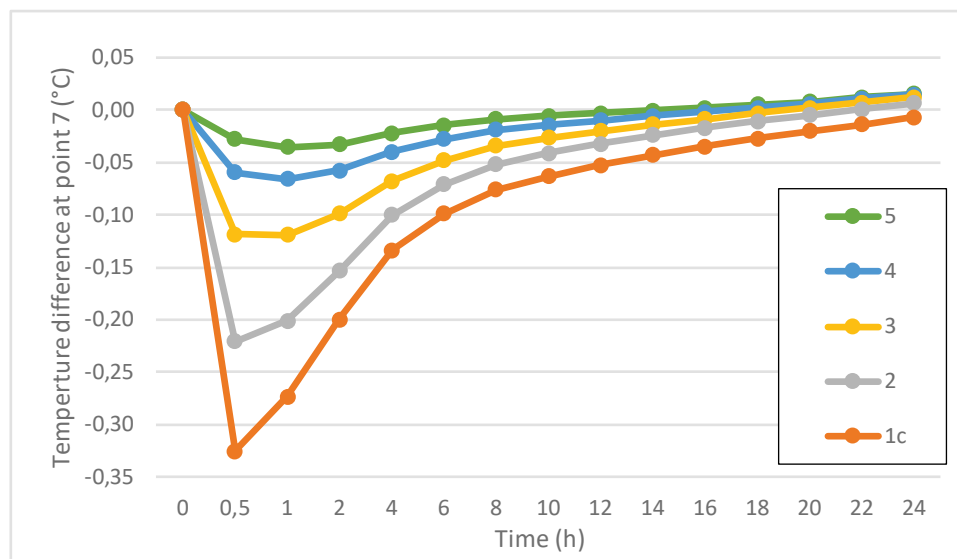
**Figure 11. Temperature difference at point 7, for the case with a crack filled with air.**

The lowest simulated temperature on the wall surface occurred at the crack and the highest temperature occurred furthest from the crack. The temperature difference decreased over time. After 30 minutes, 1 hour, and 4 hours, the temperature difference was 0.32, 0.27 and 0.13°C, respectively, for the wall surface (between points 1c and 7). After 24 hours, the difference was only 0.02°C for the wall surface.

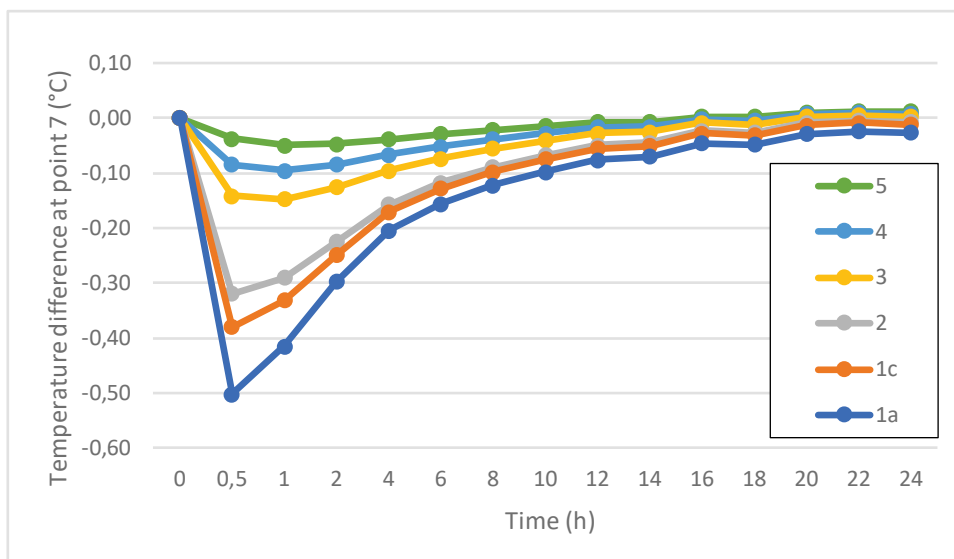
Figure 12. Temperature difference at calculation point 7, for a water-filled crack.

The lowest simulated temperature on the wall surface occurred at the crack and the highest temperature occurred furthest from the crack. The temperature difference decreased over time. After 30 minutes, 1 hour, and 4 hours, the temperature difference was 0.38, 0.33 and 0.18°C, respectively, for the wall surface (between points 1c and 7). In addition, during the first two hours, the difference was another tenth of a degree greater between the water-filled crack, 1a, and calculation point 7. After 24 hours, the difference was only about 0.01°C for the wall surface.

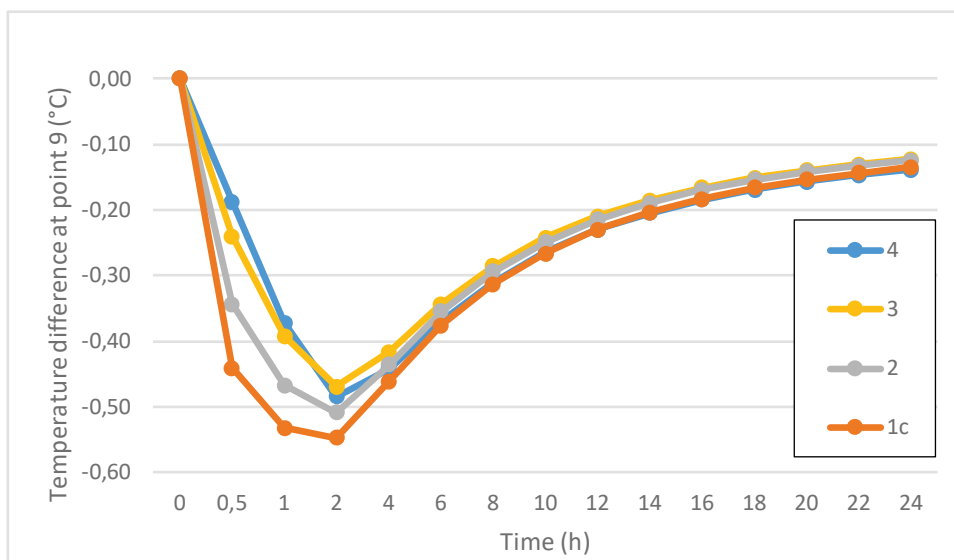
Figure 13. Temperature difference at calculation point 9, for delaminated concrete.

The lowest simulated temperature on the wall surface occurred at the crack and the highest temperature occurred furthest from the crack. The delaminated part also showed lower temperatures compared to the wall surface further away from the crack. The temperature difference decreased over time. After 30 minutes, 1 hour, and 4 hours, the temperature difference was 0.44, 0.53 and 0.46°C, respectively, for the wall surface (between points 1c and 9). After 24 hours, the difference was at most 0.14°C for the wall surface calculation points.
