# DETERMINATION OF STRESSES IN GROUTED STRANDS OF A REACTOR CONTAINMENT BY A DESTRUCTIVE TEST METHOD

REPORT 2025:1130

# **Determination of stresses in grouted strands of a reactor containment by a destructive test method**

PETER LUNDQVIST AND MANOUCHEHR HASSANZADEH

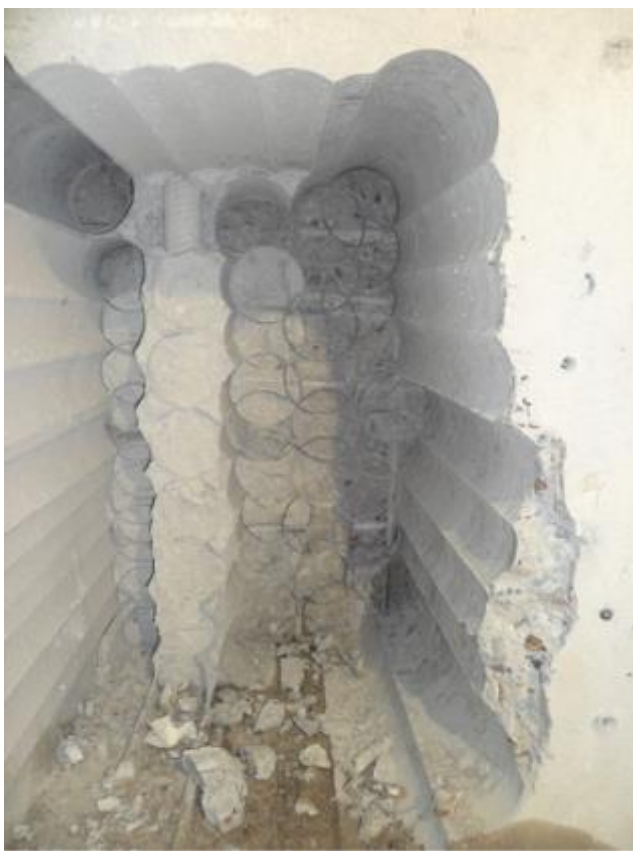
**Figure 6 Initial drilling and waterjetting to determine the exact position of the tendon**

In the first step, the exact position of the duct was identified using GPR. Concrete cores were drilled along the axial direction of the tendons to depths less than the estimated concrete cover. Then, the remaining part of the cover was removed using a hand-held waterjet lance to uncover the duct (Figure 6).

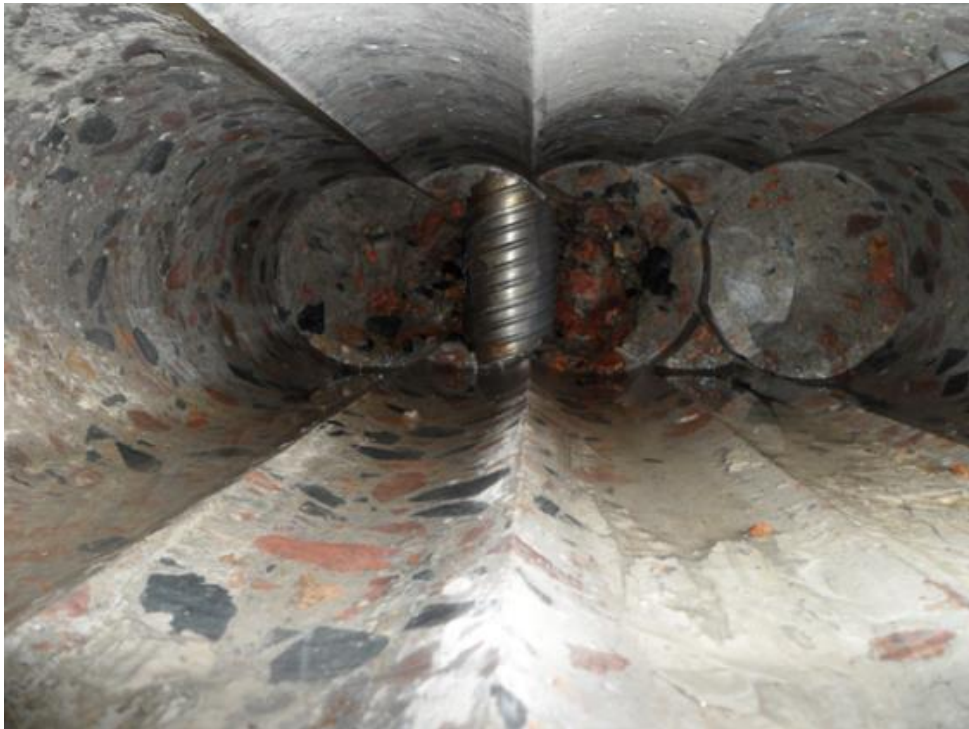
Figure 6 Series of drilling to remove much of concrete within the test window.

In the second step, almost all remaining concrete within the test window frame was drilled out (Figure 7).

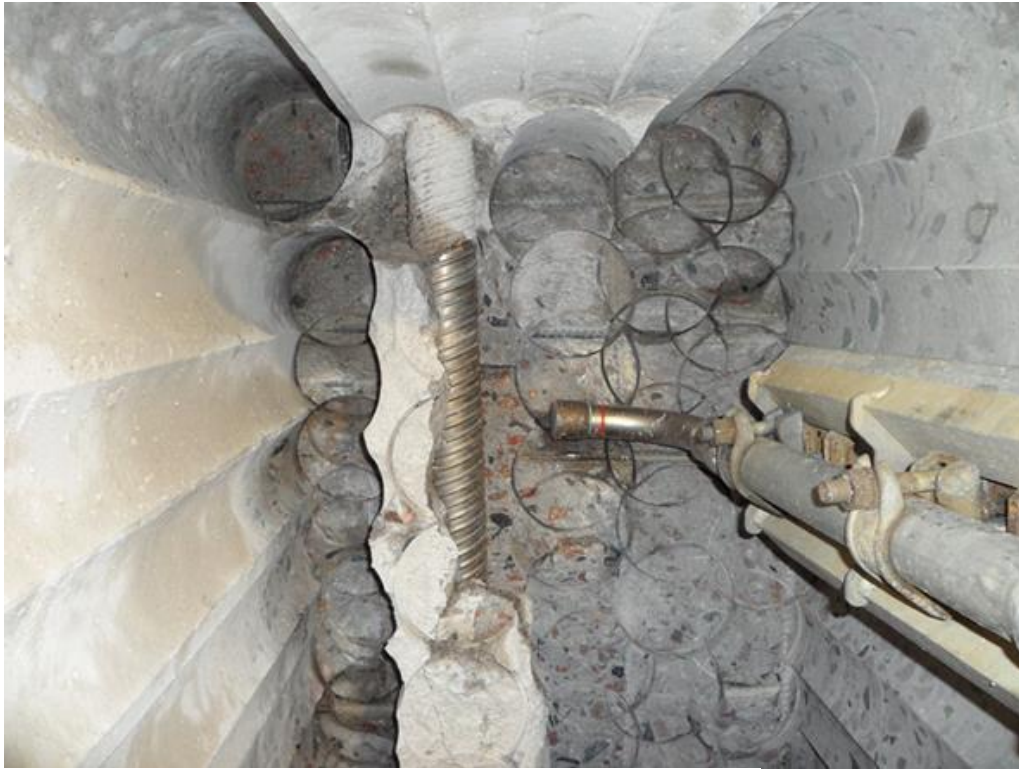
Figure 7 Uncovering the duct by means of an automated waterjetting lance

In the third step, the remaining concrete covering the duct was removed using an automated waterjetting lance (Figure 8). After removal of the concrete the duct was cut using a small circular saw blade mounted on a drill. The cutting involved two circumferential cuts spaced approximately 700 mm apart, along with an axial cut along the duct. The duct was then unrolled and removed. The grout covering the strands was removed using a hand-held waterjetting lance (Figures 9 and 10).

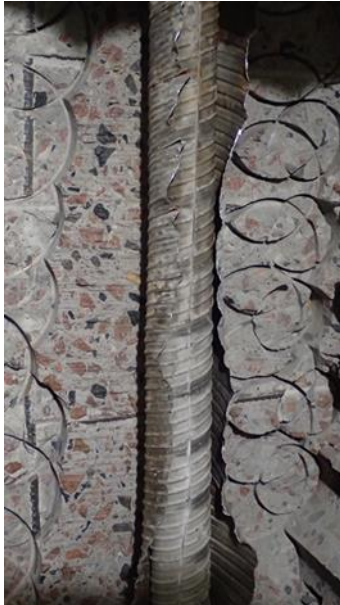
Figure 9 Removal of the duct and uncovering the strands - Cut and unrolled duct

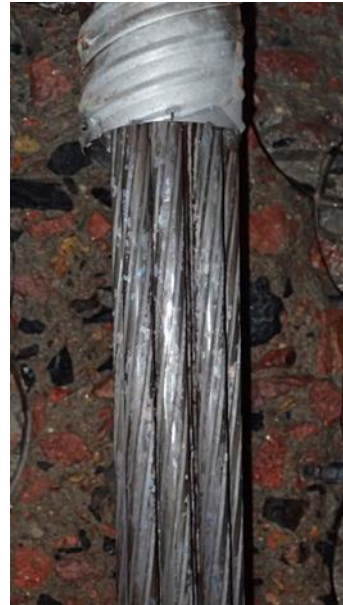
Figure 8 Removal of the duct and uncovering the strands - Waterjetted strands

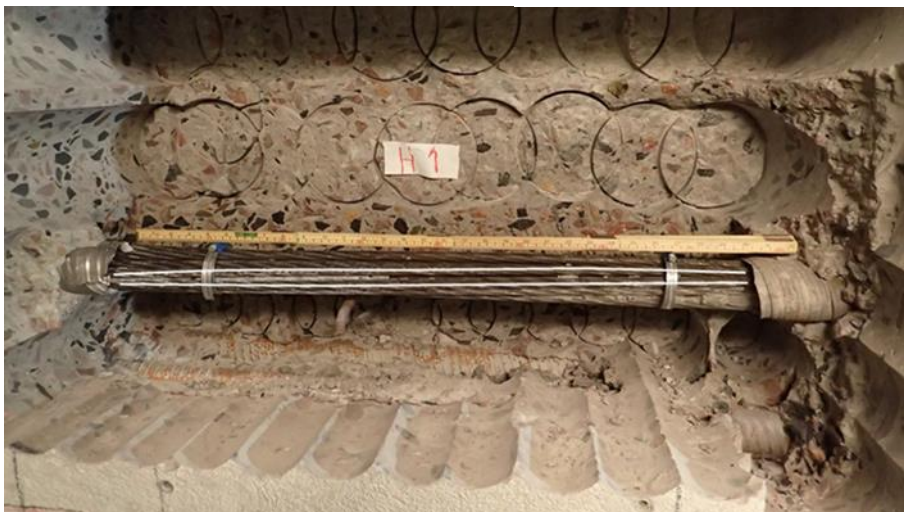
Figure 10 Arrangement of horizontal strands in a duct – direction of two horizontal strands

The prestressing imposes a radial displacement on the horizontal strands, causing them to move toward the centre of the RC, thereby pressing them against the inner surface of the duct. As observed in Figure 12, the strands are stacked and forced to the left side of the duct, towards the centre of the RC. Although parts of the grout have been removed due to waterjetting and cutting of the strands, it is still evident

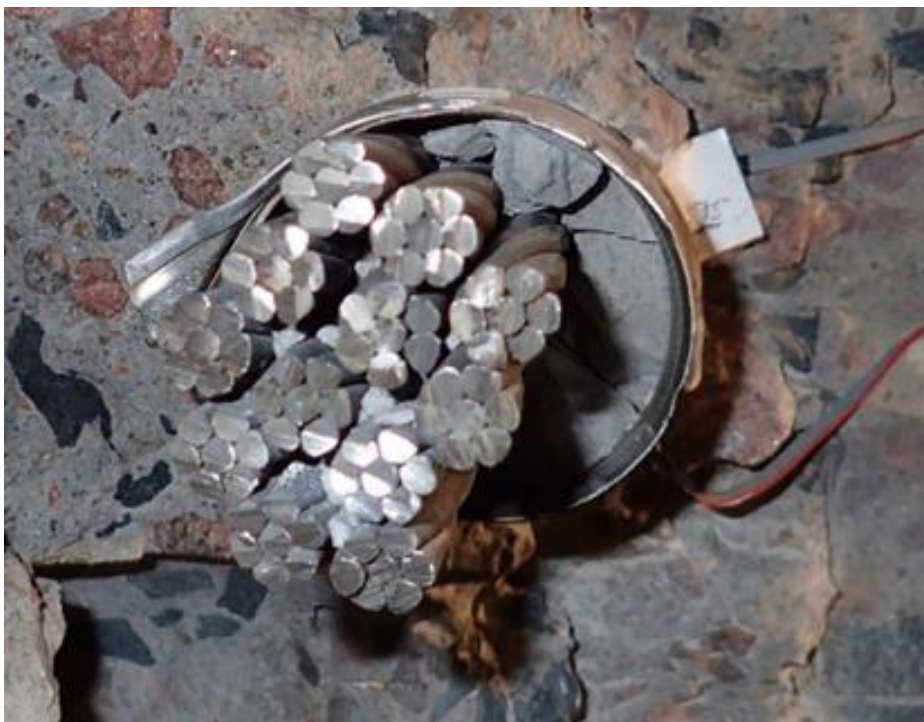
Figure 11 Grout between horizontal strands and duct

The ability of the grout to cover the prestressing steel depends on the fluidity properties of the grout and the space available between the individual strands, as well as between the strands and the inner surface of the duct. Additionally, the arrangement of the strands among themselves plays a crucial role. The strands tend to twist around their own axis and around each other, with this twisting being more pronounced in horizontal strands than in vertical strands (see Figure 11).

A visual inspection of the grout revealed that it appeared to have sufficient density and strength in areas with adequate grout thickness. However, in cases where the grout accumulated on only one side of the strands, it showed signs of cracking, possibly due to shrinkage caused by self-desiccation. In positions with insufficient grout thickness, the grout exhibited brittle and weak behaviour.

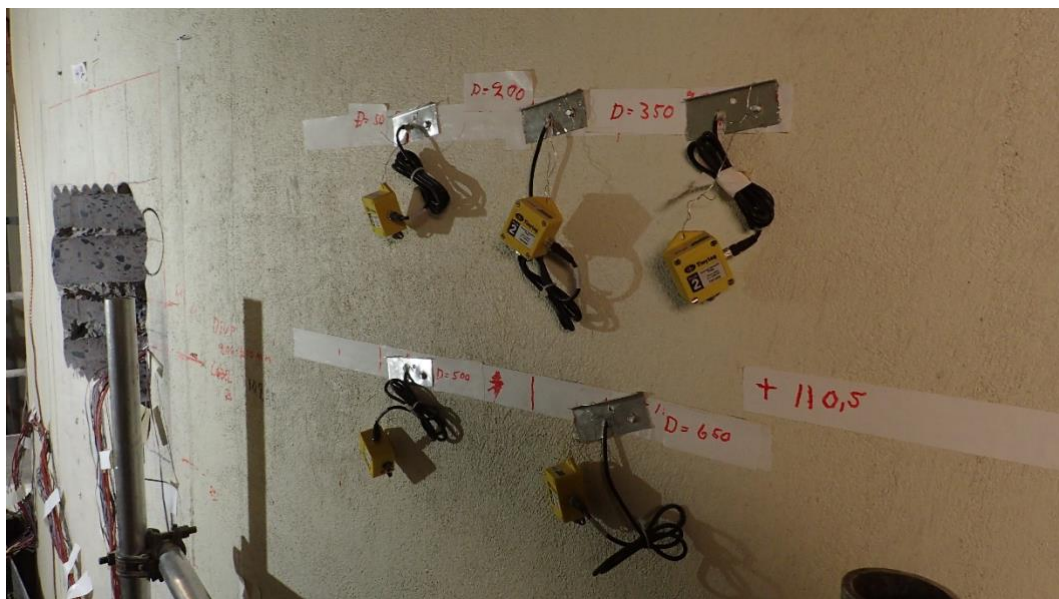
Figure 13 Installation of moisture measuring sensors on level 10,5.

RH sensors were placed in drilled holes, Figure 14, with a diameter of 17 mm at depths of  $d_{drl}=50, 200, 350, 500$  and  $650$  mm. The holes were located 200 mm apart and approximately 1 m from the closest test window. The head of the sensors was placed at the depth of  $d_{drl}-30$  mm from the surface. An electric (plastic) pipe with an inner diameter of 16 mm was inserted inside the holes, where the RH sensors were installed. The length of the pipes was  $d_{drl}-30$  mm. Hence, the sensor measured the average RH of a 30 mm long segment in front of the sensors.

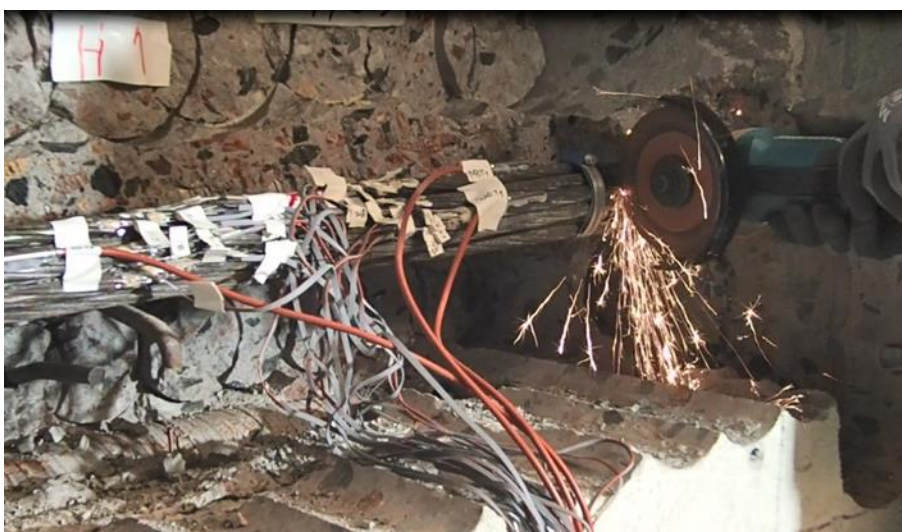
Figure 19 Cutting off the strands by means of a grinder

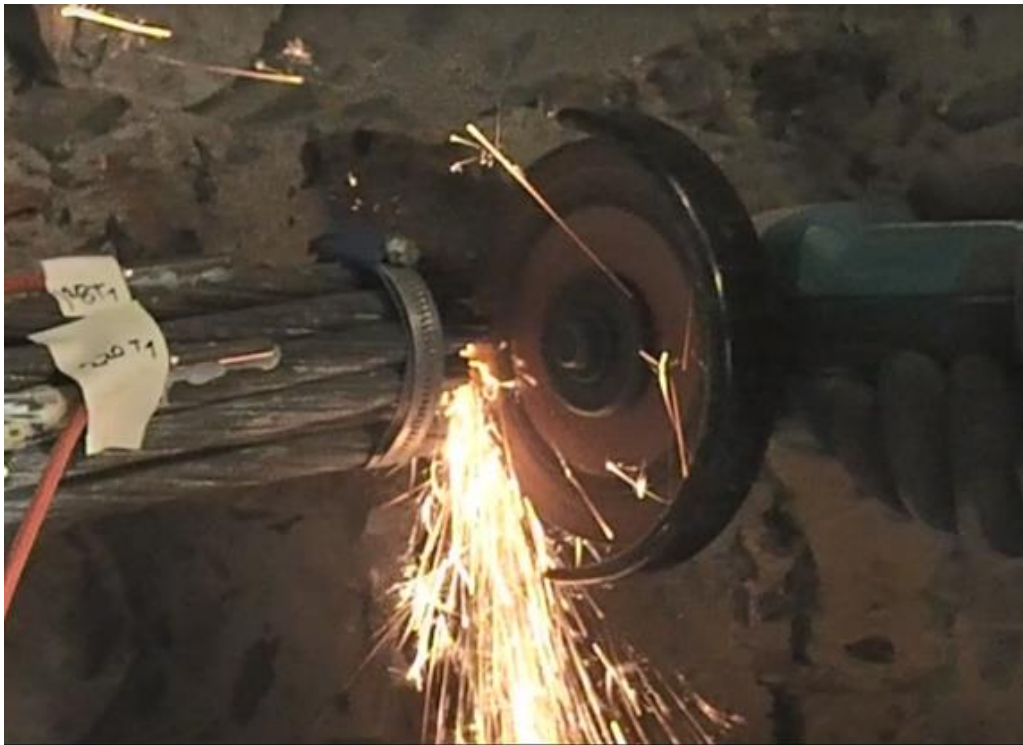
Figure 20 Cutting off the strands by means of an angle grinder.

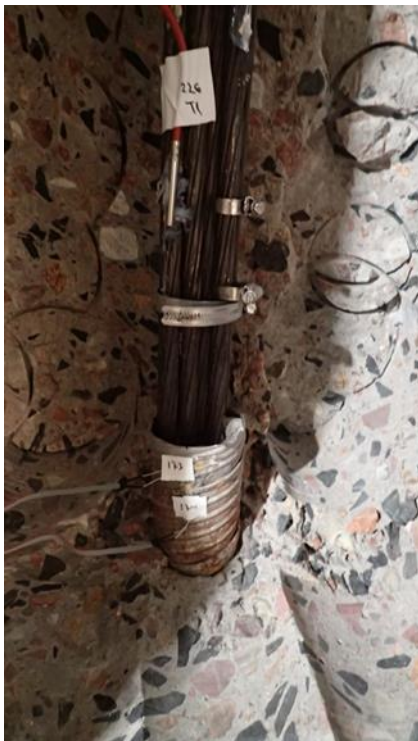
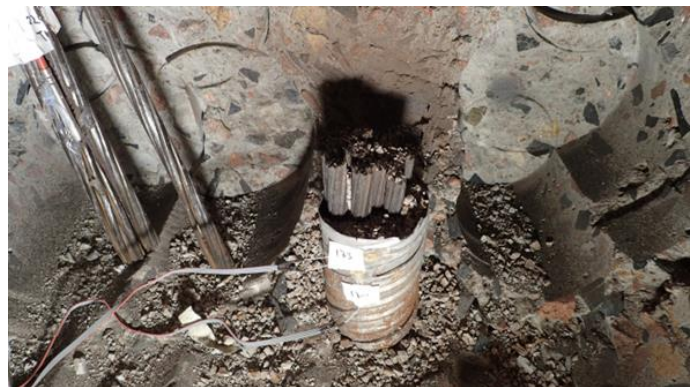
Figure 28 Attachment of strain gauges on the duct, window V5 before and after cutting of the strands

Figure 29 Attachment of strain gauges on the duct, window V5 before and after cutting of the strands
