Damage Potential of Swedish GMRS to NPP RC Structures

Energiforsk
Jordbävningsseminarium
2022-05-16

Jan Lundwall RAB, Morgan Lindqvist OKG

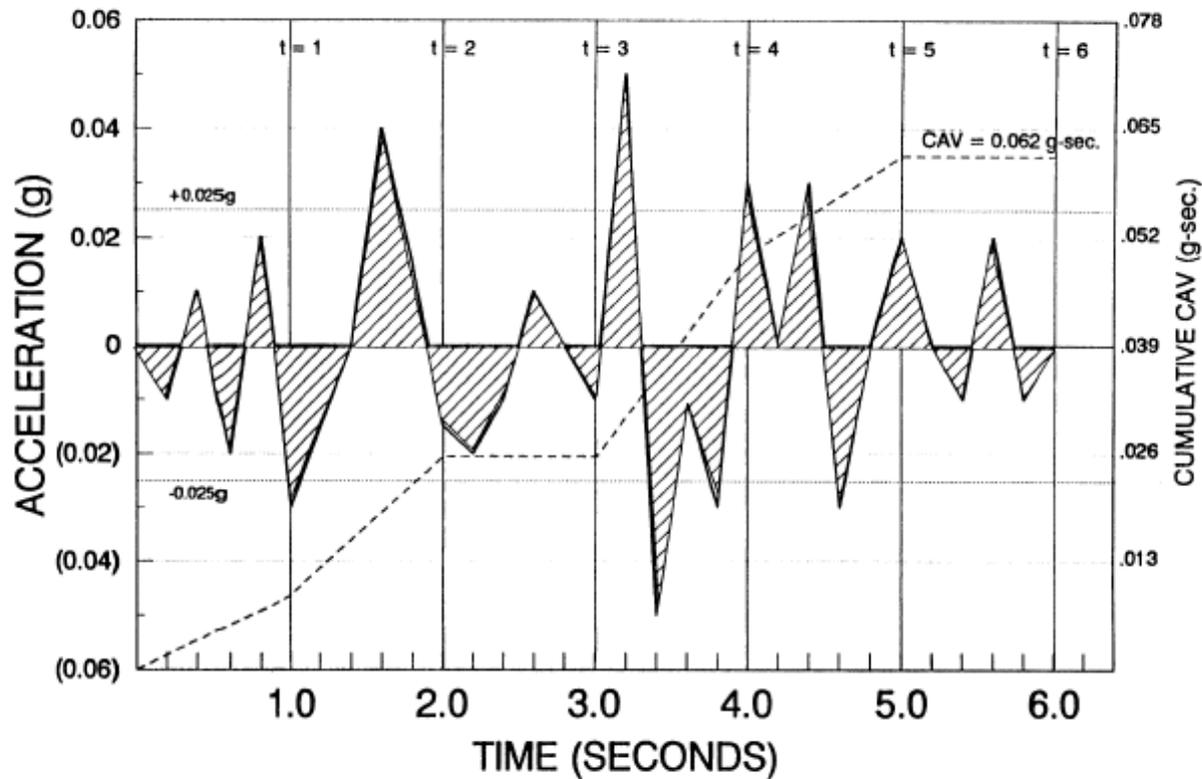
Figure 4-1. Illustration of the Standardized Method to Calculate CAV

- An acceleration time history is first fully rectified, i.e., $\underline{a}_i(t) = |a_i(t)|$
- Then each 1 second interval of the time history is examined for the threshold value exceedance, $\underline{a}_i(t) > 0.025g$
- If the threshold value is exceeded at any time during that 1 second interval, then the area under the rectified time history is computed for that interval
- The sum of all such interval areas that have a threshold exceedance of 0.025g is defined as the CAV value, or

$$CAV(t) = \sum_i \int_{t_i}^{t_{i+1}} S_i |a| dt$$

where $S_i = 0$ for $|a| < 0.025g$ and $S_i = 1$ for $|a| \geq 0.025g$

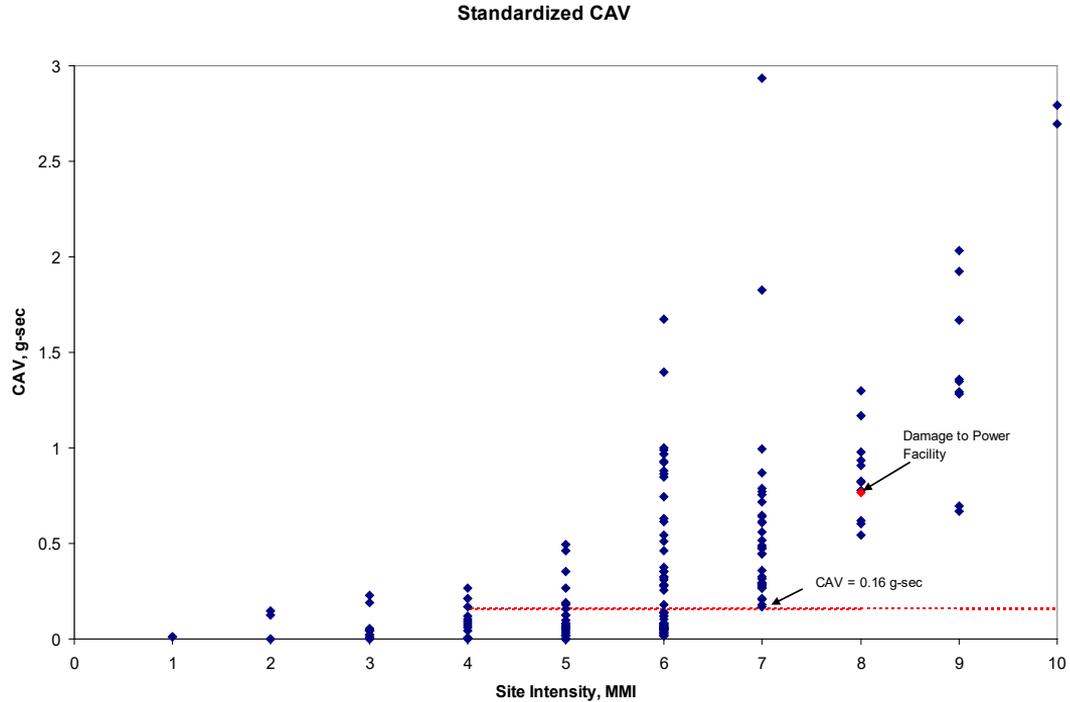
TR-100082 Results

- MMI intensity is determined by structural damage
- MMI VII is associated with damage to non-engineered structures, and therefore a CAV ≈ 0.16 g-sec was chosen as the conservative threshold of any type of damage to engineered structures
- MMI VIII is associated with minor damage to engineered structures – a CAV ≈ 0.8 g-sec is the threshold value for a SQUG database power plant having minor structural damage. Equipment at the plant, however, remained functional
- The use of a CAV damage threshold of 0.16 g-sec for a nuclear power plant is very conservative criteria

- TR-100082 studied 177 records and determined that the minimum standardized CAV value (CAV_{STD}) associated with a site intensity **MMI VII** (defined as the threshold of damage) was 0.16 g-sec.
- This value was incorporated into RG 1.66 as part of the criteria to determine if the OBE had been exceeded at any plant site experiencing an earthquake

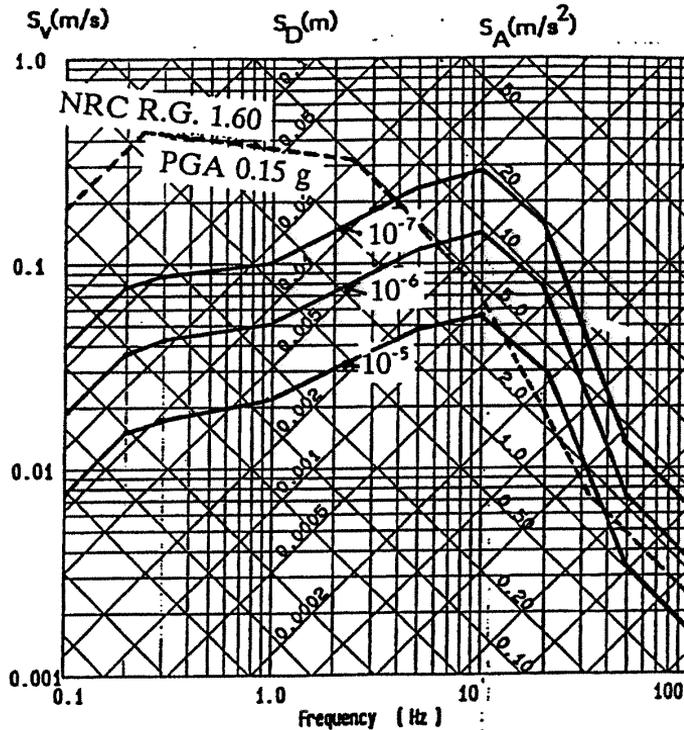
Swedish hard rock ground response spectra

- Based on a regional seismic hazard study (SKI, 1992) uniform hazard ground response spectra for various exceedance frequencies were outlined.
- Applicable for a “typical hard rock site” in Sweden.
- Consideration of site effects leads to a reduction by 15% to account for the favorable site conditions as all plants are sited on solid rock.

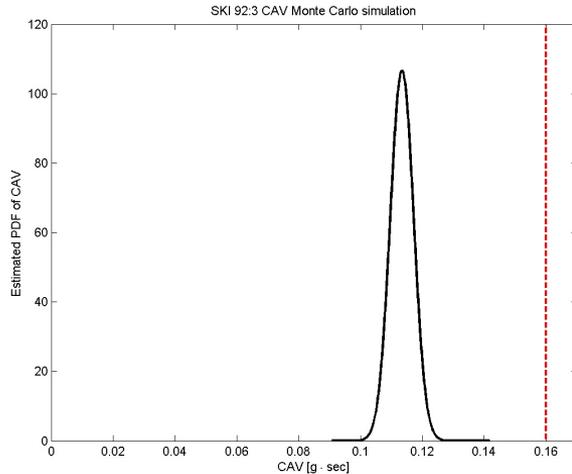
CAV BASED ON SKI 92:3 E-5 ENVELOPE SPECTRUM

- CAV computed for artificial TH for Swedish earthquake.
- A conservative CAV-estimate for the E-5 spectrum is 0.13 gsec
- A seismic event of magnitude equal to Swedish DBE loading will not require any plant shutdown if such an event occurs at a US site.

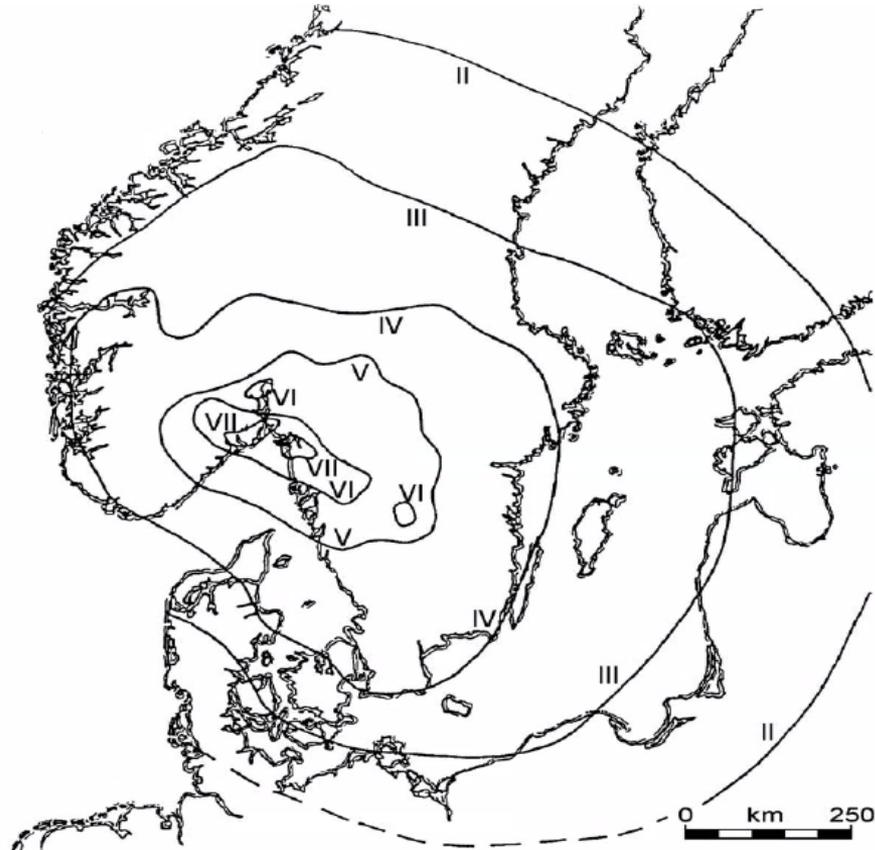
MMI Isoseismals for the Oslofjord Earthquake 1904

Intensity up to MMI VII
