The significance of rock mechanics for stability of dams

Problems, solutions and planned research...

Associate Professor Fredrik Johansson, KTH

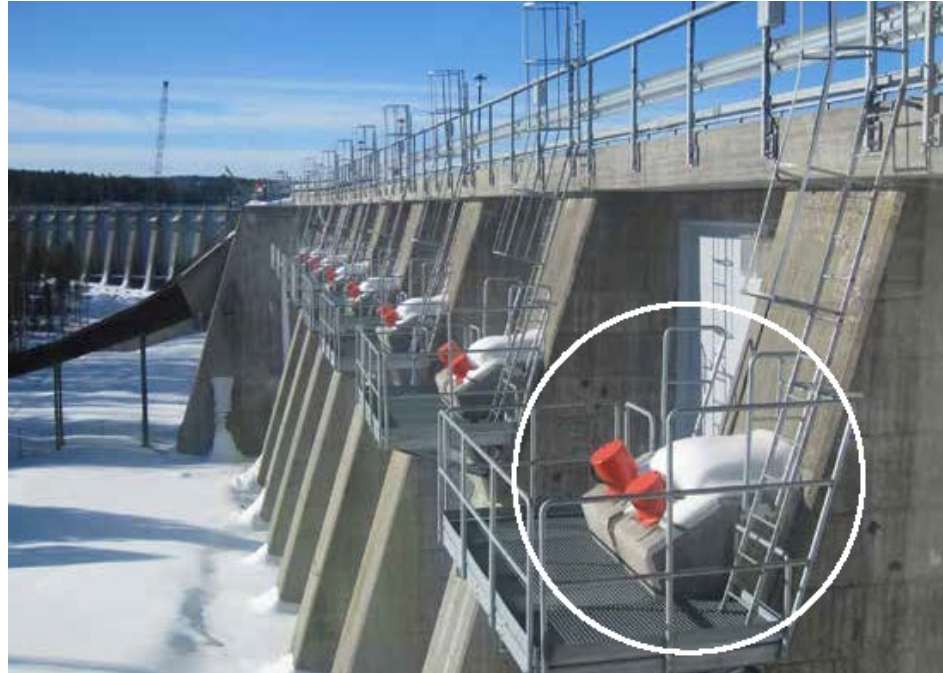
Example of stability enhancing measures, pre-stressed anchor cables at Storfinnforsen buttress dam (Photo Svenska Kraftnät)

- Safety evaluations of existing dams (SEED) showed difficulties in assessing the safety against sliding.
- Difficult to assess the peak shear strength of persistent sub-horizontal rock joints or at the concrete rock interface.
- Many dams strengthened with pre-stressed anchor cables.
- Necessary?

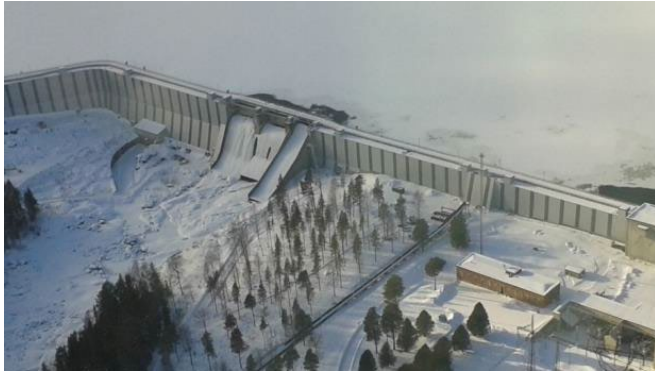
Storfinnforsen buttress dam (Photo: Fortum).

- The uplift in the rock foundation is **difficult** to estimate.
- Today, the knowledge is limited on **the variation** in uplift and how it is influenced by factors such as a degraded grout curtain and clogging of the drains, etc.
- In a rehabilitation and life extension program of two buttress dams in Sweden, the Storfinnforsen and Ramsele dams, new drains were drilled and 270 piezometers were installed in the rock foundation downstream the front plate of the monoliths.
- By using these data, is it possible to determine the **natural variation** of the **pore pressure** in the rock joints in the foundation of these dams?
- How should **alarm-limits** be **determined** to also account for time to implement **countermeasures** if needed? These questions will be studied in coming PhD project.

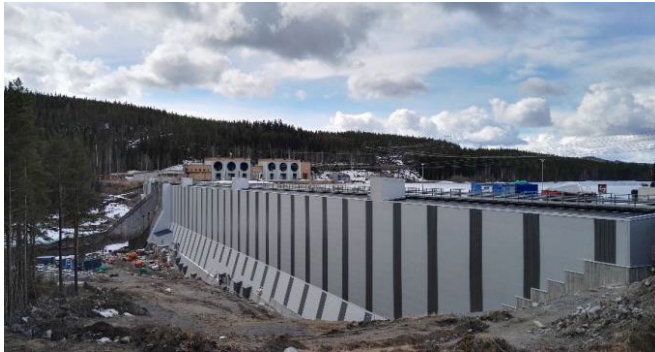
Ramsele buttress dam (Photo: Fortum).

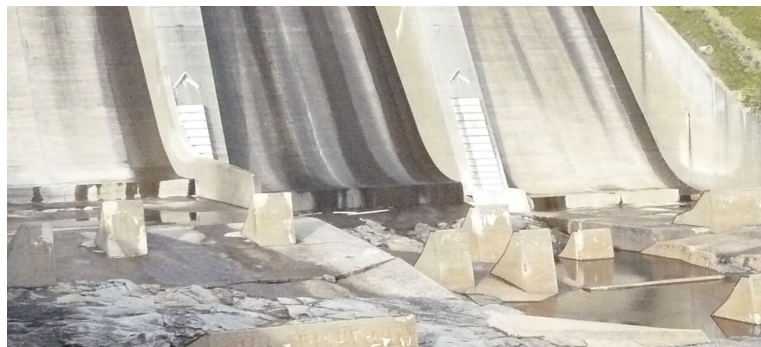
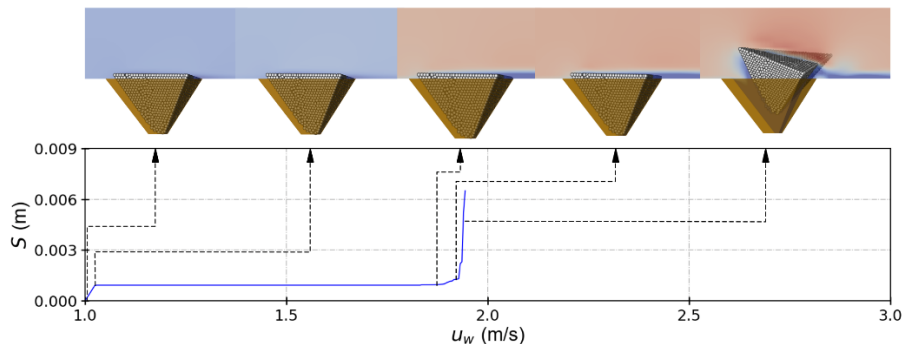
- Excessive **block erosion** can influence the **stability** of the dam.
- Erosion **difficult** to model and **predict**. Influenced by several parameters, which in combination cause the erosion – both rock mechanics and hydraulics are needed.
- In a recently performed project, a combined **CFD-DEM model** has been **validated** for the erosion of a **single block**.
- How can this model be **implemented** to **predict block erosion** in real spillway channels? This will be studied in a coming Post-Doc project where competence in both hydraulics and rock mechanics will collaborate at KTH and LTU.
