Realife, a new project on the ageing of polymers in NPP's and some examples on what we do at KTH (and with partners)

Mikael Hedenqvist

KTH Royal Institute of Technology,
Fibre and Polymer Technology,
Stockholm, Sweden

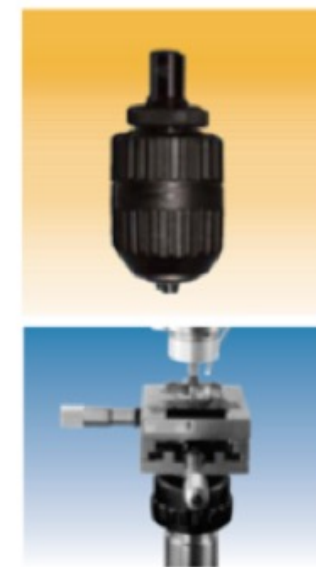
Indenter modulus profiling

- Modified Instron 5566 universal testing machine.
