## Improved estimation of lifetimes for polymer components in NPPs

Anna Bondeson, David Kiefer

RISE Report : P114242.AP01DP01.A01

Key words: EPDM O-ring, membrane, CPE cable, joint seal, lifetime estimation,

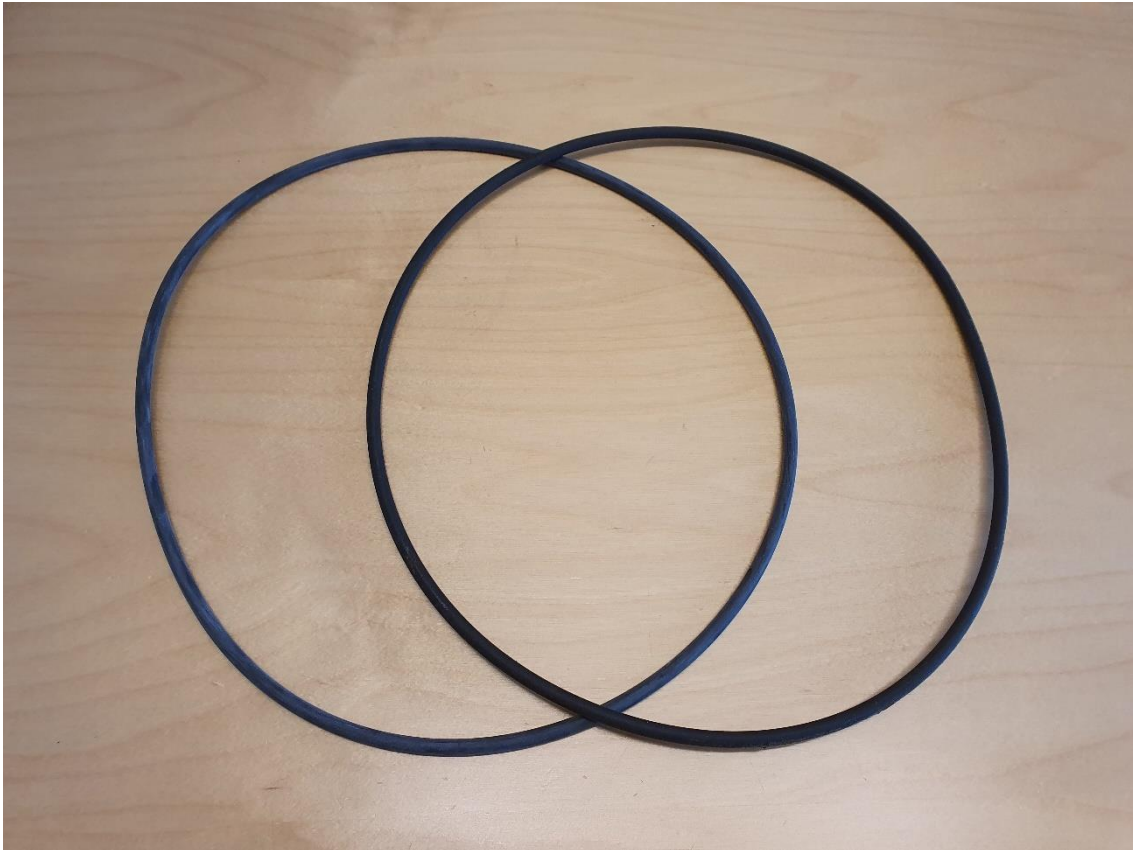
Several EPDM O-rings after service as well as new reference O-rings were received from Ringhals. The exact conditions during their service life are not known. It is assumed that the O-rings are subject to moderate temperatures.

Figure 1. O-rings delivered from Ringhals NPP.

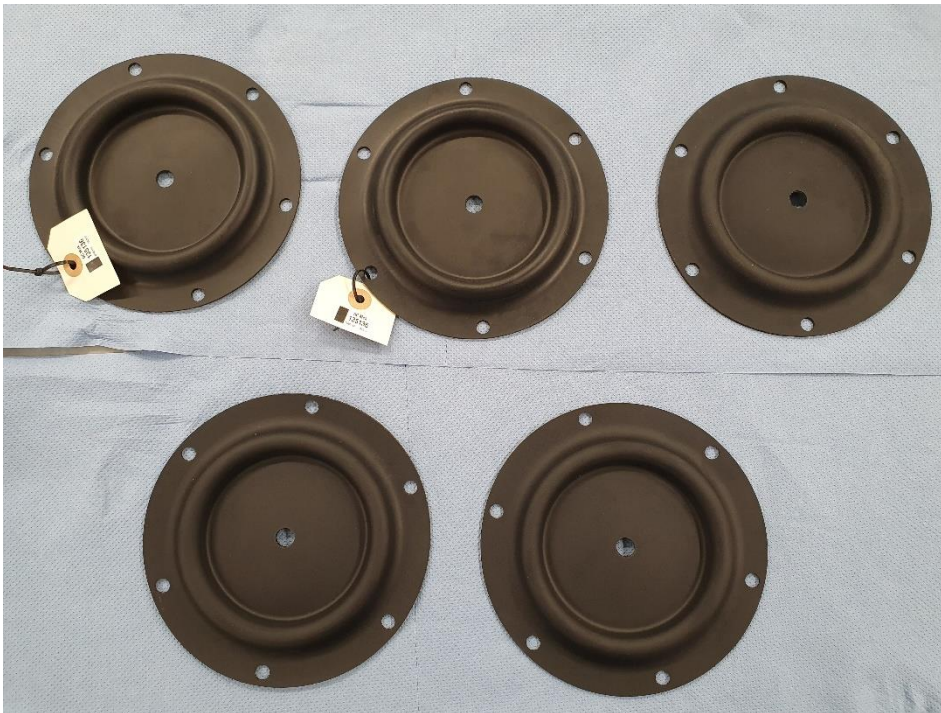
Several neoprene membranes were received from outtakes at Ringhals NPP. All membranes were in service for 8 years exposed to air at ambient, but the exact service conditions for each for individual sample is unknown. Two types of membranes with diameters 17.5 and 19.0 cm were investigated. Additionally, five pristine reference membranes (19.0 cm) were received from Ringhals NPP storage (Figure 4). Reference samples for the smaller membranes were not available, but TGA analysis indicates that both membranes are of similar type.

Figure 4. Photograph of new neoprene membranes from Ringhals NPP.

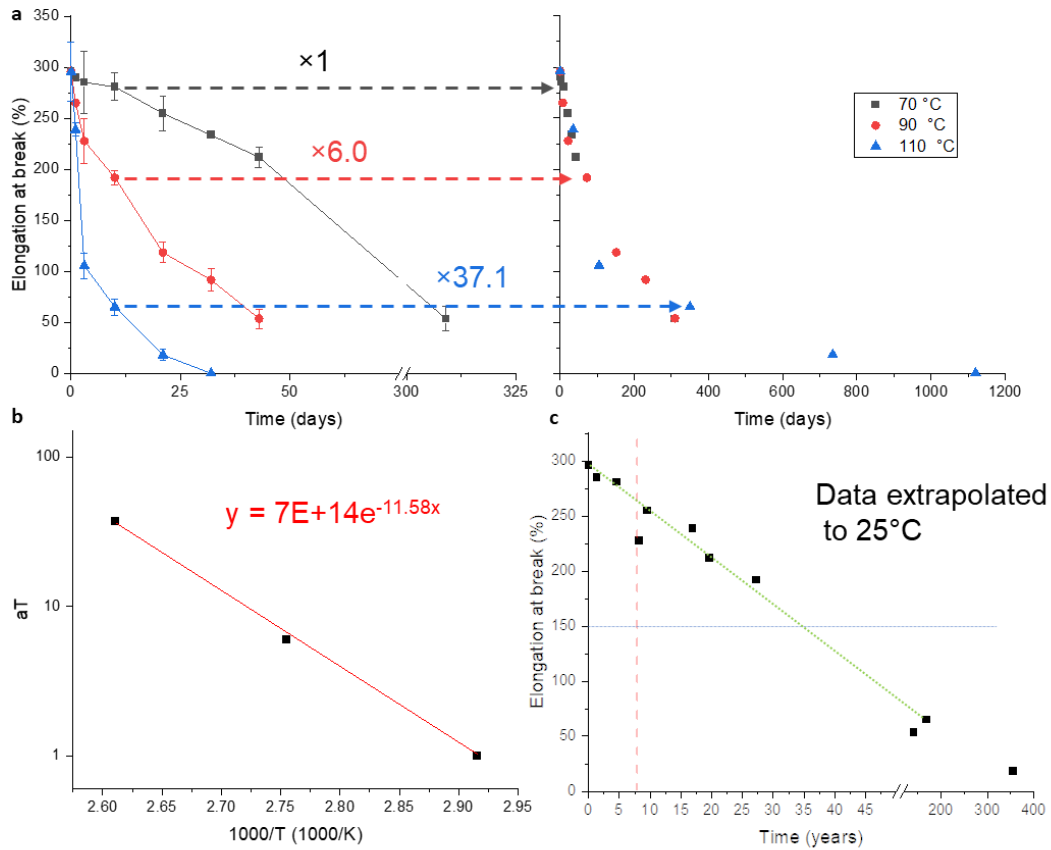
The datasets from elongation at break and hardness was used to build time-temperature superposition plots by shifting the x-axis of the curves to fit one master curve. The time-temperature superposition master curve for elongation at break data is shown in Figure 6a. By confirming that the trends from different temperatures are in line with each other it can be assumed that the same mechanism governs aging for all temperatures. Fitted shift factors were used to estimate the activation energy ( $E_a$ ) of the aging process using Arrhenius equation for both elongation at break (see Figure 6b) and hardness. Results are listed in Table 2. For both elongation at break similar shift factors and hence a similar  $E_a$  of around 98 kJ/mol were calculated.

The shift factors and master curve were used to extrapolate the aging behaviour to an ambient temperature of 25 °C allowing to estimate the total expected lifetime of the material at this temperature (Figure 6c). A common end-of-life criteria for the elongation at break is a 50% reduction corresponding to an elongation at break of around 150 % in case of the analysed neoprene samples (dashed blue horizontal line). Based on the accelerated thermal aging analysis this end-of-life criteria would be reached after approximately 35 years at 25 °C.

Figure 6. (a) Time-temperature superposition of elongation at break data, (b) Arrhenius fit to shift factors ( $aT$ ), and (c) elongation at break data extrapolated to 25 °C (Lines are guides to the eye).

Table 1. Shift factors ( $aT$ ) and activation energies ( $E_a$ ) for elongation at break and hardness.

Temperature (°C)	$aT$ – Elongation at break	$aT$ – Hardness
70	1	1
90	6.0	6.5
110	37.1	37.2
$E_a$ (kJ/mol)	98.6	98.7

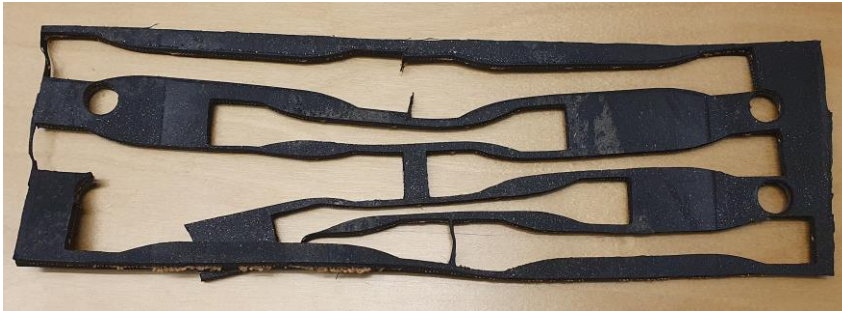
Figure 9. Photograph of joist seal received from TVO after sample preparation.

The joist seal sample (Figure 9) has approximate dimensions of 33 × 10 cm with a thickness of 9 mm. The sample was exposed to N<sub>2</sub>- atmosphere at 45 °C during its operation at TVO for approximate 15 years. There is no relevant information regarding the initial properties of the material, such as data sheets or material specifications or pristine reference material available. Without knowing the initial material properties and the small sample amount it is very difficult to provide an analysis of the remaining lifetime of the material. Nevertheless, to gain some information on the status of the material the specimens were additionally heat-aged at 120 °C for 45 days in a ventilated oven and the tensile properties and hardness was measured.

The measurement results for both as-received and additionally heat-aged samples are listed in Table 2. The tensile strength and elongation at break did not significantly change. Instead, an increase in hardness was noted upon heat aging. The results indicate that it is possible to further age the sample, but there is no indication on its remaining lifetime possible.

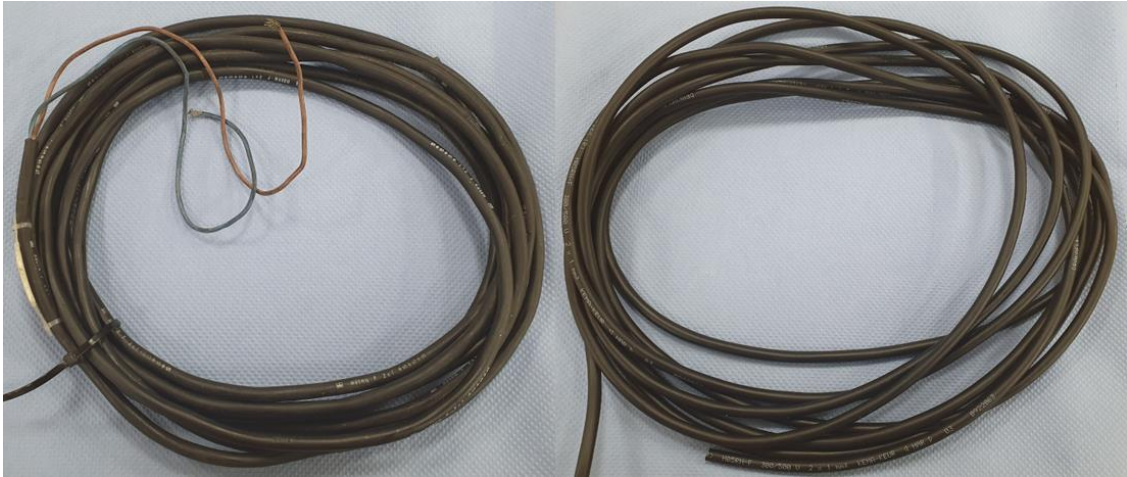
A cable with chlorinated polyethylene (CPE) was received from Forsmark NPP (Figure 10). The cable has been removed from the NPP after about 30 years of service at a temperature slightly above room temperature and has been exposed to mineral oil fog. A cable with similar specification was purchased from Draka cables for reference.

Figure 10. Photographs of CPE cables from Forsmark NPP (left) and reference cable (right).
