# EXAMINATION OF TWO IN-SERVICE-AGED PVC CABLES FROM A NUCLEAR POWER PLANT

REPORT 2025:1122

POLYMERIC MATERIALS IN  
NUCLEAR APPLICATIONS

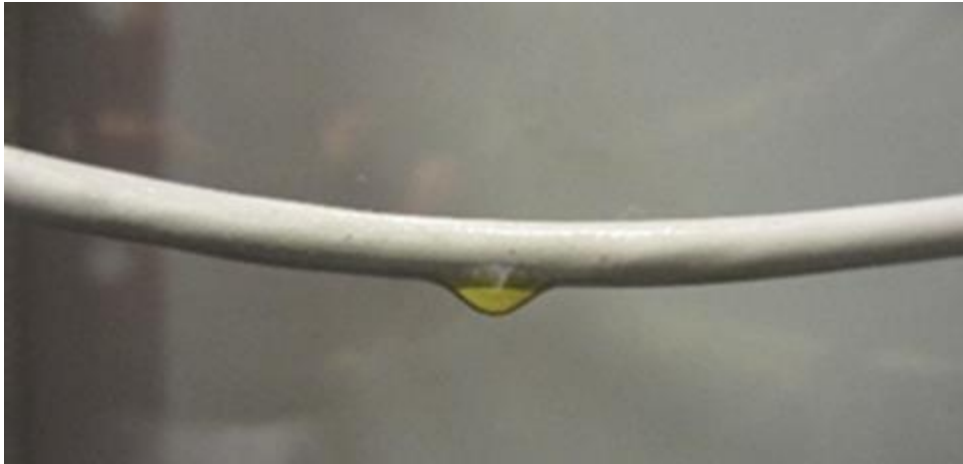
The photos in Figure 1 and Figure 2 were provided by the nuclear power plant to demonstrate the observation of the plasticizer oozing out of the cables during service.

**Figure 2. Photo provided by the nuclear power plant which captures the observation of the plasticizer coming out of the cables during service**

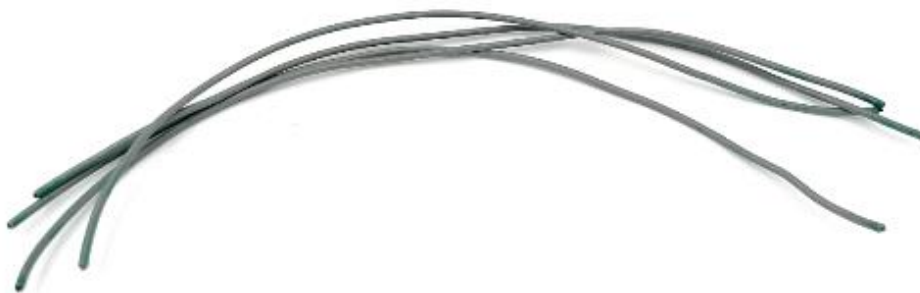
The first set of samples that was sent for analysis had all been post-aged for 2159 hours at 75°C. A photo of the 0.5 mm<sup>2</sup> cable strands can be seen in Figure 3, with a close-up of the ends of the strands in Figure 4. The cables had a green sticky deposit on the outside, especially at the ends of the cable pieces. The cables could still be bent easily without any signs of embrittlement.

Figure 3. A photo of the 0.5 mm<sup>2</sup> cable strands post-aged for 2159 hours at 75°C

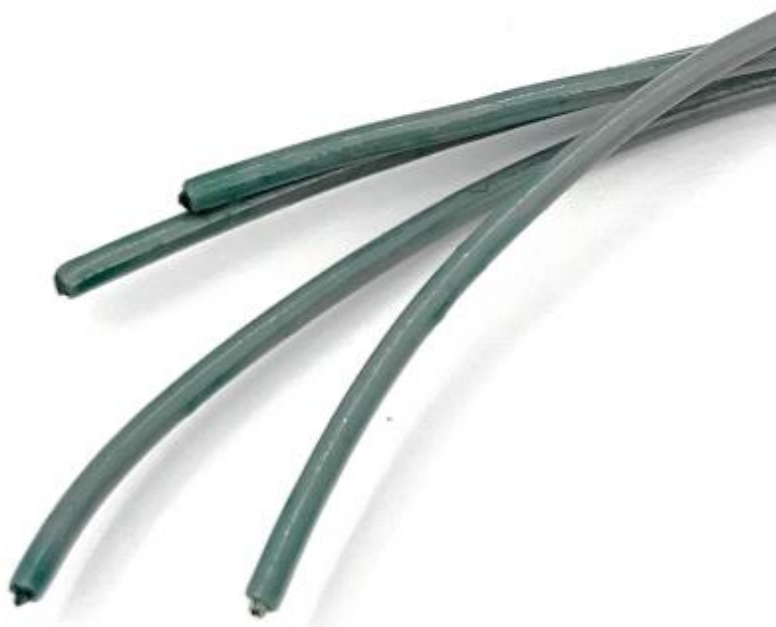
Figure 4. A close-up of the photo in Figure 3 showing the end section of the 0.5 mm<sup>2</sup> cable strands post-aged for 2159 hours at 75°C

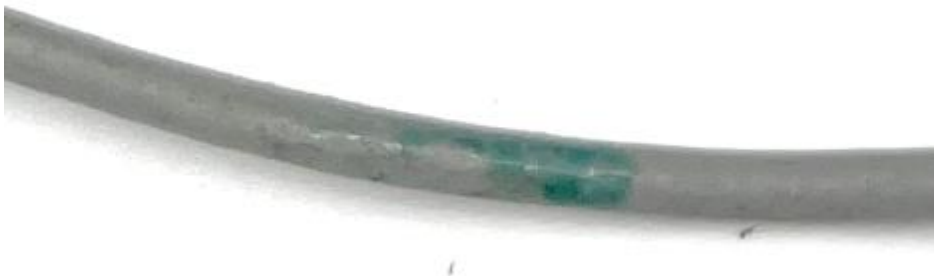
**Figure 6.** Enlarged view of one of the 0.75 mm<sup>2</sup> cables showing the green sticky deposit that was found to a lesser degree on these cable strands compared to the 0.5 mm<sup>2</sup>.

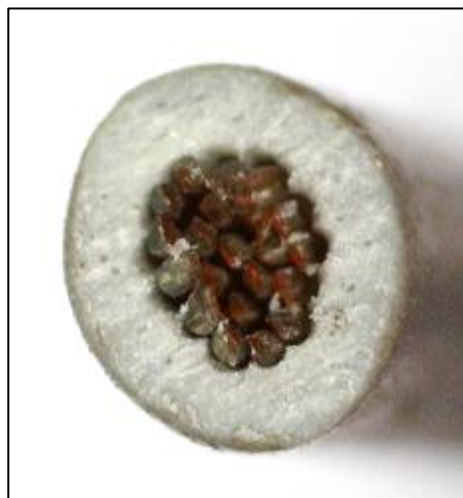
The cross sections of the two cables after 2159 hours of post-ageing are shown in Figure 7 for the 0.5 mm<sup>2</sup> cable and in Figure 8 for the 0.75 mm<sup>2</sup> cable, respectively. There is a significant amount of green liquid visible on the cross section of the 0.5 mm<sup>2</sup> cable, but not on the 0.75 mm<sup>2</sup> sample.

**Figure 8.** The cross section of the 0.75 mm<sup>2</sup> cable which had been post-aged for 2159 hours.

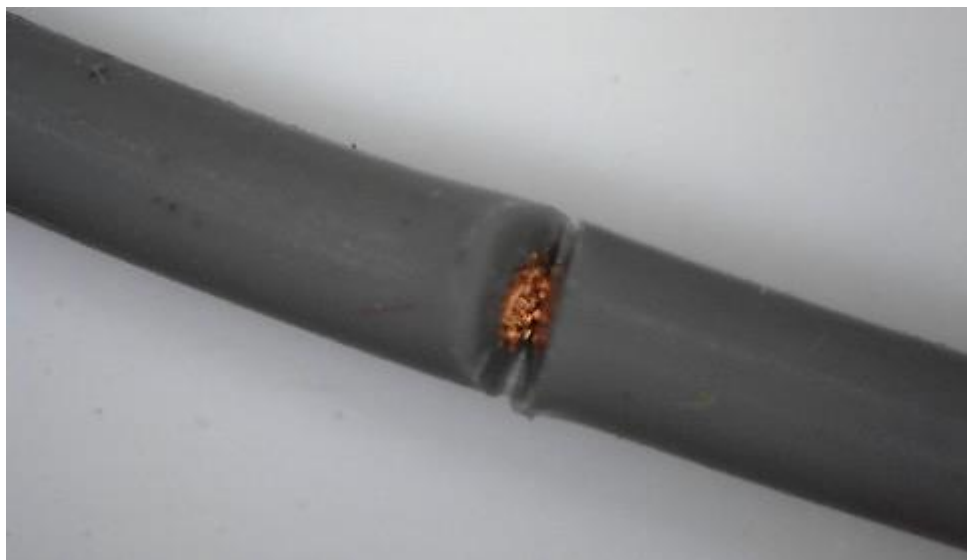
Cutting a new fresh cross section in the 0.5 mm<sup>2</sup> cable did at first not show any of the green liquid as seen in Figure 9. Eventually this new cross section also became green, and it seemed as if the liquid migrated along the conductor.

**Figure 9.** Cutting a new fresh cross section in the 0.5 mm<sup>2</sup> cable post-aged for 2159 hours.
