ANALYSIS OF LONG-TERM DURABILITY OF PRESTRESSED TENDONS IN SWEDISH NUCLEAR REACTOR CONTAINMENTS 2021

REPORT 2026:1207

Analysis of long-term durability of prestressed tendons

in Swedish nuclear reactor containments

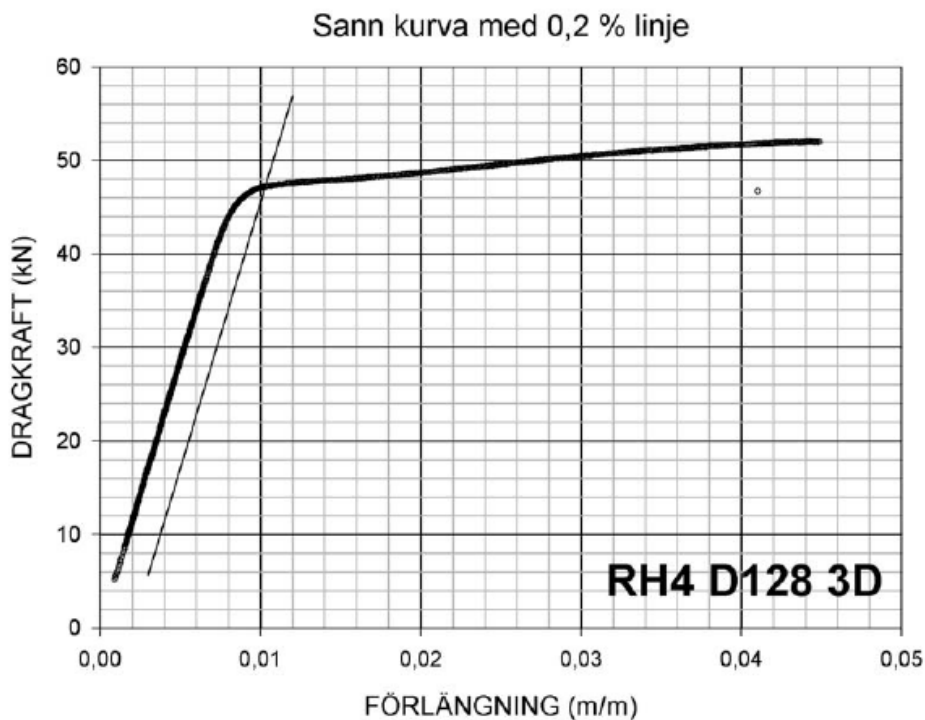
Figure 2 Typical Force (Dragkraft) – strain (Förlängning) curve from Ringhals 4 test in 2010.

The first and most extensive data set in presented analysis concerns uniaxial tensile test. Depending on the prestressing system used some measured parameters differ. For all wires, the values of ultimate tensile force F_m , ultimate elongation ε_g and modulus of elasticity E were measured. For Forsmark 1&2 where VSL 7-wire strands system was used additionally force at 1 % elongation $F_{1.0}$ was measured, while for Forsmark 3 and Ringhals where BBRW single strand system was applied force at 0.2 % elongation $F_{0.2}$ was registered. For the second case additionally a ratio of $F_{0.2}/F_m$ was calculated. A typical force-strain curve from the tests was depicted at Figure 2.

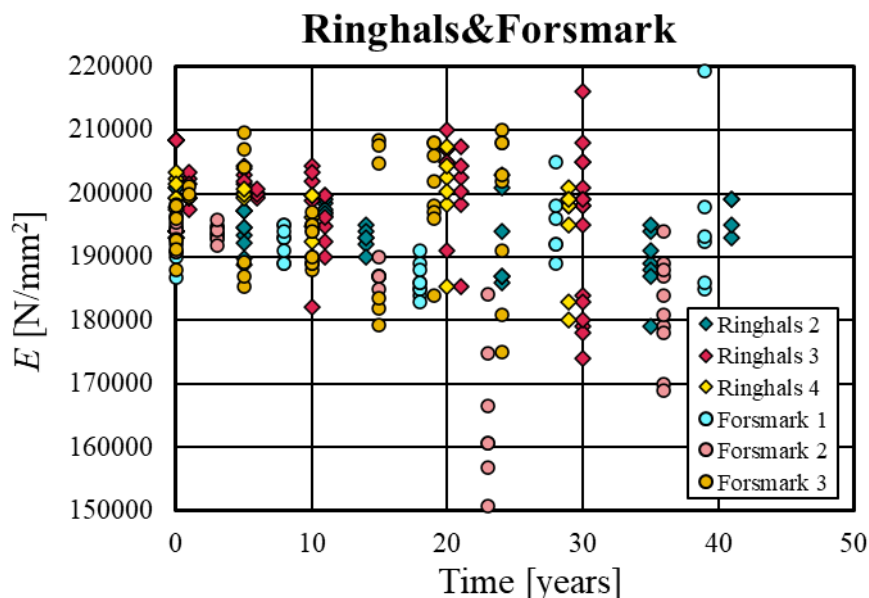
Figure 3 Results of elastic modulus in function of service life for all analyzed containments.

The results on the modulus of elasticity for all containments together were presented at Figure 3 in function of service life. The results are characterized with a very large scatter varying between 150 GPa and 220 GPa. The scatter is the highest for Forsmark 1&2 where entire strands have been tested (VSL system). The structure of the strands with 7 wires could be one of the main factors causing larger scatters. In other containments the scatters can be related to the wires extraction process. Neither in the whole dataset, nor in individual containments statistically meaningful trends could be identified. Moreover, there are no requirements in the used standards concerning the modulus of elasticity values to be fulfilled.

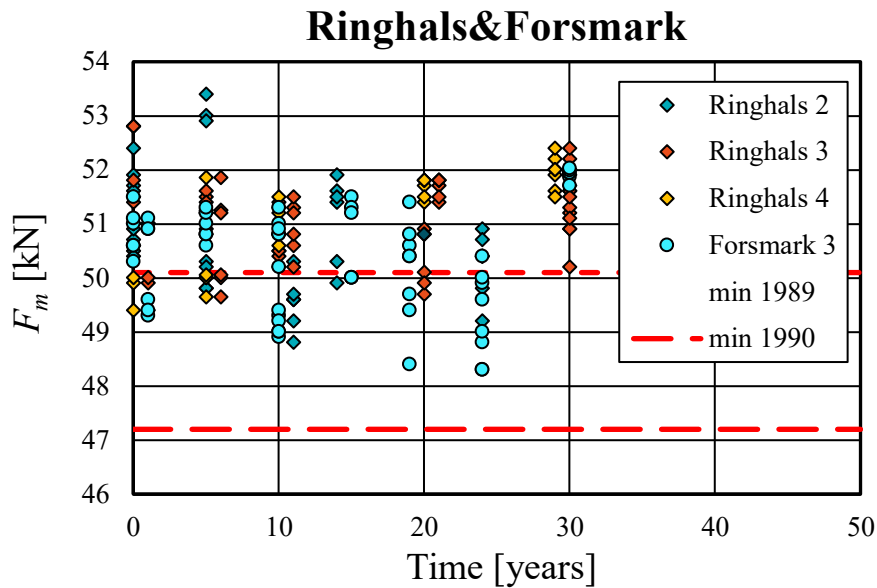
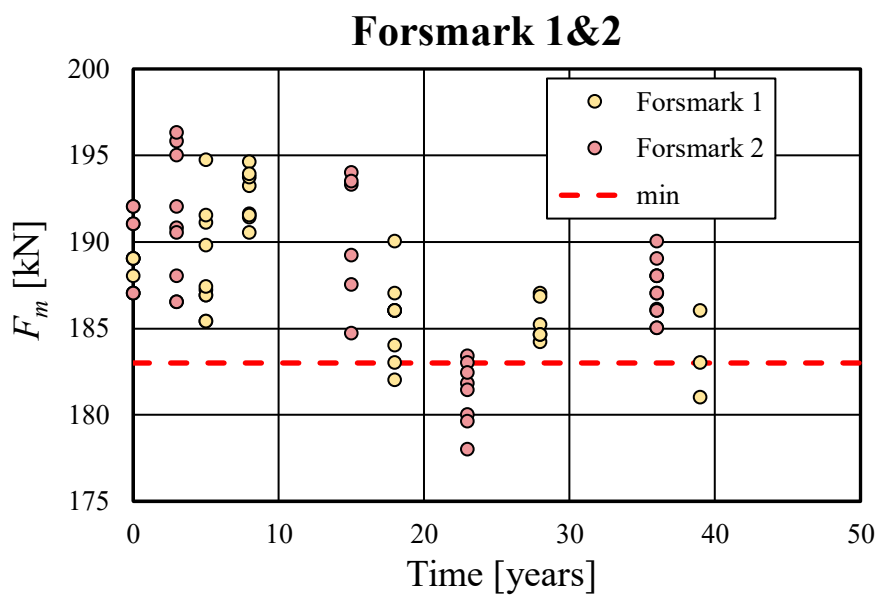
Figure 4 Ultimate tensile strength F_m in function of service life for a) Ringhals and Forsmark 3 (with BBRV single strands system) and b) Forsmark 1&2 (with VSL 7-wire strands). The red dashed line indicates the minimum value required by standard Stål 14 17 57 Stål för spännarmering (fine dashed line from 1973 and large dashed from 1987).

The minimum requirements for new steel (marked with red dashed lines at Figure 4) were not fulfilled for some individual samples, however the mean values within each testing series were above the required original values apart from Forsmark 2 in 2003, where six out of eight measured values were below the requirement. Secondly, the required ultimate tensile strength was increased between '86 and '89. That change resulted in about 40 % of results for Ringhals and Forsmark 3 below the new required values.

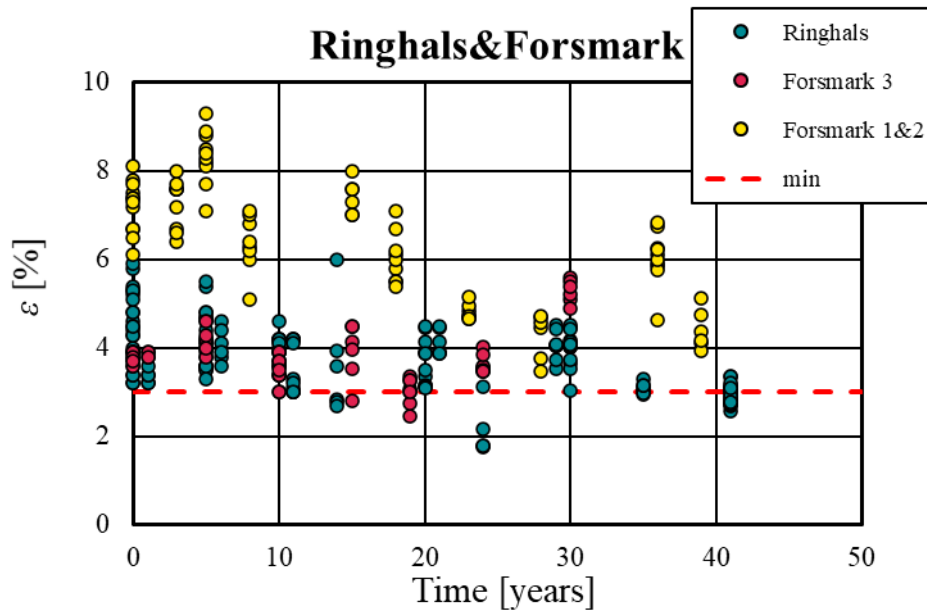
Figure 6 Ultimate elongation ε_y in function of service life for all the analyzed containments. The red dashed line indicates the minimum value required by standard "Stål 17 57. Stål för spännarmering" from 1973

High carbon content steel, like prestressing steel, are characterized with very high strength and low ductility comparing to regular reinforcing steel. Therefore, the ultimate elongation is one of the crucial properties for hard steel as it expresses the spare deformation after reaching ultimate tensile strength which could be directly related to reliability of the structure and signaled failure required by design standards¹⁷ and structural engineering practice. In the analyzed dataset the decrease of the ultimate elongation value is the most pronounce and clearly significant from statistical perspective (Figure 6). Moreover, the most recently tested samples from Ringhals do not fulfill the standard requirement of minimum 3.5%.

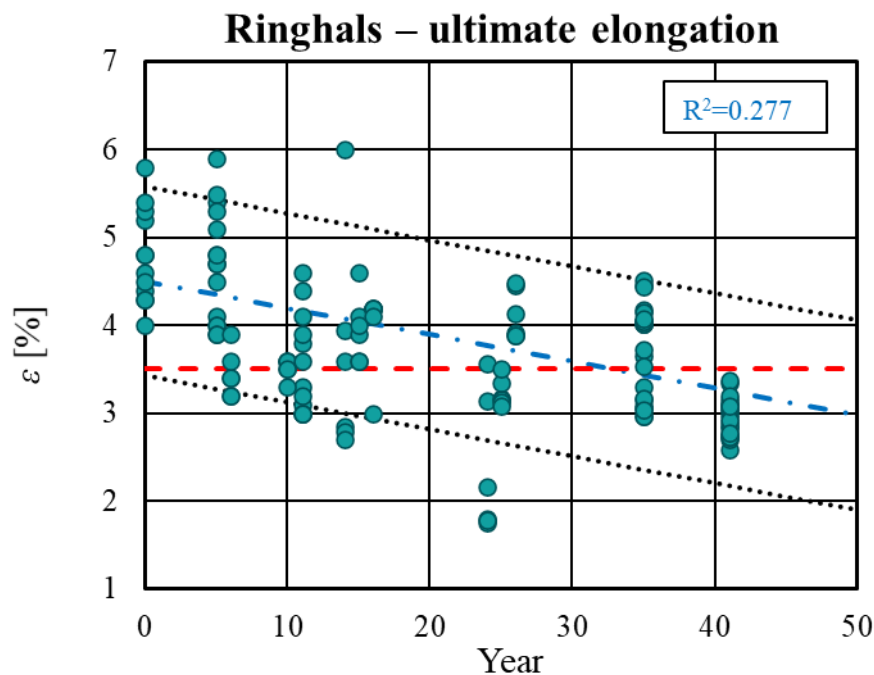
Figure 7 Ultimate elongation in all Ringhals containments in function of service life with dashed blue linear regression line and dotted lines indicating 3 times average standard deviation for the whole dataset. The red dashed line indicates the minimum value required by standard.

At first the results were split into separate plants. In the Ringhals dataset as a whole a decreasing trend was observed. The average ultimate elongation decreased from 4.6 % in the first tests to nearly 3 % in the latest once (Figure 7) which is below the required by the standard 3.5 %. In Gaussian normal distribution usually more than 95% of results are within ± 3 times standard deviation σ from the mean value. This measure was used to analyze the observed trend globally. In case of Ringhals the average standard deviation was equal to $\sigma=0.36$ %. Which means that the decrease of the mean value from 4.6 % to 2.9 % (by 1.7 %) is statistically meaningful (higher than $3\sigma=1.1$ %). Moreover, the mean value of the linear regression has crossed the standard minimum requirement of 3.5 % after around 35 years of exploitation.

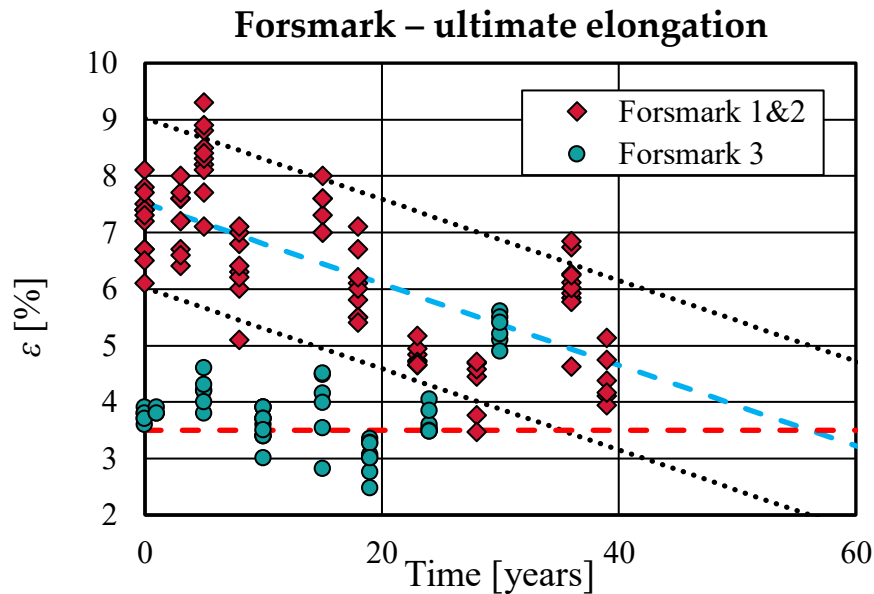
Figure 9 Ultimate elongation in all Forsmark containments in function of service life with dashed blue linear regression line and dotted lines indicating 3 times average standard deviation for the whole dataset. The red dashed line indicates the minimum value required by standard.

The results for Forsmark containments were generally divided into two groups: (1) Forsmark 1&2 where the VSL 7-wire strands system was used and (2) Forsmark 3 where the BBRV single strands system was applied. It is clearly visible that both systems exhibited completely different behavior in terms of ultimate elongation evolution over time (Figure 9). For Forsmark 1&2 a clear decreasing trend from initial value of 7.6 % down to 4.7 % after 40 years occurred. A simplified analysis of 3 times the mean standard deviation for the whole data population indicated with black dashed lines at Figure 9 presents the meaningfulness of the linear trend. Even though the decrease in ultimate elongation was great (nearly 3 %) it did not exceed the required limit of 3.5 %. However, if the linear trend would be maintained in the future (linear extrapolation indicated by the blue dashed line at Figure 9) within the next 15-20 years the mean value will decrease below the standard requirement. For the BBRV system there is no clear trend. The values measured for Forsmark 3 are partially below the standard requirement.

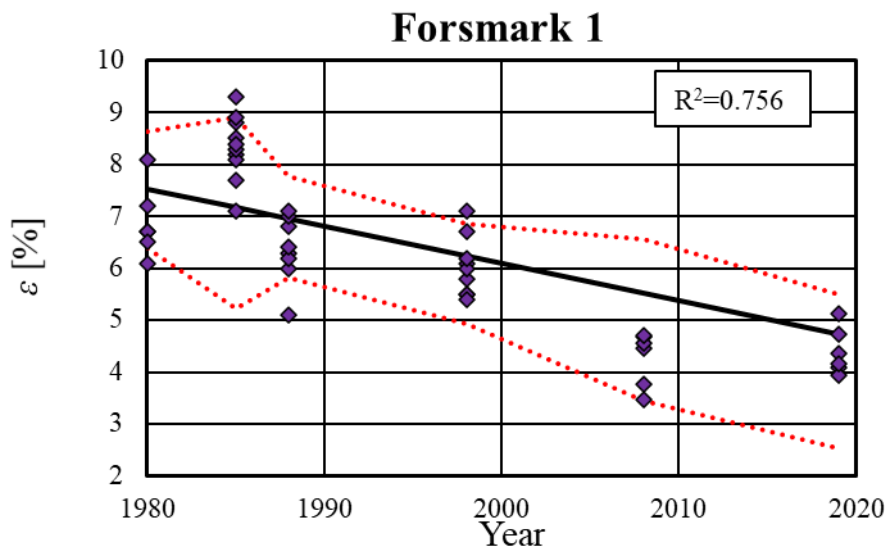
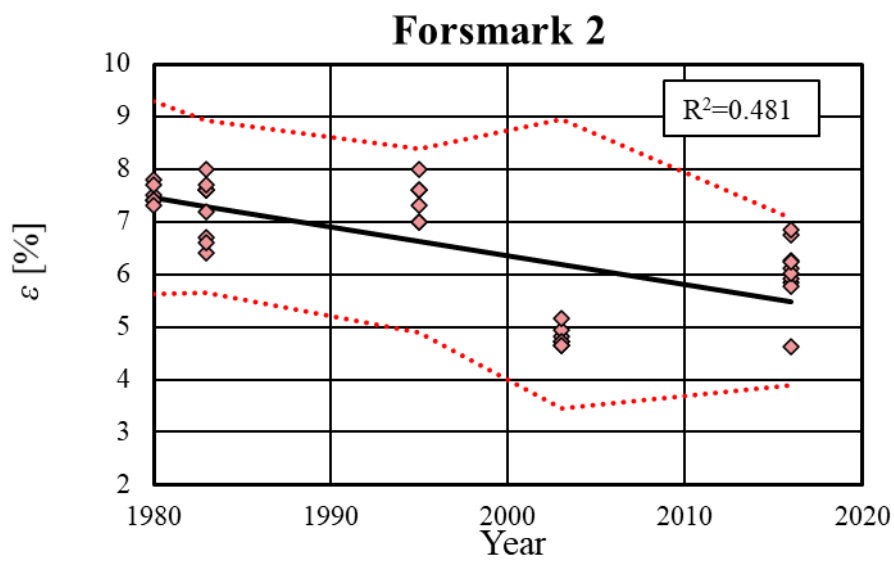
Figure 10 Ultimate elongation in function of testing year for a) Forsmark 1, b) Forsmark 2 and c) Forsmark 3 containment. Black solid line represents linear regression and red dotted lines represent confidence interval of 95%.

The increasing trend observed for Forsmark 3 (from 3.8 % in 1986 to 4.2 % in 2016) falls within the growing confidence interval $CI_{95\%} = 0.8$ -2.1 % (Figure 10c) and is not meaningful from statistical point of view.

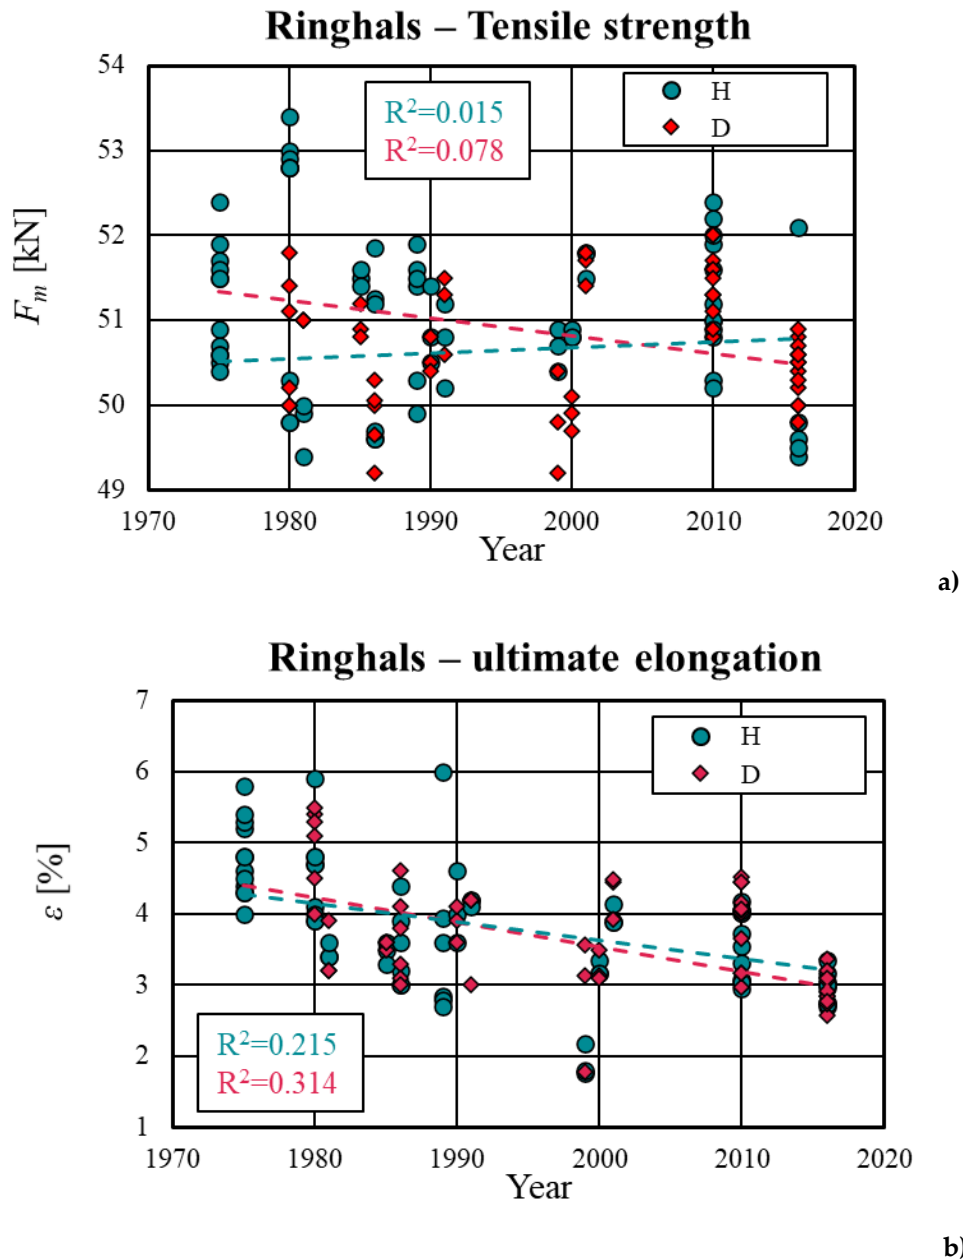
Figure 11 Results for all Ringhals containments divided for wires extracted from horizontal direction (H) and dome (D) a) Tensile strength, b) ultimate elongation in function of testing year. Dashed lines represent linear regression trend.

The results for tensile strength did not exhibit statistically meaningful trends both for horizontal and dome tendons (Figure 11a). However, even in analysis of pure linear regression no significant difference in tensile strength was observed, as the horizontal tendons mean value changes between 50.5 MPa and 50.8 MPa, while for dome tendons the mean value changes between 51.4 MPa and 50.5 MPa (Figure 11a). Similarly for ultimate elongation values the linear regressions for horizontal and dome tendons have very similar decreasing characteristic, 4.4 % down to 3.3 % for horizontal tendons, and 4.5 % to 3.0 % for dome.

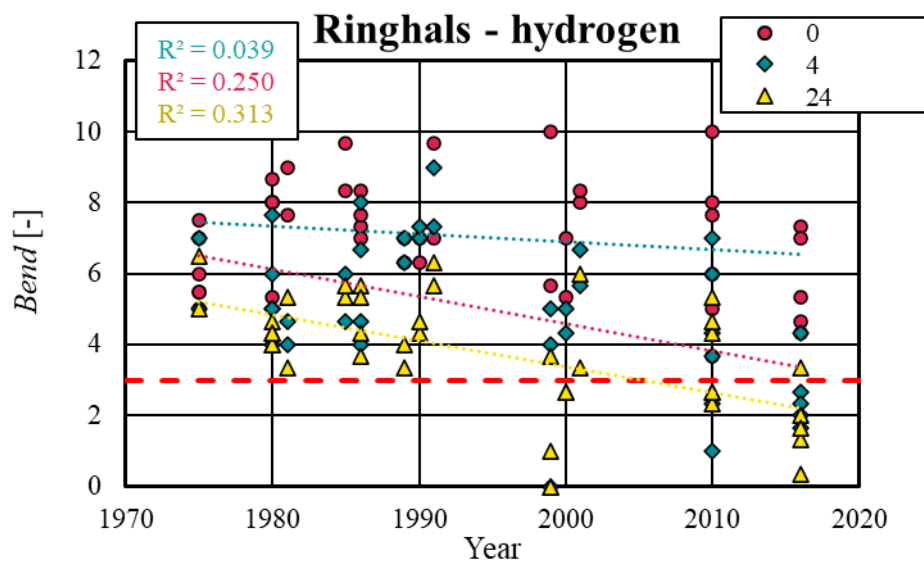
Figure 12 Reversed bend test results for a) all Ringhals containments by time of hydrogen treatment samples in original state marked as 0 (red circles), 4 hours (green diamonds), and 24 hours (yellow triangles) with trend lines in respective colors. The red dashed line indicates the minimum value required by standard.

As expected, the hydrogen treatment, especially after 24 hours decreased the maximum bend count (the wire fractured after lower number of bending cycles) (Figure 12). Moreover, the difference between the mean value of bend counts between the wires in original state and after hydrogen treatment was increasing over time (expressed by linear regression lines at Figure 12), which may indicate the material degradation. All the values for wires in original state were over the standard requirement of minimum 3 bend counts.

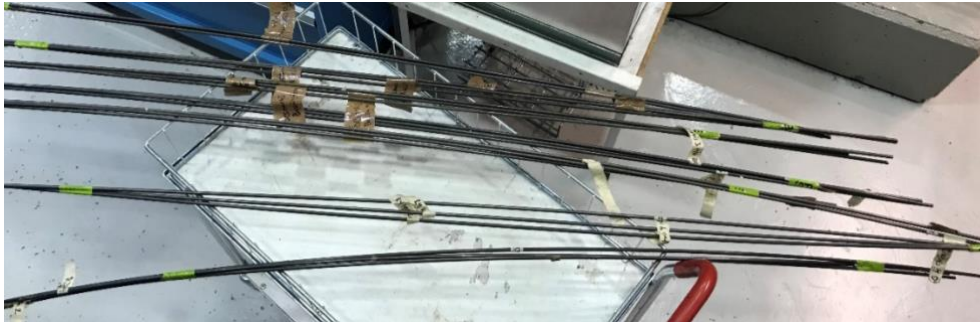
Figure 16 Wires delivered to RISE for testing with original marking

The uniaxial tensile test has been performed parallelly at RISE facilities in Borås and in Vattenfall lab in Älvkarleby. The wires diameter 6 mm, approximately 2 m long, from seven different 7-wire strands were delivered to RISE for testing (Figure 16). Three wires were taken from each strand. The received samples with marking according to Table 3 were cut to obtain samples with length of 500 mm.

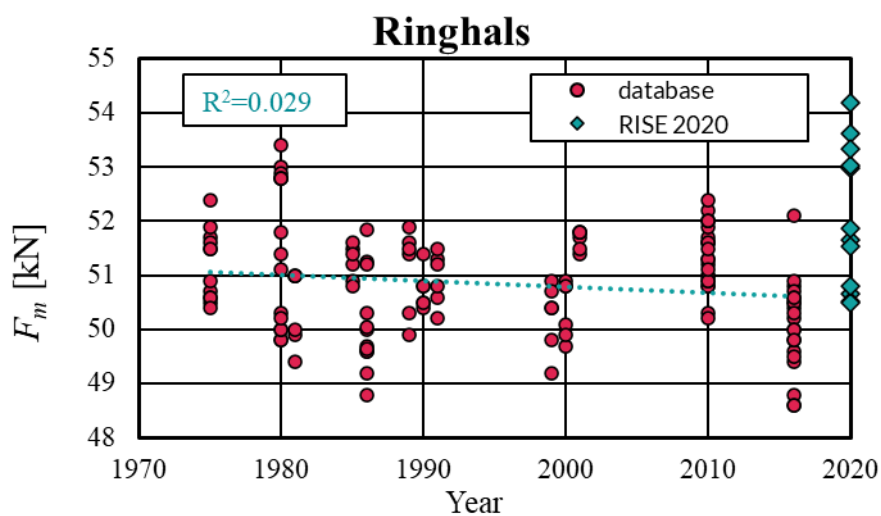
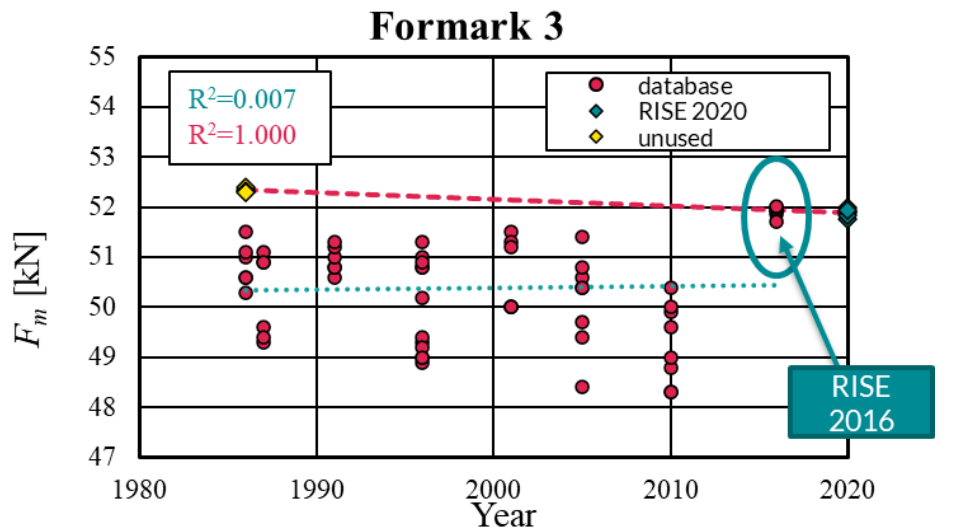
Figure 19 The results of maximum tensile force for a) Ringhals and b) Forsmark 3 in historical database (red circles), from the tests performed within the project on used (green diamonds) and unused wires (yellow diamonds). The red dashed line indicates linear regression line for unused tendons and new tests by RISE only, while the dotted green line indicates linear regression for the historical database only.

The ultimate tensile strength measured by RISE for Ringhals and Forsmark 3 was higher than all historical results (Figure 19). The strength of used and unused tendons from Forsmark the same apart from differences falling within the uncertainty of the measurement (Figure 19b). The mean value changed within the confidence interval – no strength degradation was observed. The results scatters for Forsmark wires were much lower than in historical data (COV=0.2 % to COV=1.5 %). The result from 2016 for Forsmark 3 has also been obtained by RISE and falls within a linear trend between unused and used wire. This confirms the lack of long-term changes in tensile strength. All measurements from RISE are over the SIS standard requirement of $F_m=51.1$ kN.

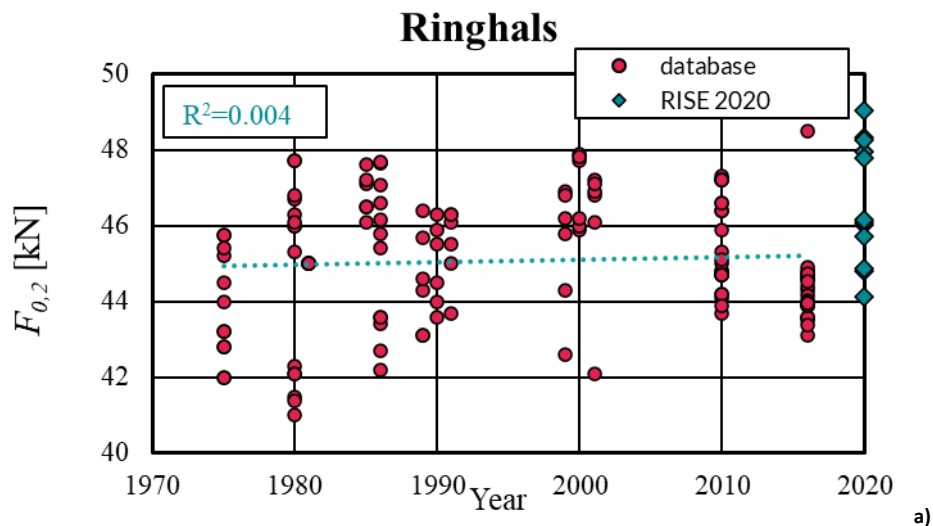
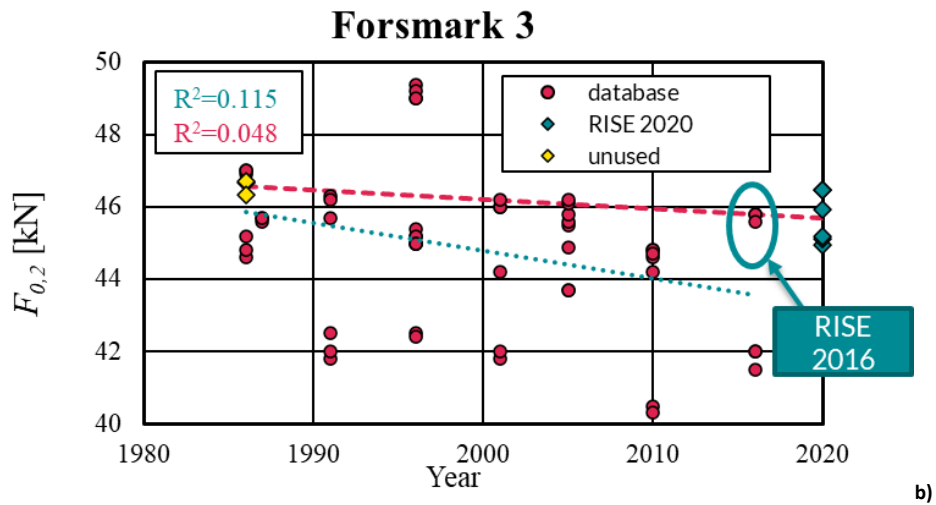
Figure 20 The results of force at 0,2 % strain for a) Ringhals and b) Forsmark 3 in historical database (red circles), from the tests performed within the project on used (green diamonds) and unused wires (yellow diamonds). The red dashed line indicates linear regression line for unused tendons and new tests by RISE only, while the dotted green line indicates linear regression for the historical database only.

The force at 0.2 % elastic limit measured by RISE falls within the scatters of data from historical measurements (Figure 20). The trends fall within the uncertainty of the measurement and therefore are statistically non-meaningful. There was no meaningful change in the elastic limit between the used and unused samples – no material degradation (Figure 20b).

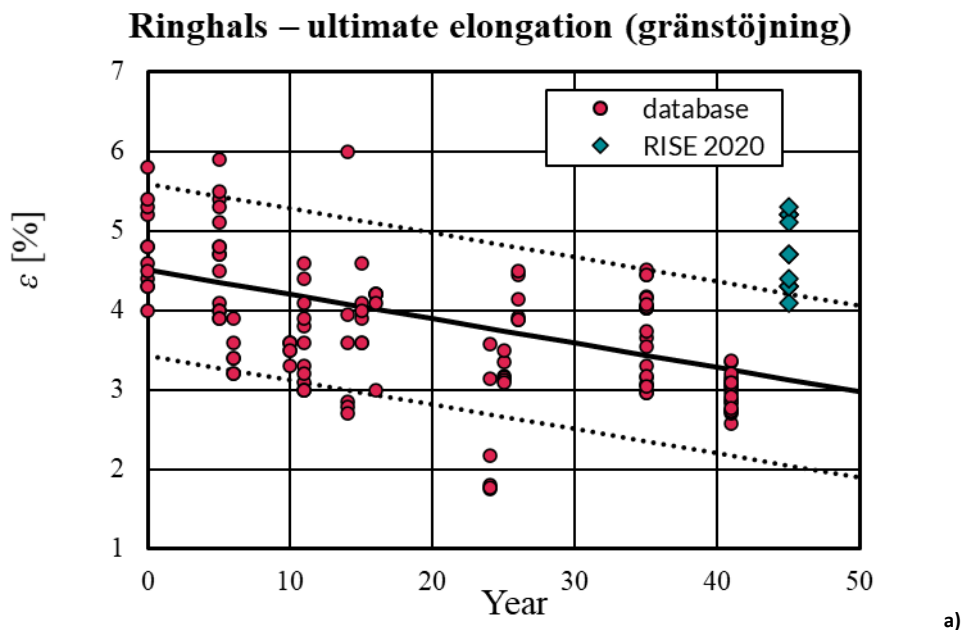
Figure 21 The results of ultimate elongation for a) Ringhals and b) Forsmark 3 in historical database (red circles), from the tests performed within the project on used (green diamonds) and unused wires (yellow diamonds). The green dashed line indicates linear regression line for unused tendons and new tests by RISE only, the continuous black lines are linear regression lines for the database only, while the red and black dotted lines indicate confidence interval for all Forsmark 3 and three standard deviations for Ringhals samples.

The measured values of ultimate elongation are contradictory to the identified trend for all Ringhals containments. The new values fulfill the SIS standard requirement of 3.5 %. The mean value obtained by RISE is the same as for the first registered measurement in 1975 (Figure 21a). The new results for Forsmark 3 were higher by 50 % in comparison with historical data. This increases significantly the confidence interval and therefore make the overall trend statistically nonmeaningful (Figure 21b). The results obtained for unused wires indicate lack of material degradation in comparison with the new results. The results obtained by RISE in 2016 are in line with the lack of material degradation between original and aged material.

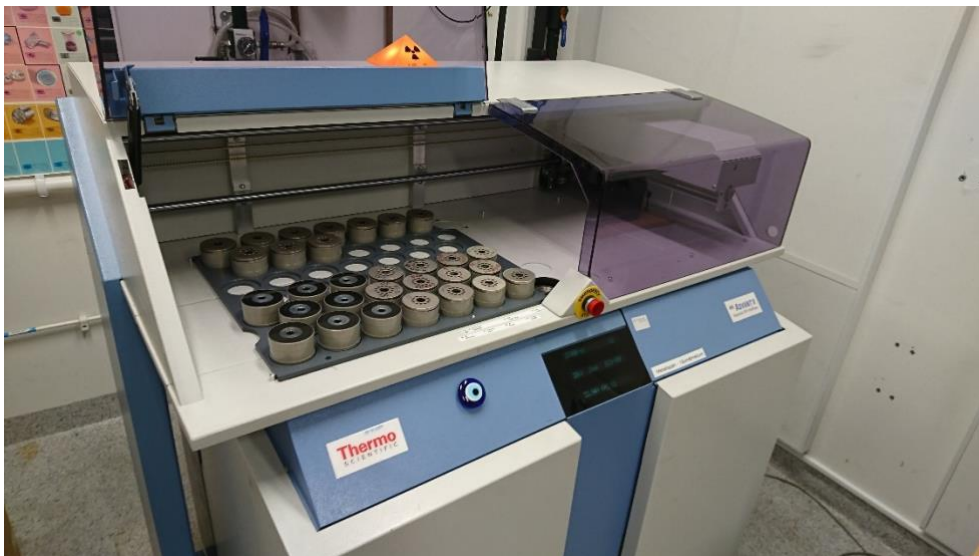
Figure 22 The testing setup for X-ray fluorescens measurements of elements content in steel.

From the ends of wire samples received (Table 3) for mechanical tests longitudinal sections were cut out for chemical analysis of the steel. The samples were tested for the weight proportion of elements (Al, Si, P, S, Ca, Ti, V, Cr, Mn, Co, Ni, Cu, Zr, Nb, Mo, Sn, Sb, Ta and W) with X-ray fluorescens technique (Figure 22) with internal method SP1494. The method is based on a semi-quantitative analysis of the surface layer. The samples surface was grinded before the analysis. The carbon content was determined on steel samples with IR detection of formed CO₂ by combustion in oxygen in high frequency induction furnace, method SP0653. The test was conducted on the 8th of April 2021.
