# EFFECTS OF MECHANICAL LOADS ON AGEING OF PREFABRICATED DISTRICT HEATING PIPES

REPORT 2024:1041

- manufactured according to EN 253

JAN HENRIK SÄLLSTRÖM  
IGNACY JAKUBOWICZ  
NAZDANEH YARAHMADI

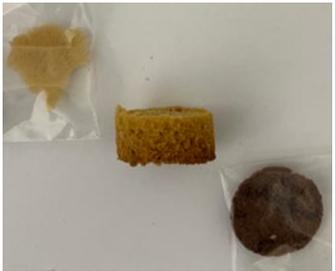
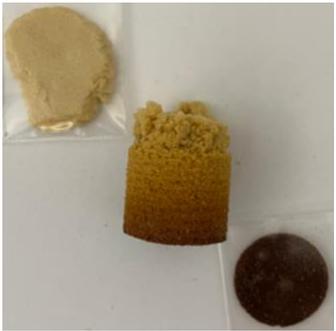
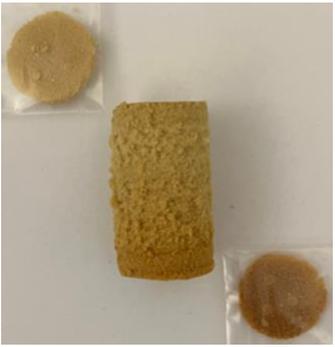
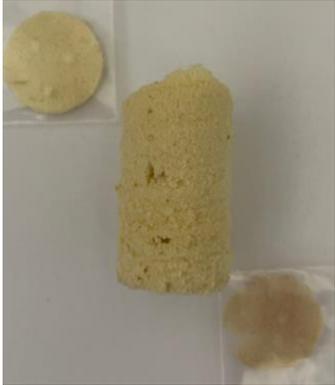
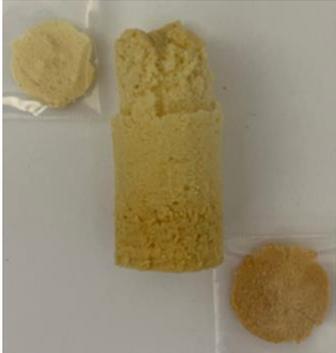
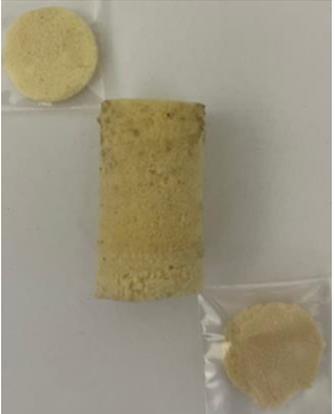
Kabelgatan: Fixed zone flow	Kabelgatan: Sliding zone flow	Kabelgatan: Return

Errarpsvägen: Fixed zone flow	Errarpsvägen: Sliding zone flow	Errarpsvägen: Return

Pictures of plugs from the field tests are presented in Appendix A. During thermo-oxidative degradation of polyurethane, it darkens, meaning that the intensity of the brown colour is a measure of degradation.

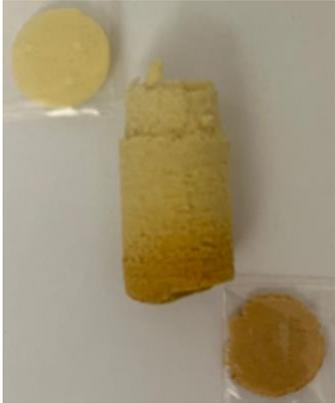
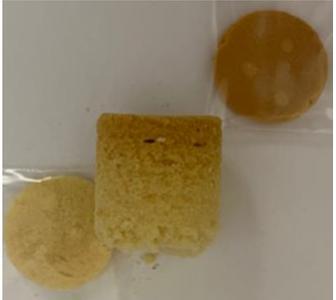
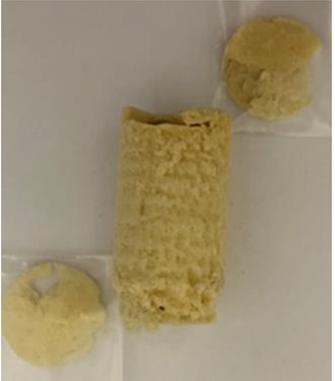
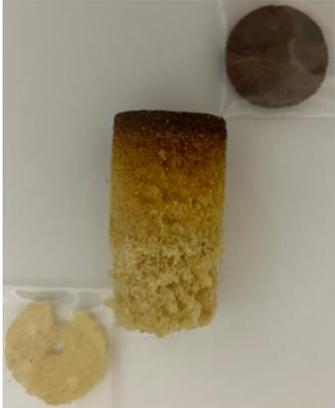
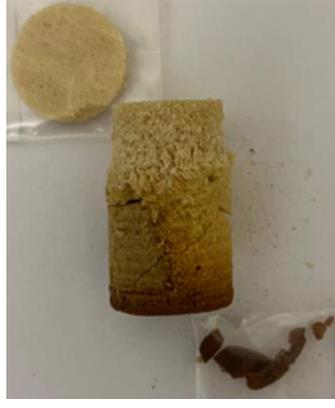
Huskvarnavägen: Fixed zone flow	Huskvarnavägen: Sliding zone flow	Huskvarnavägen: Return

Bergavägen: Fixed zone flow	Bergavägen: Sliding zone flow	Bergavägen: Return

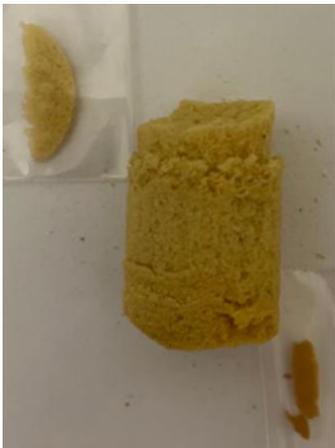
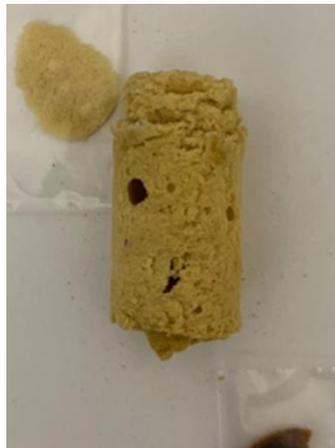
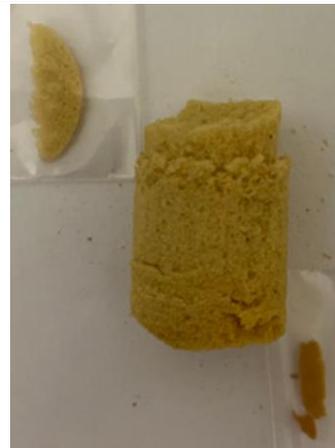
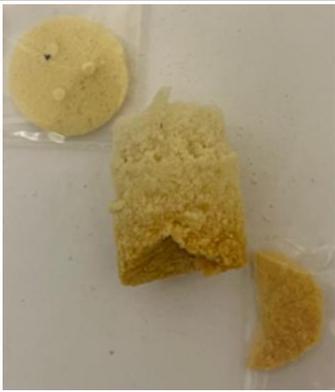
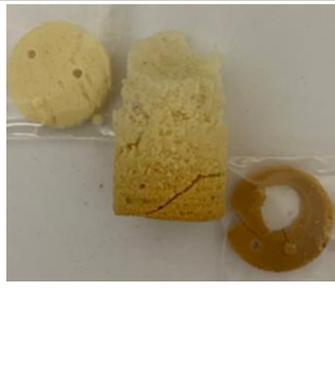
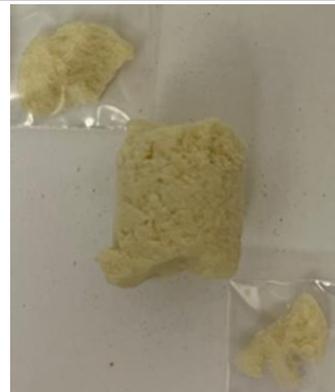
Kanalgatan: Fixed zone flow	Kanalgatan: Sliding zone flow	Kanalgatan: Return

Ekhagsringen: Fixed zone flow	Ekhagsringen: Sliding zone flow	Ekhagsringen: Return

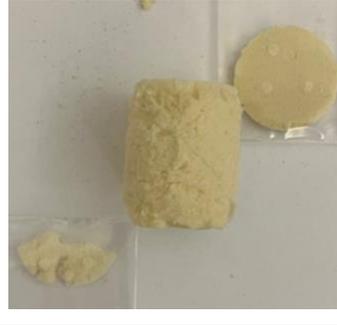
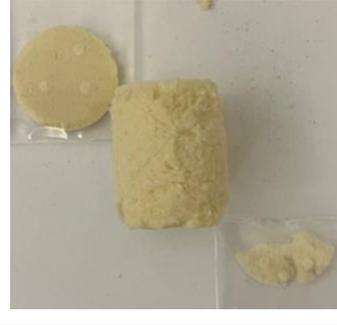
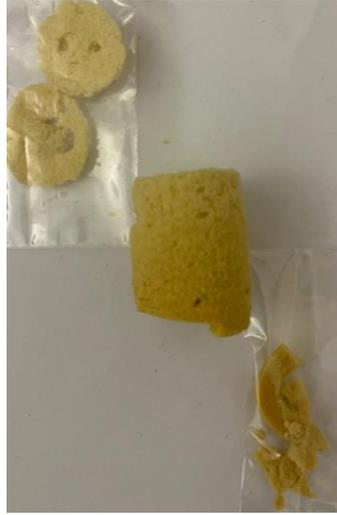
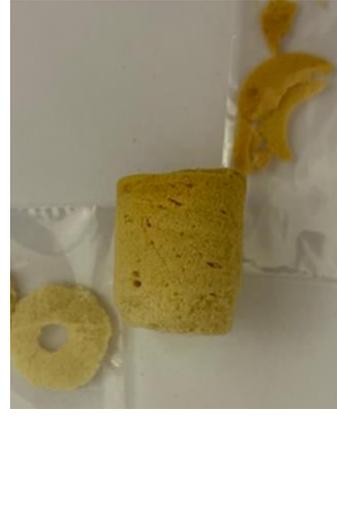
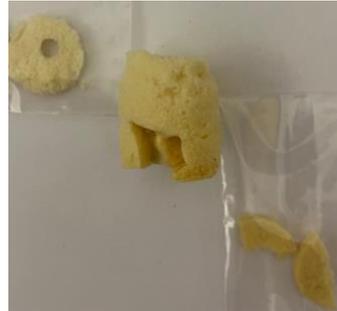
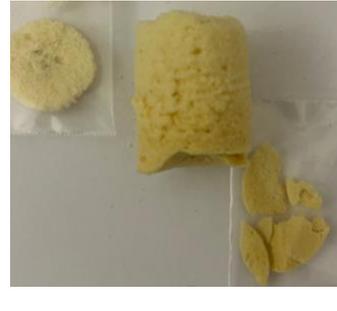
Hermansvägen: Fixed zone flow	Hermansvägen: Sliding zone flow	Hermansvägen: Return

Södra Jordbro: Fixed zone flow		Södra Jordbro: Return

Jordbro v.v.: Sliding zone flow	Jordbro v.v.: Return

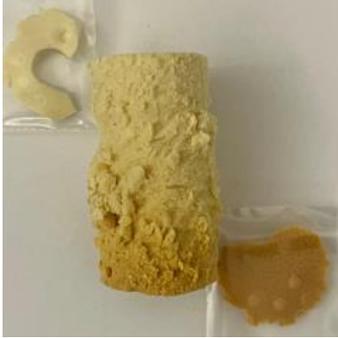
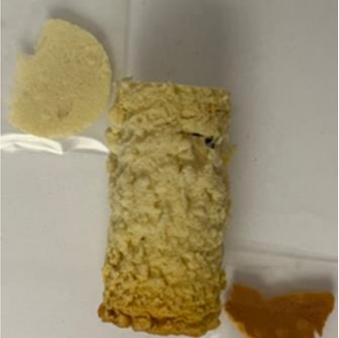
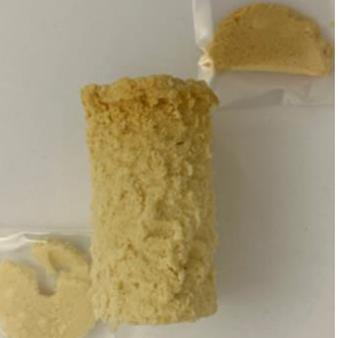
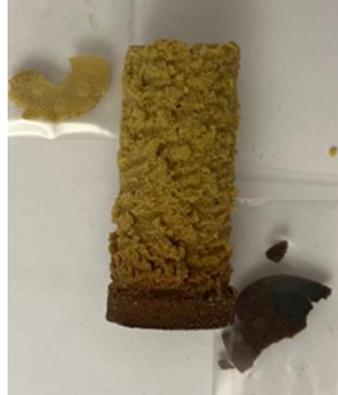
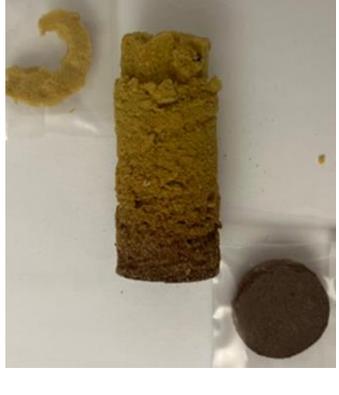
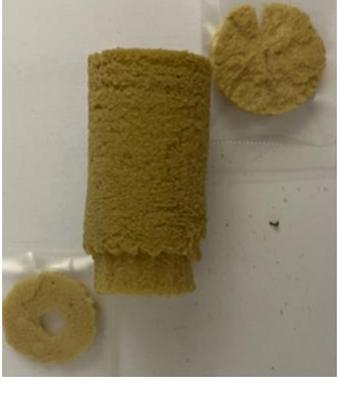
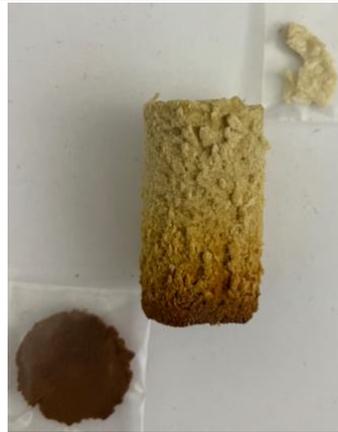
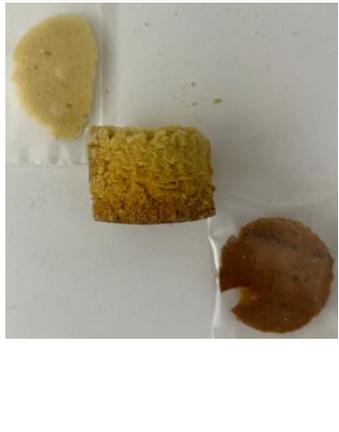
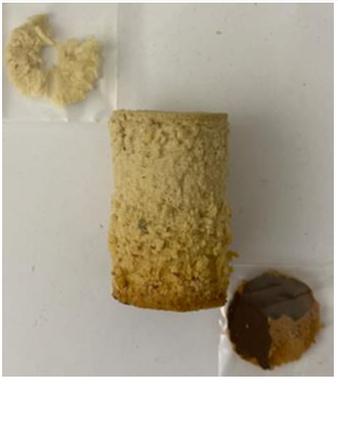
Ölandsgatan: Fixed zone flow	Ölandsgatan: Sliding zone flow	Ölandsgatan: Return

Ristippen: Fixed zone flow	Ristippen: Sliding zone flow	Ristippen: Return

Lantmätarvägen: Fixed zone flow	Lantmätarvägen: Sliding zone flow	Lantmätarvägen: Return
