## **Internal Erosion Detection at the Røsvatn Test Site**

Experiences from blind test using Resistivity, Self Potential, Temperature, and Visual inspection

**Rapport 05:42**

### **Part A - Assessment report**

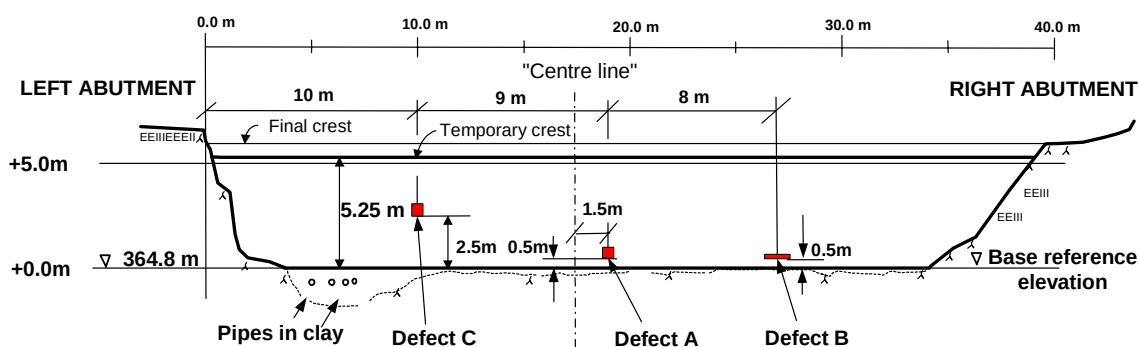
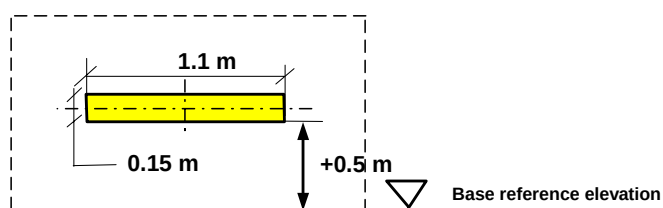
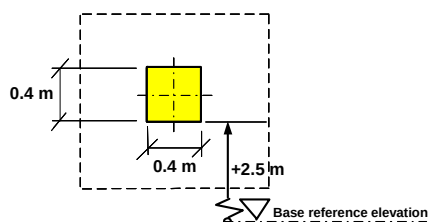
Figure 1 Location and sizes of defects.

The location and geometry of the defects are shown in **figure 1**. The three defects (called A, B and C) are also shown relative to the cross-sectional geometry of the core, as well as upstream and downstream shells in **figure 2, 3 and 4**. The material in the defects was a sandy gravel from a natural deposit. Most of the minus 2mm material was washed out from the natural material before it was used for the construction of the defects.

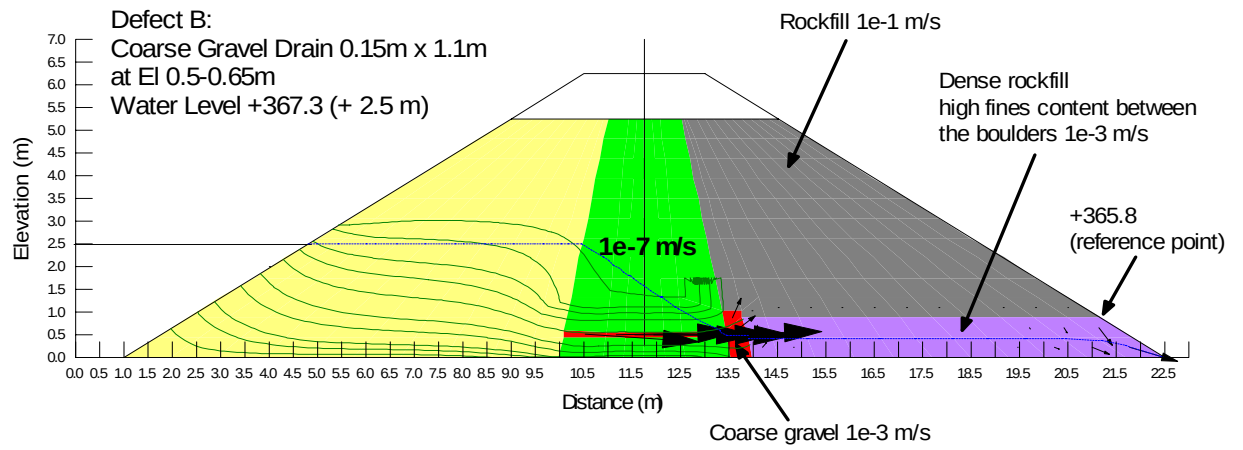
The hypothesis above has been tested by analysing the seepage through the section using different permeability in the lower portion of the rockfill in the downstream shell. A high seepage exit point of +365.8m can be obtained by assuming that the lower part of the downstream supporting fill does not exceed  $10^{-4}$  m/s. Should the permeability be higher than  $10^{-4}$  m/s it generates a lower exit point of seepage (figure 11 and 12).

**Figure12** Phreatic line assuming a permeability of  $10^{-3}$  m/s in the lower portion of the downstream shell.

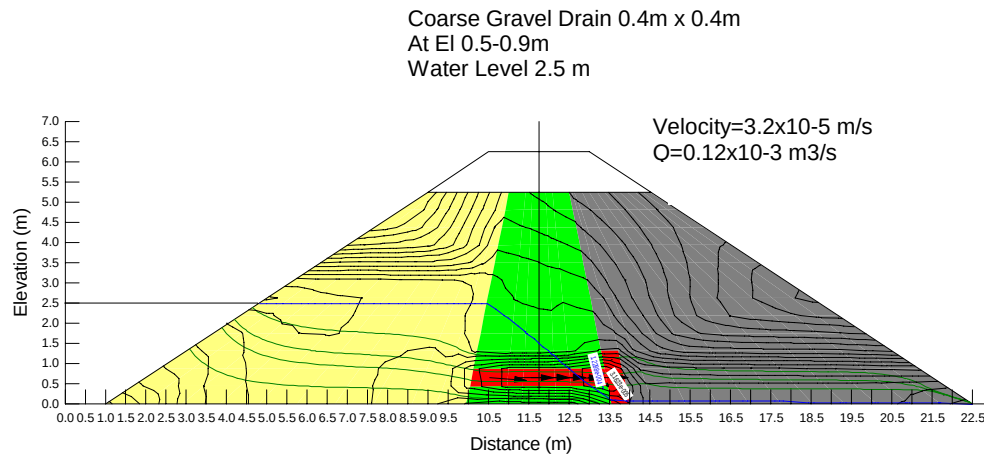
**Figure 5 Defect A, Gravel Drain 0.4m x 0.4m, At El 0.5-0.9m, water level 2.5m**

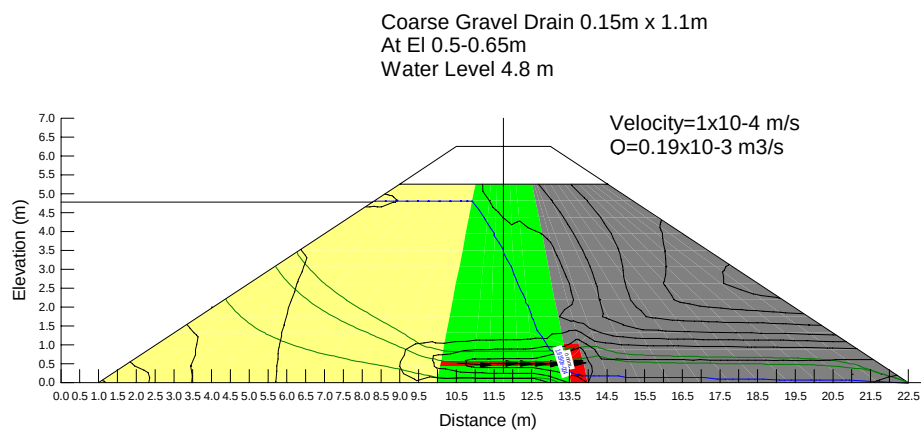
**Figure 6 Defect B, Coarse Gravel Drain 0.1m x 1.6m, At El 0.5-0.9m, water level 4.8 m**

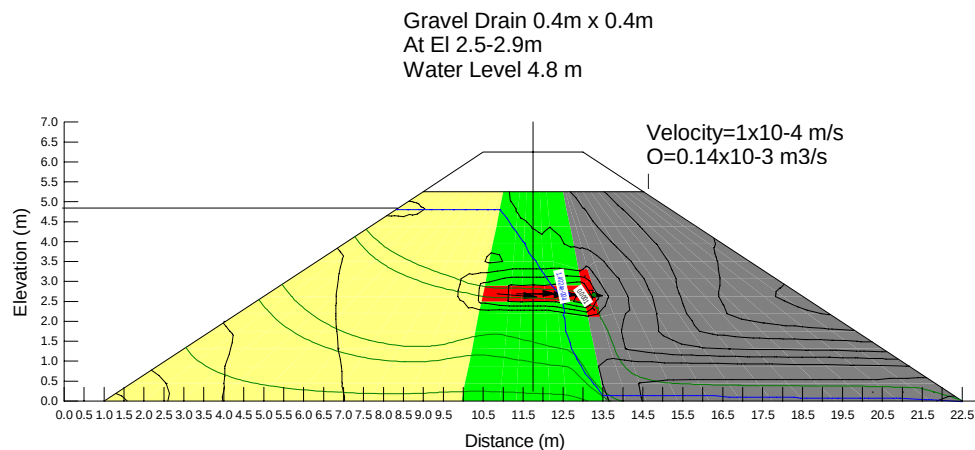
**Figure 7 Defect C, Coarse Gravel Drain 0.4m x 0.4m, At El 2.5-2.9m, water level 4.8 m**

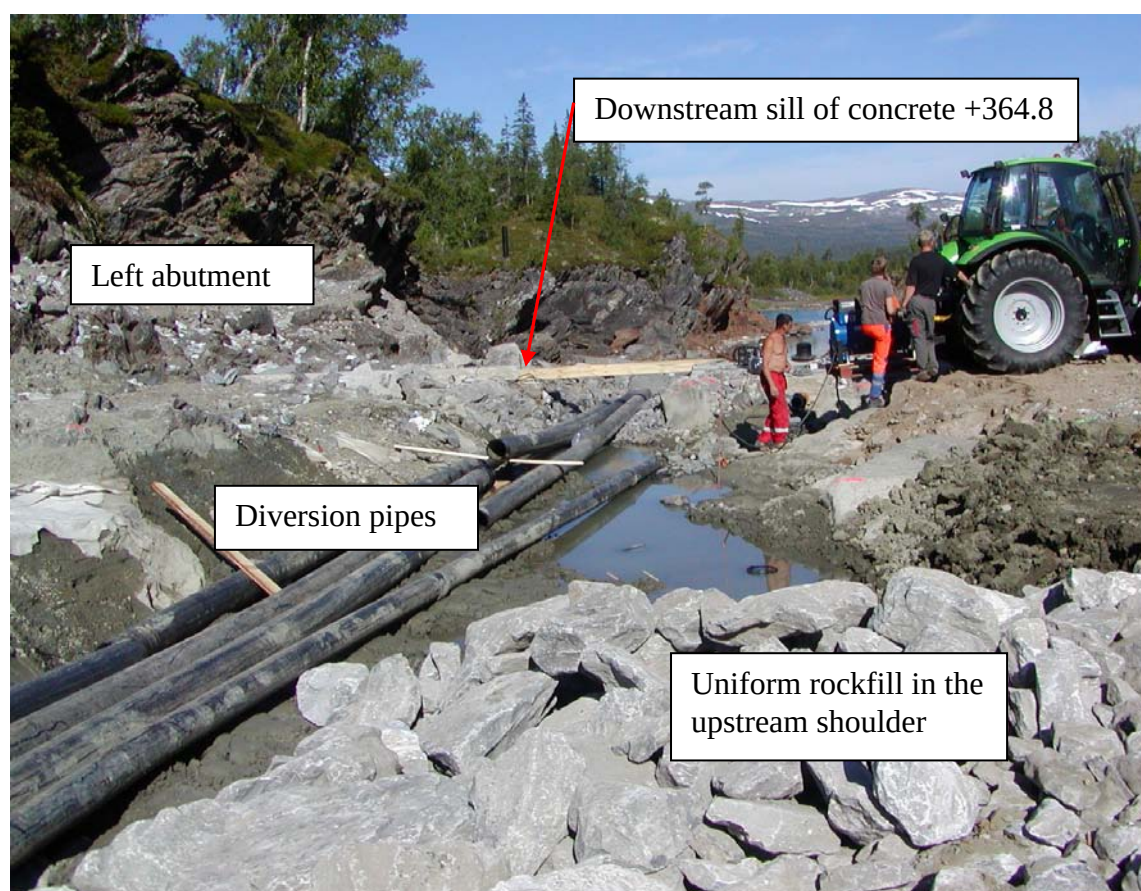
In the area of chainage 3 – 9m diversion pipes were installed and backfilled with clay, see **Figure 9**.

**Figure 9** Diversion arrangements in the foundation close to the left abutment

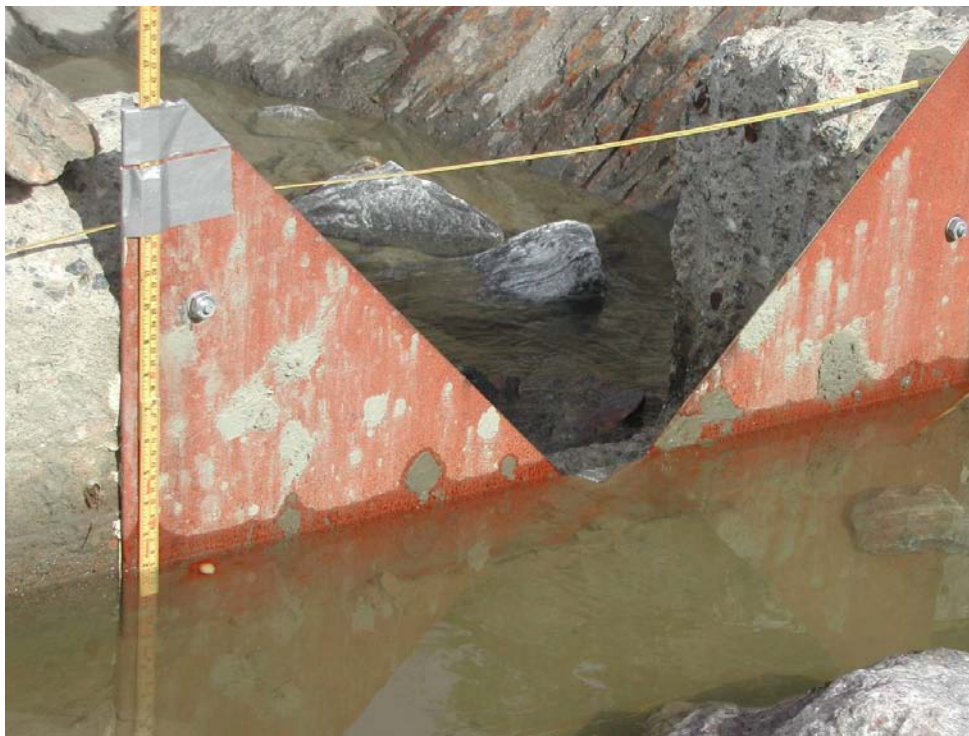
Just downstream of the dam a concrete sill was constructed and a Thomson weir was installed, see **figure 10**. The concrete sill was intended to catch all the leakage through the dam. There was later found to be some leakages through the downstream sill in the area for the diversion pipes close to the left abutment.

**Figure 10** Weir where the seepage flow during the test was measured manually.

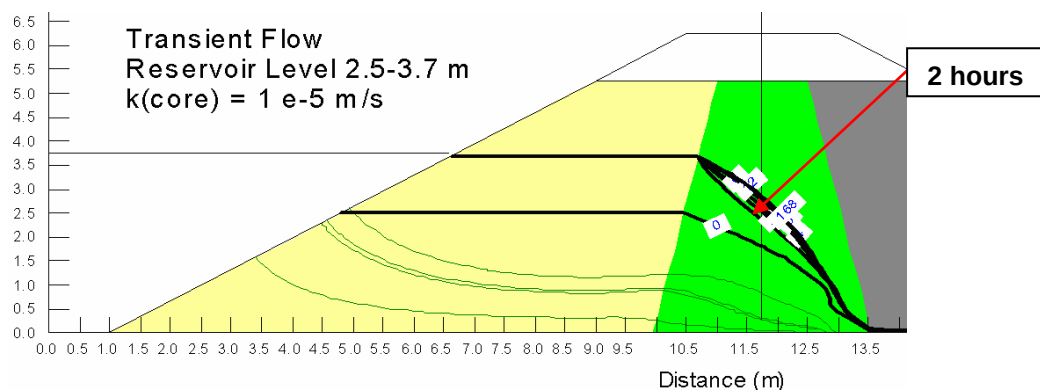
The fast response e.g. for piezometer 50102 (located at the foundation level in the centre of the core) when the reservoir was raised 2.5 to 3.7m above the reference elevation indicates that the permeability of the moraine is fairly high. The high permeability can be a result from the compaction of the moraine dry of optimum moisture content. Analyses of the transient flow by SEEP/w using different permeability for the moraine indicate that the permeability can be in the order of  $10^{-5}$  m/s.

**Figure 28** shows the transient flow for a permeability of  $10^{-5}$  m/s (in all directions) in the moraine, indicating that the time lag will be a couple of hours to reach a flow fairly close to steady state seepage. The shape of the theoretical phreatic line (compared to the response of Pz 49902 when the reservoir was raised at higher water levels) also indicates that the permeability in the field is higher in horizontal direction compared to the vertical direction. This is as expected and assumed be caused by the spreading and compaction of the moraine in layers.

**Figure 28** Transient seepage flow, permeability  $10^{-5}$  m/s in the moraine, each time increment equals 1h

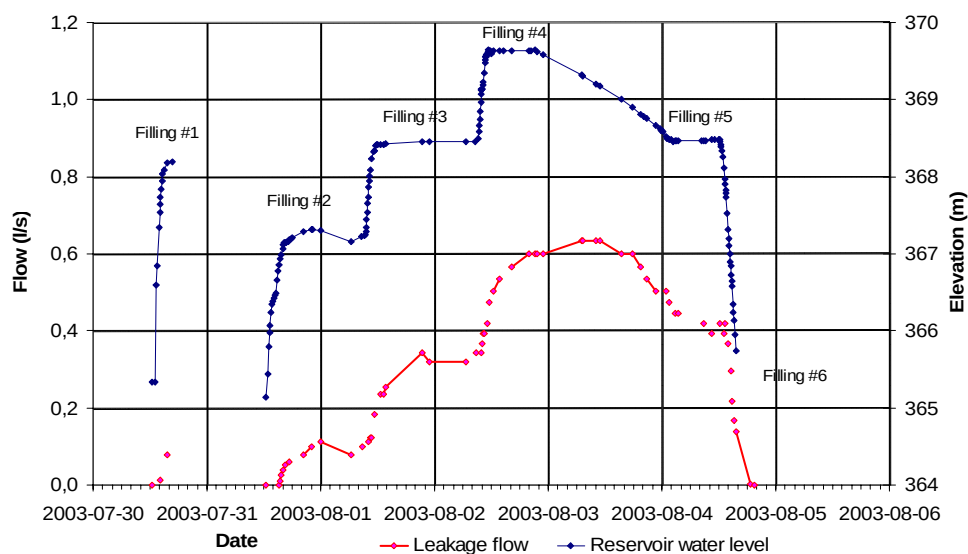
The leakages were measured manually by the “monitoring group” during the testing period. The results of the measurements of leakages are shown in **Figure 29** together with the reservoir elevations. The measured leakages indicate, as shown in section 2.3 above, a permeability in the order of  $10^{-3}$  m/s for the gravel in the defects.

**Figure 29** Reservoir level and leakages during the period of the measurements

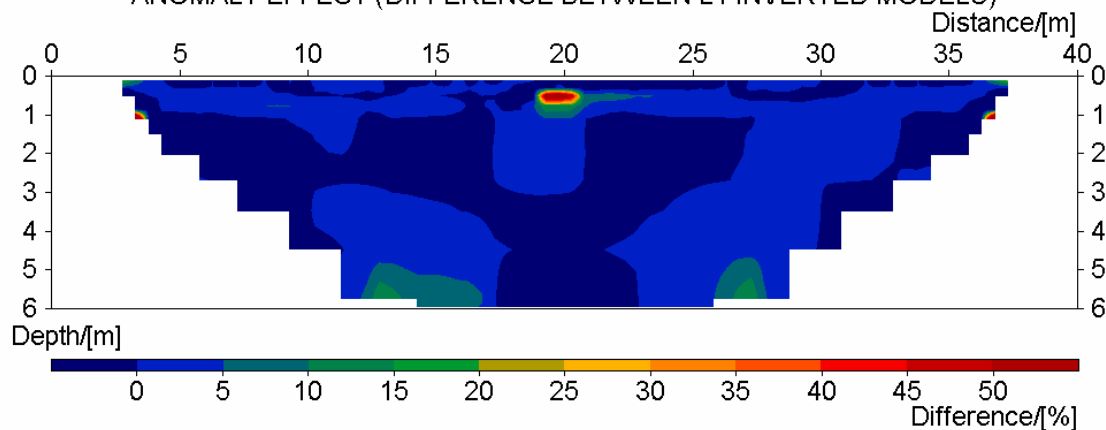
Simulations were done for all three depths for fine sand, coarse sand and gravel. For the medium square defects the shallowest one is obviously detectable (Figure 4-2), whereas no effect at all is seen from the two deeper locations. The same goes for the medium wide defects.

Figure 4-2 Inverted models (above) and difference model (below) for the medium square defect of fine sand located at 1 m depth.

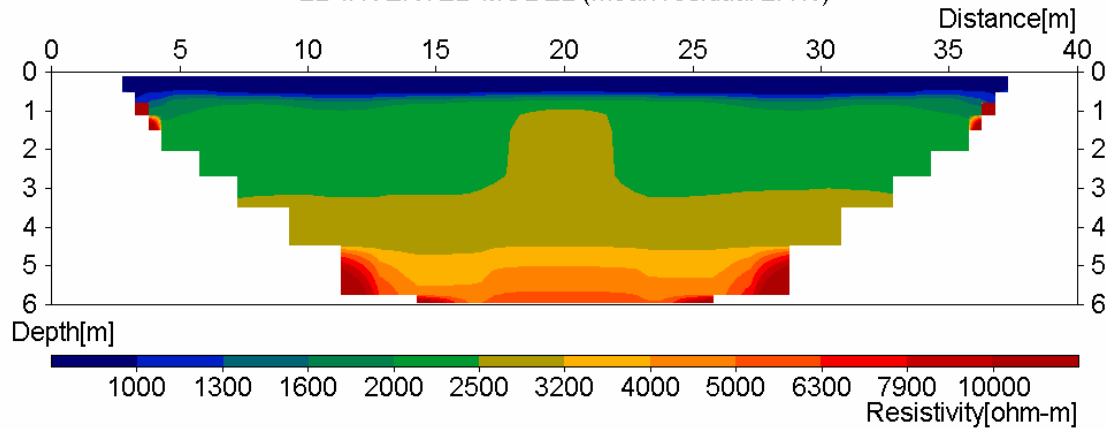
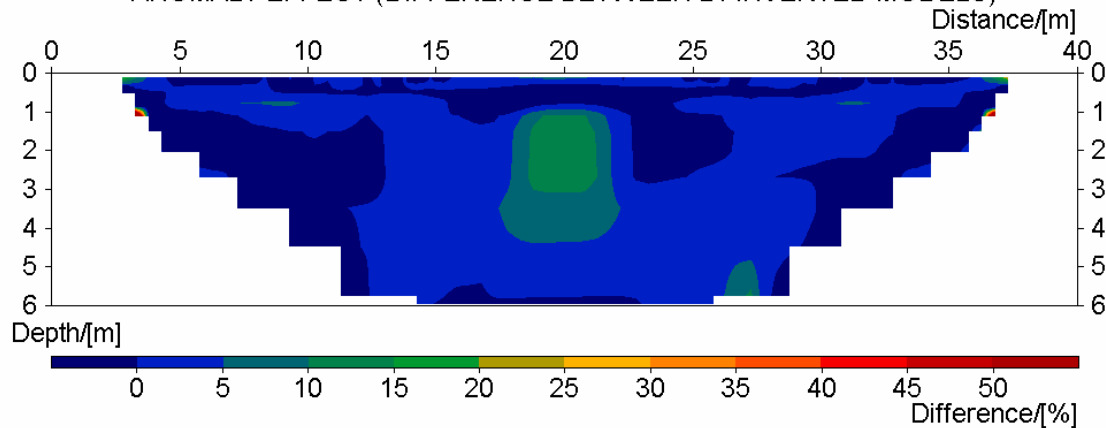
Simulations were done for all three depths for fine sand, coarse sand and gravel. In this case both the large square (Figure 4-3) and the large wide defects are detectable for all depths, but harder to locate the deeper they are positioned. For the largest depth there is a tendency that the defect area is smeared out and due to this it seems very difficult to confidently identify the exact location. Moreover, the depth seems to be somewhat distorted for the medium depth, where the impression is that the defect area is placed more shallow than is the real case. This distortion of lateral location is something we have seen from prior studies of dam geometries (Sjödahl et al. 2002) and is something that we need to accept as long as 3D inversion schemes are not available and practically usable.

**Figure 4-3** Inverted models (above) and difference model (below) for the large square defect of fine sand located at 3 m depth.

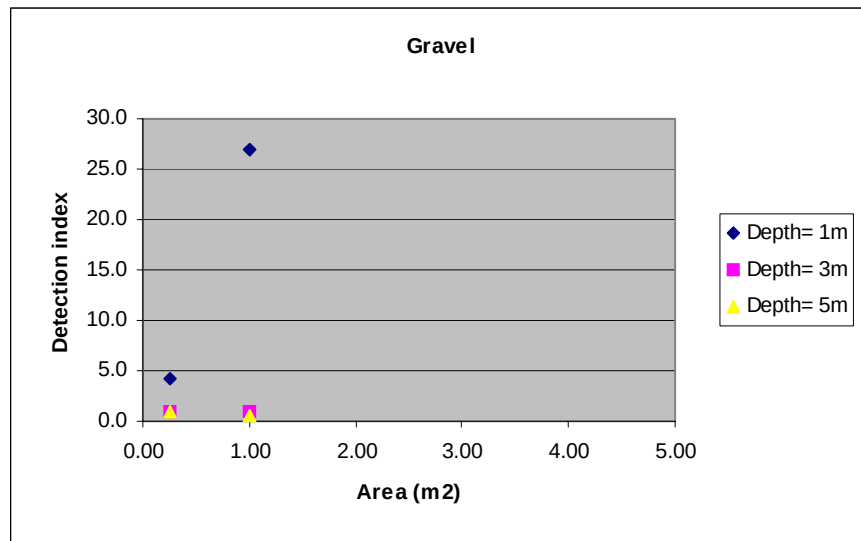
detectable, and as defined in chapter 2.4 the detection index is defined as the detectable anomaly divided by this number. The detection index for 1m depth are well over 1, i.e. all defect level decreases rapidly with depth, as seen in Figure 4-4.

**Figure 4-4 Detection index as a function of area for different depth to the defect.**

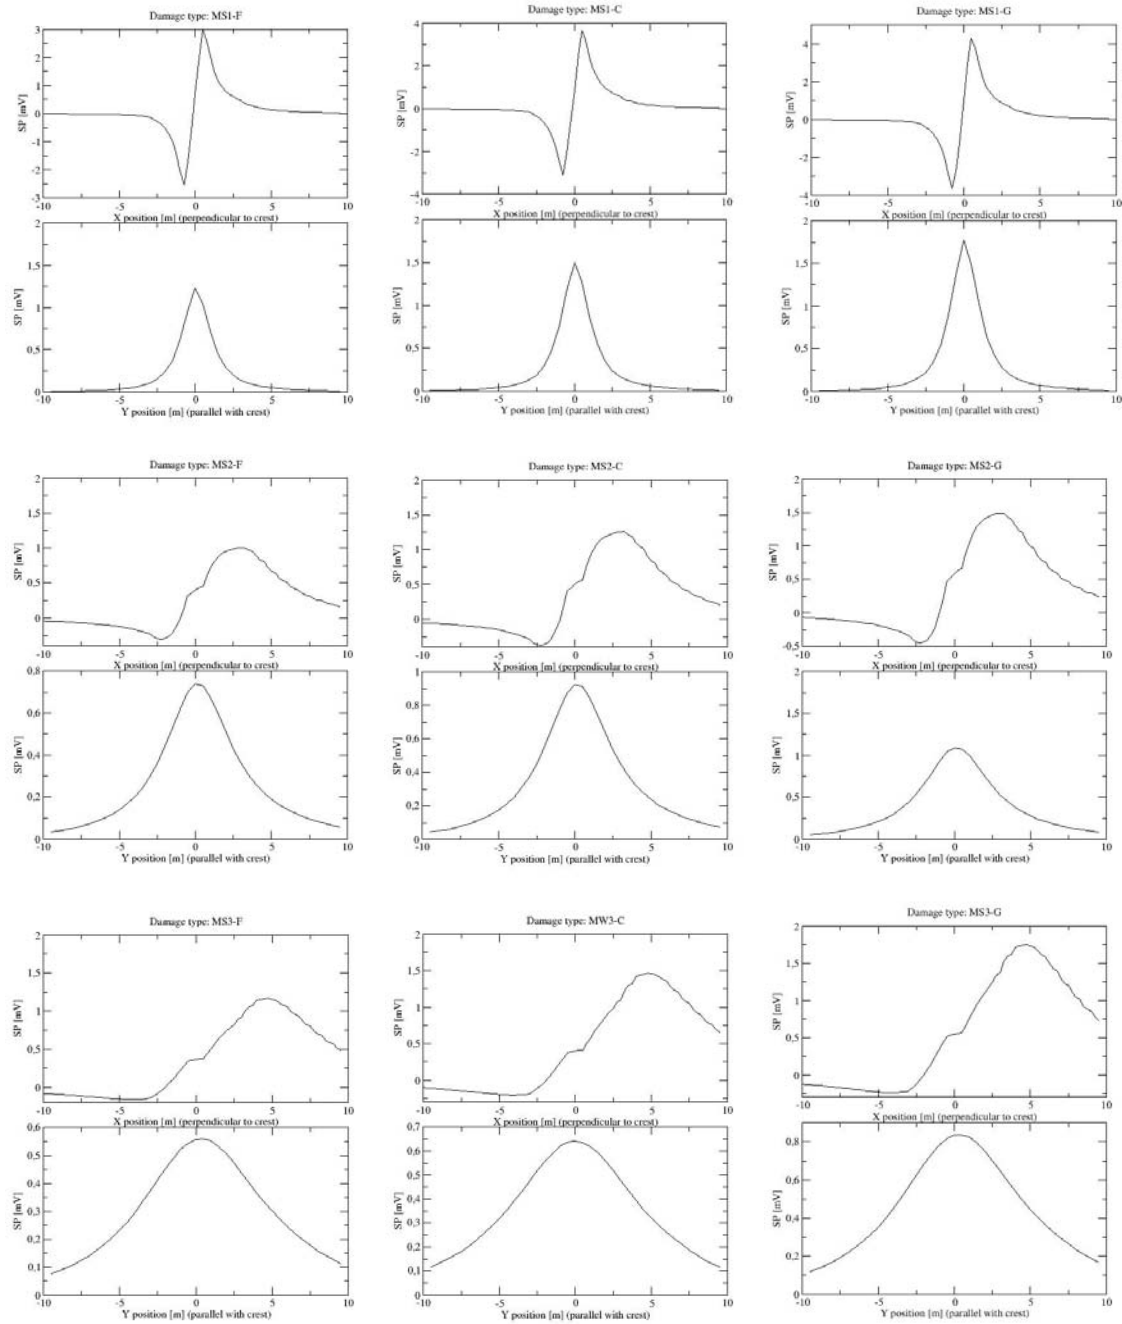
The medium defect has a cross section of  $0.25\text{m}^2$ . Figure 5-1 and Figure 5-2 show the results of the modelling. For this defect the amplitudes of the anomalies are less than  $3\text{mV}$ , and consequently not detectable with the assumptions made for the purpose of the present modelling. There are also only very small differences between the square and the wide defect.

**Figure 5-1** Calculated SP anomalies for the "medium square" defects. MS-1, MS-2, MS-3 denote defects at 1, 3 and 5 metres, respectively. The letters F, C and G indicate the type of material in the defect area (F=fine sand, C =coarse sand, G=gravel).

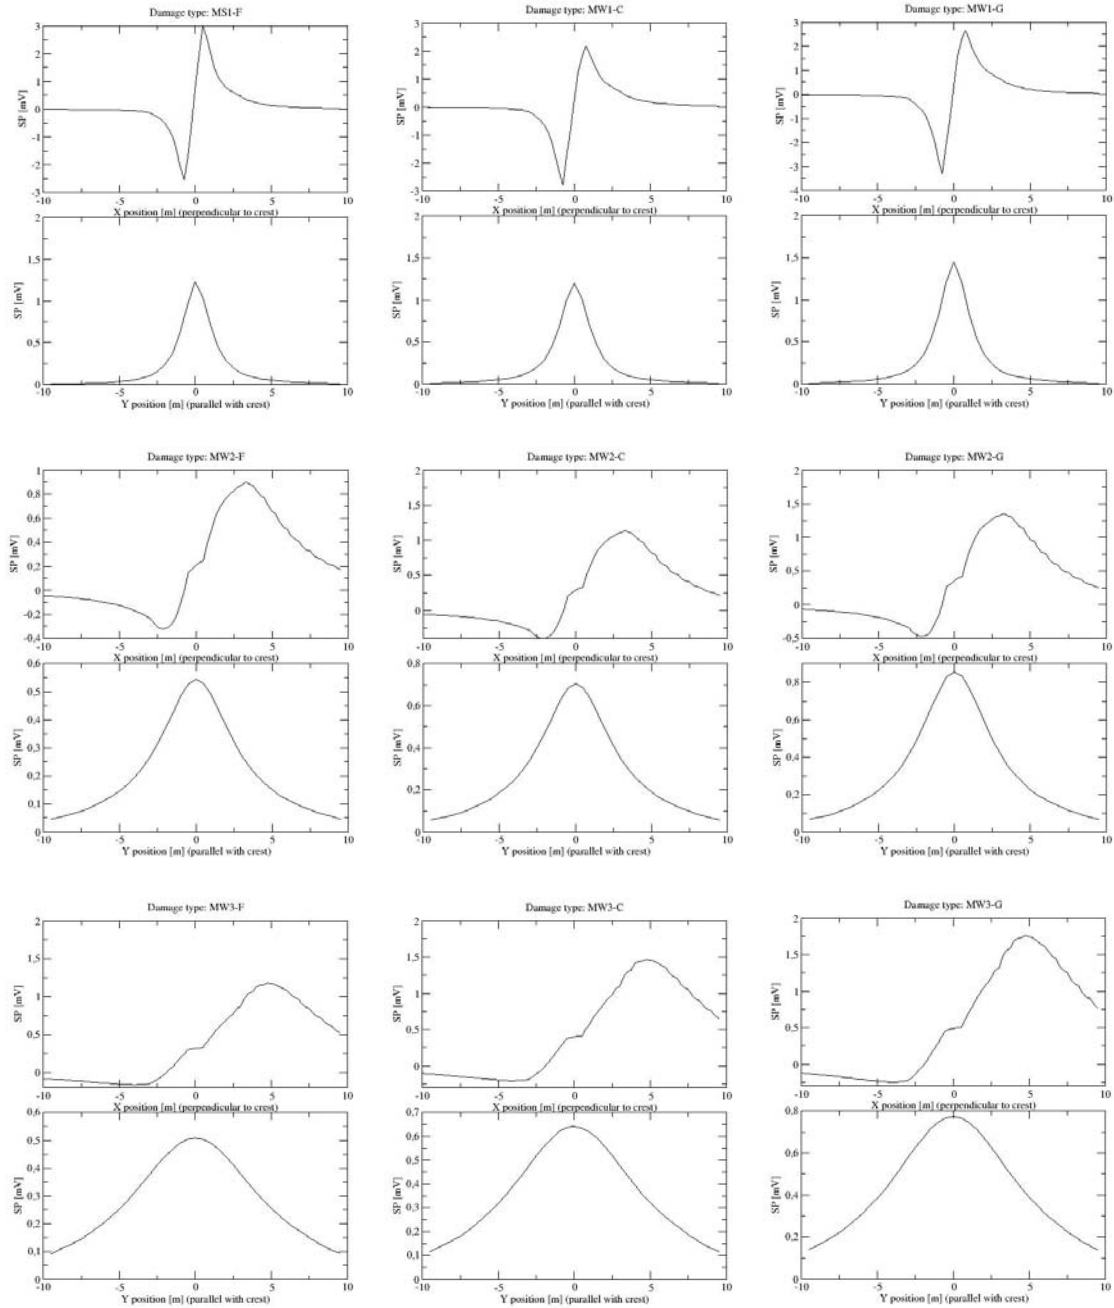
**Figure 5-2** Calculated SP anomalies for the "medium wide" defect. MW-1, MW-2, MW-3 denote defects at 1, 3 and 5 metres, respectively. The letters F, C and G indicate the type of material in the defect area (F=fine sand, C =coarse sand, G=gravel).

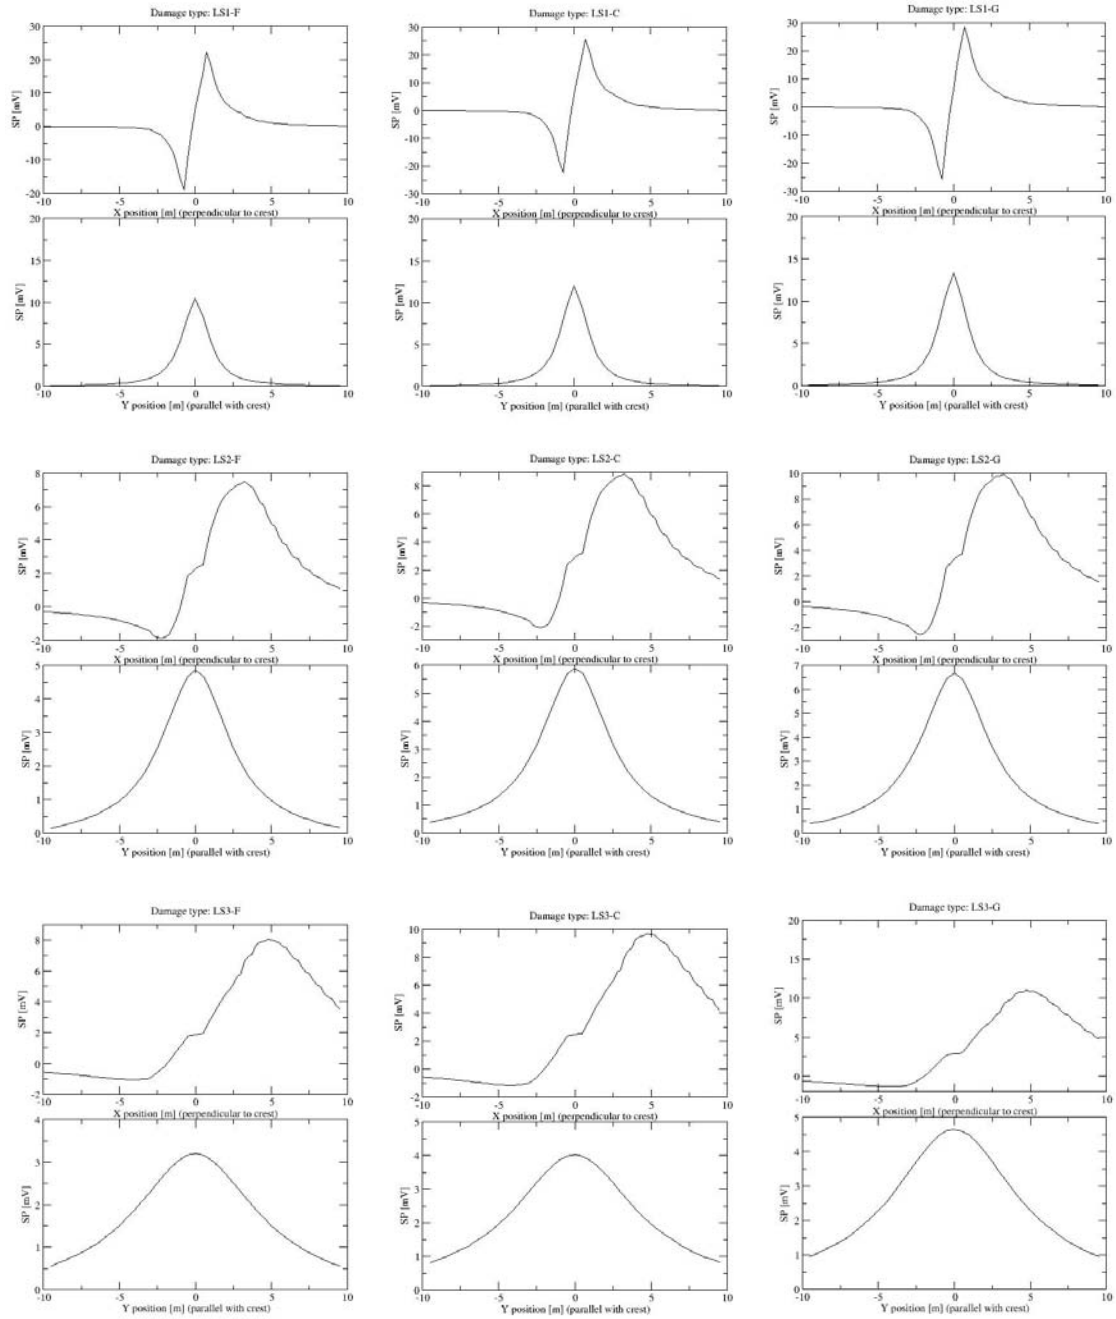
The large defect has a cross section of  $1.0\text{m}^2$ . The results of the modelling are shown in Figure 5-3 and Figure 5-4. For this defect the anomalies are less than  $15\text{mV}$ , which should be detectable. There are only very small differences between the square and the wide defect.

**Figure 5-3** Calculated SP anomalies for the "large square" defect. LS-1, LS-2, LS-3 denote defects at 1, 3 and 5 meters, respectively. The letters F, C and G indicate the type of material in the defect area (F=fine sand, C =coarse sand, G=gravel).

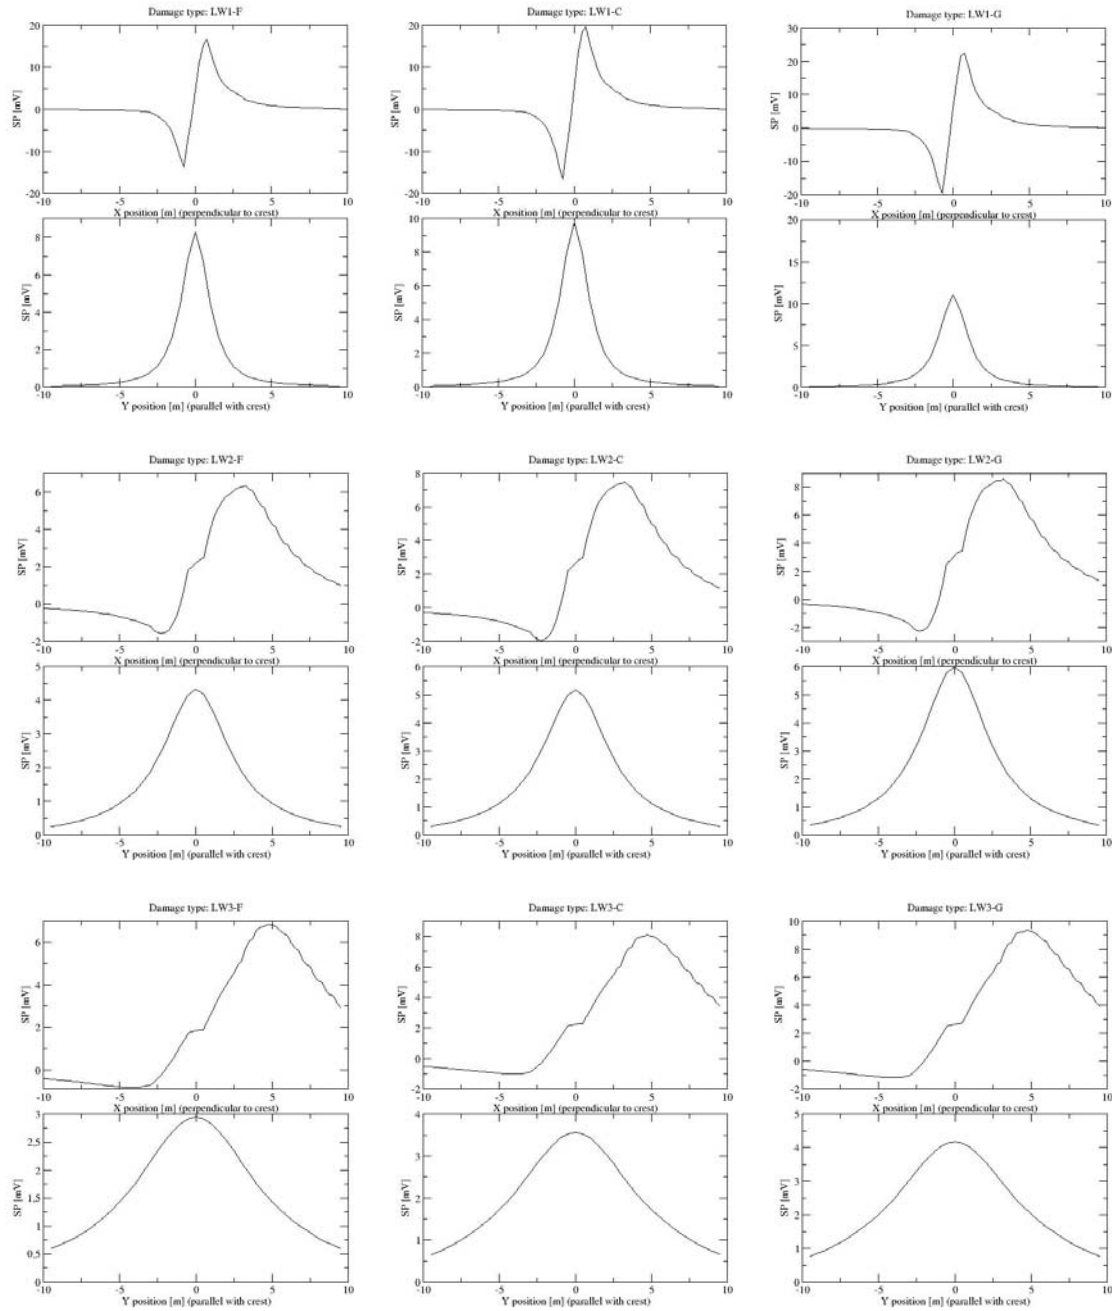
**Figure 5-4** Calculated SP anomalies for the "large wide" defect. LW-1, LW-2, LW-3 denote defects at 1, 3 and 5 meters, respectively. The letters F, C and G indicate the type of material in the defect area (F=fine sand, C =coarse sand, G=gravel).

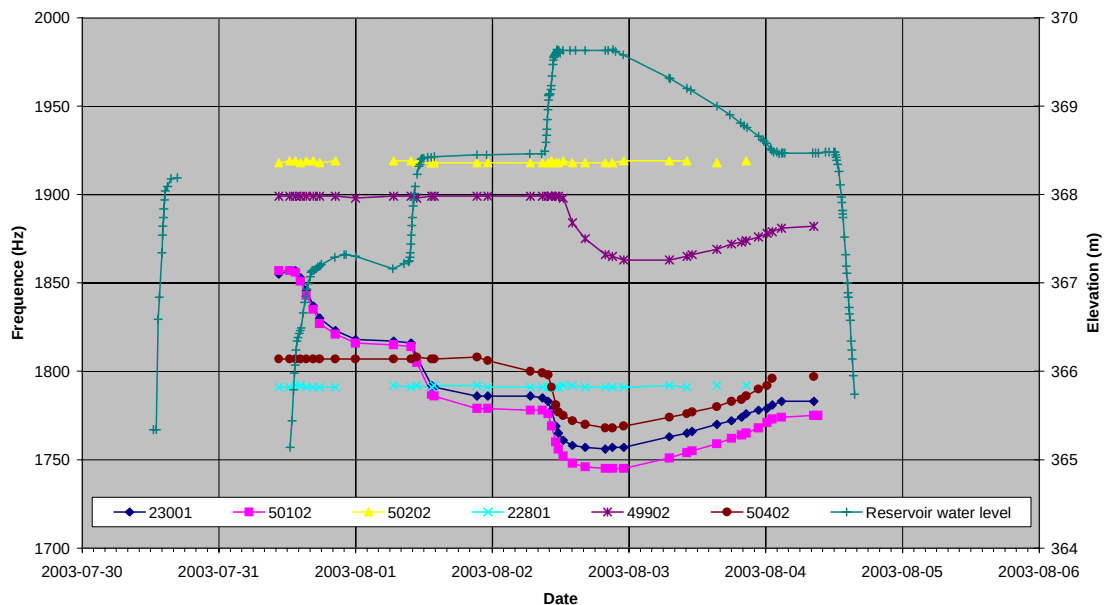
Water level in the reservoir was observed regularly towards a level gauge, located about 20 metre upstream the dam crest. The water level in the reservoir was measured regularly (Figure 7-1). The lowest levels are more uncertain since they were below the gauge and are estimated.

**Figure 7-1** Reservoir water level and pore pressures in the piezometers (just measured frequencies, the location of the piezometers are unknown).

Six vibrating wire pressure sensors were also installed in the dam. Their locations and levels are unknown. Frequency readings were taken manually during the tests (Figure 7-1), but the result has not been converted to pressure, as decided by the reference group. The vibrating wire piezometers were also measured regularly. Their levels and locations are still unknown, but the result gives some indication if the condition is transient or stationary.

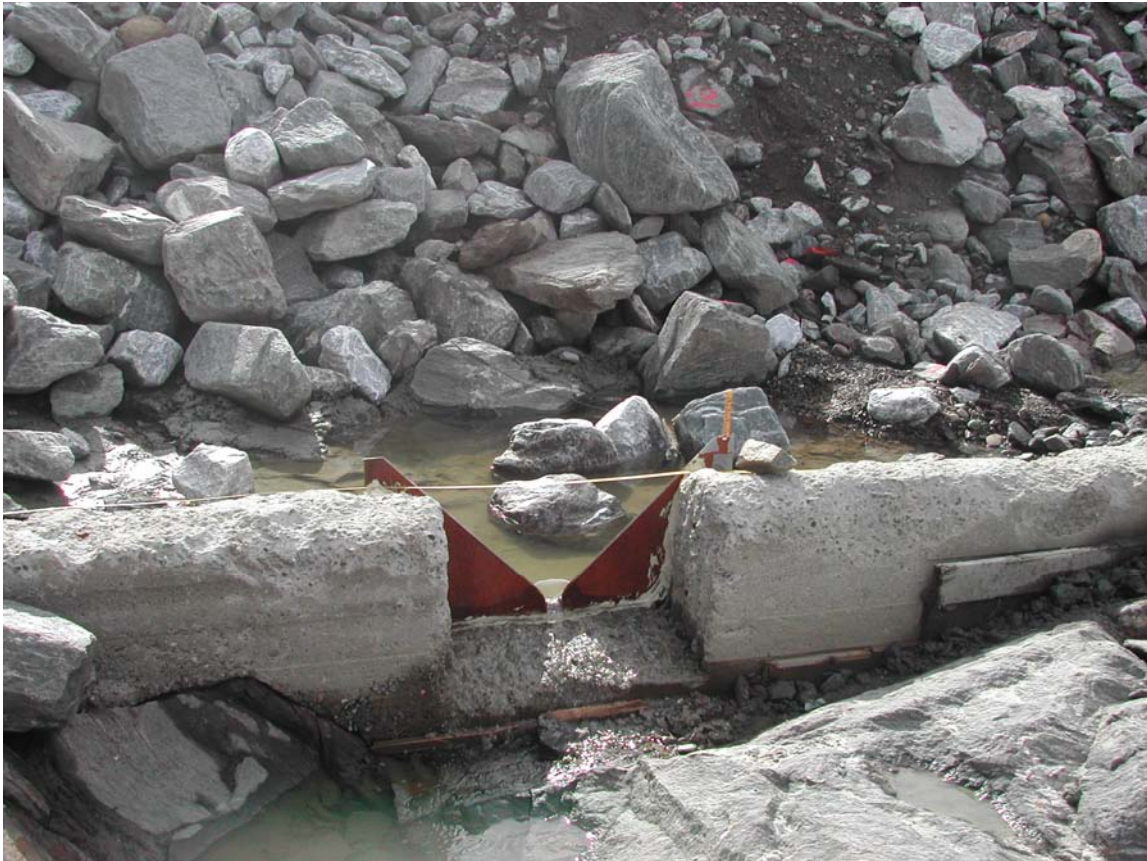
All leakage water is intended to be caught in a weir at the left abutment. The weir was built in into the concrete bar located downstream the dam toe. Measurements were made regularly during the tests. The visual inspections showed however that some water was passing under the bar around section 5-6m. This outflow will probably collect water from the left part of the dam, maybe up to section 10-12m. The total leakage will thus be higher than measured, and only valid for the right and the middle parts of the dam.

**Figure 7-2** Seepage flow weir downstream the dam.

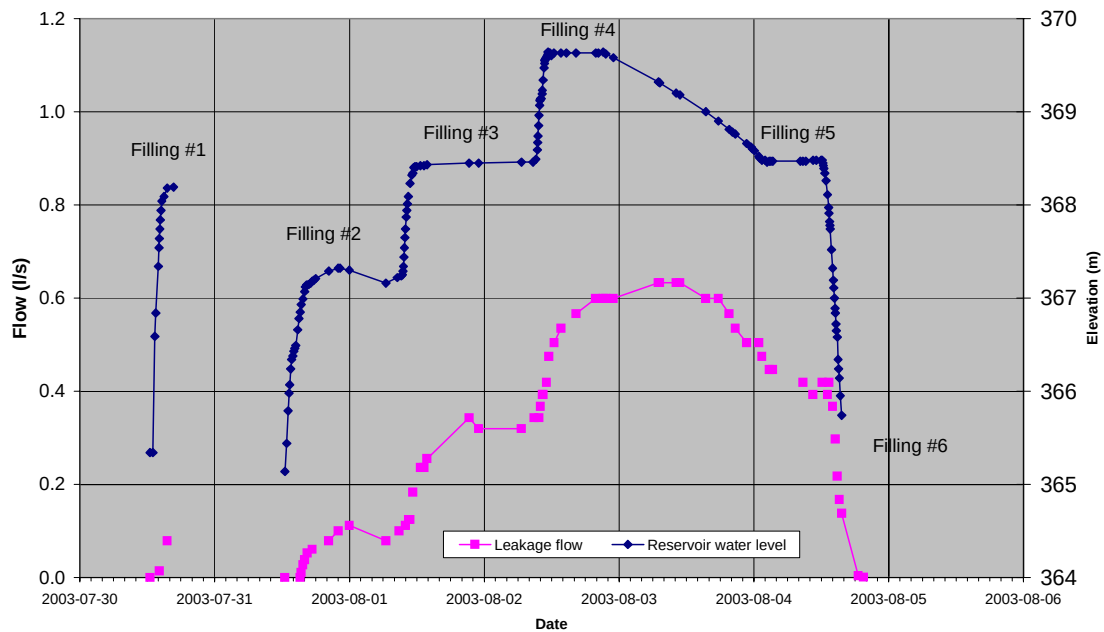
Figure 7-3 Seepage flow (l/s) in the weir.

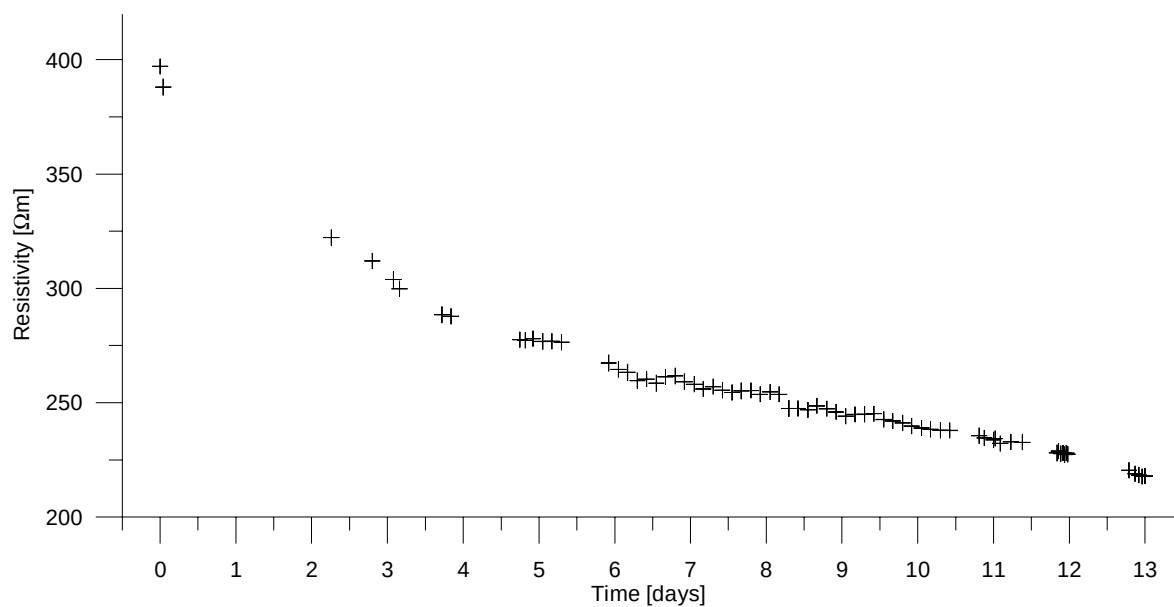
One sample was saturated with water collected at the site, and for this sample only a few measurements were taken. The sample with no water added was kept for measurements over a long time (measurements are still running after 13 days). An unexpected clear resistivity decrease (more than 40%) with time was identified. The resistivity decrease was more rapid at the start, but still had not completely levelled out after 13 days (Figure 7-5).

The cause of the decrease in resistivity of the core sample is not clear. Since the cylinder is sealed with o-rings the moisture content should not have changed. Unfortunately, the temperature variation was not recorded during the experiment, but the outdoor temperatures have been decreasing during the measurement period which means that the indoor temperature in the laboratory have decreased rather than increased. Hence, if there were any significant temperature effect it would increase rather than decrease the resistivity.

A tentative explanation might be that the mineral grains settle gradually over a period after the compaction in the cylinder, and that this process increases the contact between the grains and thereby enhance the surface conduction. Furthermore, anisotropy can be expected in the material after the compaction. Possibly this has some significance in a process where the mineral grains of the core material re-orient themselves gradually after the compaction is completed. Similar processes can be expected for the core material in the dam. If this is the case it should be noted that the compaction direction, and thereby the plane of anisotropy, is perpendicular to the electrode layout direction in the laboratory case, whereas in the field experiment the plane of anisotropy is parallel to the electrode layout. Hence, the change with time might be different in the field case if anisotropy is part of the explanation.

**Figure 7-5 Resistivity over time for sample of moraine core from Røsvatn dam.**

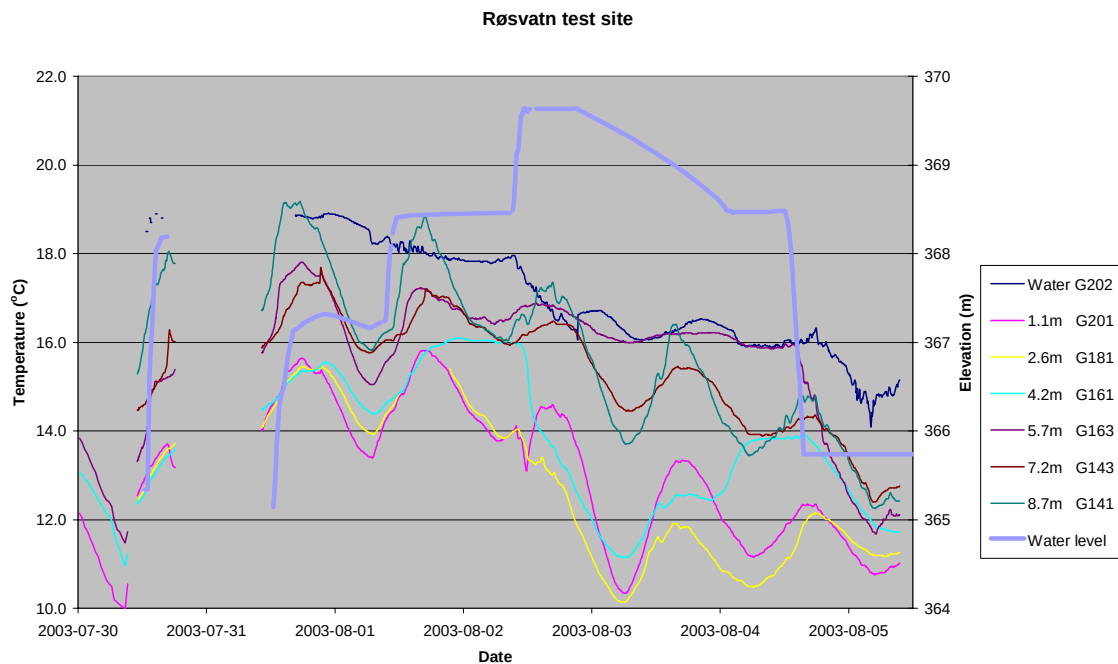
Measurements before and after the first filling is not complete but the result from the sensors at section 1.1m, 2.6m, and 4.2m shows no indication of seepage. A significant change is found at section 5.7m, where an immediate temperature response is seen due to the water level increase. The delayed temperature increase at section 7.2-8.6m is probably not caused by seepage because they are similar to the temperatures during the following sunny days, and also larger than in the reservoir.

The second filling confirms the result from the first filling with immediate temperature response at section 5.7m. Some daily temperature effects can still be seen, which are reduced after the third filling especially at section 4.2m. The outflow width is also increased after the third filling with temperature change also in the adjacent sensors at section 4.2m and 7.2m.

**Figure 8-2** Temperature measurements from section 1.1m to section 8.7m (left axis) and water level (right axis).

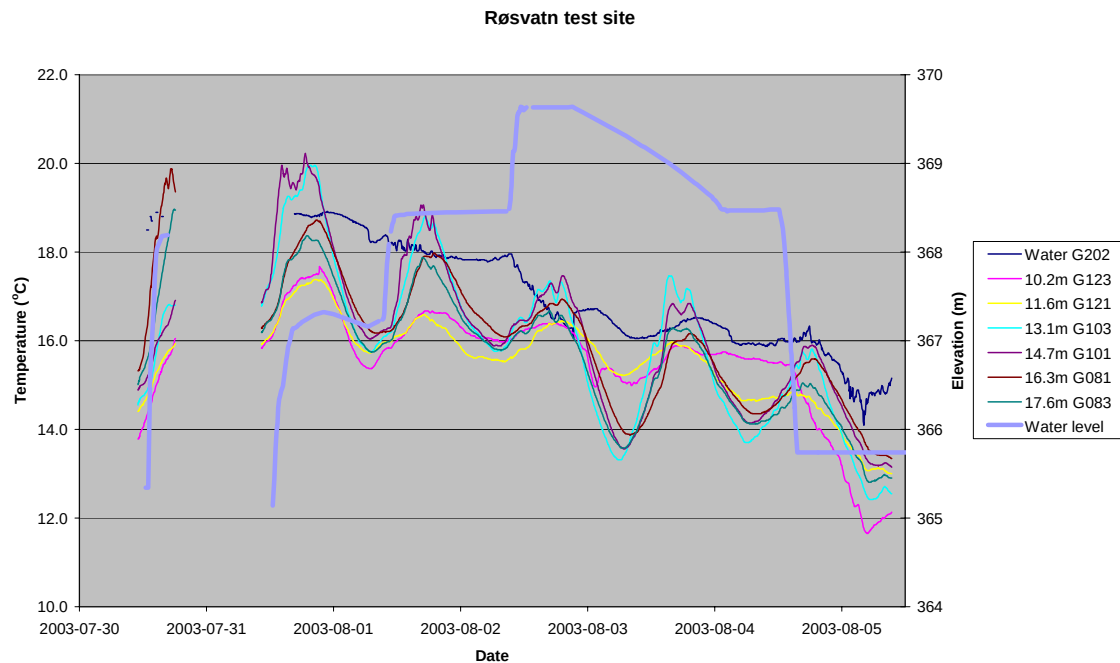
The measurements from the first and second filling indicate no clear seepage increased temperature change between section 10.2m and 17.6m (Figure 8-3). A temperature anomaly is however seen at section 10.2m and 11.6m after the third filling. The influence of the daily variation can still be seen, indicating a lower seepage than at section 4.7m. A short

temperature dip is also found at section 10.2m that may be caused by a similar temperature change in the reservoir.

**Figure 8-3** Temperature measurements from section 10.2m to section 17.6m (left axis) and water level (right axis).

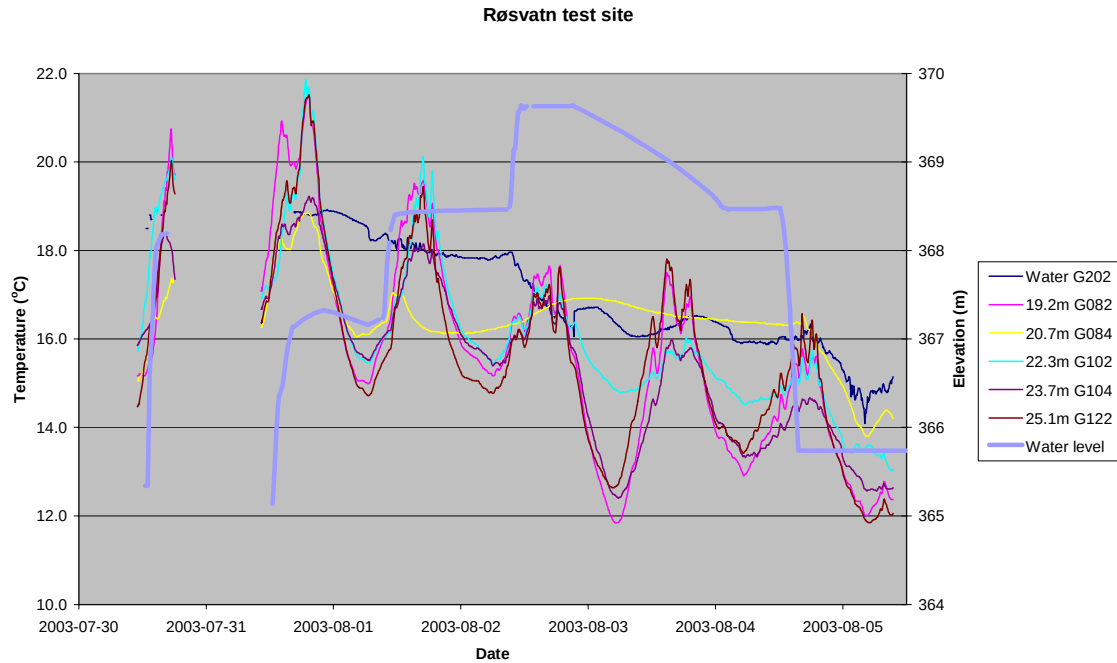
The part of the dam between section 19.2m and 26.6m exhibits daily temperature variations around section 19.2m and between section 23.8m and 25.1m, (Figure 8-4). Seepage induced temperature variations are seen after the third filling at sec 20.7m, also widening towards section 22.3m probably due to the flow along the dam toe to the weir. There is also a small thermal impact from the sun until the third filling, after which the temperature is much more stable. This part of the dam is close to the seepage weir and with some cm deep water collected between the weir and the dam toe. Some sensors were covered with water at high reservoir levels.

**Figure 8-4** Temperature measurements from section 19.2m to section 26.4m (left axis) and water level (right axis).

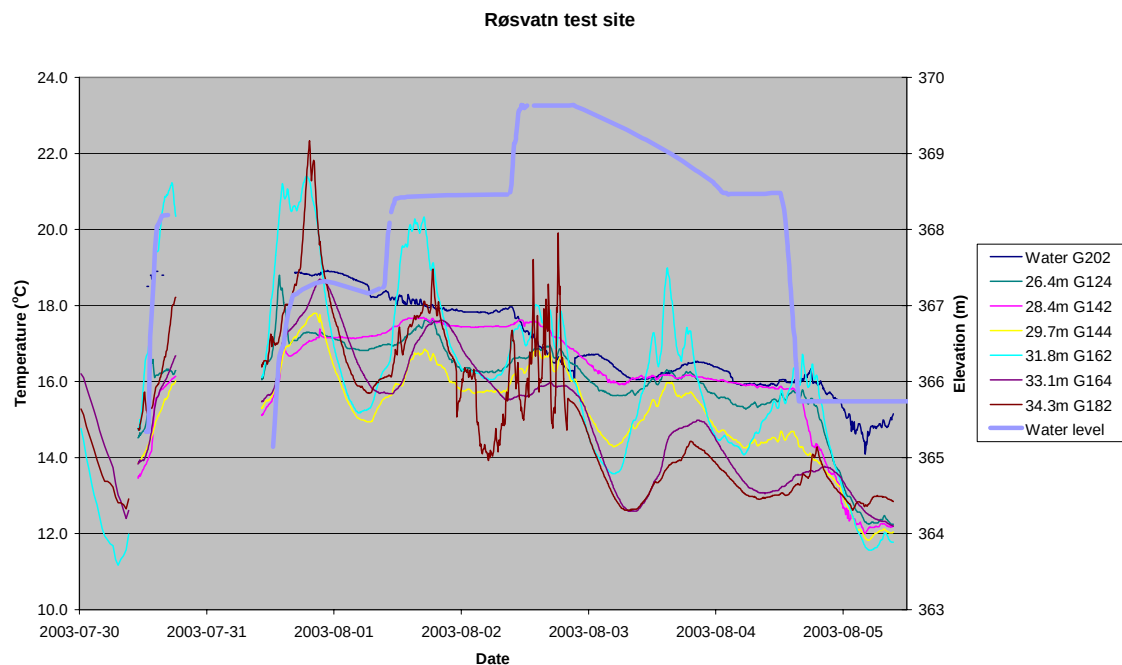
Some remaining sensors towards section 34.3m were also continuously inundated. Significant seepage induced temperature is seen for section 26.4m and 28.4m at the first filling (Figure 8-5). The large variation of temperature at section 34.3m after the third filling was caused by a dislocated sensor. It was immediately put back in place when detected. The effect of the sunshine impact of the shallow water, where the sensors were located can clearly be seen.

**Figure 8-5** Temperature measurements from section 28.4m to section 34.3m(left axis) and water level (right axis).
