## **Internal Erosion Detection at the Røsvatn Test Site**

Experiences from blind test using Resistivity, Self Potential, Temperature, and Visual inspection

**Rapport 05:42**

### **Part A - Assessment report**

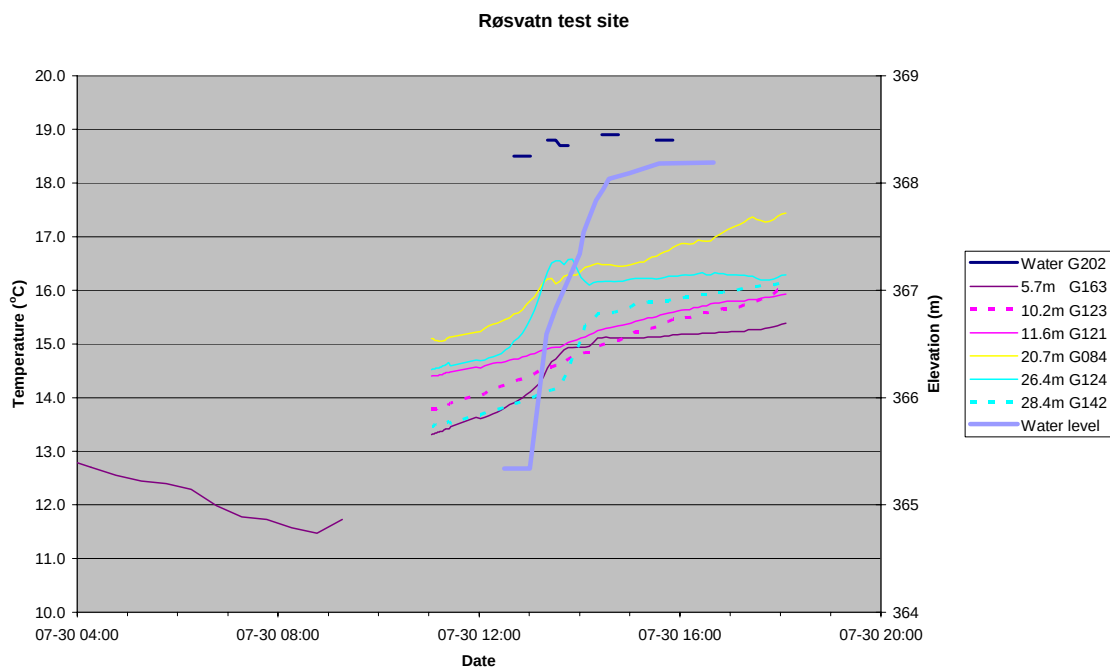
First, some comments from all fillings (Figure 8-6 to Figure 8-8) may be of interest to show the thermal response at the dam toe in the outflow areas that were described above. Before the real filling started the reservoir was filled by the natural inflow to the reservoir, which explains the quick temperature rise in section 26.4m before the first filling started. Significant response can also be seen for section 5.7m and 28.4m. The slow temperature increase in the remaining points is probably caused by the sunshine. The temperature dip in section 26.4m may be caused by a small movement of the sensor. Similar result was also obtained from filling #2 that was made up to almost the same level as the first filling.

**Figure 8-6** Measured temperature at filling #1 (left axis) and water level (right axis).

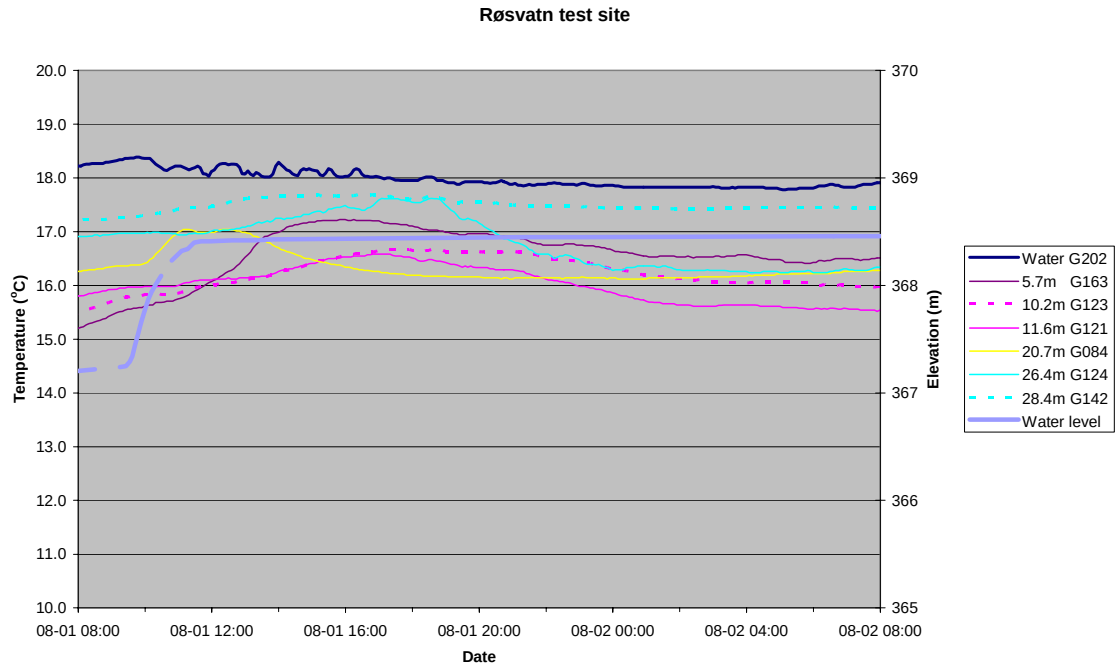
The first response at the filling #3 (Figure 8-7) is seen in section 20.7m, probably due to the transient flow, as the slower one at section 10.2 and 11.6m. The response at section 5.7m and 26.4/28.4m can also be seen.

**Figure 8-7 Measured temperature at filling #3 (left axis) and water level (right axis).**

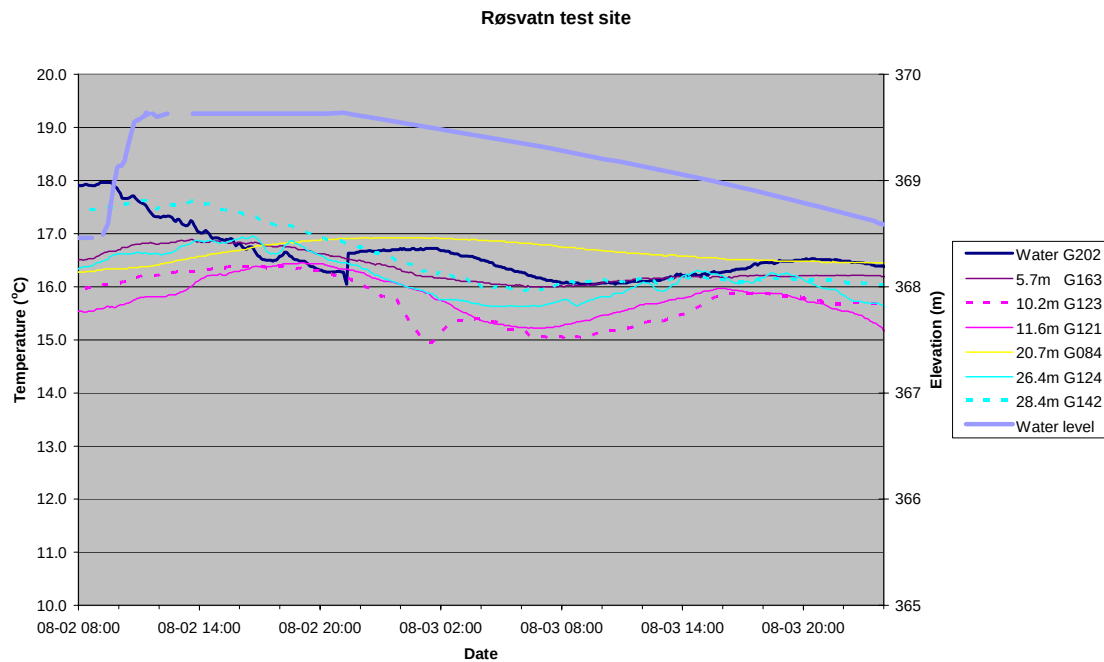
The highest seepage flow rate is about 0.6l/s,m<sup>2</sup> at the leakage at section 26.4/28.4m. (The real value would have been ever higher if the measurements have been made directly in the out-flowing water that was seen on the downstream face). The lowest seepage flow is about 0.2l/s,m<sup>2</sup> at section 20.7m. The leakage flow at section 5.7m is about 0.4l/s,m<sup>2</sup>, and about

0.3l/s,m<sup>2</sup> at section 10.2/11.6m. The total flow in those leakages is however unknown, unless the leakage area can be estimated. Temperature measurements at the dam toe alone will not give enough information. Some estimation is however presented in the next section, based on the width of the thermal disturbance at the dam toe, and the response at different water levels.

**Figure 8-8 Measured temperature at filling #4.**

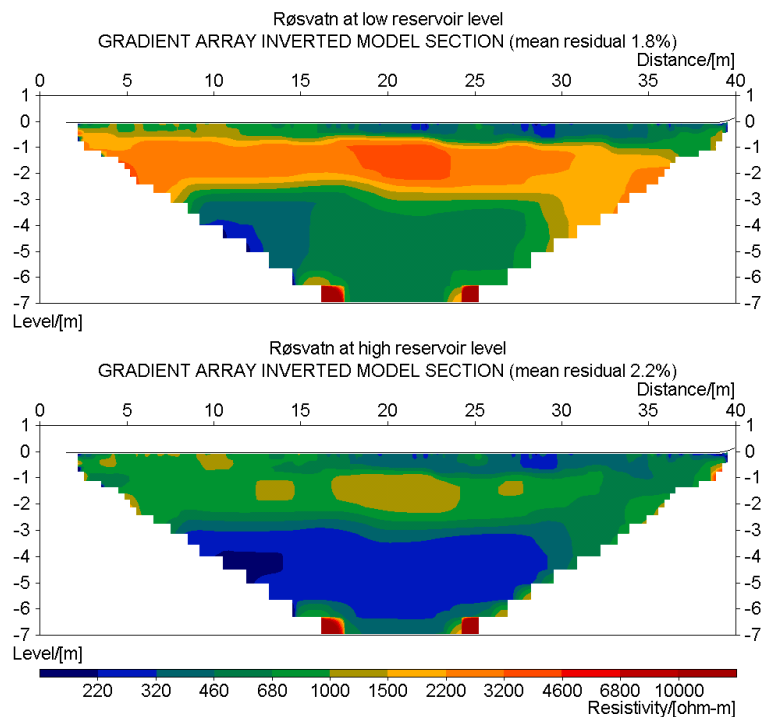
**Figure 9-3** Inverted resistivity sections based on: a) gradient array at empty reservoir (between filling #1 and #2), b) gradient array at high reservoir level (filling #4).

The resistivity in the dam itself has an apparent layered structure, going from bottom and upwards from low, via high/intermediate to low/intermediate. The low resistivity in the bottom layer is probably showing the combined effect of the clay layer used to seal the bottom, plus the water saturated core, filter and rock fill at the lower levels. The method's resolution does not make it possible to discriminate between these parts with the electrodes placed along the top of the core alone. At section 5-7m in Figure 9-3 and Figure 9-4 a high resistive anomaly is visible at 2-3 metres depth, which may be associated with a leakage zone according to the expectations.

Furthermore, at section  $\approx 22\text{m}$  a high resistivity anomaly is located at rather shallow depth (Figure 9-3a Figure 9-4a). All anomalies, low resistive or high resistive, indicate inconsistent material properties and may therefore be associated with leakage zones. However, as higher resistivity is assumed in the defect material high resistive anomalies in the core are the most probable.

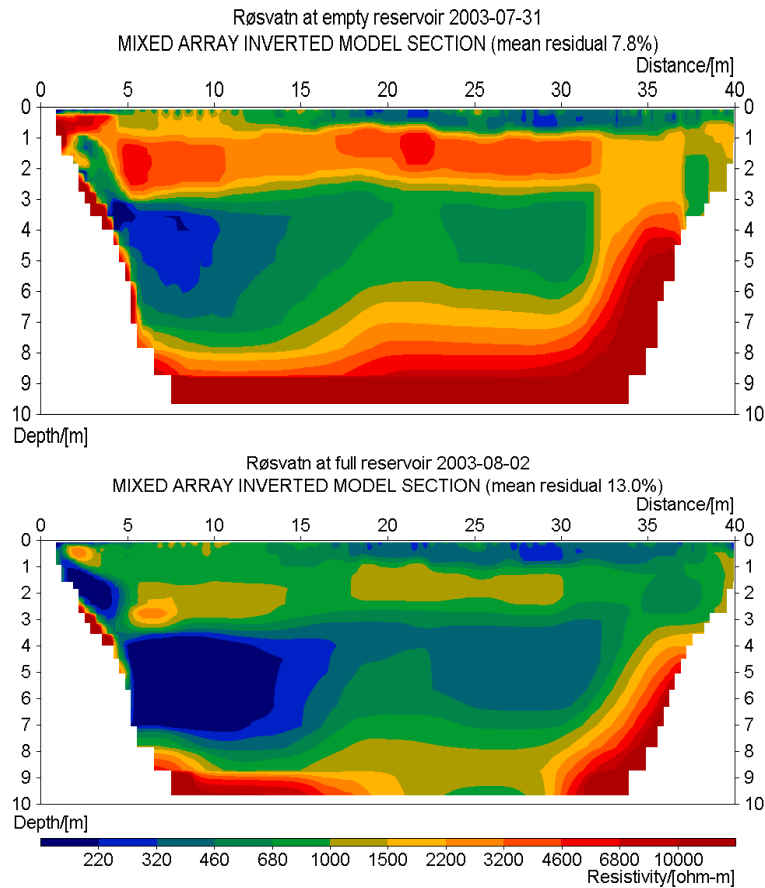
**Figure 9-4** Inverted resistivity sections based on: a) mixed array at empty reservoir (between filling #1 and #2), b) mixed array at high reservoir level (filling #4).

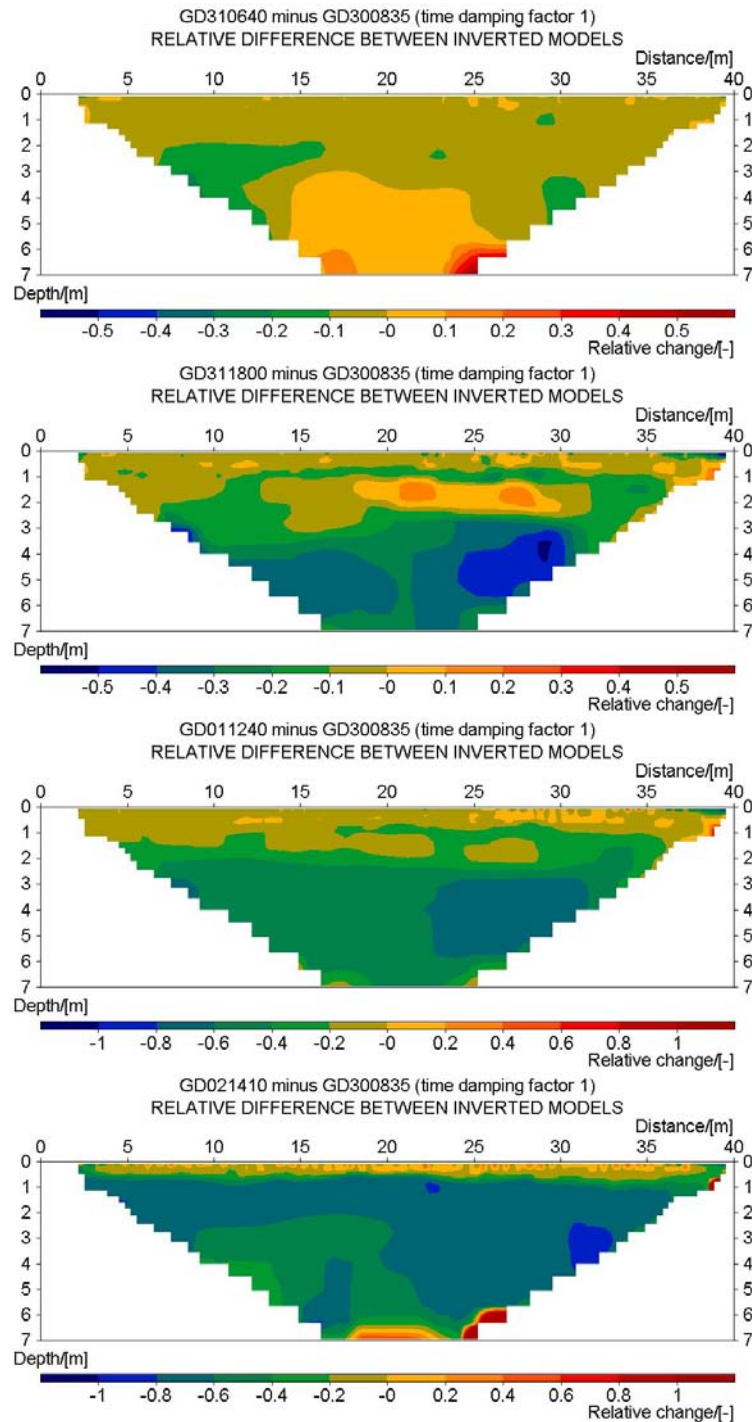
The section in Figure 9-6a shows the change resulting from the drop from the water level at the start of the experiment to the completely empty reservoir after filling #1 (the first attempt to fill it that failed). There is not a big change in resistivity between these sections, possibly a slight drop in resistivity in the upper 3 metres which may be caused by increased moisture content resulting from the higher water level, and slight increase at the lower levels. Exceptions from this trend are zones centred around 7-8 metres and 29-30 metres at the mid-lower parts of the section with a slightly larger drop in resistivity. The latter might be indicative of anomalous material properties and possible leakage that would give a faster breakthrough of higher moisture content and increased temperature. The increase in resistivity at the deeper levels may be a result of the drop in reservoir water level.

**Figure 9-6** Difference in inverted resistivity sections based on gradient array: a) at low reservoir level, b) at reservoir level between filling1# and #2, c) at reservoir level +3.5m (filling #3), b) at high reservoir level (filling #4). Note difference in scale between the sections.

After filling #2 (increasing the reservoir water level to +2m again), most of the dam section below 2m below the crest exhibits a drop in resistivity of 10-20% (Figure 9-6b), except in a zone centred around section 27 metres and another zone around section 7-8 m where the drop is over 40%. The latter may be interpreted as potential leakage zones. Two zones at 1-2m depth centred around section 22m and 27m, corresponding to earlier identified high resistive zones (Figure 9-3 and Figure 9-4), show an unexpected increase in resistivity.

Filling #3 (rising the water to +3.5m) leads to a 40-50% decrease in resistivity, compared to the start conditions, for model depths below 2m below dam crest (Figure 9-6c). Again areas around section 8m and section 27m stand out with a larger decrease (>60%).

Filling #4 (the final rise in water level) leads to a resistivity drop of more than 60% in most of the depth section below 0.5m depth (Figure 9-6d), except between section 10-15m where the drop is between 40-50% at depth. Furthermore, at the centre of the dam (section 20m) there is hardly any increase at the bottom of the section, a tendency that can also be observed in the previous two time steps.

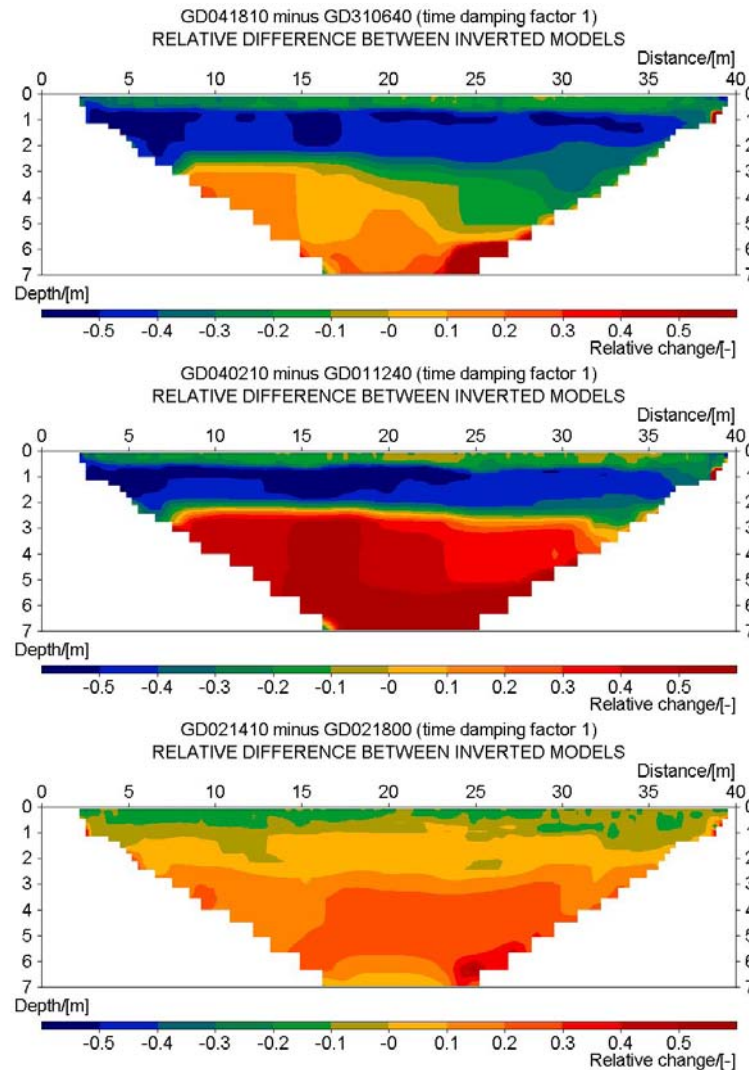
The result for the empty reservoir is shown in Figure 9-7a, and a decrease in resistivity of around 40-60% in the shallow part (0.5-3m depth) is clear. This change is quite even, except around section 7m and 16m where the change is >60%. The overall change is interpreted as caused by increased moisture content following wetting of the embankment dam when the water level increased, and the zones with larger change may indicate zones of anomalous material properties. Below 2.5-3m depth the resistivity has increased, indicating that the moisture content was already high in that part (as discussed above for Figure 9-6a), except in the rightmost part (notably from section 24m and up) where there is a decrease in resistivity.

**Figure 9-7** Difference in inverted resistivity sections based on gradient array data: a) at empty reservoir before and after rising water level, b) at filing #3 vs. #5, c) at high reservoir level (filling #4) 1<sup>st</sup> recording vs. 2<sup>nd</sup> recording.

The pattern described for the empty reservoir is largely seen also for the results from the two data sets recorded at filling level #3, i.e. with the reservoir water 1.6m below the dam crest (Figure 9-7b). One major difference, however, is that the resistivity has increased throughout the lower part of the inverted section.

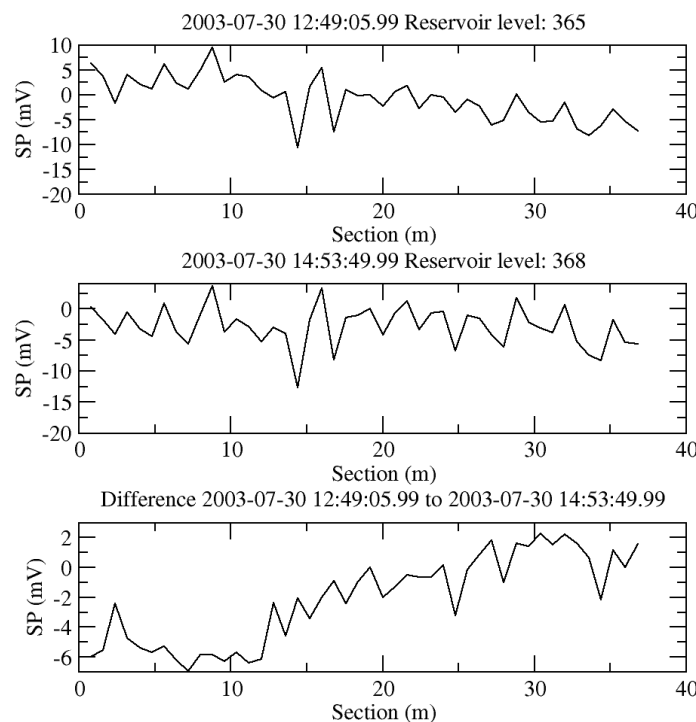
Figure 10-2 shows the change in SP going from water level 365.4 to 368.2 metres. This was the first filling after the dam construction was completed. Between sections 0 and 12 metres the SP has decreased. Between section 20 and 38.4m there is no appreciable change in SP. In the intermediate zone the SP changes smoothly from one extreme to another. Possibly interesting short wavelength anomalies are found at sections: 2.4, 12.8 (weak), 24.8, 28.0 (weak) and 34.4m (weak) metres.

**Figure 10-2** Processed profiles before (top) and at (middle) filling #1. Bottom pane shows difference.

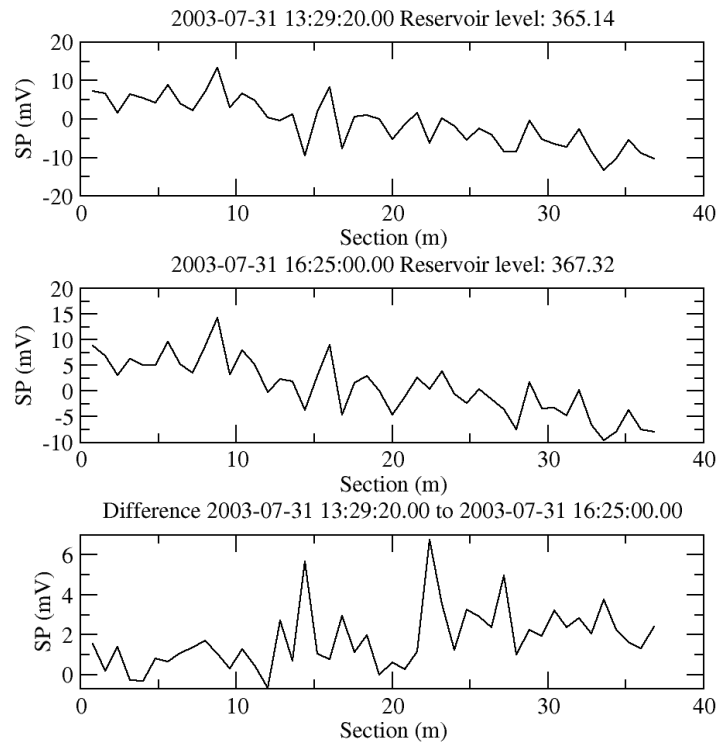
After the first water level change one of the rubber packers in the drainage pipe failed and the reservoir was emptied. The second level change is then a repetition of the first although the final water level was about a meter less. Figure 10-3 shows the SP change going from level 365.14 to 367.32 metres. There is a weak increase in SP going towards higher section

**Figure 10-3** Processed profiles before (top) and at (middle) filling #2. Bottom pane shows difference.

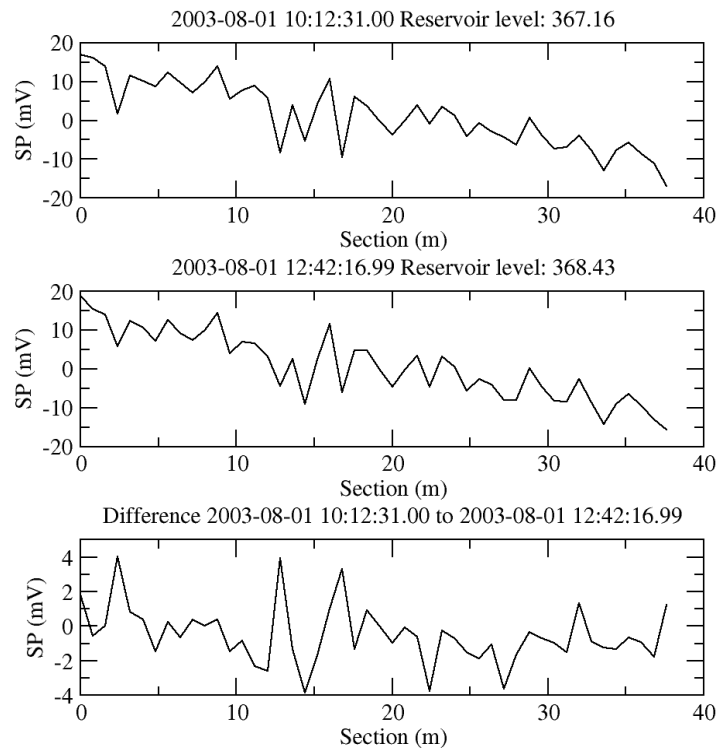
Figure 10-4 shows the change in SP when the reservoir water level changes from 367.16 to 368.43 metres. One prominent feature of the difference plot is the bipolar character of the section 12.2 to 17.6 metres (approximately). This is quite difficult to explain as it implies the presence of closely spaced anomaly sources. For now we will consider the whole section anomalous. Other interesting anomalies occur at sections: 2.4, 22.4, 27.2 and 32 (weak) metres.

**Figure 10-4** Processed profiles at fillings #2 (top) and #3 (middle). Bottom pane shows difference.

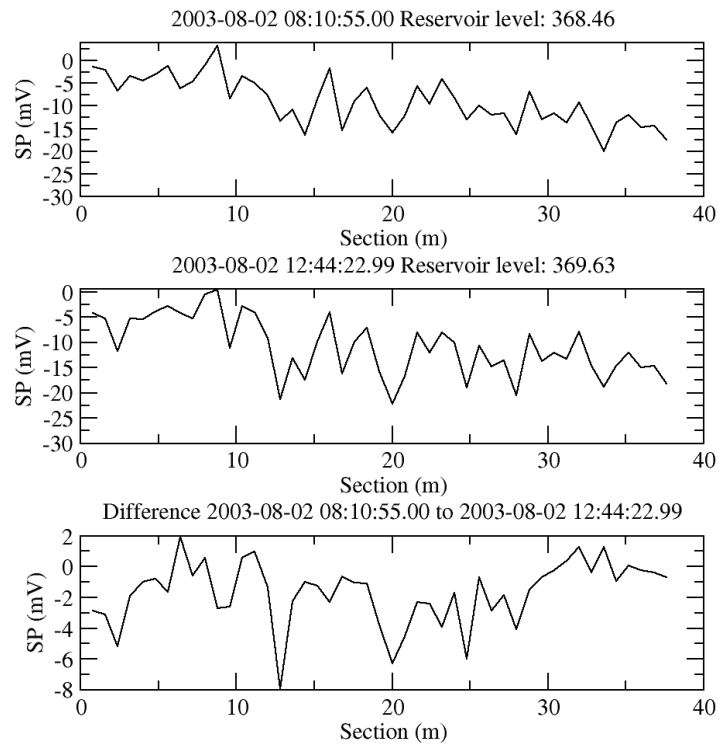
Figure 10-5 shows the effect of changing the reservoir level from 368.46 to 369.63 metres. Anomalous areas appear around sections: 2.4, 12.8, 20.0 and 24.8 (weak) metres.

**Figure 10-5** Processed profiles at fillings #3 (top) and #4 (middle). Bottom pane shows difference.

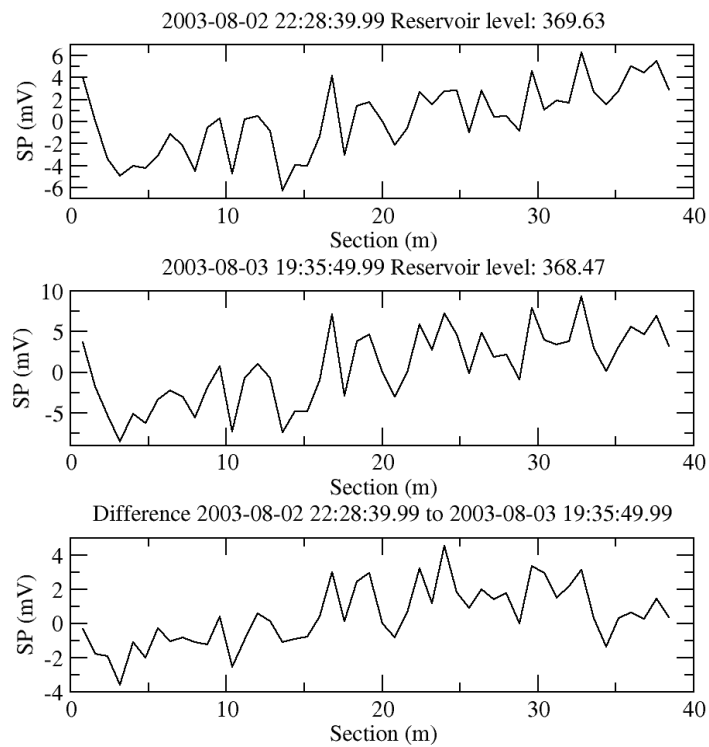
Figure 10-6 shows SP changes during the lowering of the water level from 369.63 to 368.47 metres. This is the longest continuous recording of SP. The rate of change of the water level is much lower than for the other level changes. The reason for this was the limited capacity of the drainage pipes. The SP changes are small overall. Weak but possibly relevant anomalies occur around sections: 3.2, 17.6, 24.0 and 31.2 metres.

**Figure 10-6** Processed profiles at fillings #4 (top) and #5. Bottom pane shows difference.

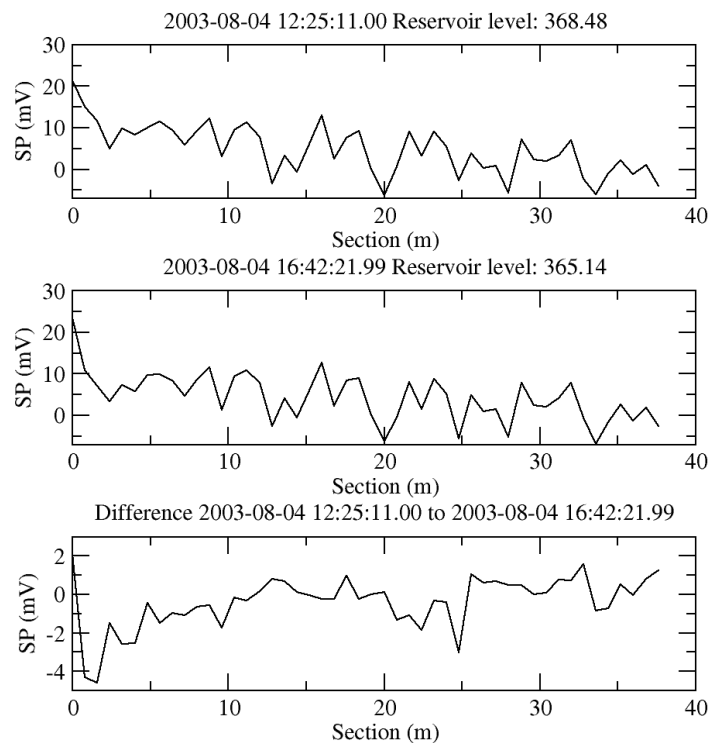
Figure 10-7 shows SP changes during the final emptying of the reservoir. The rate of change in water level was higher than in the previous level change because we could now remove the rubber packers from the sealed drainage pipes. Changes in SP are small. Weak anomalies can be found around sections: 2.4, 24.8 and 33.6 metres.

**Figure 10-7 Processed profiles at fillings #5 (top) and #6 (middle). Bottom pane shows difference.**

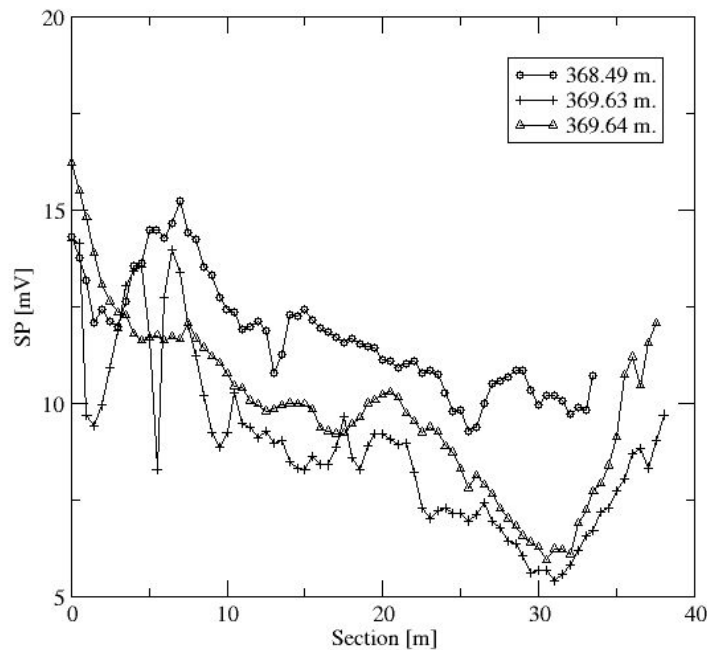
All three anomalies appear slightly bowl shaped possibly reflecting the depth to the bedrock foundation. The most interesting feature, however, is the strong minimum that occurs at section 30 metres as the reservoir level is increased. Such a minimum would be expected where there is a concentration of influx of water into the core. It should be noted, however, that strong resistivity variations have been observed during the filling of the reservoir, and it is not impossible that this variation contributes significantly to this anomaly.

An equivalent point source interpretation of the depth to the anomaly source shows that the source should lie about 2-3 metres below (or more correctly distant from; the source need not lie directly below the profile) the profile. This means that the source should be located at a level of about 366-367 m.

**Figure 10-9** SP-profiles along the upstream shoreline measured at different reservoir levels as shown in the legend.

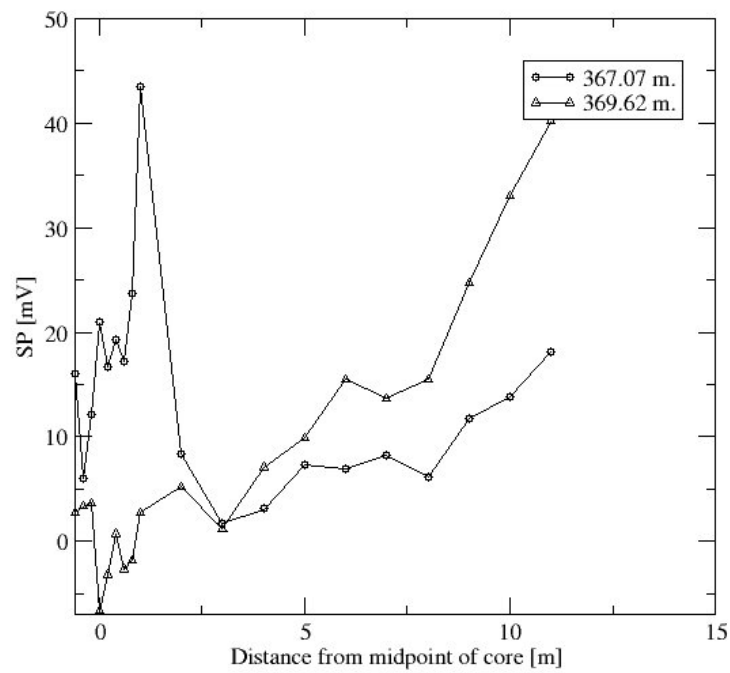
Figure 10-10 Cross-profile at section 10m.

A number of profiles perpendicular to the dam crest were measured at sections 10, 21, and 31m; these are shown in Figure 10-10, Figure 10-11 and Figure 10-12. The profiles are quite noisy and it is difficult to draw any strong conclusions from them. One would expect the anomalies to increase going downstream. This seems to be the case with the profiles at sections 10 and 21m, although the strong positive tails in sections 10 and 21m are probably caused by the observation point moving closer to the concrete foundation that lies under part of the dam. The fact that the anomaly decreases going downstream at section 31m is also difficult to explain, but the observation strengthens the observation in the preceding that the part of the dam around section 30m is anomalous.

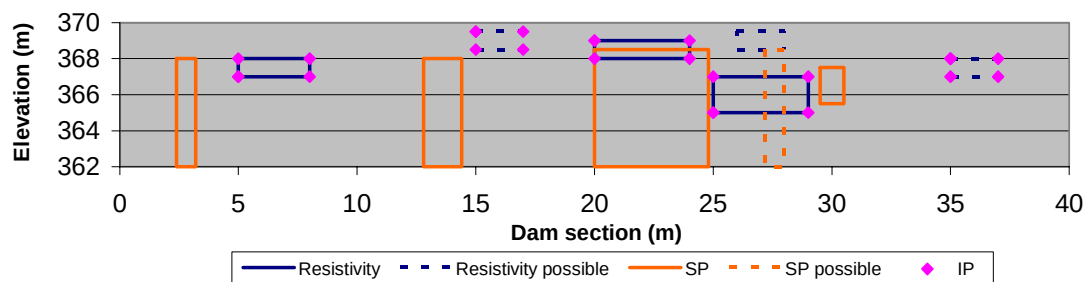
The agreement between resistivity and IP is good, where a resistivity anomaly is followed by a decrease in IP, except for one defect that is observed by resistivity only (Figure 12-1). Good agreement is also achieved between resistivity and SP around section 22m and maybe at section 27m. The location of the other defect areas differ some metres between the methods.

**Figure 12-1** Result from all electrical methods. Note that the defect elevations for SP are based on water level information.

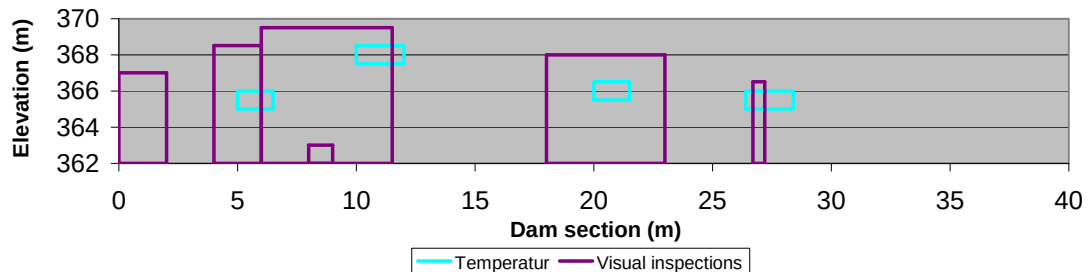
The levels of the defects observed by temperature and visual inspections have as SP been estimated based on water level information and just the maximal highest extension is showed in the Figure 12-3. The temperature measurements give however some additional information that allows an estimation of the lower limit. Both these methods use information from the dam toe, i.e. not in the core where the defects are located. The two methods agree well. It seems as the temperature gives a more distinct location of the defect

at the dam toe, which may be explained by a more sensitive response and less affected by standing water etc.

**Figure 12-2 Result from temperature measurements and visual inspections at the dam toe. Note that the elevations for the defects are based on water level information.**

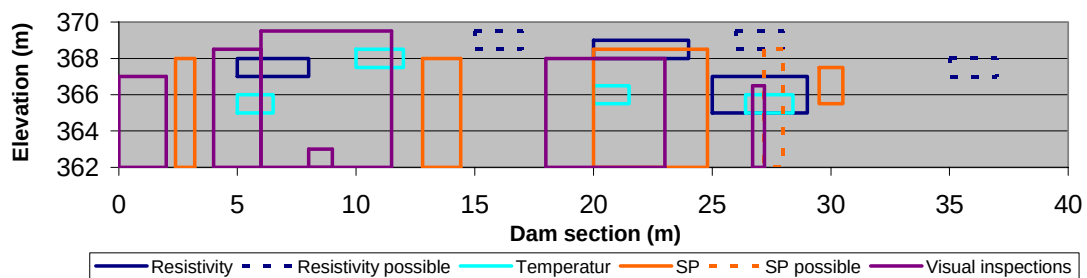
The collected final information from all methods shows three main defect areas (Figure 12-3). The most significant defect is found around section 22m, which is shown by all methods. The elevation is more uncertain varying from elevation 365 to 368m.

**Figure 12-3 Summarized result from all methods. Note that the elevations for the defects are based on water level information for all methods except resistivity. The height is also set constant to 1m for all methods except resistivity.**

A second significant defect is observed at section 27m at elevation 365-367m. The SP anomaly is however weak and interpreted only as possible defect.
