## **DAMMSÄKERHET**

**Dam-Break Project in Norway,  
Slope Stability Analysis on Rockfill  
and Gravel Test Dams in correlation  
with test results**

**Rapport 05:13**

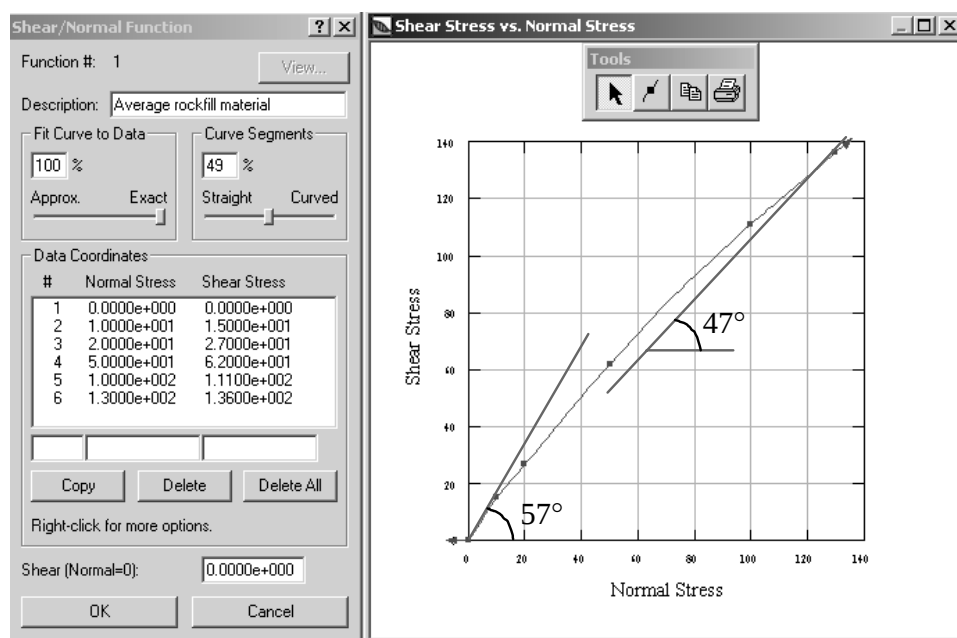
**Figure 4.3 Estimated nonlinear shear/normal effective stress (kPa) relationship of the rockfill.**

The estimated shear/normal stress relationship for the rockfill material is shown in figure 4.3. This function represents a decrease in friction angle from  $57^\circ$  right at the surface to about  $47^\circ$  at the bottom of the dam, approximately 6 m below the surface.

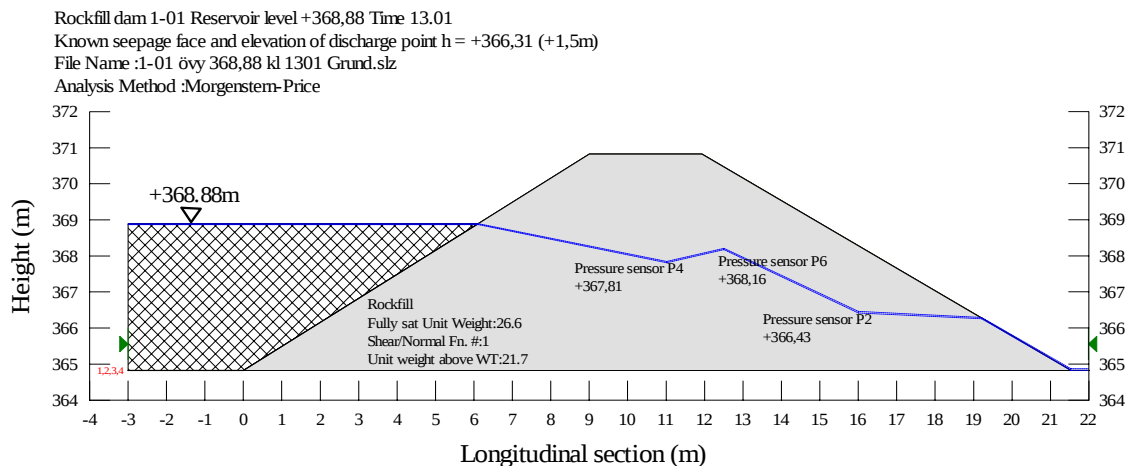
**Figure 4.4 Rockfill test dam 1-01 model.**

Figure 4.4 shows the analysis model cross-section for the rockfill test dam during test day 19-10-01, time 13.01.

No breach was developed in this test, which correlates with the analysis result. The analysis show that superficial slides (thin failure plane, barely visible with a potentially small impact on the slope) have a factor of safety of approximately  $SF = 1,2$  which is just over stable conditions ( $SF = 1$ ) and these occur just below the seepage face as would be expected due to the effect of the pore pressure uplift.

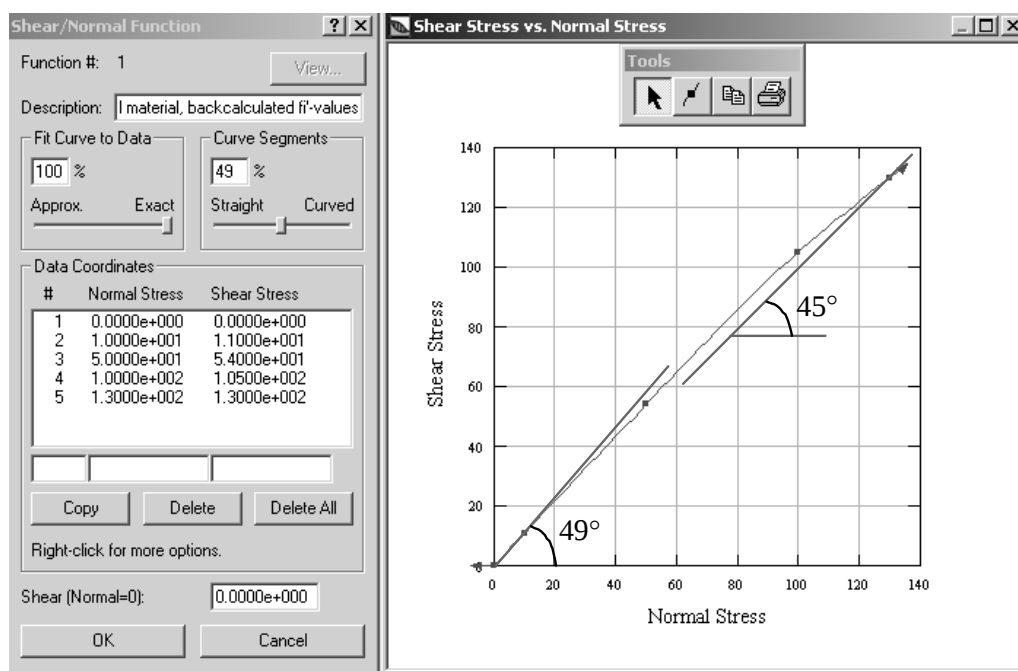
**Figure 5.4** Estimated nonlinear shear/normal effective stress (kPa) relationship of the gravel.

Based on the back calculation the shear/normal stress relationship for the gravel material is displayed in figure 5.4. This function represents a decrease in friction angle from 49° right at the surface to about 45° at the bottom of the dam, 5 m below the surface.

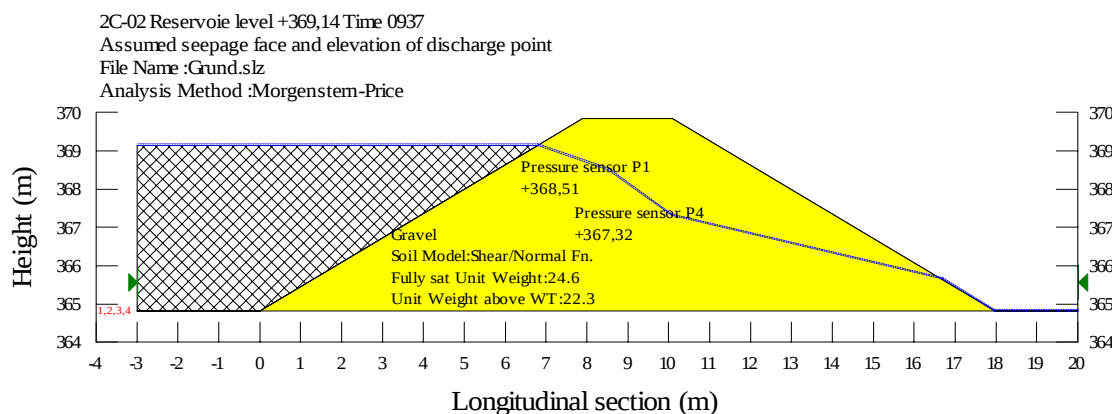
Figure 5.7 Gravel test dam 2C-02 model.

Figure 5.7 shows the analysis model cross-section during the initial test of gravel dam 2C-02 Oct 16th 2002. Due to the dense and tight quality of the gravel material changes in reservoir level was made gradually and then letting it set in order to permit adjustments in the pore pressure while it positioned.

The analysis show that the factor of safety for thin barely visible slides is below stable conditions ( $SF = 1$ ) and these slides occur just below the seepage point under the influence of uplift. So according to this some erosion should have initiated under the seepage face during the first part of the test, this never happened. The influence of suction in this case is minimal because the failure occurred below the point of discharge. Maybe the erosion process would have started in the actual test dam if this case of load had continued for a longer time allowing the seepage situation to settle. A more tangible, but still small slip surfaces, has  $SF = 1.4$  (according to the analysis in figure 5.8). Without the influence of suction 1.33.

The factor of safety of a deep slip surface that probably would have resulted in a breach under these conditions is 1.92 (1.83 if negative pore water pressure is not considered, no suction), see figure 5.9. This is far above stable conditions.
