# INCREASED STEAM TEMPERATURE IN GRATE FIRED BOILERS

RAPPORT 2018:551

# Increased Steam Temperature in Grate Fired Boilers

Steamboost

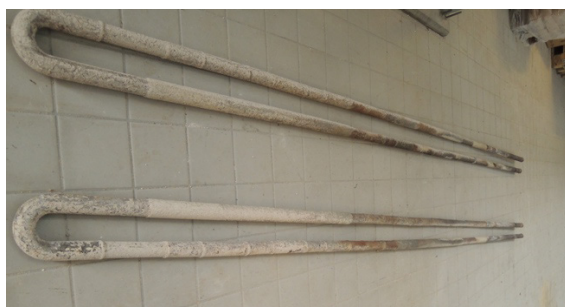
**Figure 9. Photo showing of two of the three Steamboost tubes removed from the boiler.****Table 6: Materials exposed in second fixed installation.**

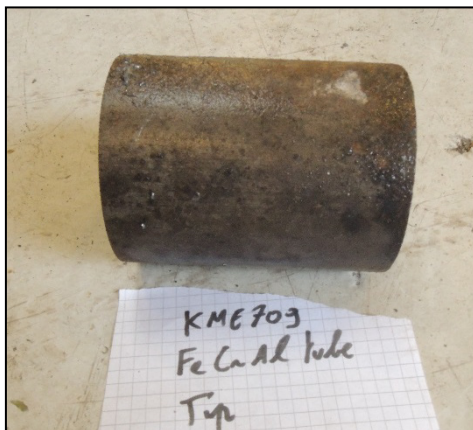
The tube consisting of the commercial Kanthal APMT FeCrAl material was positioned inside the furnace near the Steamboost superheater during several steps of the project. The first exposure lasted for 4500h. Figure 11 shows the tip of the tube after being cut for analysis. The temperature of the tube was measured to be about 900 °C and recorded during the exposure with a thermocouple. The commercial Kanthal® APMT FeCrAl alloy was in addition tested on a corrosion probe along with FeCrAl model alloys, see section 3.2.4.

**Figure 11. Tip of the FeCrAl tube after cut for analysis**

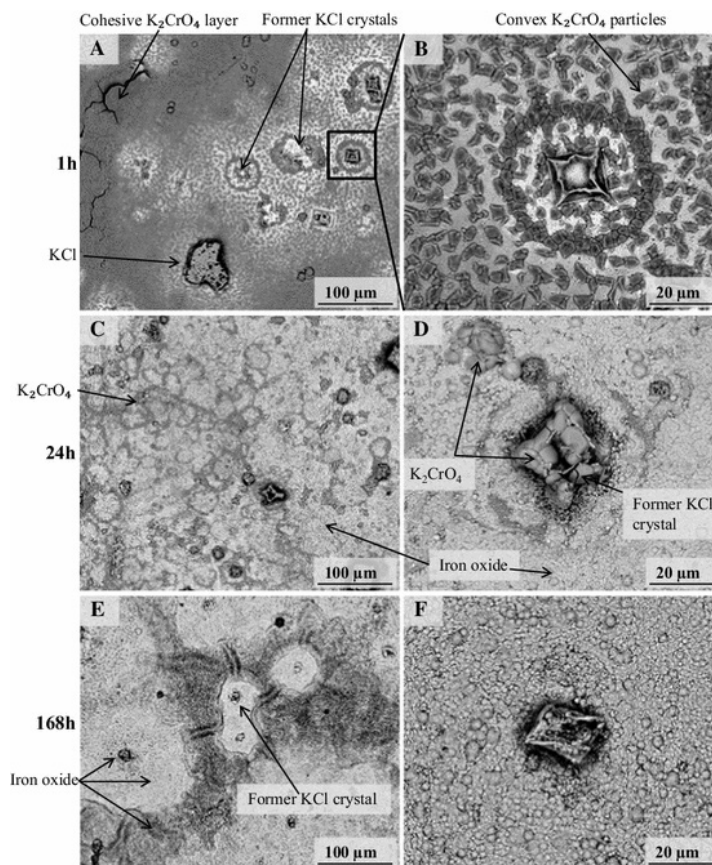
In Figure 16 plan view SEM/BSE images are shown of untreated samples exposed in the presence of KCl after different amount of times. Already after one hour of exposure  $K_2CrO_4$  particles are found around partly unreacted KCl particles and in some areas  $K_2CrO_4$  particles formed a layer that tend to crack (might be due to large expansion coefficient of  $K_2CrO_4$ ). Some KCl particles are already at this stage overgrown by iron-rich oxide.

After 24 hours, most of the surface consisted of iron oxide and no KCl crystals were left unreacted.  $K_2CrO_4$  has grown in size and tend to agglomerate in certain areas, especially at former KCl crystals. Morphological features with similar distribution and shape as that of the  $K_2CrO_4$  particles after one hour could be seen but now seems to have been decomposed.

After 168 hours the entire surface was overgrown by iron-rich oxide with ridges of iron-rich oxide surrounding the former KCl crystals.

**Figure 16:** SEM/BSE images of Kanthal APMT exposed in 5%  $O_2$  + 40%  $H_2O$  in the presence of KCl (0.1 mg/cm<sup>2</sup>) for 1h (a,b), 24h (c,d) and 168h (e,f)

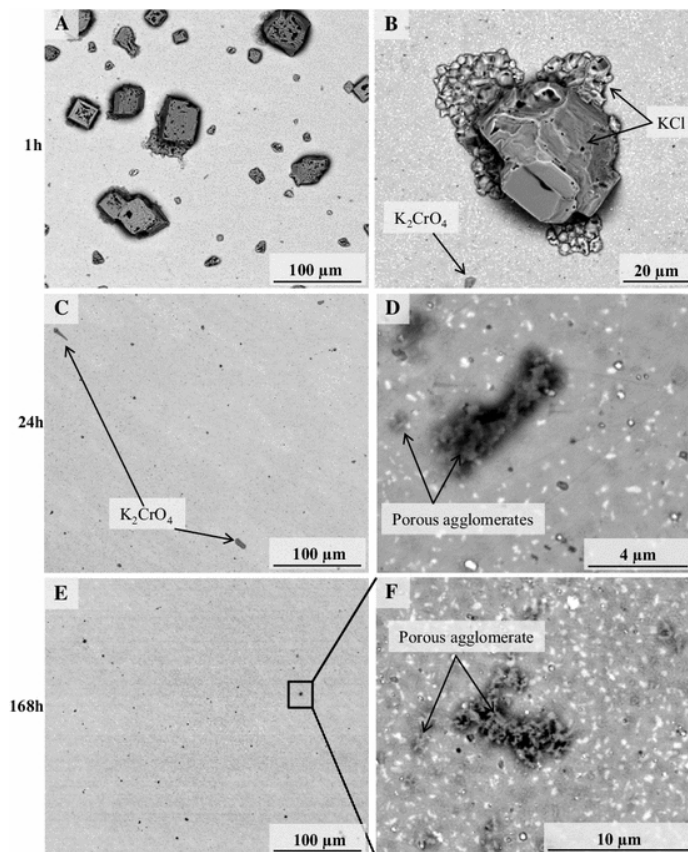
In Figure 17 plan view SEM/BSE images are shown of pre-oxidized samples exposed in the presence of KCl after different amount of times and can be compared to the case with untreated samples. After one-hour surface morphology has barely changed and shows a large difference from the case without pre-oxidation. Just a few  $K_2CrO_4$  particles can be found and the KCl particles are less reacted than in the case without pre-oxidation.

After 24 hours, no indication KCl crystals on the surface could be detected and no morphological traces were left either (probably KCl was evaporated). The amount of  $K_2CrO_4$  particles increased compared to after 1 hour (can be seen as dark spots in the image) but was much less than in the case without pre-oxidation.

After 168 hours the surface morphology looks similar to that after 24 hours with the only actual difference being that the  $K_2CrO_4$  particles had been replaced with porous agglomerates of similar size and distribution. This is assumed to be remnants of decomposed  $K_2CrO_4$  particles.

Figure 17: SEM/BSE images of pre-oxidized Kanthal APMT exposed in 5%  $O_2$  + 40%  $H_2O$  in the presence of KCl (0.1 mg/cm<sup>2</sup>) for 1h (a,b), 24h (c,d) and 168h (e,f)

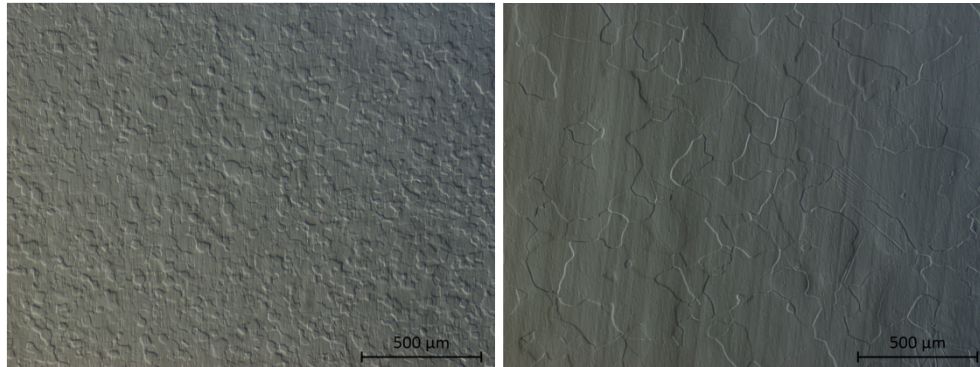
Heat treatments of FeCrAl model alloys were performed in order to minimize the grainsize distribution of the as-received alloys. Figure 18 shows an example of the as received microstructure. Large elongated grains could in addition be observed

**Figure 18:** Images from optical microscope on two different areas of the surface of one of the as-received FeCrAl model alloys.

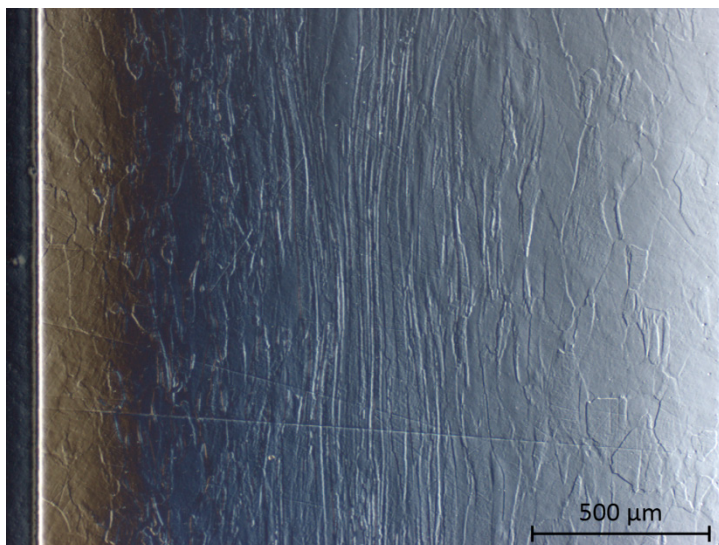
in the cross sections of the as-received alloys due to insufficient heat treatments, see Figure 19.

**Figure 19:** Image from optical microscope on the cross section of one of the as received FeCrAl model alloys.

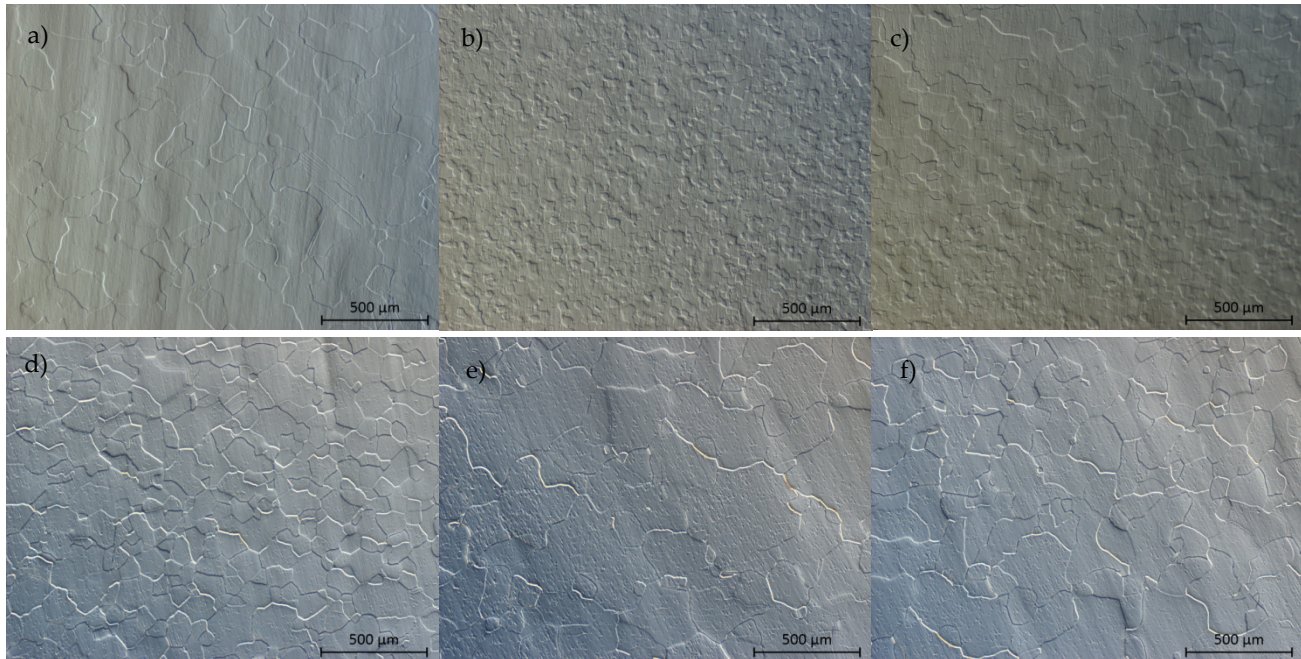
Heat treatments were performed at 950 °C for 1h and 22h in a box furnace with the samples laying in alumina boats. The results of these heat treatments varied where some samples showed an even grain size distribution while others showed larger variation of grain sizes. Even within the same batch of alloys heat treated at the same time, differences in the resulting grain size distribution were found. However, the elongated grains seen in the cross section of the as-received alloys were removed by the heat treatment already after one hour.

Figure 20: Images from optical microscope of a FeCrAl model alloy before (a,b,c) and after (d,e,f) heat treatment at 950°C for 22 hours.

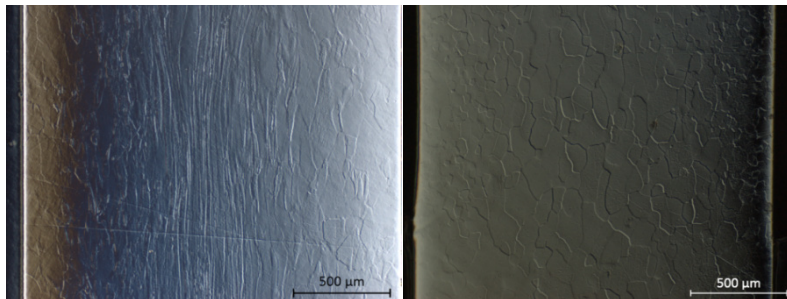
Figure 21: Images from optical microscope of the same FeCrAl model alloy before (left) and after (right) heat treatment at 950°C for 1 hour.

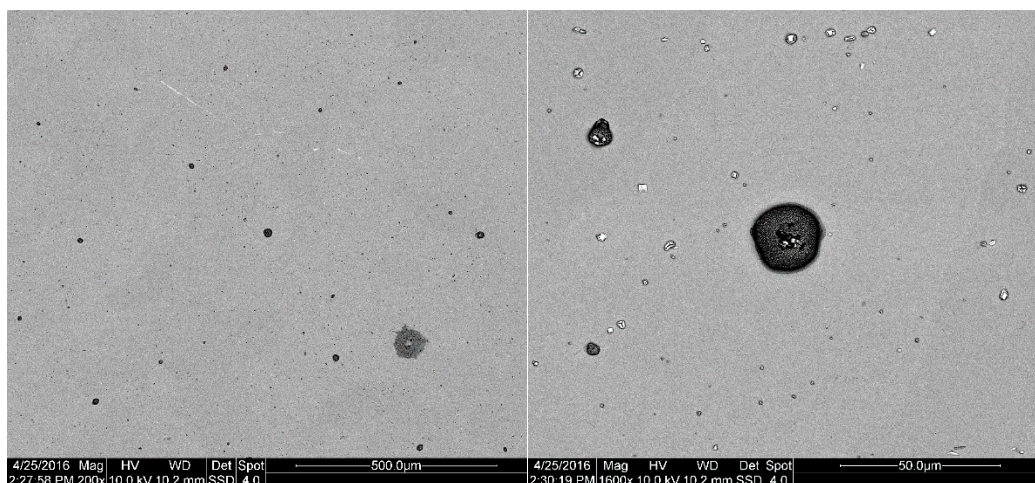
The resulting mass gains were low for all of the different alloys shown in Table 9. The resulting oxide layers on the samples were in the nanometre range, which could be concluded from the surface morphology/colour and mass gain of the samples after exposure. The oxide surface morphology was further studied with SEM, see Figure 22. In the image to the left, the grains of the alloy are visible, indicating that the oxide layer is very thin. As can be observed, small dark spots, corresponding to iron oxide, are scattered evenly on the surface. When looking at the right image (with higher magnification) smaller bright particles can also be observed which corresponds to zirconia particles. When taking a closer look at the larger of the dark iron oxide spots, zirconia particles can be seen in the centre of the spot. Similar features are observed in most of the other iron oxide crusts on the surface.

Figure 22: SEM BSE plan view images of Fe5CrAl2Si sample exposed in 5% O<sub>2</sub> + 20% H<sub>2</sub>O + N<sub>2</sub> at 600°C for 168h.

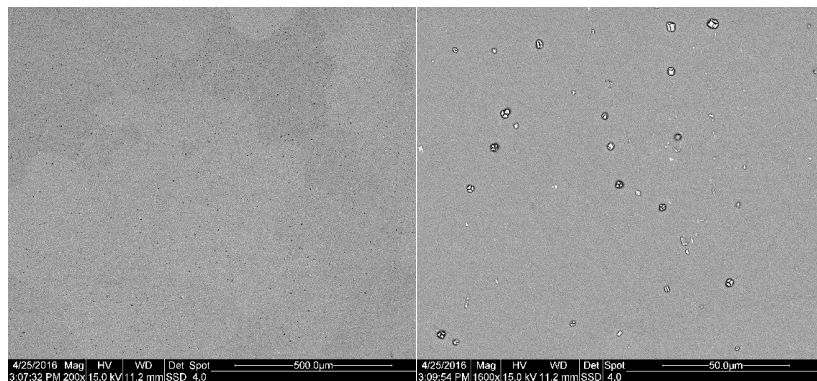
Figure 23 shows SEM/BSE images of two different alloys. The alloy grains of the sample with lowest mass gain can be observed indicating an even thinner oxide layer. Also, no dark iron oxide spots can be seen in either of the magnifications. In the image to the right bright zirconia particles can be observed.

**Figure 23:** SEM/BSE plan view images of Fe<sub>20</sub>CrAl<sub>2</sub>Si sample exposed in 5% O<sub>2</sub> + 20% H<sub>2</sub>O + N<sub>2</sub> at 600°C for 168h

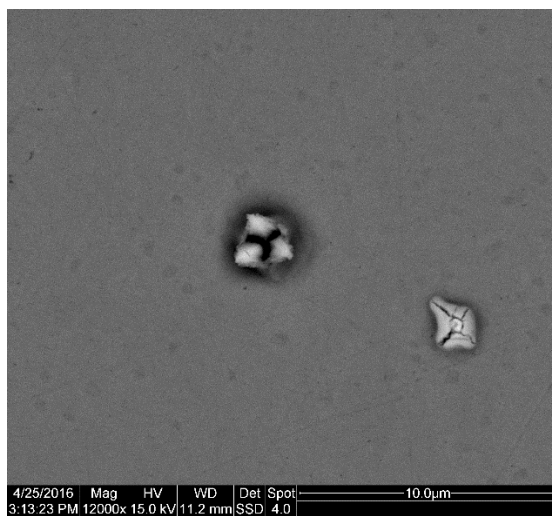
The higher magnification SEM/BSE image (Figure 24) indicates that the zirconia particle opens up in the centre. This may indicate that the spots of iron oxide originate from zirconia particles.

**Figure 24:** SEM BSE plan view image of Fe<sub>20</sub>CrAl<sub>2</sub>Si sample exposed in 5% O<sub>2</sub> + 20% H<sub>2</sub>O + N<sub>2</sub> at 600°C for 168h. Image shows a zirconia particle that have “opened up”.

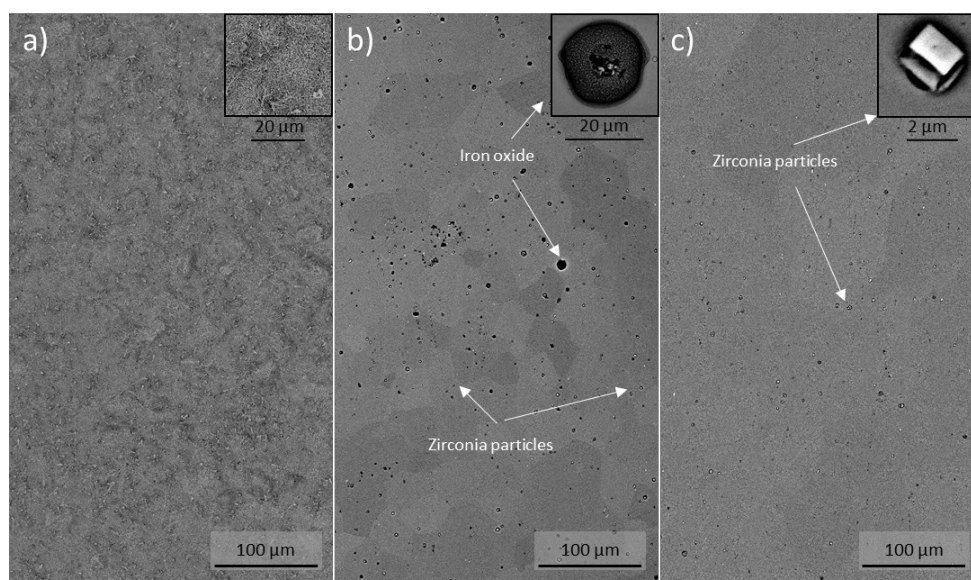
The resulting mass gains differed drastically. FeCrAl0Si has formed a very thick oxide while FeCrAl1Si and FeCrAl2Si have formed thin protective oxides which is shown in Figure 25. The much thicker oxide of FeCrAl0Si is indicated by the rough surface morphology (Figure 25(a)).

**Figure 25:** SEM BSE plan view images of (a) FeCrAl0Si, (b) FeCrAl1Si and (c) FeCrAl2Si exposed in 5% O<sub>2</sub> + 20% H<sub>2</sub>O + N<sub>2</sub> at 600°C for 168h.

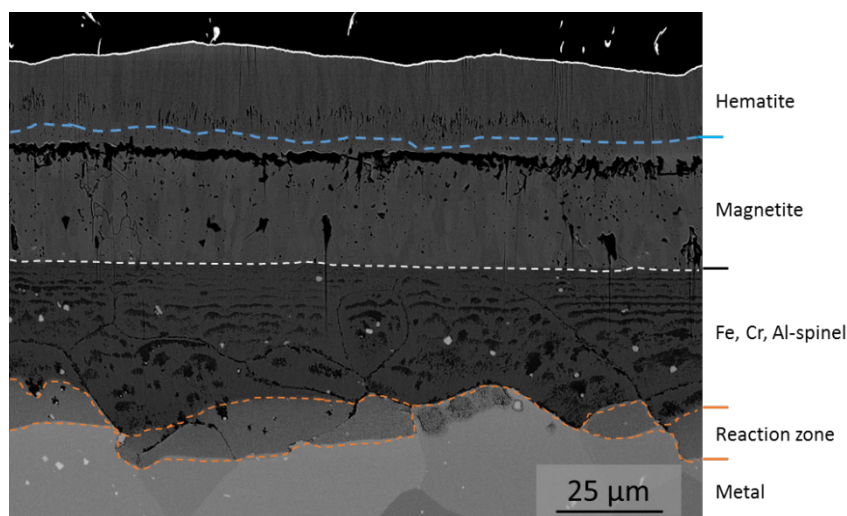
A cross-section image of FeCrAl0Si is presented in Figure 26, i.e. the only alloy that had a high mass gain in the reference environment. It shows a thick oxide of about 85  $\mu\text{m}$  thickness. It has formed an outward growing oxide consisting of an upper hematite layer, followed by a magnetite layer. Underneath the magnetite it has formed an Fe-, Cr-, Al-spinel followed by a reaction zone. The thickness is in good agreement with the reported mass gain.

Figure 26: SEM-BSE cross section image of FeCrAl0Si after exposure in 5% O<sub>2</sub> + 20% H<sub>2</sub>O + N<sub>2</sub> at 600°C for 168h

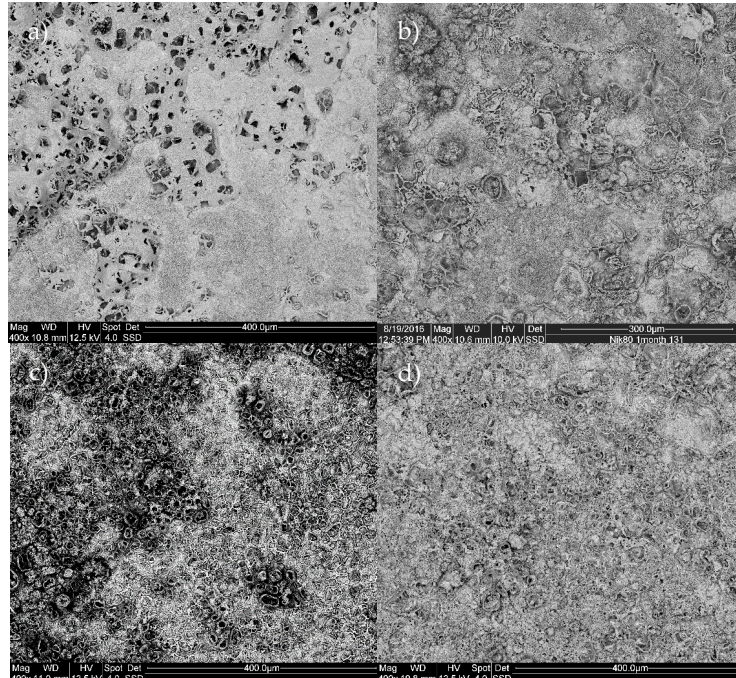
The samples were analysed with SEM/EDX both in plan view and in cross section. Figure 24 shows plan view images of the different model alloys. Figure 27(a) corresponds to Fe<sub>5</sub>CrAl<sub>2</sub>Si. A porous upper oxide layer can be seen consisting mainly of iron oxide. Figure 27(b) corresponds to Fe<sub>10</sub>CrAl<sub>2</sub>Si. The surface morphology is different and no porous oxide such as in (a) can be observed. When performing an EDX-mapping, indications of K<sub>2</sub>CrO<sub>4</sub> was observed evenly distributed across the surface. Figure 27(c) corresponds to Fe<sub>15</sub>CrAl<sub>2</sub>Si. K<sub>2</sub>CrO<sub>4</sub> was distributed in a similar way but more and larger dark regions was observed

on Fe10CrAl2Si. Finally, Figure 27(d), corresponding to Fe20CrAl2Si, shows less dark areas but large amounts of K<sub>2</sub>CrO<sub>4</sub> appear distributed over the whole surface.

Figure 27: SEM BSE plan view images. (a) Fe5CrAl2Si, (b) Fe10CrAl2Si, (c) Fe15CrAl2Si and (d) Fe20CrAl2Si after 168 hours exposure in 5% O<sub>2</sub> + 20% H<sub>2</sub>O + N<sub>2</sub> + 1.0 mg/cm<sup>2</sup> with KCl present at 600°C

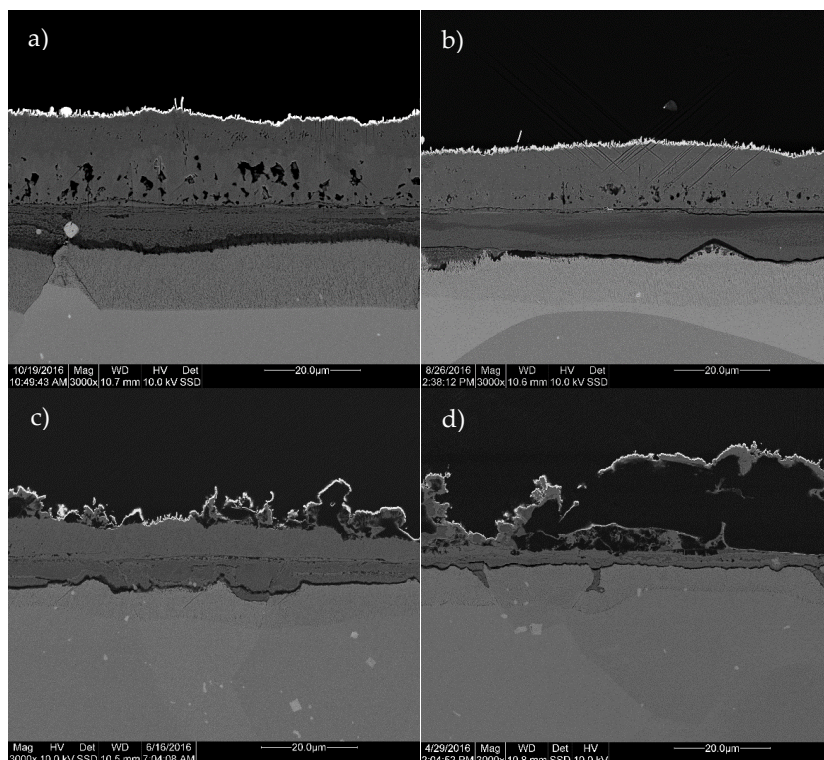
In Figure 28 the decrease in oxide thickness with an increase in Cr in the alloy can be observed. The oxide scales are well adherent to the substrate in all the alloys. The oxide thickness corresponds well with the mass gains (Table 11), neglecting the crusts of K<sub>2</sub>CrO<sub>4</sub> on top of the base oxide on Fe15CrAl2Si and Fe20CrAl2Si. The oxides on Fe5CrAl2Si to Fe15CrAl2Si consist of an outward growing iron oxide and an inward growing spinel oxide. It is difficult to distinguish the original metal surface on Fe20CrAl2Si and therefore it is unclear if it has both an inward and outward growing oxide. However, chromium-rich oxide grows inward in the alloy on some parts indicating metal grain boundary attack. This phenomenon was also observed for Fe15CrAl2Si but not to the same extent as Fe20CrAl2Si. A nitridation zone beneath the oxide scale was observed on all of the model alloys.

**Figure 28:** SEM BSE cross section images of a) Fe5CrAl2Si, b) Fe10CrAl2Si, (c) Fe15CrAl2Si and (d) Fe20CrAl2Si after 168 hours exposure in 5% O<sub>2</sub> + 20% H<sub>2</sub>O + N<sub>2</sub> + 1.0 mg/cm<sup>2</sup> KCl at 600°C.

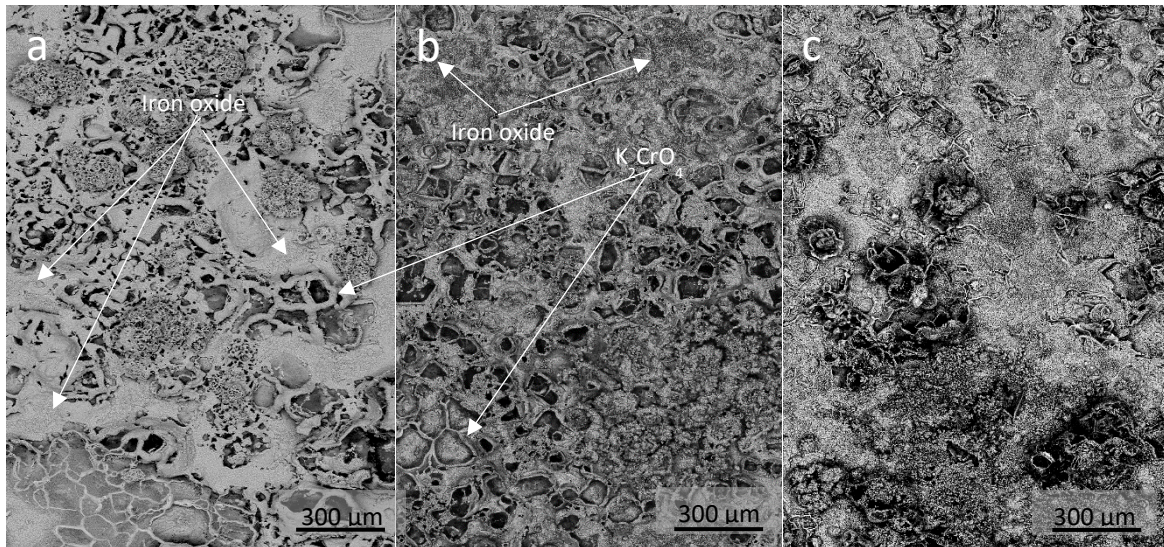
The plan view images in Figure 29 indicate that all three alloys have formed thick oxides, indicated by the rough surface morphology with K<sub>2</sub>CrO<sub>4</sub> spread out all over the surface, in good agreement with the mass gains. The thin protective scale formed in the reference environment with oxygen and water vapor has broken down at an earlier stage or not formed at all.

Figure 29: SEM-BSE plan view image of a) FeCrAl0Si, b) FeCrAl1Si and c) FeCrAl2Si after being exposed with KCl present for 168 hours at 600 °C.

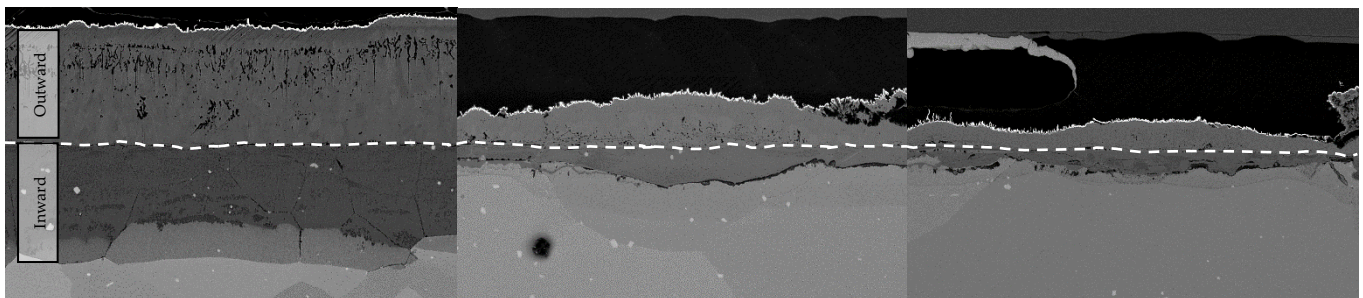
Figure 30 shows all the cross sections and the beneficial effect of adding Si could be observed as well as the effect of amount of Si.

Figure 30: SEM-BSE cross section images of a) FeCrAl0Si, b) FeCrAl1Si and c) FeCrAl2Si after exposure with KCl present for 168 hours at 600 °C.

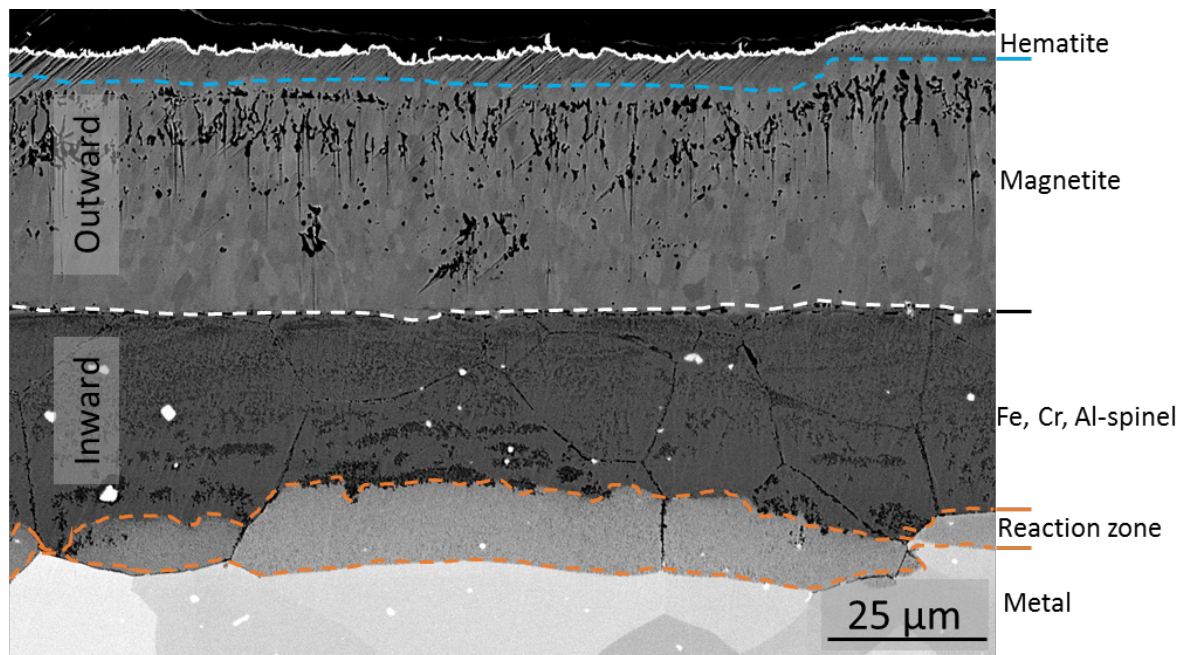
Figure 31 shows the oxide layer formed on FeCrAl0Si. An outward growing oxide consisting of a thin upper hematite layer followed by a much thicker magnetite layer, has grown. Underneath the magnetite layer it was found an inward growing oxide consisting of an Fe-, Cr-, Al-spinel followed by a reaction zone, indicated by the brighter contrast compared to the spinel (darker compared to the bulk).

Figure 31: SEM-BSE cross section image of FeCrAl0Si after exposure with KCl present for 168 hours at 600 °C.

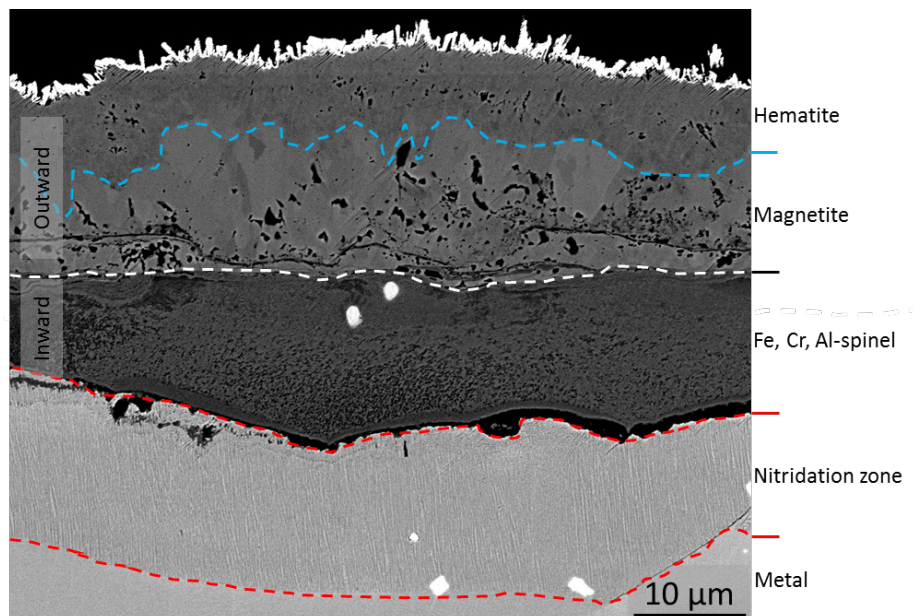
Figure 32 shows the different oxide layers of FeCrAl1Si in cross-section. It has formed an outward growing oxide consisting of an upper hematite layer followed by a magnetite layer. It has also formed an inward growing Fe-, Cr-, Al-spinel. Underneath the spinel, instead of a reaction zone, a nitridation zone has formed.

Figure 32: SEM-BSE cross section image of FeCrAl1Si after exposure with KCl present for 168 hours at 600 °C.

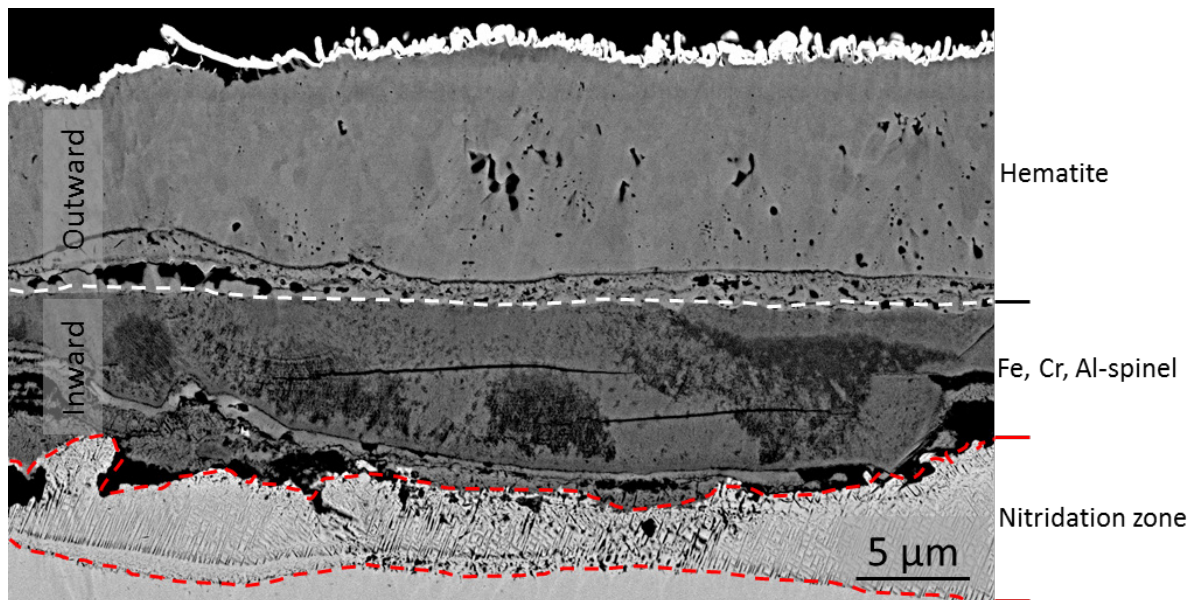
Figure 33 shows the different oxide layers of FeCrAl2Si in cross-section. It has formed an outward growing oxide but it only consists of a thicker hematite layer

and no magnetite. Underneath the hematite it has formed an Fe-, Cr-, Al-spinel, followed by a nitridation zone.

Figure 33: SEM cross section image of FeCrAl<sub>2</sub>Si after exposure with KCl present for 168 hours.

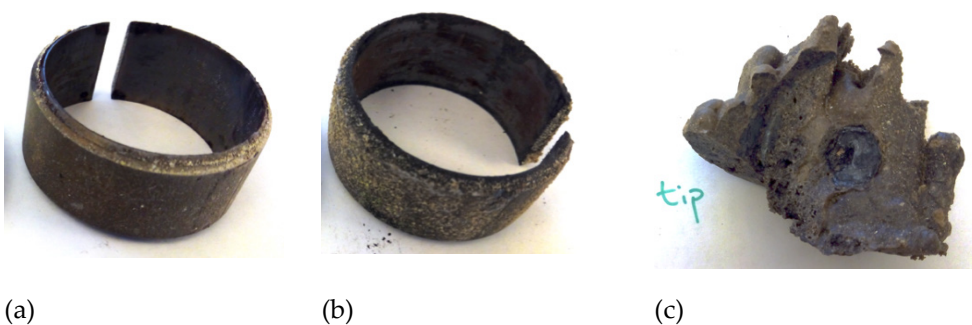
The air-cooled probe was inserted at the Steamboost position 1h after the settings were changed which was time enough for the boiler to be stable with the new settings. After 2h exposure in the boiler, the samples were removed for analysis and pictures were taken for optical inspection. Figure 34 shows three different deposits formed at three different settings (setting K22, S22 and C11 in Figure 35). The amount of deposit is different for every setting going from very small amounts (Figure 34 (b)) to extremely thick deposits (Figure 34 (c)).

Figure 34. Images of three different deposits after 2 hours of exposures from the settings (a) K22, (b) S22 and (c) C11. 29 different conditions were set up in the boiler in order to find out the less corrosive one. All the deposits from the 29 settings were analysed to select the one to run the corrosion test

The deposit investigation was followed by different investigations of the corrosion at the steamboost position at AffaldPlus. A fixed FeCrAl tube was inserted, seven different materials (at two temperatures) were investigated through air-cooled probes together with a large number of FeCrAl model alloys and nine materials were investigated through two sets of fixed installed materials (the materials were repeated two times in three loops). During the second Steamboost campaign the tube exposed under the most severe conditions (highest temperature) failed due to a leakage after 6500h. The tube was removed from the boiler and stored in desiccators for analysis and comparison with the first Steamboost. It should be noted that the fixed installed materials were exposed during the deposit tests, i.e. exposed also to settings generating large amount of very corrosive deposits, see Figure 34. The corrosion investigation generated a very large set of samples. The

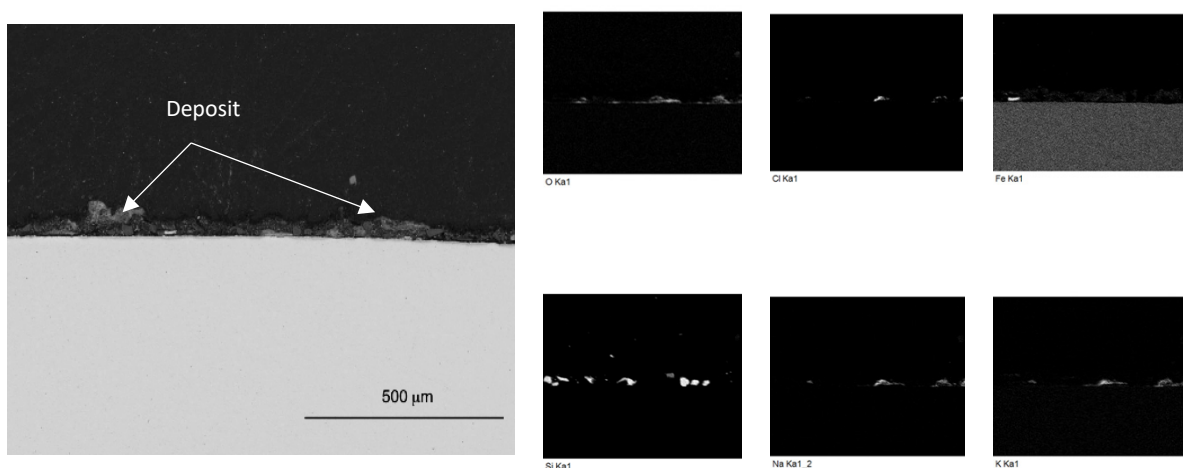
A selected reference sample was cast and cut in order analyse the deposit in cross-section with SEM/EDX. The aim was to check the amount of deposit and its composition and compare this with the IC results. After 2h exposure the amount of deposit was limited in this setting (setting C33 in Figure 35) and according to EDX it is mainly composed of silicon with some calcium and sodium (Figure 36).

Figure 36. Scanning Electron Microscopy backscattered image of a Sanicro 28 material exposed 2h in the Steamboost region

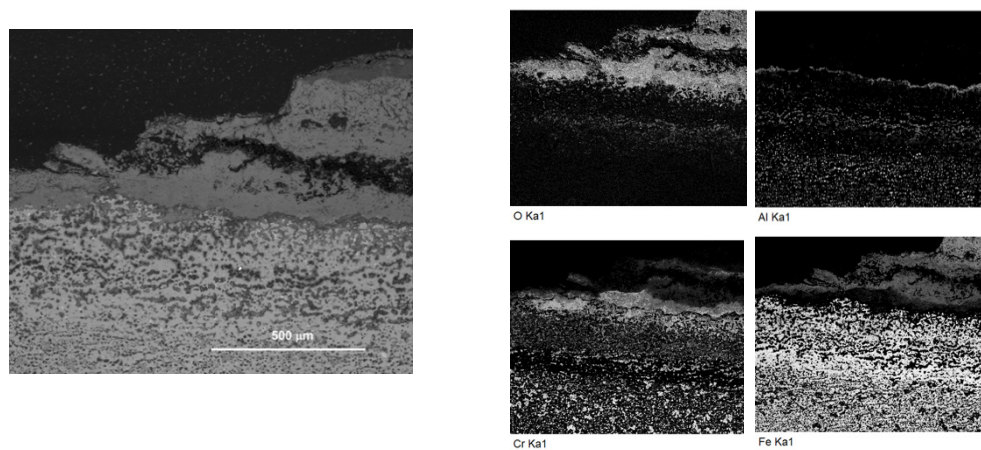
Figure 42 shows a SEM/BSE images of the top part of the tube. The sample was very corroded and indications of nitrides could be found all the through the sample, see EDX analysis. No traces of an alumina scale were observed on any part of the sample. Figure 43 shows the bottom part of the tube which had a similar microstructure and corrosion attack.

Figure 42. Backscattered SEM image and EDX analysis of the top of the FeCrAl tube

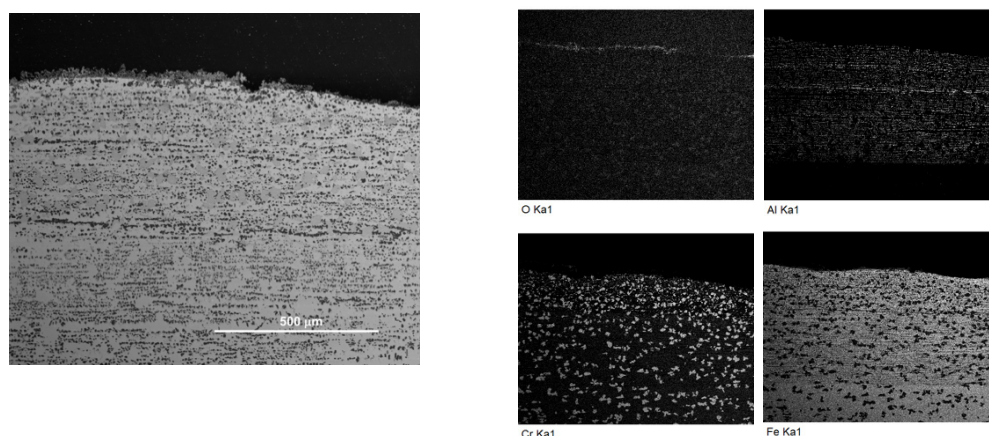
Figure 43. Backscattered SEM image and EDX analysis of the bottom of the FeCrAl tube

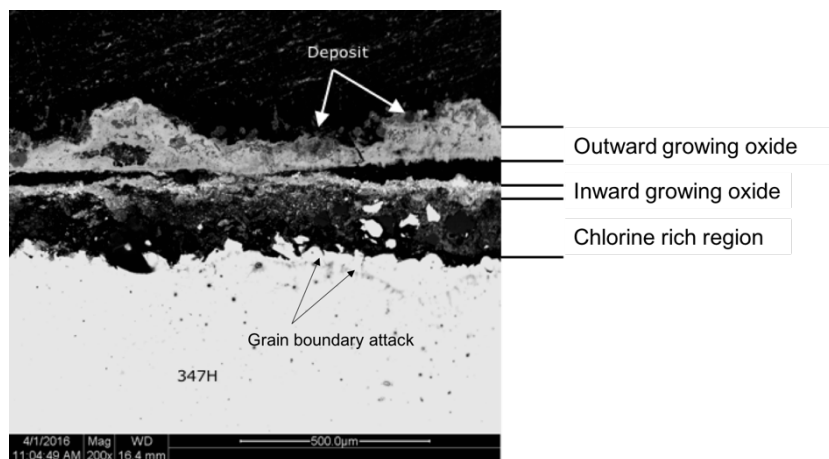
The SEM/EDX investigation of the cross-section shows that only small amounts of deposit are left on the sample, see Figure 45. The remaining deposit consist of K, Ca, Na and S while very little/no chlorine could be found in the deposit. The oxide scale is approximately 250 µm and composed of an outward growing Fe rich oxide of about 100 µm, and an inward growing Fe-Cr-Ni oxide. In the inner part of the oxide scale chlorine could be detected indicating the presence of metal chlorides, see Figure 46. Indications of alloy grain boundary attack could be observed on some positions.

**Figure 45. Backscattered SEM image of the 347H sample after 24h exposure**

The microstructural investigation of the air-cooled exposed 347H sample shows an extensive corrosion attack already after 24 hours exposure, see Figure 45. This may be caused by the rapid temperature ramp and the exposure of a clean metal surface in the hot flue gas initially building a very corrosive deposit, described above. Higher amounts of chlorine indicates the formation of metal chlorides at the metal/oxide interface and indications of an alloy grain boundary attack. However, the microstructure still indicates an ion diffusion controlled growth mode as the outward growing part consists of pure iron oxide/mixed with some deposit [22]. After 1000h exposure very little oxide could be observed on the sample while instead an extensive alloy grain boundary attack could be seen. This indicates a scale with low adhesion caused by metal chlorides at the metal/oxide interface and is concluded that the scale spalled off during sample preparation. The results from the microstructure investigation is in line with the fixed installed 347H sample where an alloy grain boundary attack also could be observed. The results indicate that the alloy grain boundary attack is driven by the corrosion and not changes (aging) of the alloy microstructure as has been reported in similar environments [20].

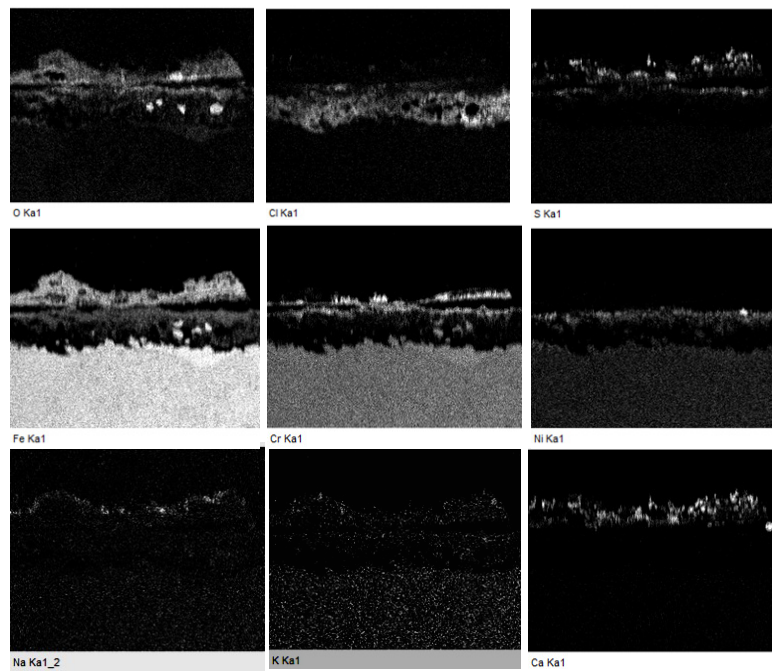
Figure 46. EDX mapping analysis of the 347H sample after 24h exposure

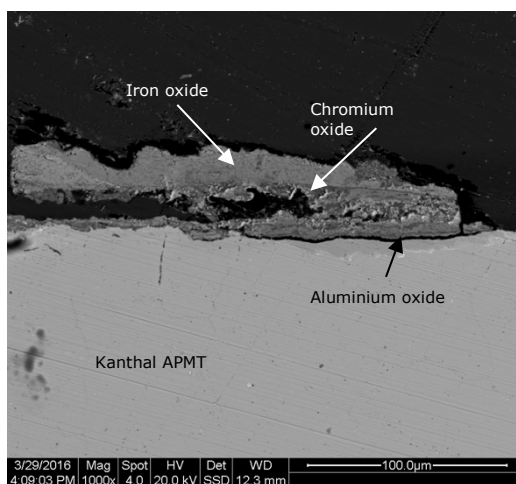
The SEM/EDX investigation of the Kanthal APMT alloy exposed at 700 °C also shows that only small amounts of deposit are left on the sample, see Figure 47. The remaining deposit consists of K, Ca, Na and S while very little/no chlorine could be found in the deposit also at 700 °C. The oxide scale is approximately 50 µm and composed of an outward growing Fe rich oxide of about 25 µm, and an inward growing Fe-Cr-Al oxide. A discontinuous aluminium oxide was found at the metal/oxide interface. SEM/EDX quantification showed that it was pure alumina. Indications of the formation of a Cr rich phase along alloy grain boundary could be observed in the bulk material, see Figure 48. No indications of any nitridation could be observed.

Figure 47. Backscattered SEM image of the Kanthal APMT sample after 24h exposure

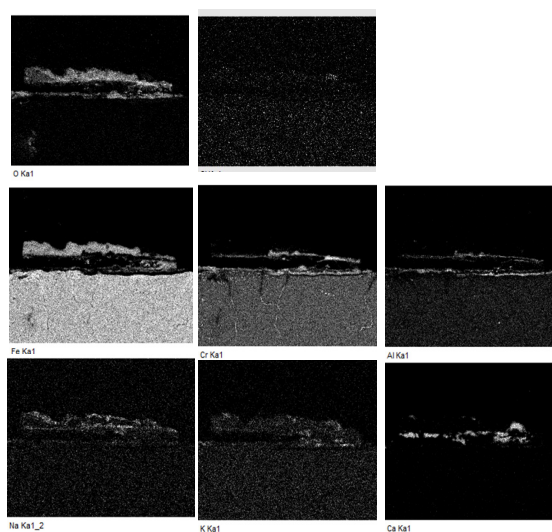
Figure 48. EDX mapping analysis of the Kanthal APMT sample after 24h exposure

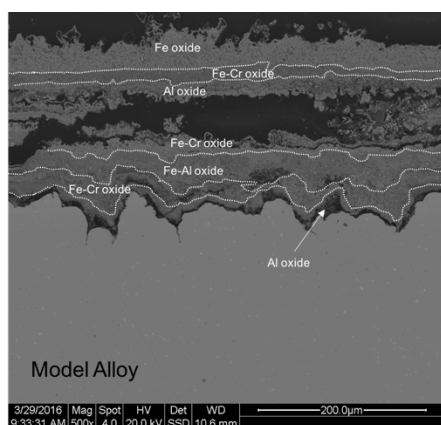
A representative image from the model alloy after 24h exposure is presented in Figure 49. The EDX analysis presented in Figure 50 shows that no or very little deposit was left after the handling of the sample. A chromium and aluminium oxide appears covering the whole surface of the sample and an approximately 100  $\mu\text{m}$  layered iron, chromium and aluminium oxide is formed over it.

Figure 49. Backscattered SEM image of the model alloy after 24h exposure

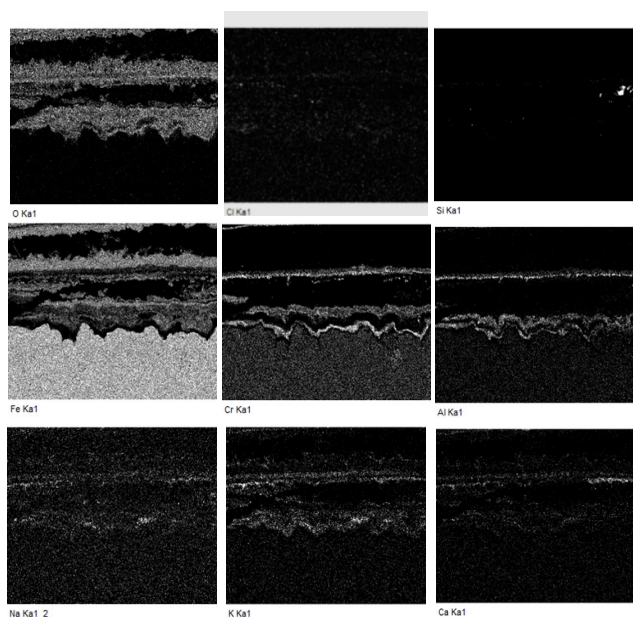
Figure 50. EDX analysis of the model alloy sample after 24h exposure

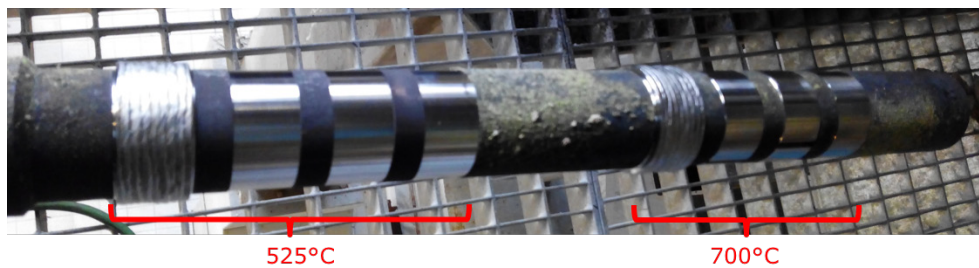
Nikrothal PM58, Inconel 625 over weld and a the FeCrAl model alloy (Fe10Cr3Al2Si). In order to study the corrosion attack after 1000h material loss measurements as well as cross-sections investigations by SEM/EDX analysis were conducted. Figure 51 shows the probes with the samples before and after the exposure. After 1000h exposure a thick deposit covers the probe. The sample closest to the probe tip, i.e. the model alloy sample ring broke due to mechanical failure during mounting on the probe. It was still possible to mount the sample and start the exposure (no extra sample was available). After 500 h exposure one part of the ring was lost exposing the thermocouple to the hot flue gas. This affected the thermocouple controlling of the 700 °C temperature zone for approximately 100 h of the exposure.

Figure 51. (a) Probe with the samples before exposure (b) Probe with the samples after 1000 h exposure in the Steamboost region

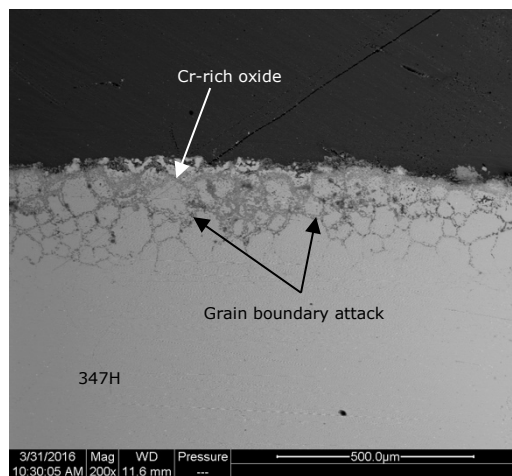
The cross section of the sample presented in Figure 53 shows that no deposit is left on the sample after 1000h exposure on the 347H sample. The thick deposit formed over the samples during the exposure was lost during the removal of the samples from the probe.

The SEM/EDX results show that very little of the oxide scale remains while a deep grain boundary attack could be observed. The attack penetrates about 300  $\mu\text{m}$  deep into the alloy. The EDX maps (Figure 54) shows that the oxide scale is formed mainly by chromium oxide at the grain boundaries and a nickel enriched metal close to the Cr rich oxide. Very little chlorine was detected and, when detected, it was at the outside of the alloy indicating spallation at the oxide/chloride/metal interface.

Figure 53. Backscattered SEM image of the 347H sample after 1000 h exposure

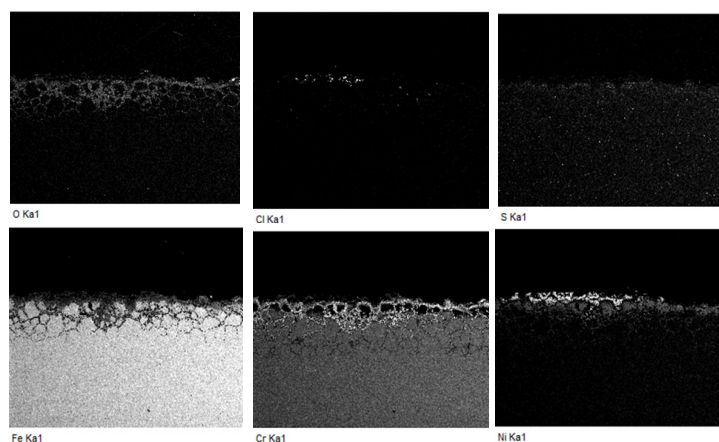
Figure 54. EDX mapping analysis of the 347H sample after 1000 h exposure

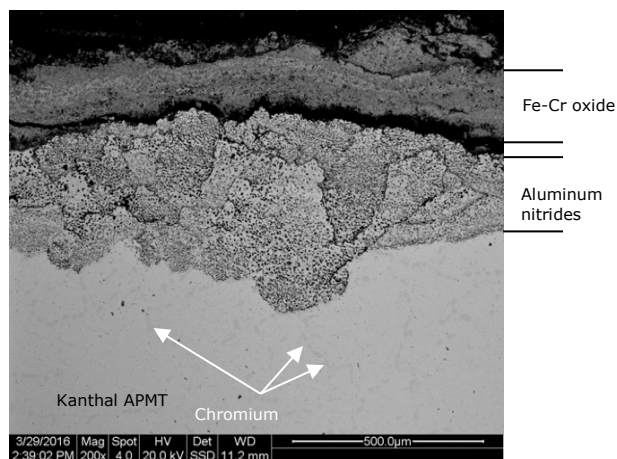
A cross-section of the Kanthal APMT sample exposed 1000h at 700°C is presented in Figure 55. The material is heavily corroded with a corrosion product layer thicker than 500  $\mu\text{m}$ . The EDX analysis (Figure 56) shows that the outer part of the corrosion products consists of an about 150  $\mu\text{m}$  iron-chromium oxide layer. This is followed by a very thick and non-continuous and non-protective aluminium oxide. A large nitridation zone could be observed as well as the formation of a Cr rich phase in the bulk.

Figure 55. Backscattered SEM image of the Kanthal APMT sample after 1000h exposure

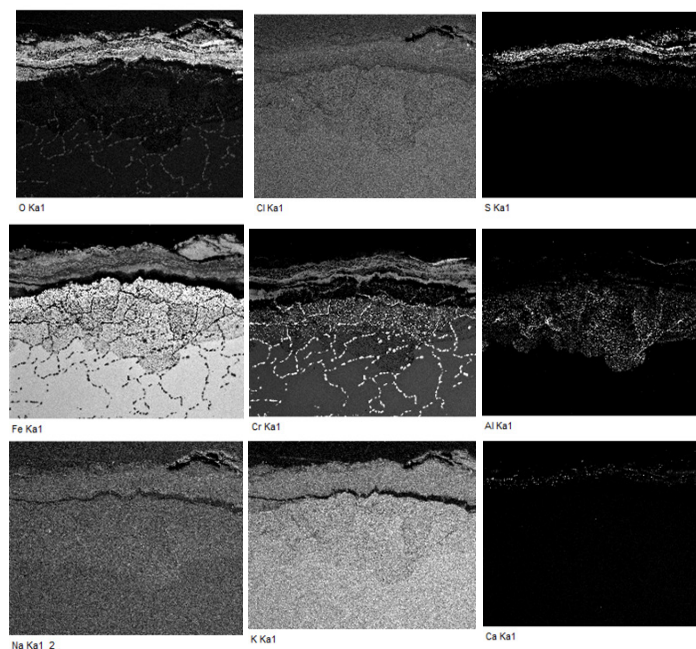
Figure 56. EDX mapping analysis of the Kanthal APMT sample after 1000h exposure

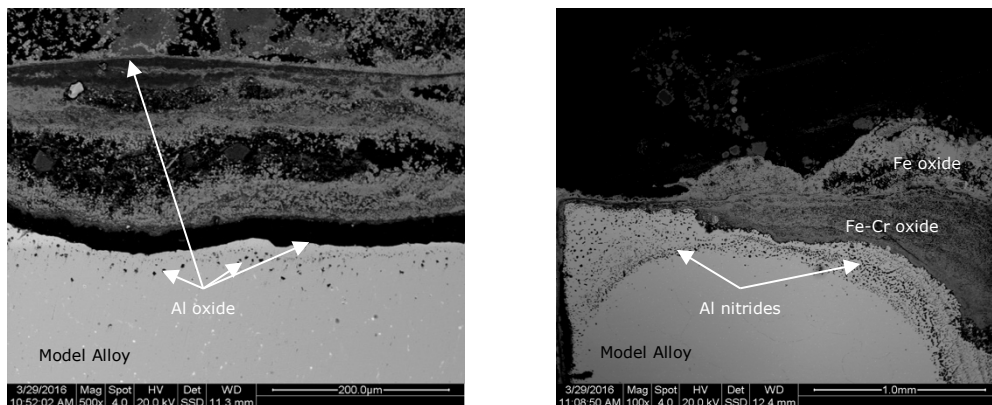
Figure 57 shows two cross-sections of the model alloy sample after 1000h exposure. Due to mechanical failure, the sample was cracked when inserted. During the exposure half of the sample ring fell off, leaving the thermocouple exposed during approximately 100h until a deposit covered the area again. The failure makes the temperature profile during the exposure uncertain.

The Figure 57(a) shows the surface of the non-broken remaining part. The SEM/EDX analysis presented in Figure 58 indicates that an alumina oxide has formed at the metal/oxide interface all over the sample. No signs of nitridation could be observed beneath the alumina scale. Figure 57(b) shows a part of the sample near the crack of the sample which is heavily corroded where homogeneous alumina was formed on the surface.

Figure 57. Backscattered SEM image of the model alloy sample after 1000h exposure (a) non-broken part (b) broken part

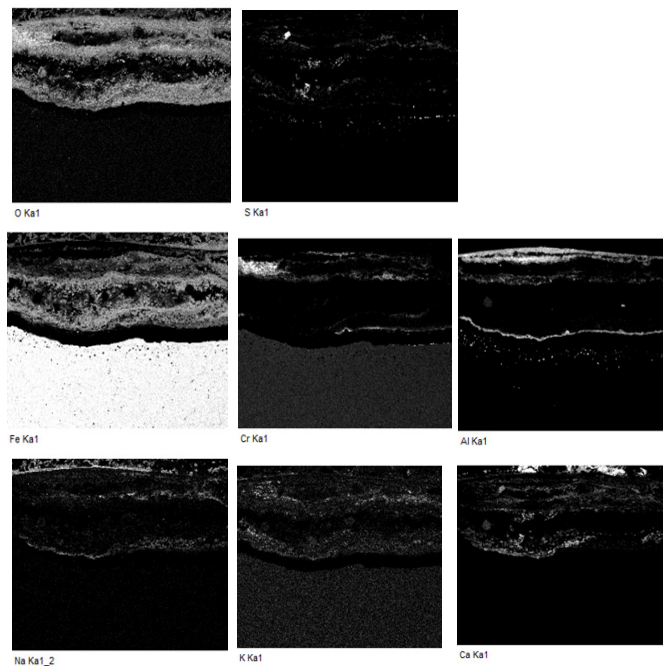
Figure 58. EDX mapping analysis of the model alloy sample after 1000h exposure (non-broken part)

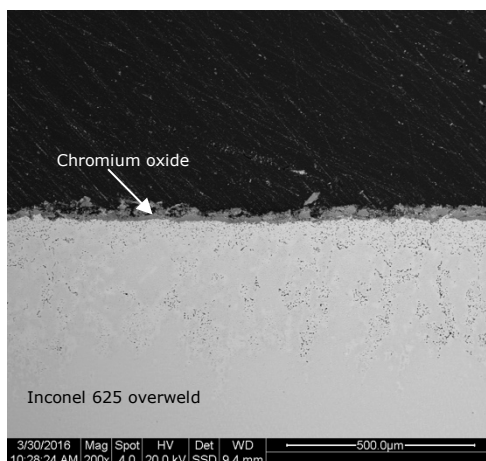
Figure 59 shows an image of the Inconel 625 over welded material. After 1000h exposure at 700 °C the surface is covered by a 20 µm thick chromium rich oxide.

Figure 59. Backscattered SEM image of the Inconel 625 overwelded sample after 1000 h exposure
