# INCREASED STEAM TEMPERATURE IN GRATE FIRED BOILERS

RAPPORT 2018:551

# Increased Steam Temperature in Grate Fired Boilers

Steamboost

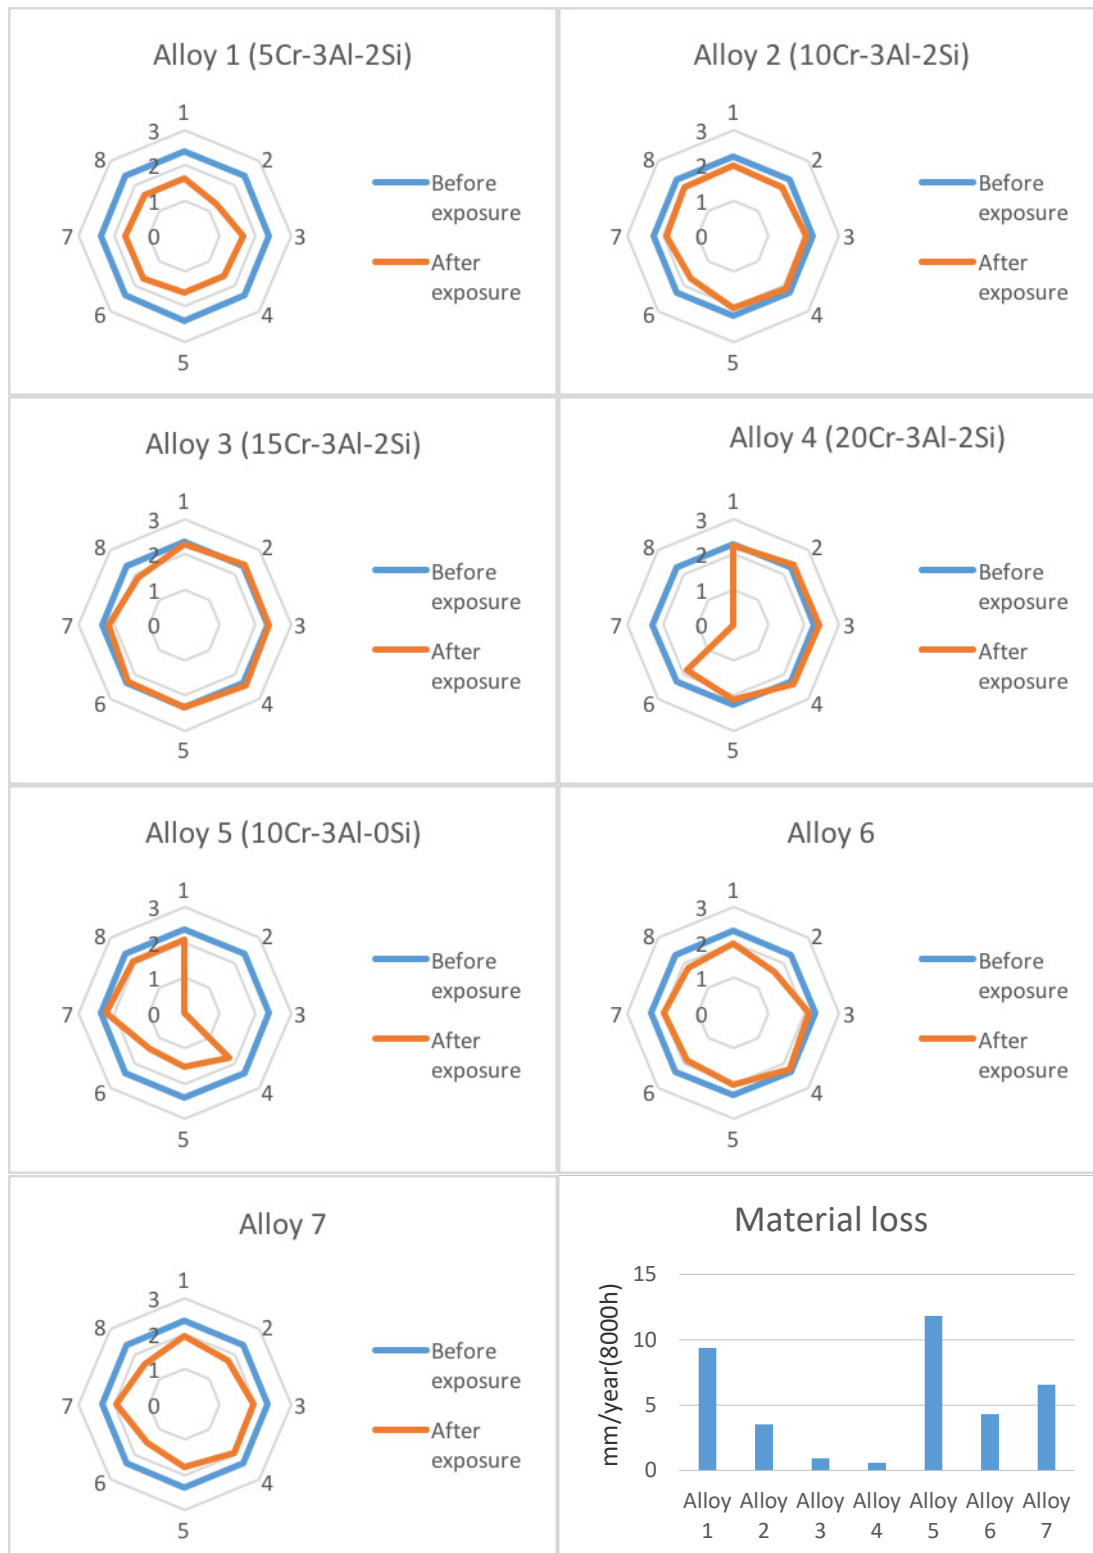
The material loss was calculated and is presented in Figure 60. It has also been illustrated in 7 different diagrams (one for each sample ring, except for the over weld). From alloy 1 to alloy 4, the Cr content is varied. An increased corrosion resistance is observed by terms of reduced material loss. However, for alloy 4, two of the measuring points after exposure is set to zero. This result is due to the ring breaking when trying to remove it from the probe. This indicates an embrittlement of the material as the Cr content is increased. For alloy 3, the material loss is close to zero all over the ring except for one of the measuring point in which the corrosion attack was more severe (see Figure 62). This is due to this part of the ring being situated on the flue gas side, causing a much harsher environment.

The difference in composition between alloy 2 and alloy 5 is the silicon content. Alloy 2 demonstrates a much higher corrosion resistance compared to alloy 5, in which large parts of the ring has been corroded all the way through.

Figure 60: Material loss after corrosion test of FeCrAl model alloys.

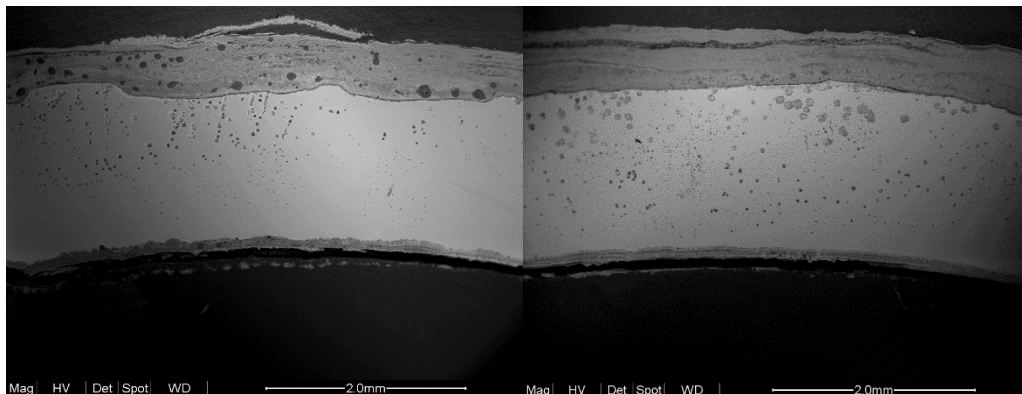
Figure 61 shows two different cross section images of alloy 1. As can be seen, the material loss is roughly the same all over the ring. Figure 62 shows SEM cross sections of the alloy 3 sample ring which is the sample that performed the best. In the left image a cross section from the least corroded area is shown. Barely any oxide is visible and the material loss is close to zero. This is the case for the majority of the sample ring surface. The exception is the part of the ring that was on the flue gas side which has corroded much more severely. This can be seen in the left image of Figure 62 as the oxide is reaching into the material.

**Figure 61:** SEM cross section images of two different points of the alloy 1 sample ring.

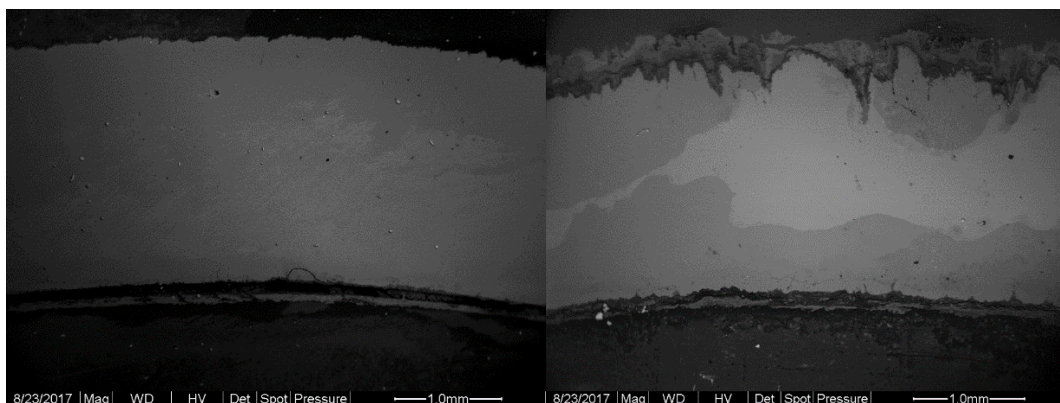
**Figure 62:** SEM cross section images of the least severely corroded (left) and the most severely corroded (right, flue gas side) point on the alloy 3 sample ring.

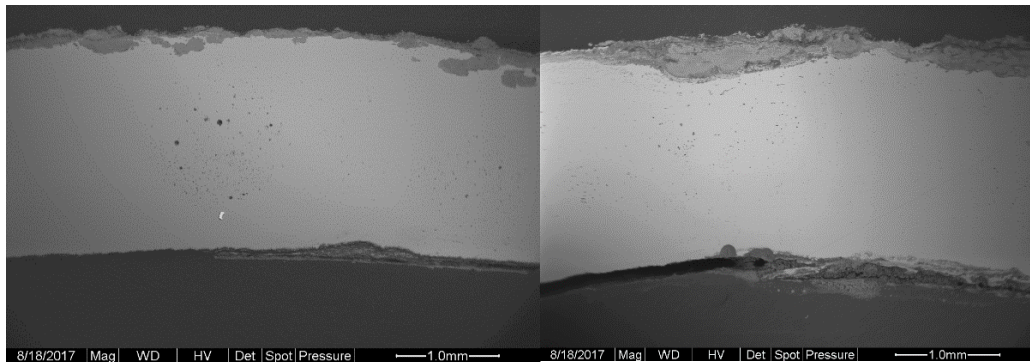
Figure 63 and Figure 64 shows SEM cross section images of alloy 2 and alloy 5 in which the silicon content is varied from 2 to 0 wt-%. The material loss for alloy 2 is quite uniform all along the ring but slightly higher at the flue gas side (see right image in Figure 63). Alloy 5 has only a few areas of the ring which isn't severely corroded (see left image of Figure 64) and on the flue gas side the sample ring has been corroded all the way through the ring (see right image of Figure 64).

Figure 63: SEM cross section images of the least severely corroded (left) and the most severely corroded (right, flue gas side) point on the alloy 2 sample ring.

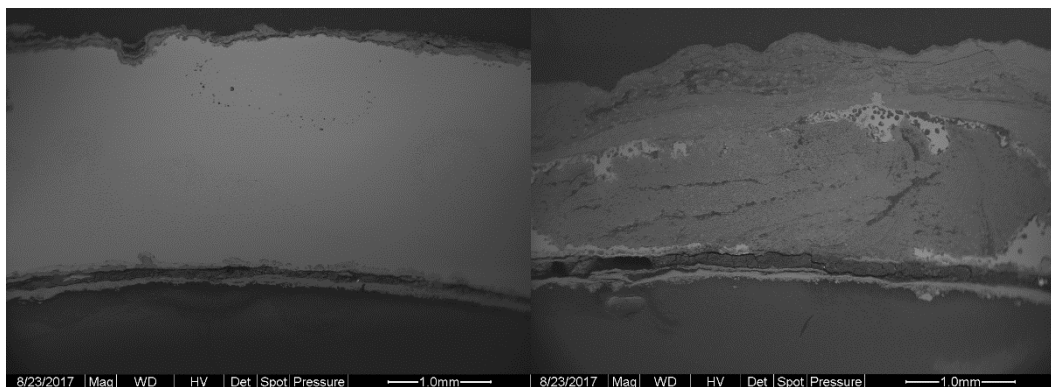
Figure 64: SEM cross section images of the least severely corroded (left) and the most severely corroded (right, flue gas side) point on the alloy 5 sample ring.

The silicon content is varied between alloy 2 (2% Si) and alloy 5 (0% Si). The material loss varies significantly and shows a clear trend of increased corrosion resistance upon addition of Si. This correlates well with the results from the laboratory study in which small additions of silicon resulted in a large decrease in corrosion rate. The SEM cross section images show that the severity of the corrosion attack doesn't differ to such a large extent between the part of the ring pointing towards the flue gas side and the rest of the ring for alloy 2. But for alloy 5 (0% Si) a large part of the ring is corroded almost all the way through the ring.

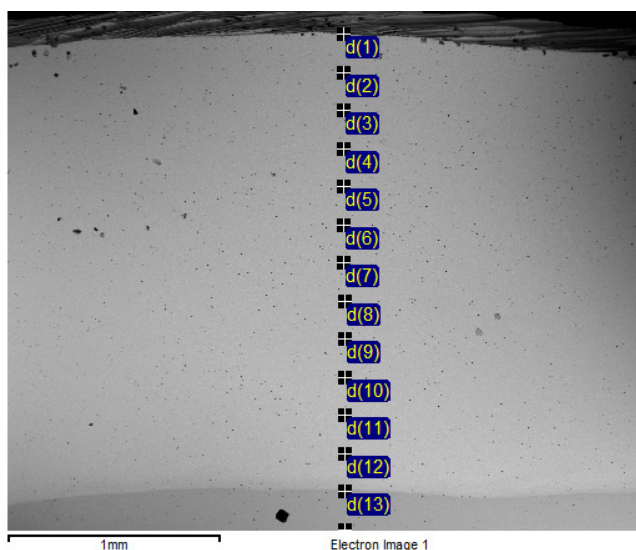
As mentioned earlier a reference ring, consisting of an Inconel 625 over weld was exposed together with the other FeCrAl alloy rings. A non-exposed Inconel 625 ring was analysed with EDX to investigate if Fe from the substrate had diffused into the Inconel over weld during the welding (see figure). The iron content remained constant at 1 at-% throughout the over weld layer.

Figure 65: SEM cross-section image of unexposed Inconel 625 over weld showing the points of EDX-analysis

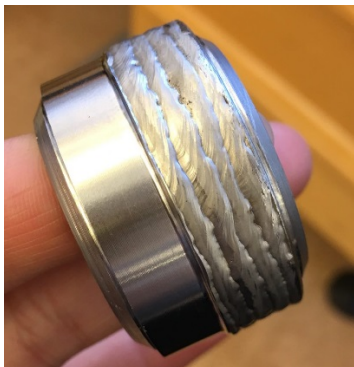
In very corrosive environments alloy 625 over weld is commonly used. The aim in this project was therefore to compare with this material and it was included as a reference in all exposures. The project group decided to keep the surface as received as the surface finish is known to influence the corrosion properties. However, this made material loss measurements difficult. The average corrosion attack was instead investigated as shown in section 6.3.4. An attempt was in addition performed to investigate both the general behaviour as well as a smooth pre-measured surface. In this way both the average corrosion attack could be observed and a material loss measurement performed. Half of a ring sample was turned and measured prior to the air-cooled exposure, see Figure 71. However, the

compressed air to the probe failed during the exposure and no results could be acquired from the sample. This may be a strategy for future investigations.

**Figure 71:** Picture of the half turned Inconel 625 over weld ring.

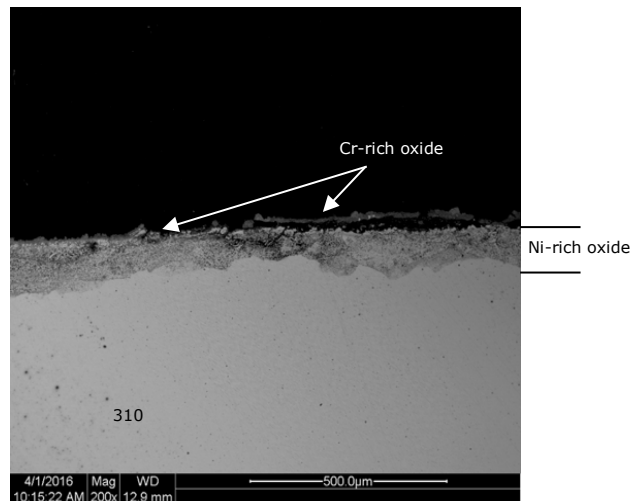
No deposit was found over the 310 sample after 24h. That was due to falling off of the deposit while removing the samples from the probe (Figure 72).

Figure 72. Backscattered SEM image of the 310 sample after 24h exposure

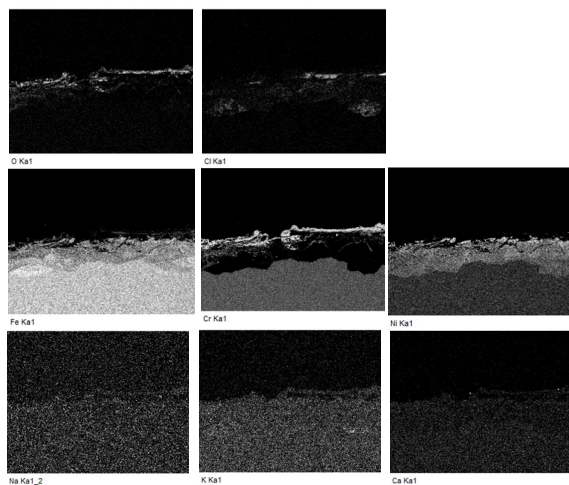
The EDX maps presented in Figure 73 show a layer of chromium rich oxide present on the top of the sample, all over the surface, followed by a 150 – 200 µm nickel rich oxide. Small amounts of chlorine were detected on the top of the sample which are remains of the fallen deposit.

Figure 73. EDX mapping analysis of the 310 sample after 24h exposure

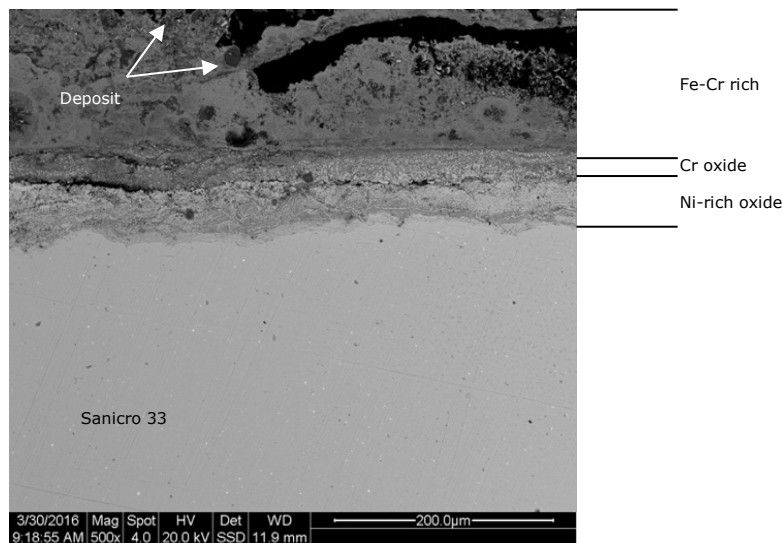
The Sanicro 33 sample presents a chromium oxide layer all over the surface (Figure 74). On the top of this layer, a Fe-Cr rich non-homogeneous outward growing oxide was found. A 50  $\mu$ m nickel rich oxide is present under the chromium oxide.

Figure 74. Backscattered SEM image of the Sanicro 33 sample after 24h exposure

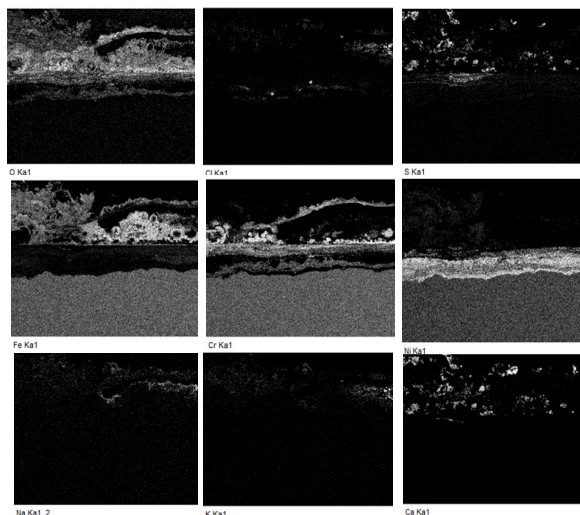
Some traces of the deposit formed during the exposure still present over the oxide. As an effect of cutting and polishing of the samples, the EDX analysis presented in Figure 75 shows some calcium mixed within the oxide.

Figure 75. EDX mapping analysis of the Sanicro 33 sample after 24h exposure

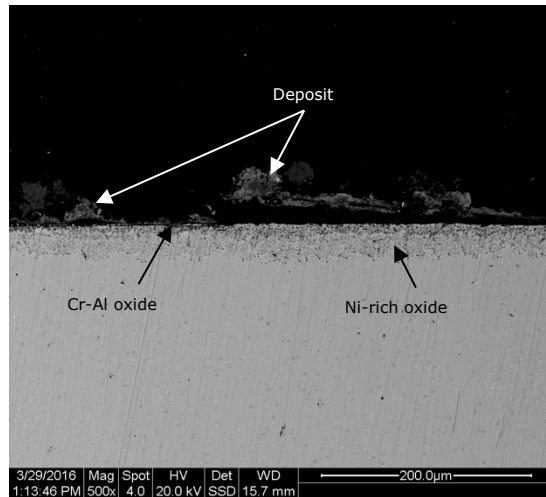
The Nikrothal PM58 presents a smooth surface with very little corrosion after the 24h exposure at 700°C (Figure 76). A very thin chromium-aluminium oxide is found all over the surface and a nickel enrichment is found under. The traces of the deposit over the surface are mainly potassium and calcium (Figure 77).

Figure 76. Backscattered SEM image of the Nikrothal 58 sample after 24h exposure

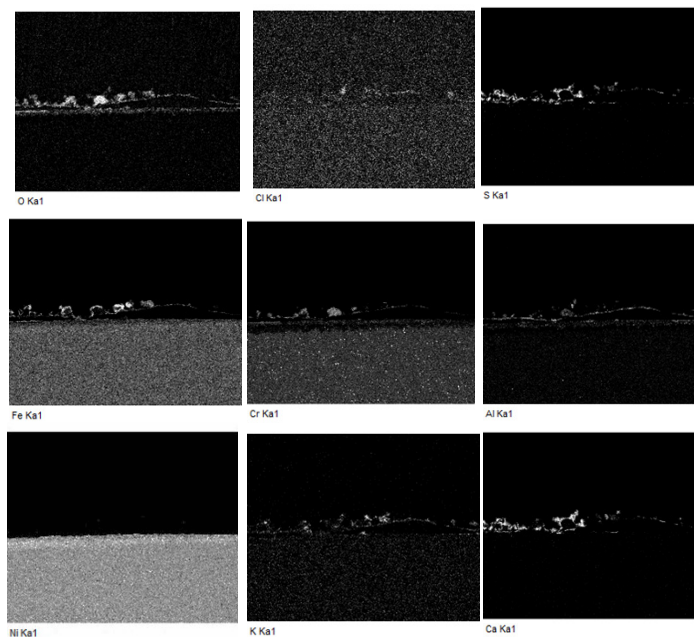
Figure 77. EDX mapping analysis of the Nikrothal 58 sample after 24h exposure

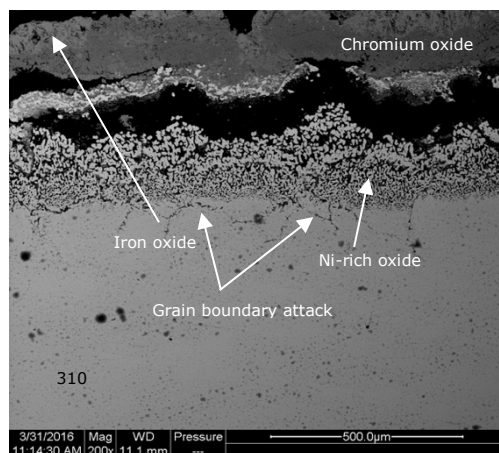
A cross section of the 310 sample after 1000h is presented in Figure 78. The corrosion products layer found is around 500  $\mu\text{m}$ . According to the EDX analysis (Figure 79) it is composed by an outer iron oxide layer followed by a thick chromium oxide of about 50-80  $\mu\text{m}$ . A thick and porous nickel rich oxide was found under that, followed by a deep grain boundary attack with mainly iron oxide in the grain boundaries and nickel enriched oxide when reaching the surface of the sample.

No deposit remains were found over the sample.

Figure 78. Backscattered SEM image of the 310 sample after 1000h exposure

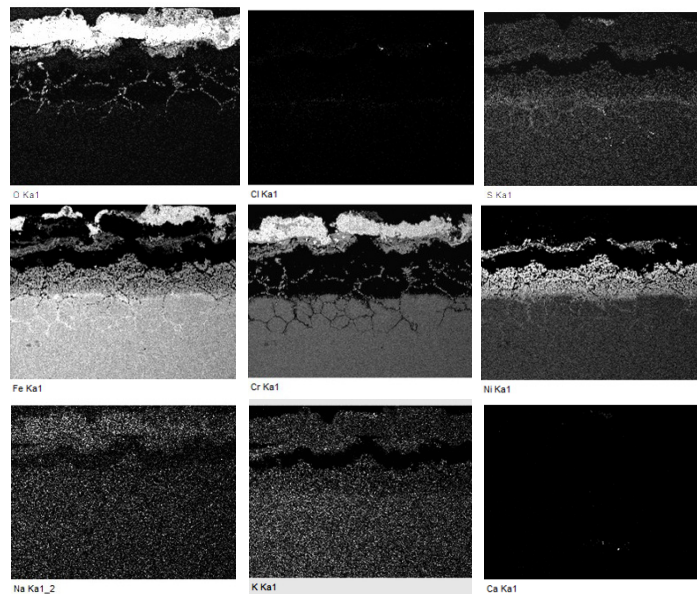
Figure 79. EDX mapping analysis of the 310 sample after 1000h exposure

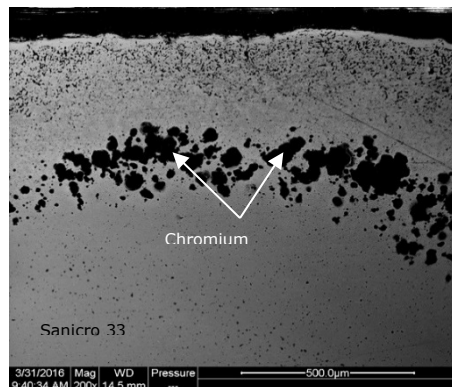
The Sanicro 33 sample cross-section is presented in Figure 80. After 1000h exposure at 525°C it presents corrosion products thicker than 500 µm.

Figure 80. Backscattered SEM image of the Sanicro 33 sample after 1000h exposure

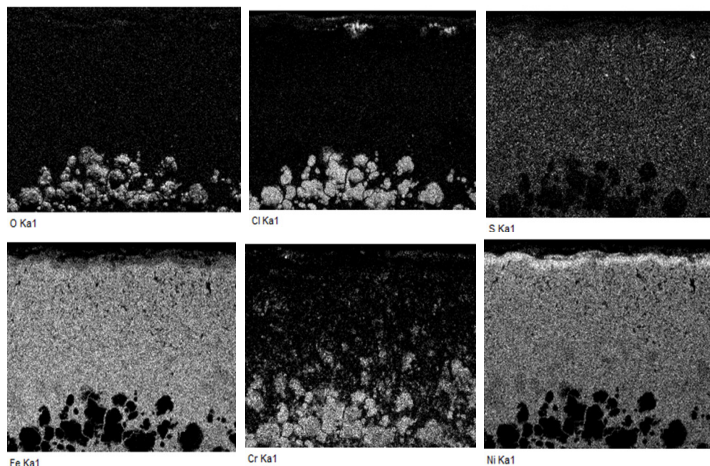
The most remarkable corrosion effect for this material, showed in the EDX analyses of Figure 81 is the effect of the chlorine penetration. Very big rounded-size chromium chlorates were found up to 500 µm deep into the material. Some chlorine is still present on the surface of the sample and chromium enrichments were found all the way until the big chromium chlorates. This indicates that the chlorine was able to travel through the grain boundaries deep into the material causing a big corrosion attack.

Figure 81. EDX mapping analysis of the Sanicro 33 sample after 1000h exposure

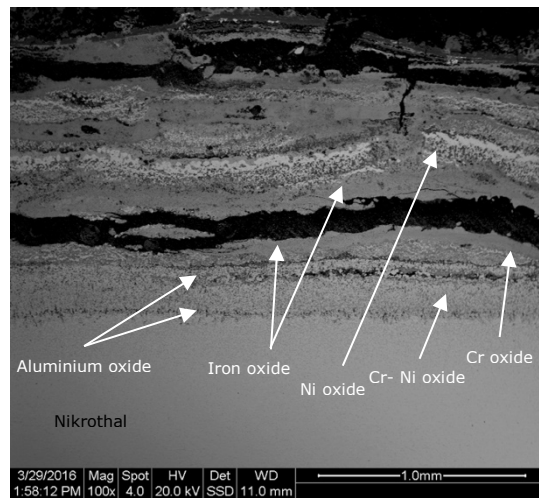
A cross-section of the Nikrothal PM58 sample after 1000h exposure is presented in Figure 82. It presents a very thick layer of corrosion products of around 1mm which has been separated from the surface due to sample preparation. It is possible that the corrosion products are even thicker than those shown in the figure as some parts could have been lost during the handling of the samples after the exposure. The EDX analysis presented in Figure 83 shows that the corrosion products are formed by non-homogeneous layers of different oxides. An aluminium oxide layer is covering the whole surface of the sample, followed by a chromium-nickel oxide. Another alumina layer has grown over that followed by a thicker chromium oxide. Over those oxide layers a thick layer of iron oxide has grown. The rest of the corrosion products over are a mix of nickel, iron and aluminium oxides.

Figure 82. Backscattered SEM image of the Nikrothal PM58 sample after 1000h exposure

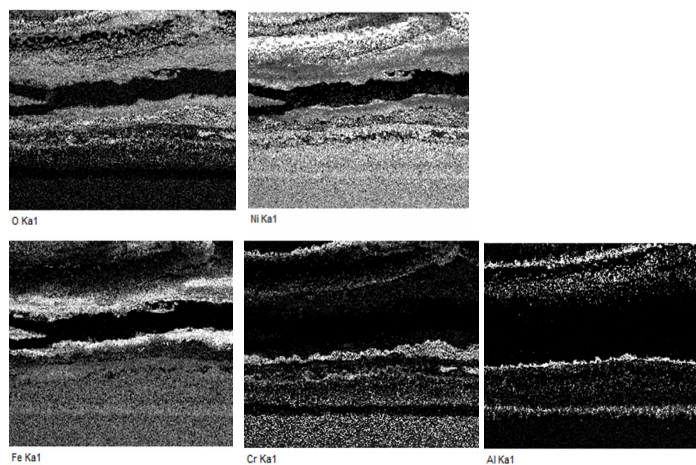
Figure 83. EDX mapping analysis of the Nikrothal PM58 sample after 1000h exposure
