# SAMPO Workshop 27 – 28.11.2019

## New "Lining" in Tanks on Ringhals AB

22-11.2019 Stjepan Jagunic

Expiriens – Leakage in PTFE pipe on  
Ringhals AB

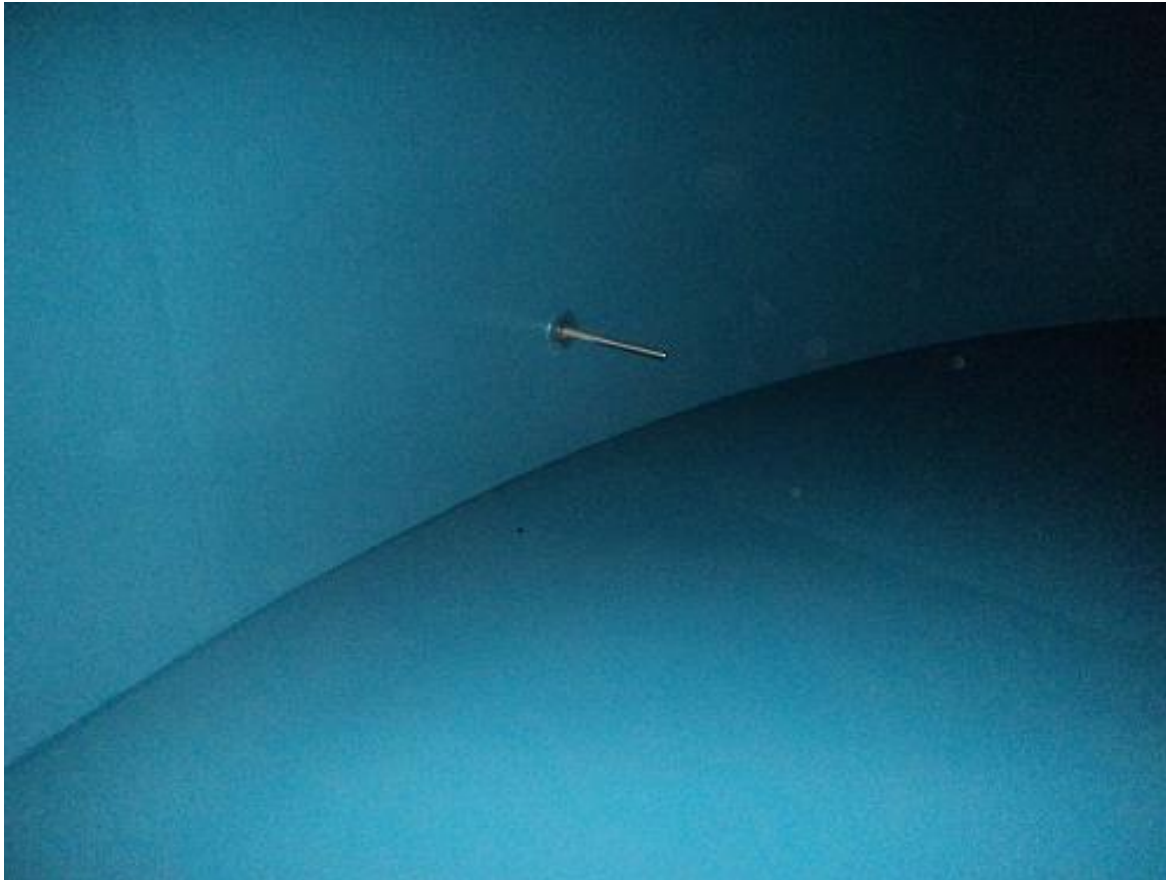
## Outage 2019 - visual inspection

On the south side of the tank roof, an area of about 0.5 m<sup>2</sup> was noted where the upper inner composite layer has dropped from the underlying composite layer. However, nothing has fallen into water.

The reason was hot days and exceeded time span for application of the second composite layer. The underlying layers were intact.

4 m<sup>2</sup> of the bad adhesive layer was removed before repair.
