Measurement and analysis of piping vibrations in turbine feed-water systems

Vibrations in nuclear applications 2020

Thomas.Probert@OKG.Uniper.Energy

Applying the methodology to damage in system 462

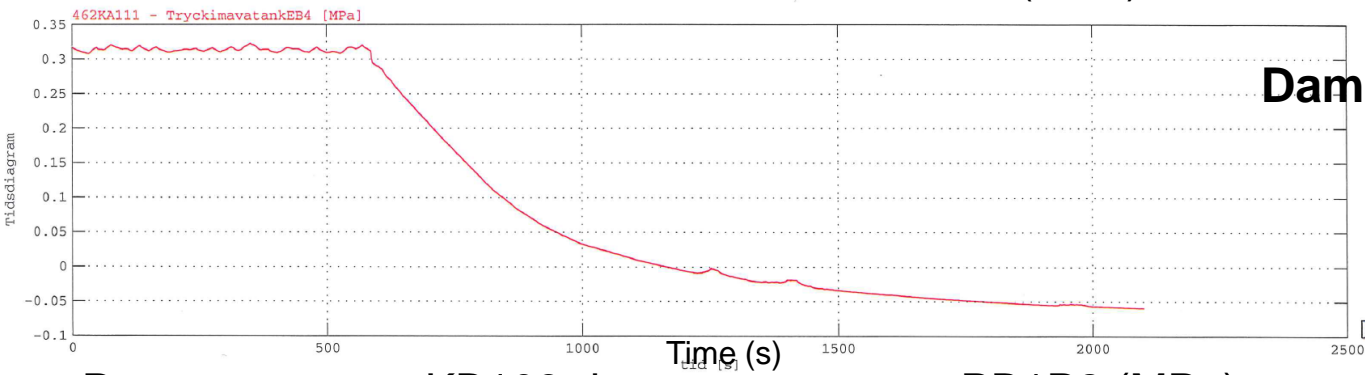
Pressure sensor KA111 in the feed-water tank (MPa)

The load that until recently was denoted unknown load

Pressure sensor KA111
in the feed-water tank

Pressure in the feed-water tank and in loop B downstream PB1P2

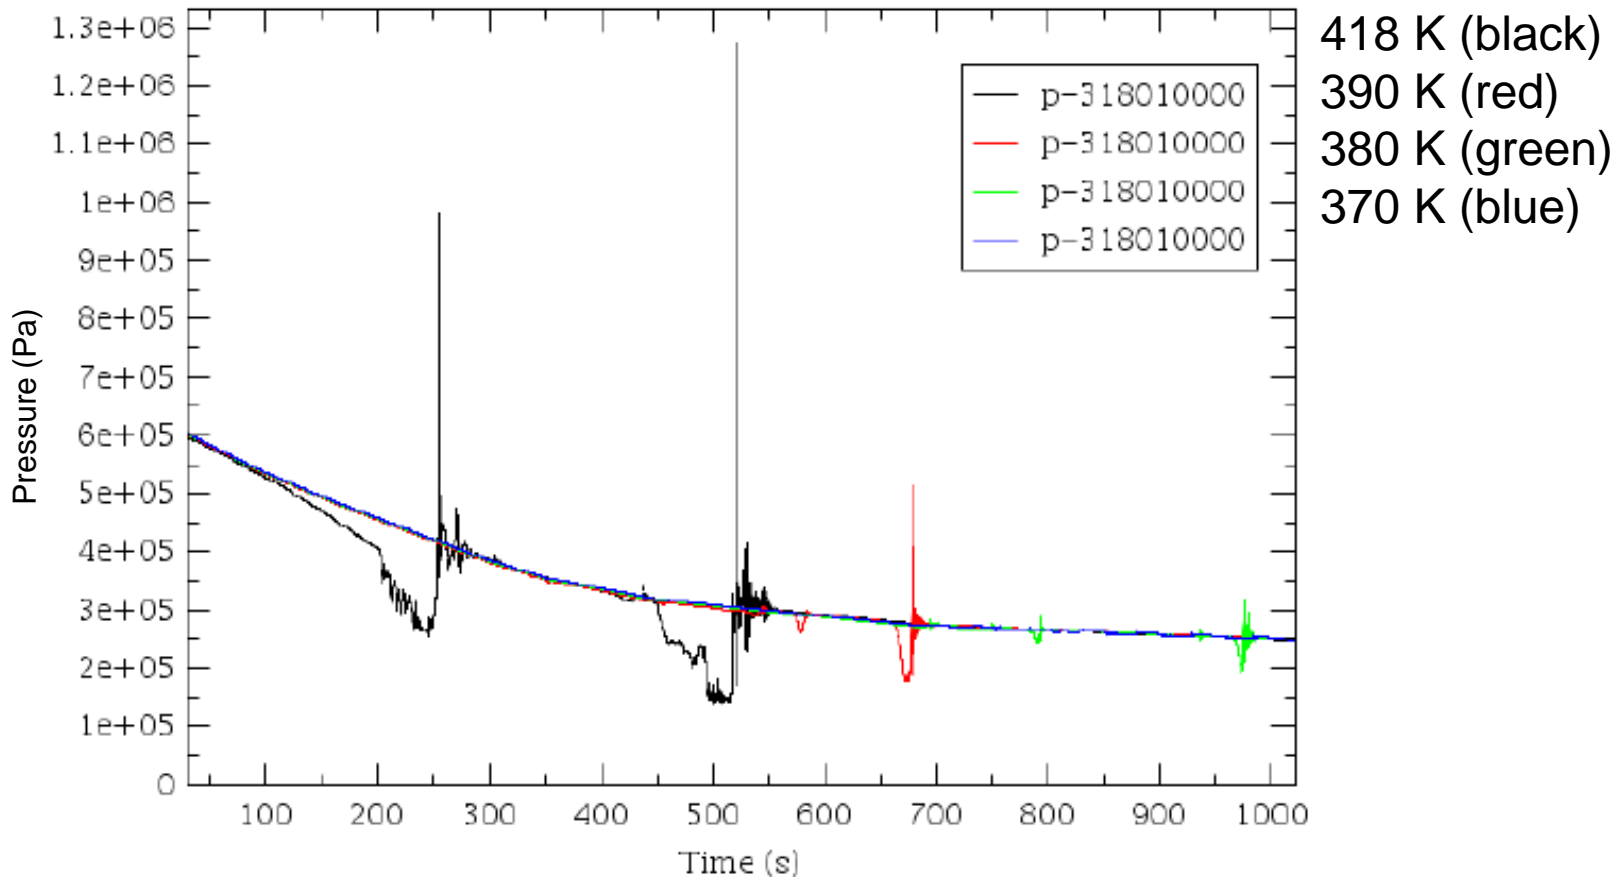
Loop temperature dependency

Initial temperature in the loop

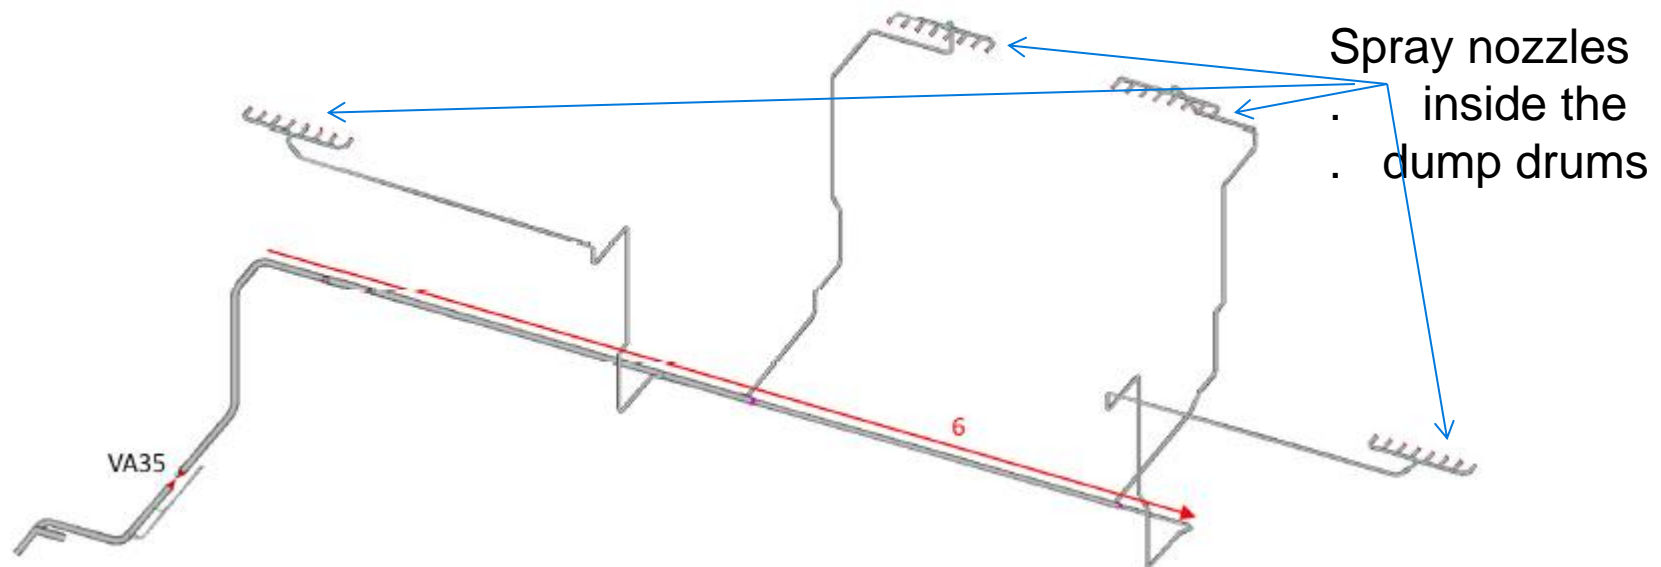
The piping leading to the dump-drums

- Damaged supports were found
- Small bore piping was displaced in several places, some supports had loose expanders and one support was cracked
- The cause was said to be fatigue and displacements due to vibrations and water-hammers. **No specific load was identified. More investigation was needed**
- We installed accelerometers on the damaged supports and ran the plant for another cycle

The system is used to spray water into the dump drums to condensate steam that is dumped there from the steam-lines.
