# INCREASED FUEL FLEXIBILITY AND PERFORMANCE FOR BOILERS WITH CHALLENGING FUELS

RAPPORT 2023:928

# Increased fuel flexibility and performance for boilers with challenging fuels

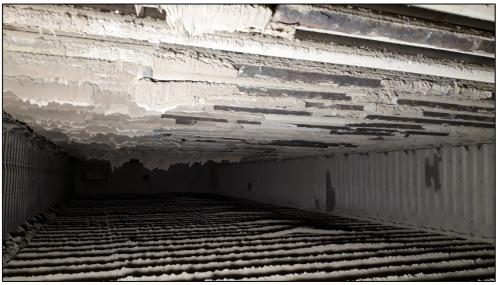
Figure 6 Manhole view at level +5 (evaporator bank) in the boiler Händelö P14. The top row of tubes corresponds to the "roof" position, while the bottom row is the "floor" position.

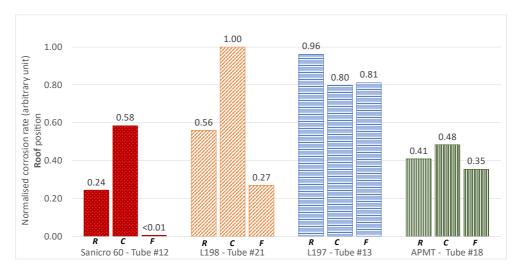
Figure 9 Normalised corrosion rate or metal loss of overlay welds in arbitrary units corresponding to the "roof" position described in Figure 6. Sanicro 60, L198, L197 and Kanthal® APMT cladding materials were included in the assessment. The plot shows the corrosion rate of three areas of each tube shield (edge R, edge F and C).

The dispersion of the results and the seeming inconsistencies (for example the difference shown by Sanicro 60 roof position between the sides and the centre of the tube), are indicatives of several phenomena not only inside the complex boiler environment, but as well of the challenges during the welding process of the clads.

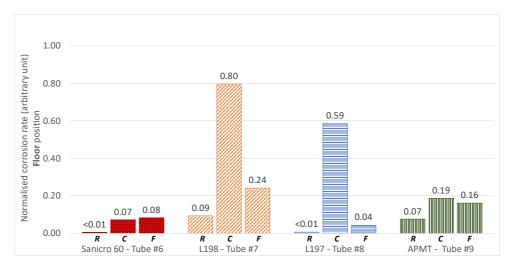
Figure 10 Normalised corrosion rate or metal loss of overlay welds in arbitrary units corresponding to the "floor" position described in Figure 6. Sanicro 60, L198, L197 and Kanthal® APMT cladding materials were included in the assessment. The plot shows the corrosion rate of three areas of each tube shield (edge R, edge F and C).

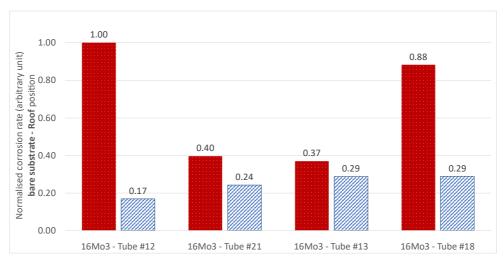
Figure 11 Normalised corrosion rate or metal loss of the bare substrate material (16Mo3) in arbitrary units corresponding to the "roof" position described in Figure 6. The plot shows the corrosion rate of the two ends of each tube shield (edge R and edge F) at a position without overlay weld.

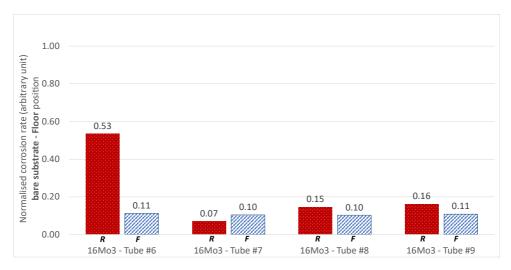
Figure 12 Normalised corrosion rate or metal loss of the bare substrate material (16Mo3) in arbitrary units corresponding to the "floor" position described in Figure 6. The plot shows the corrosion rate of the two ends of each tube shield (edge R and edge F) at a position without overlay weld.

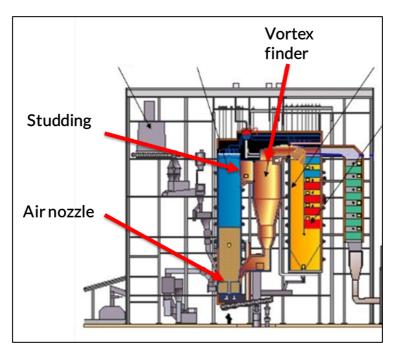
Figure 14 WP3 investigation comprised of specimens retrieved from boilers Händelö P14 and Mälarenergi P6, at the indicated positions (vortex finder, studding, air nozzle).

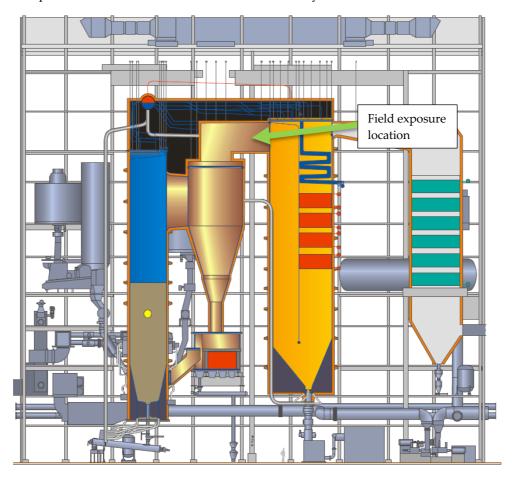
Figure 30 Schematic of location of the field exposure. The probe was installed in a manifold duct just before the vertical empty pass in Mälarenergi P6 boiler system.

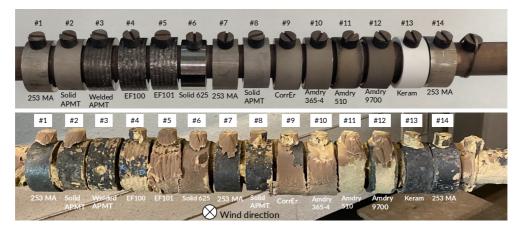
Figure 34 Metallic rings before and after exposure. The rings were fastened to the probe with Kanthal® APMT™ bolts to prevent potential shift during exposure. The bolt corresponding to one of the specimens was lost during the probe installation process and consequently the specimen was rotated approximately 90° with respect to the others. The wind direction is shown in the bottom picture.

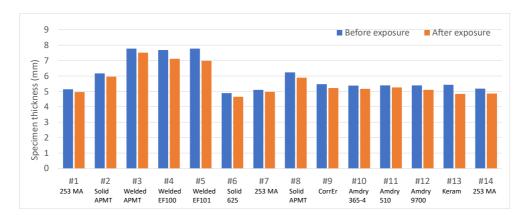
Figure 35 Specimen thickness before and after exposure. Before exposure the specimens were measured with a micrometre (solid and sprayed coated specimens) or a calliper (welded specimens). After exposure, the thickness of the specimens (approximately 30° off from the wind side) was measured using a light optical microscope and the software ImageJ. The horizontal axis refers to the specimen number shown in Table 10 and Figure 34.

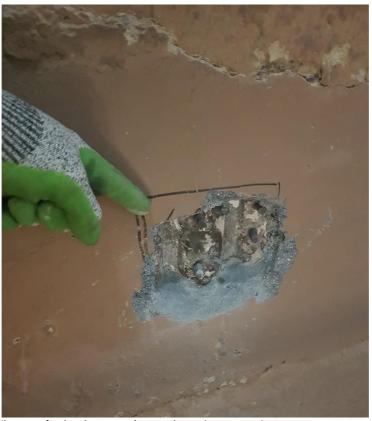
The boiler areas where the broken-out samples were taken were, after no tube damage was seen, then carefully casted using the same product, see Figure 53. The area was marked on the refence drawings including production date, batch number etc should any follow-up be needed. The re-installed areas were given the standard dry-out needed as there were also other areas re-lined in the boiler.

Figure 53 Boiler area after break-out sample was taken, prior to re-casting.

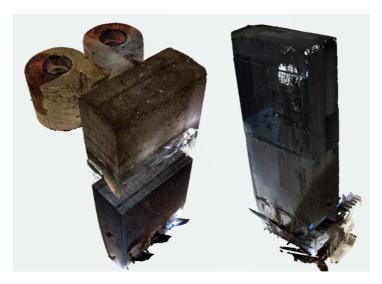
Figure 54 3D cloud image from multiple scan positions giving a 360 degree image fully measurable.

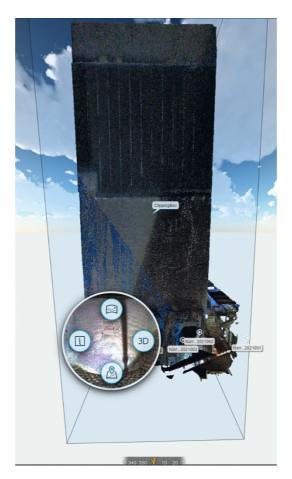
$Figure\ 56\ Use\ of\ the\ 3D\ scan\ cloud\ to\ orient\ and\ check\ detailed\ areas\ in\ various\ views\ such\ as\ panoramic.$

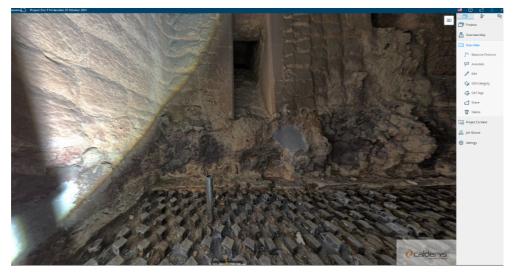
Figure 57 From the image seen in Figure 56 it is one click to get a 3D view fully measurable for surface analysis.

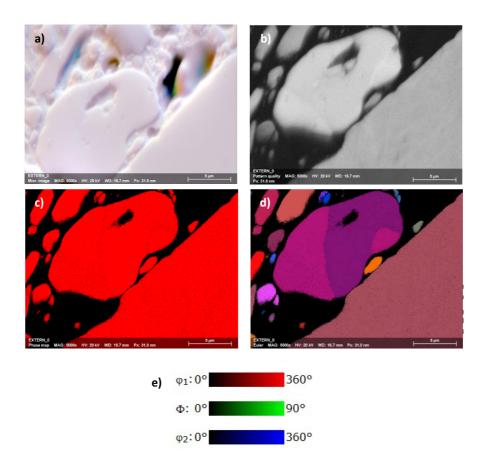
Analysis of refractory material (CALDE® STIX PB 85 CG) shows that the Al<sub>2</sub>O<sub>3</sub>-phase gives diffraction patterns and can be indexed, see Figure 58. No other crystalline phases are identified and/or indexed in the material (in the binding

Figure 58 a) Forward scattered electron (FSE) image of CALDE® STIX PB 85 CG reference (0 years) taken at x5000, with corresponding EBSD maps: b) pattern quality map, c) phase map (red =  $Al_2O_3$ ), d) Euler angle orientation map, and e) corresponding Euler angle legend.

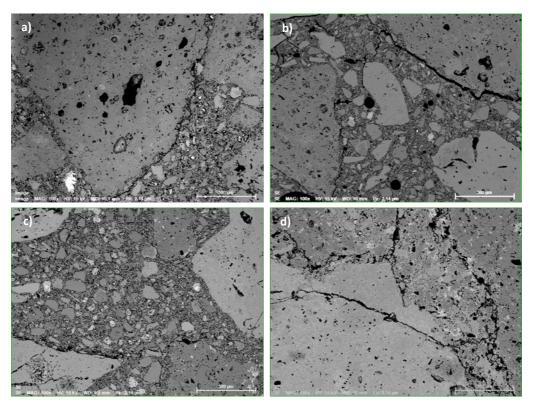
The microstructures of CALDE® CAST LM74A and CALDE® SPRAYCAST SIC 70 consist of crystals, both large (hundreds of micrometres) and smaller (tens of micrometres), dispersed in a binding phase, see Figure 59 and Figure 60.

Figure 59 SEM-images of CALDE® CAST LM74A after different exposure times: a) reference, 0 years (specimen CALDE LM74-REF); b) 7 months, 0.6 years (specimen EON LM74-7m); c) 2 years (specimen EON LM74-2y); and d) 7 years (specimen ME LM74-7y). Notice that the material extracted from Mälarenergi (specimen ME\*) is from a different material batch compared to the CALDE and EON materials (specimens CALDE\* and EON\*).

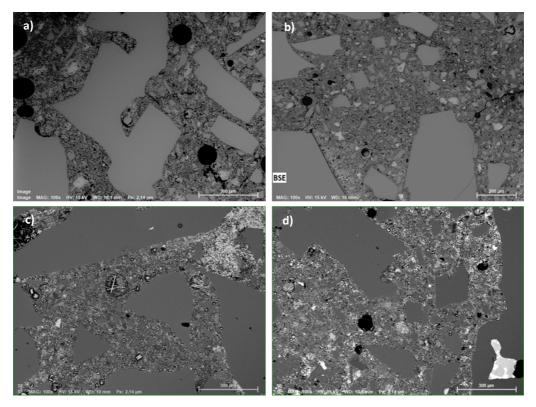
Figure 60 SEM-images of CALDE® SPRAYCAST SIC 70 after different exposure times: a) reference, 0 years (specimen CALDE SIC-REF); b) 6 months, 0.5 years (specimen EON SIC-6m); c) 2 years (specimen EON SIC-2y); and d) 7 years (specimen ME SIC-7y). Notice that the material extracted from Mälarenergi (specimen ME\*) is from a different material batch compared to the CALDE and EON materials (specimens CALDE\* and EON\*).

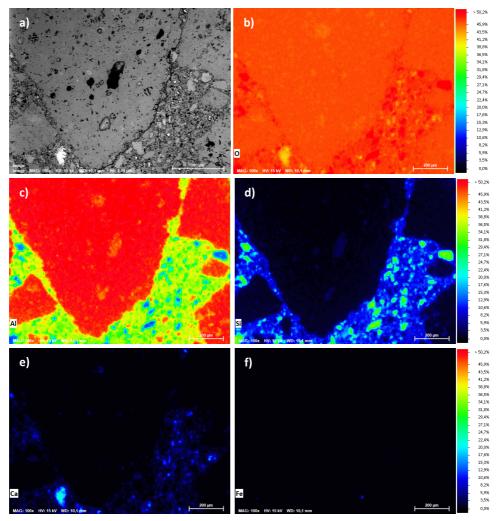
CALDE® CAST LM74A is a mullite based material with the main constituents O, Al, Si, Ca and Fe. As seen in the EDS maps shown in Figure 61 b-f, all these elements are present in the binding phase, the largest crystals in the microstructure are rich in Al and O (Al $_2$ O $_3$ ), and the smaller consist of Si and O (SiO $_2$ ), Ca and O (CaO) and Fe and O (Fe $_3$ O $_4$ , very small amounts).

Figure 61 a) SEM-image of CALDE LM74-REF (exposure time 0 years), and corresponding EDS maps for main constituent elements (colour scale with maximum 50 weight%): b) O; c) Al; d) Si; e) Ca; and f) Iron (Fe).

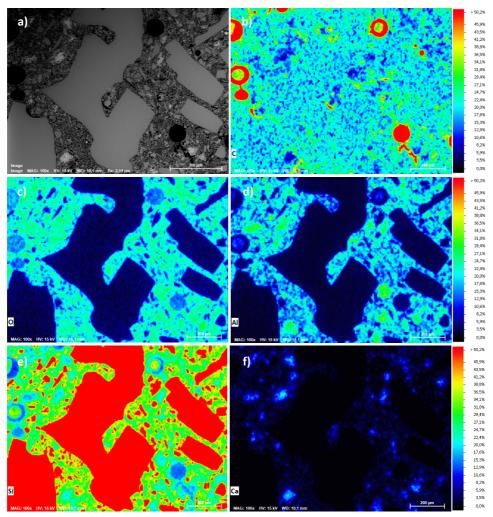
CALDE® SPRAYCAST SIC 70 is a silicon carbide material with the main constituents C, O, Al, Si, Ca and Fe. As seen in the EDS maps shown in Figure 62 b-f, all these elements are present in the binding phase, the largest crystals in the microstructure are rich in Si and C (SiC), and the smaller consist of Si and O (SiO2), Al and O (Al2O3), and Ca and O (CaO).

Figure 62 a) SEM-image of CALDE SIC-REF (exposure time 0 years), and corresponding EDS maps for main constituent elements (colour scale with maximum 50 weight%): b) C; c) O; d) Al; e) Si; and f) Ca.

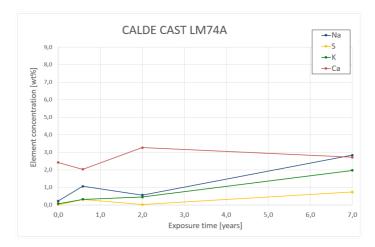
Figure 64 Element concentration as a function of exposure time in CALDE® CAST LM74A. Notice that the material exposed for 7 years is from a different material batch compared to the other materials.

For the CALDE® CAST LM74A material, there is a good correlation between the material extracted from E.ON. and Mälarenergi. In general, the amounts of Ca, S and alkali (Na, K) increase somewhat with exposure time in the binding phase, but the levels are very low. No Pb and/or Zn is detected by EDS analysis in the binding phase (1-2 cm under the surface) after exposure.

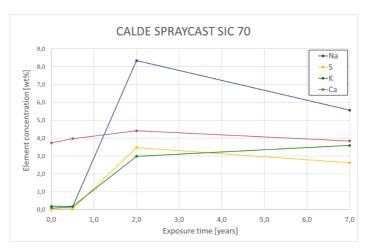
Figure 65 Element concentration as a function of exposure time in CALDE® SPRAYCAST SIC 70. Notice that the material exposed for 7 years is from a different material batch compared to the other materials.

For CALDE® SPRAYCAST SIC 70, the measured concentrations of elements in the binding phase are not increasing gradually with exposure time: the concentrations of S and alkali (Na, K) are somewhat higher after 2 years at E.ON. compared to after 7 years at Mälarenergi. This may be due to differences in the waste chemistry, operating parameters, etc used in the different boilers. The general trend seems to be that the concentration of S and alkali (Na, K) in the binding phase starts increasing after 0,5 years and stabilizes after 2 years exposure time. The concentration of Ca however seems to stay rather constant. Like for the mullite based refractory material, no Pb and/or Zn is detected in the binding phase after exposure (1-2 cm under the surface).

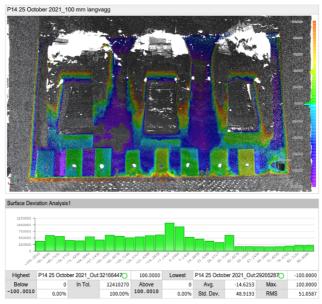
Figure 66 3D software used to show refractory lining surface deviations in a rainbow scale.

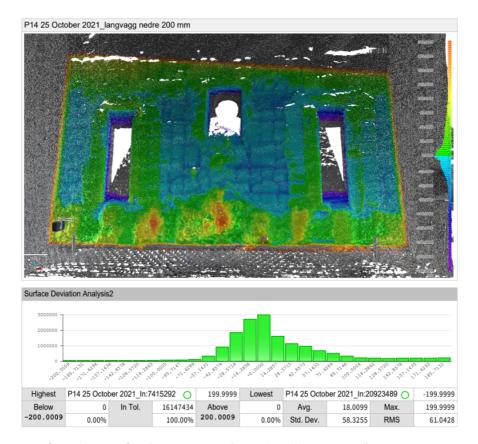
Figure 68 Refractory lining surface deviations in a rainbow scale on the opposite wall.

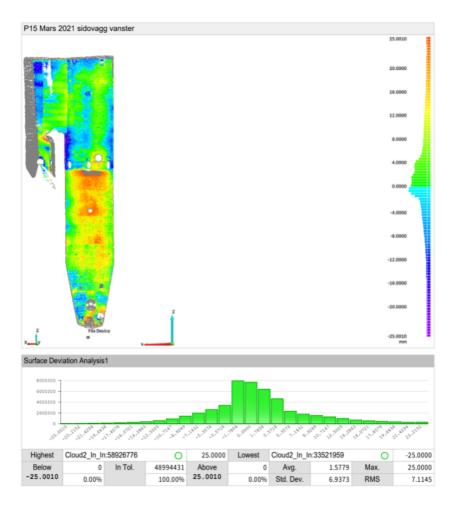
Figure 69 Full boiler side wall indicating lining surface deviation using the rainbow scale.

Results on the 3D scanning method was that is working well and with high accuracy giving output on the surface compared to either a best fit flat surface or compared to previous historic 3D scan cloud images.

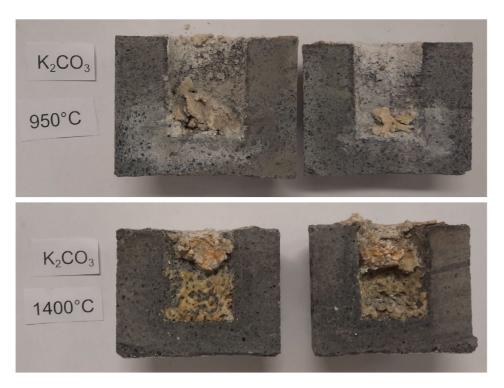
Figure 70 Photos of CALDE® SPRAYCAST SIC 70 cup-test specimens tested with  $K_2CO_3$ .

CALDE® SPRAYCAST SIC 70 is a very corrosive resistant material against alkali (K<sub>2</sub>CO<sub>3</sub>) attack at both 950°C and 1400°C. Virtually no infiltration into the material of the potassium powder can be observed. Some traces of white powder in the picture at 950°C is something that has happened during the sawing of the samples after the test.

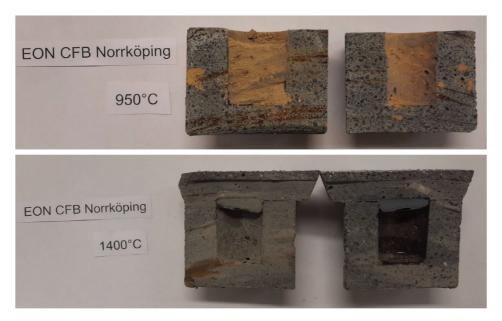
Figure 71 Photos of CALDE® SPRAYCAST SIC 70 cup-test specimens tested with ash sample (1).

CALDE® SPRAYCAST SIC 70 also has not suffered any degradation from the ash sample at either of the two temperatures tested. At 1400°C we can see that the ash sample has melted. Some of the material is glued to the surface of the refractory material but without infiltration or generation of cracks. Most of the ash at 1400°C seems to have recondensed on the top cover of the sample resulting in the fact that the cover has got stuck on top of the cup sample.

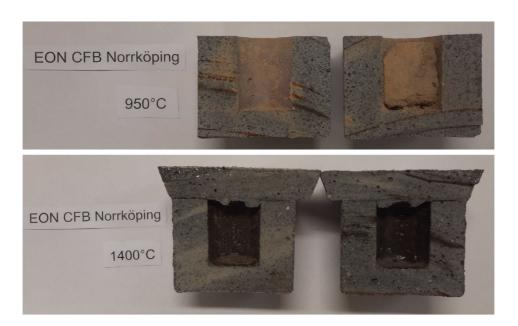
Figure 72 Photos of CALDE® SPRAYCAST SIC 70 cup-test specimens tested with ash sample (2).

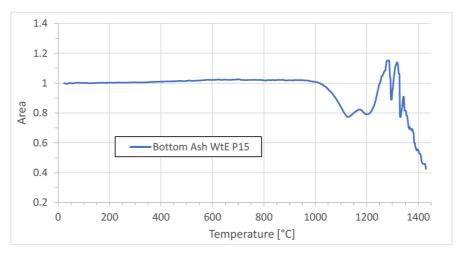
Figure 74 Heating microscopy course for the sample area.

The softening and melting temperatures are given in Table 21. The softening temperature is determined as the temperature at which the test piece has rounded corners and its height corresponds to the length of its baseline (DIN 51730:2007). The melting temperature is determined according to DIN 53710:1984 (the sample height has attained one third of its initial height).

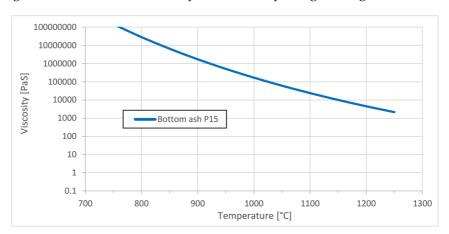
Figure 75 Slag viscosity calculation using the FactSage.

From the graph in Figure 75 it can be seen that the viscosity is relatively high which can be directly related to the relatively high amount of silica.
