Photogrammetry of Kalhovd dam

Kalhovd Dam

Case study of Stable Dams (2015-2019)

Pillar 49: condition assessment

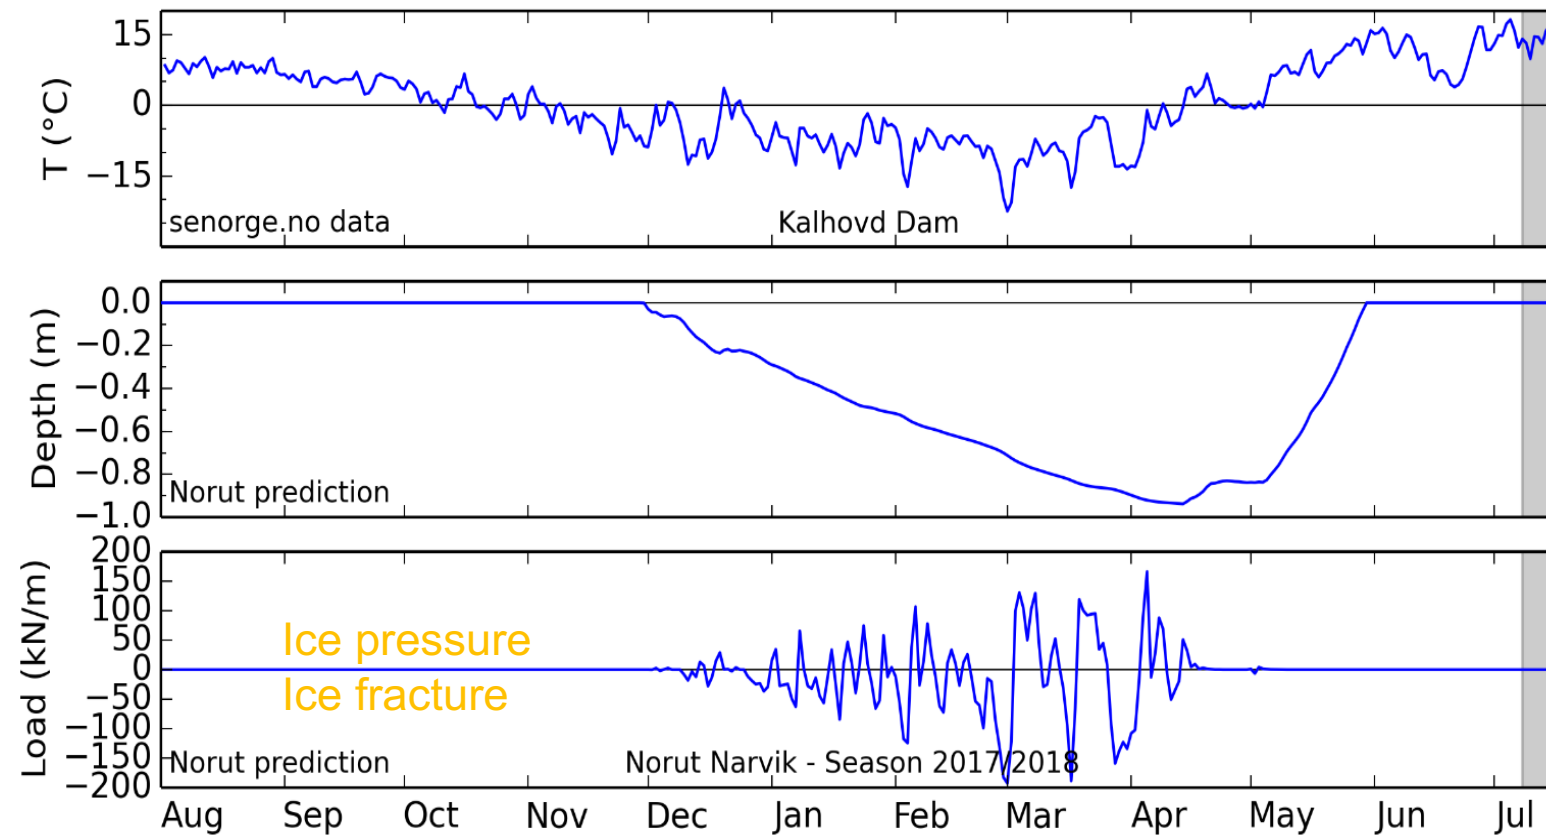
Ice loads predictions based on daily temperature variations (<https://ndat.no/sd/>).
Calculations based on Petrich et al. (2015).
