TESTING OF ACOUSTIC CAMERAS TO DETECT LEAKAGE THROUGH A CONCRETE STRUCTURE

REPORT 2026:1189

Testing of acoustic cameras to detect leakage through a concrete structure

Testing performed during a leak rate test of Vercors

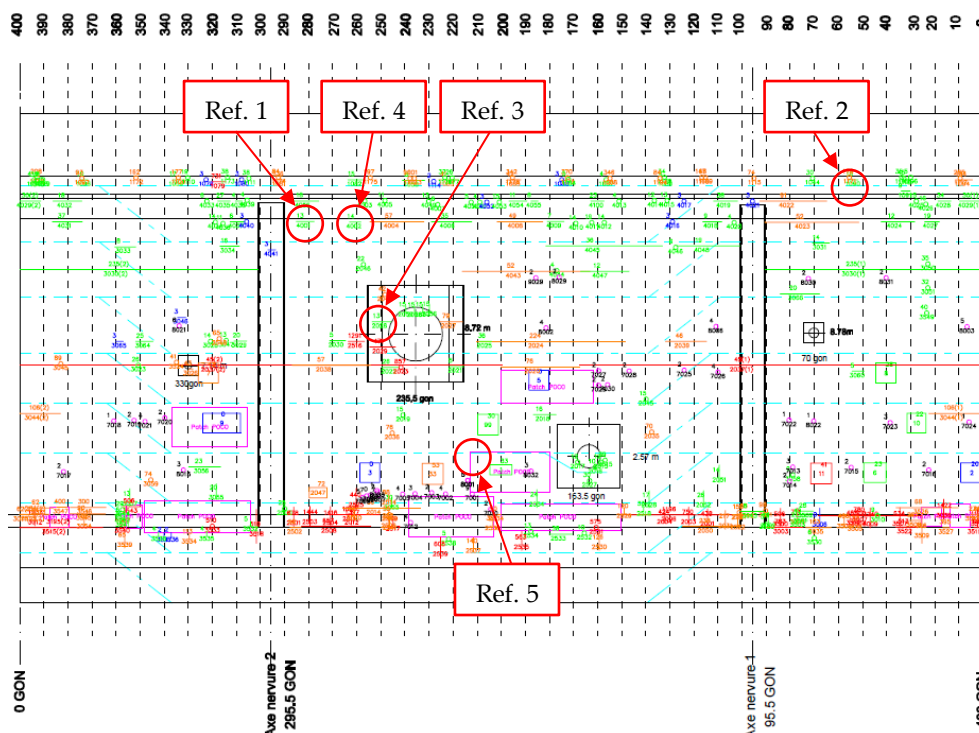
Figure 5 Location of the reference points

Reference point 1 was selected as an example with a smaller leakage. In this area there is a joint in the construction with a deviation of the used material.

Reference point 2 was selected as an example where leakage could be found in an area without leakage spray added during the first visit.
