# OPERATIONAL EVENTS IN OFF-SITE POWER SYSTEM

REPORT 2016:323

# **Operational Events in Off-Site Power System**

Nuclear power plant Experiences and Mitigating Actions

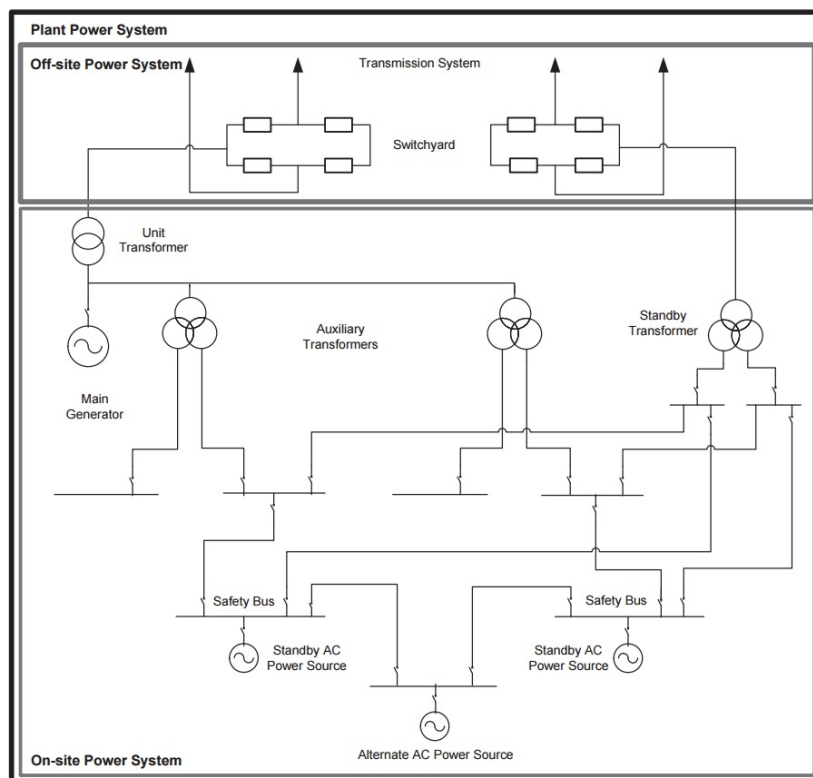
Figure 1.1. Relationship of the plant electrical power system, the off-site electrical power system and the on-site electrical power system for a nuclear power plant. [11]

According to IAEA [11] “the on-site power systems and off-site power systems work together to provide necessary power in all plant conditions so that the plant can be maintained in a safe state. Off-site power systems are not plant equipment. They are, nevertheless, essential to the safety of a nuclear power plant, and they are important in the defense in depth concept.” The relationship is illustrated in figure 1.1.

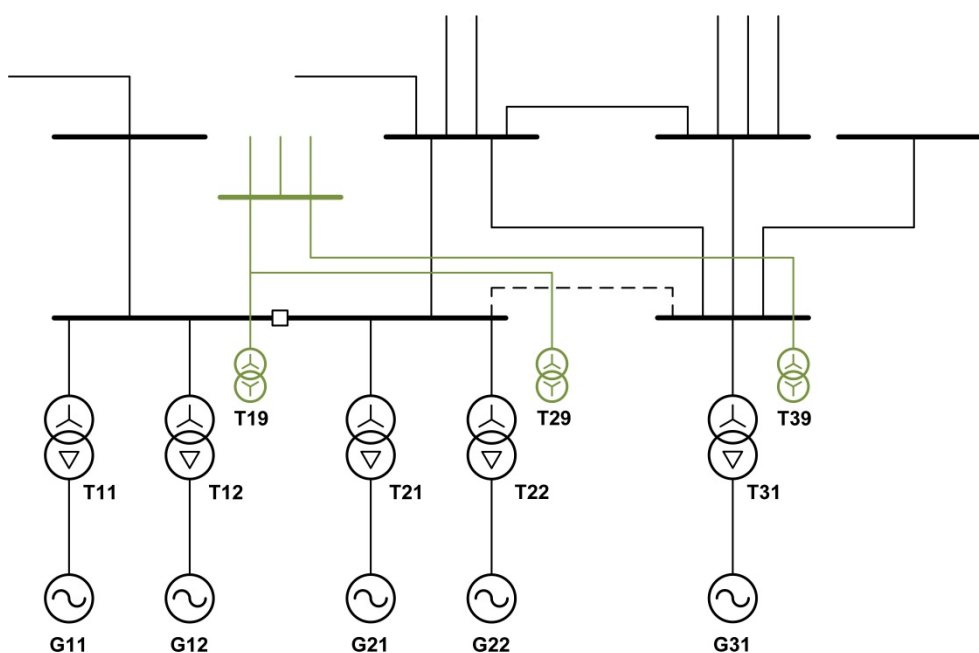
Figure 3.1. Simplified diagram of 70 kV (green) and 400 kV network connections of Forsmark.

Forsmark nuclear power station is situated on the East coast of Sweden, North of Stockholm. It consists of three units, Forsmark 1, 2 and 3; all BWRs. All units are primarily connected to the 400 kV transmission network, Unit 1 radially connected to Tuna, Unit 2 radially connected to Odensala, whereas Unit 3 is a meshed connection point in the network. The secondary infeed is the 70 kV network where a gas turbine is also available as backup power. In figure 3.1 a simplified diagram of the off-site power supply to Forsmark is shown.

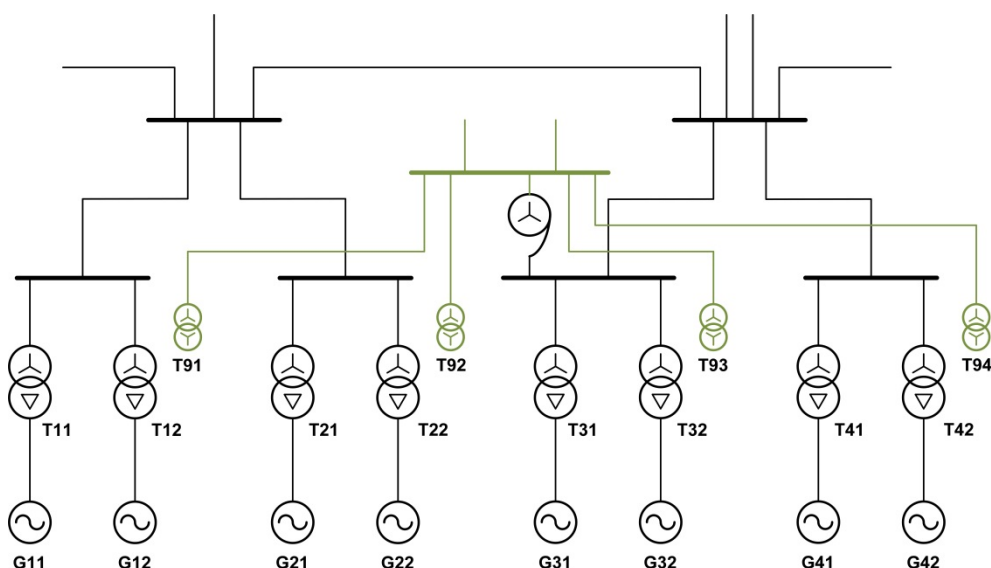
Figure 3.2. Simplified diagram of 130 kV (green) and 400 kV network connections of Ringhals.

Ringhals nuclear power station is situated on the West coast of Sweden with four units, Ringhals 1, 2, 3 and 4. Unit 1 is a BWR whereas the other units are PWRs. All units are connected radially to the 400 kV transmission network, with Strömme and Horred being the first meshed stations. The secondary infeed of power is from the 130 kV network where also a gas turbine is available as backup. The 400 kV and 130 kV connections are placed in the same switchyard some hundred meters from the units. A system transformer interconnects the two voltage levels at the connection point of Ringhals 3. In figure 3.2 a simplified diagram of the off-site power system is shown.

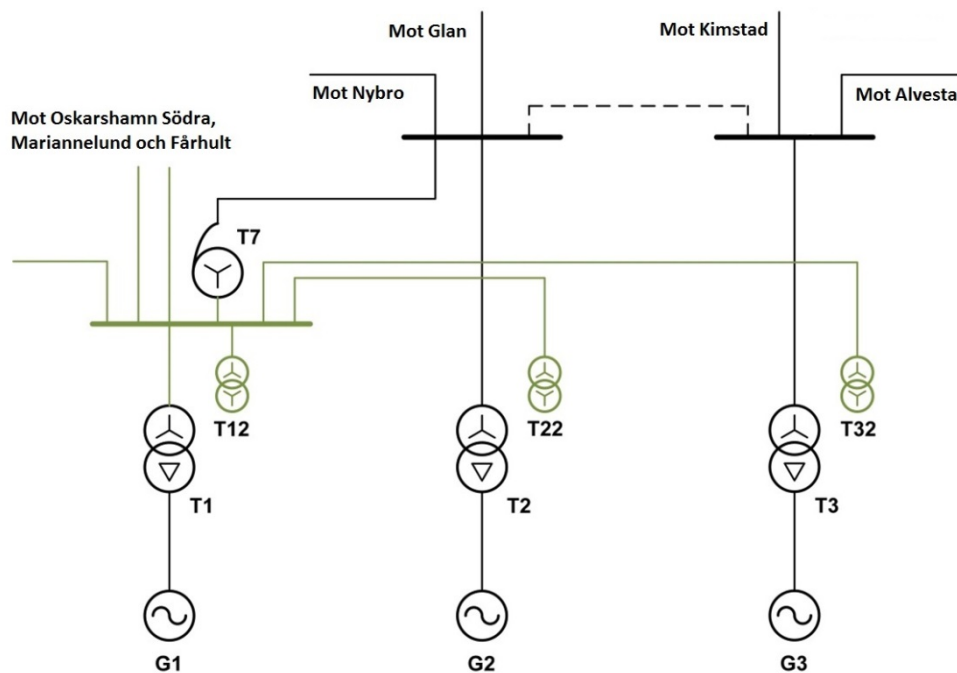
Figure 3.3. Simplified diagram of 130 kV (green) and 400 kV network connections of Oskarshamn.

Oskarshamn nuclear power station is situated on the East coast of Sweden, South of Stockholm, with three units, Oskarshamn 1, 2 and 3. All three units are BWRs. Unit 1 is connected to the 130 kV grid, whereas Units 2 and 3 are connected to the 400 kV transmission network. The secondary infeed of power is from the 130 kV network where also a gas turbine is available as backup. The 400 kV and 130 kV systems are interconnected via the system transformer T7. In figure 3.2 a simplified diagram of the off-site power system is shown.

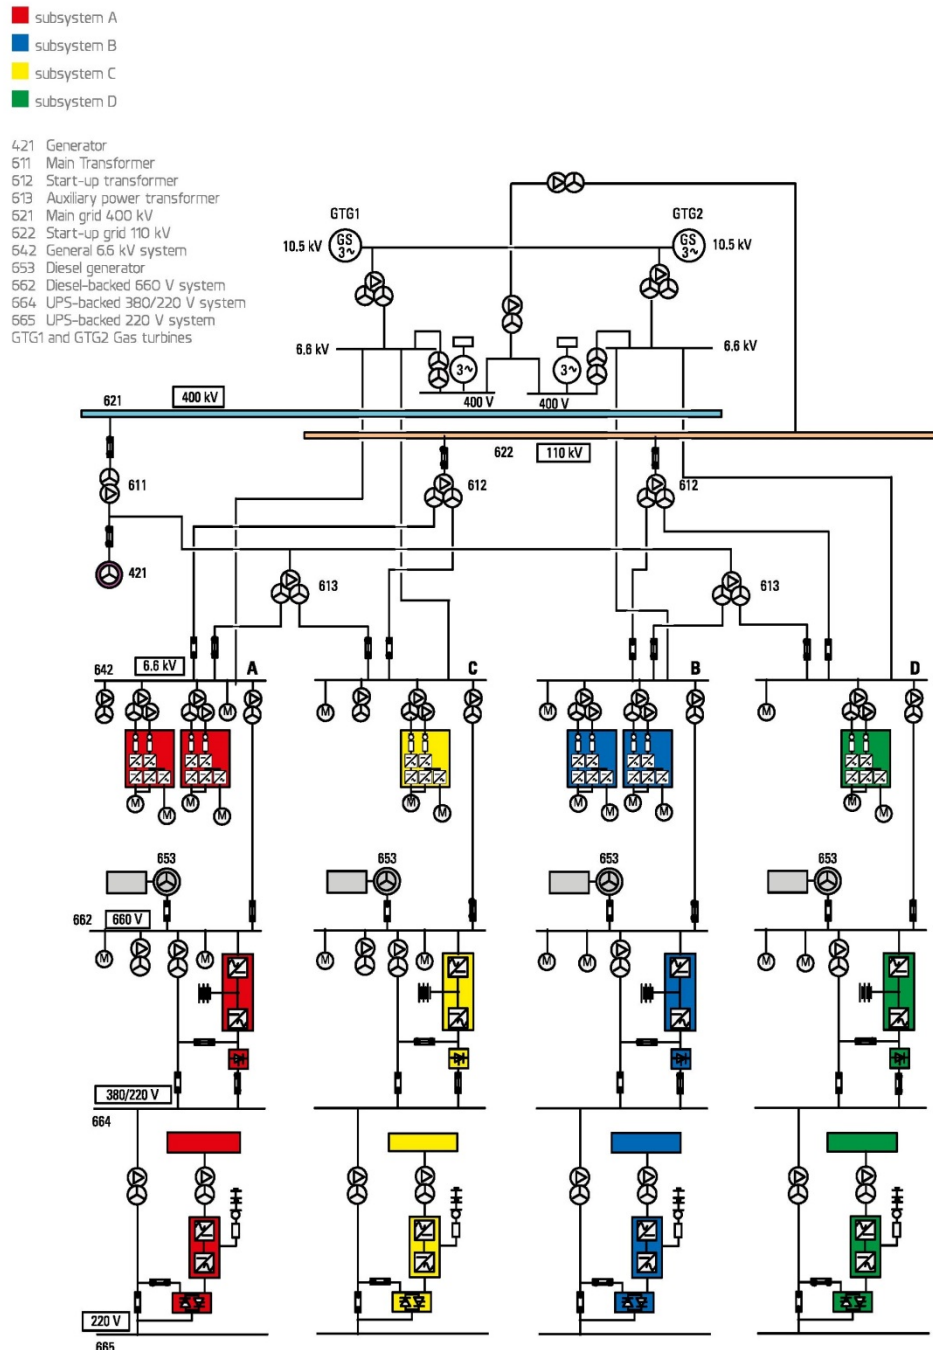
Figure 3.4. Simplified diagram of Olkiluoto 1 and 2 connection to grid. From [www.tvo.fi](http://www.tvo.fi).

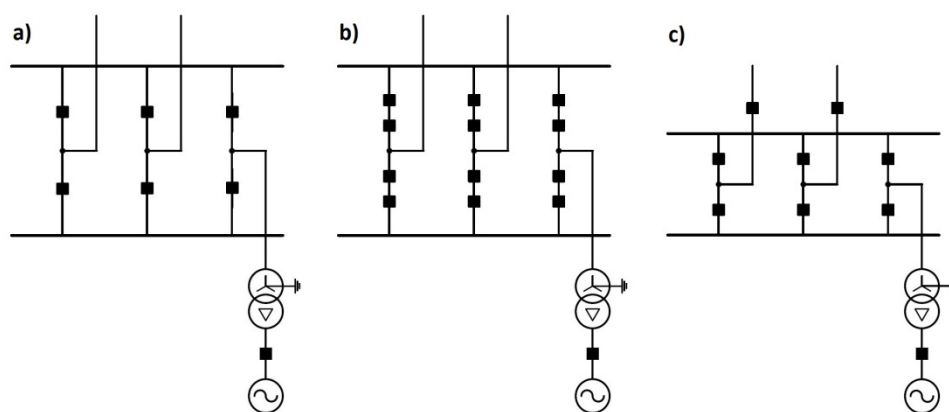
Figure 4.1. Different double-breaker arrangements. Figures from [5].

A typical double-breaker arrangement is shown as a) in figure 4.1. The concept results in a high reliability and the consequences of a bus-bar fault will not result in any loss of any bays (lines or generator in the figure). The double-breaker arrangement is highly utilized in many transmission and sub-transmission networks, e.g. by Svenska kraftnät. The reliability is ensured by duplicating the components of the fault-clearing system, i.e. protection functions, relay protection, current-transformer cores, trip coils, etc. However, it has not been practice by many network owners to duplicate the circuit-breakers. This implies that a bus-bar fault or line fault in combination with a non-functioning circuit breaker will result in fault-clearing times governed by the breaker-failure protection, i.e. ~170 ms.

By duplicating also the circuit-breaker in the double-breaker arrangement this delay of fault-clearing time, due to breaker-failure protection, can be eliminated. The corresponding arrangement is shown as b) in figure 4.1.

The alternative c) in figure 4.1 is an arrangement that inherits some of the benefits from b). By adding a line circuit-breaker on the outgoing lines the delayed fault-clearing time for close-up line faults on these lines is eliminated, in case of a non-functioning circuit-breaker. However, the benefits from the series circuit-breaker arrangement are lost for bus-bar faults. This arrangement could be an attractive way to build new lines in order to fulfil the demands for fault ride-through capability.

By studying the double-breaker arrangements a) and b) in figure 4.1 it can be seen that due to the two paths from a line or transformer to the two bus-bars, both arrangements are quite insensitive to inadvertent operations of a single circuit-breaker. For the arrangement c) in the figure the added line circuit-breaker introduces a possible source of concern. However, not adding an additional series breaker to the transformer bay minimizes the risk for unwanted disconnection of the unit.

By studying the arrangements in figure 4.1 the advantage of the duplicate circuit-breaker in series is obvious. A non-operating circuit-breaker (or one or more of the poles) in a series arrangement will not lead to a prolonged fault-clearing time since the adjacent circuit-breaker will operate. The arrangement c) in figure 4.1 also minimizes the fault-clearing times for close-up line faults, where two circuit-breakers operates in series. However, not so for bus-bar faults; where only the currents from the outgoing lines are cleared by circuit-breakers in series (not the currents from the adjacent bus-bar or the generator).<

There might be a possibility to retrofit existing double-breaker substations with a third line circuit-breaker, according to arrangement c) in figure 4.1. With this arrangement the line circuit-breaker will not be located between the bus-bars but along the incoming line close to the switchyard.

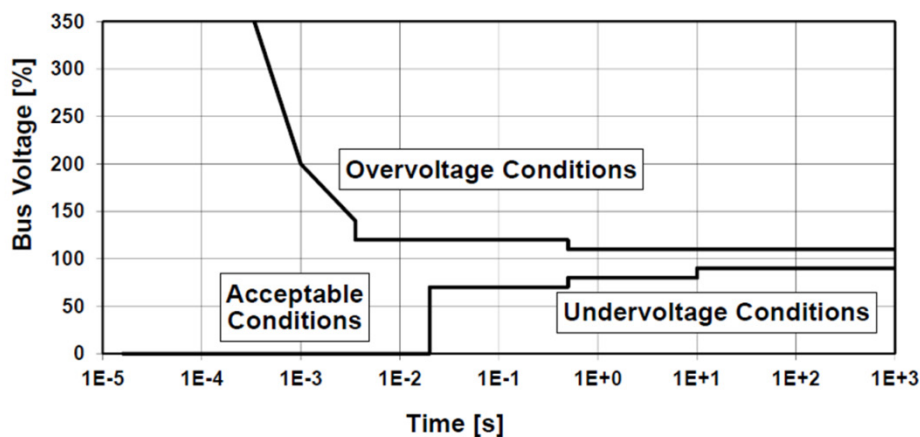
Figure 4.2. The ITIC curve. [7]

Applying the concept to the supply voltage of an apparatus this can be illustrated by for example the ITIC curve in figure 4.2. The figure shows two areas of conditions for which the equipment must be isolated; "over-voltage conditions" and "under-voltage conditions", and one area representing the operating conditions the equipment can withstand; "acceptable conditions". It is worth noting that the acceptable supply voltage may vary in level depending on the duration of condition. In steady state the

ITIC curve is represented by a relatively narrow interval around 100% voltage level. For more transient behaviors, e.g. 100  $\mu$ s, the acceptable variation in voltage level is considerably larger.

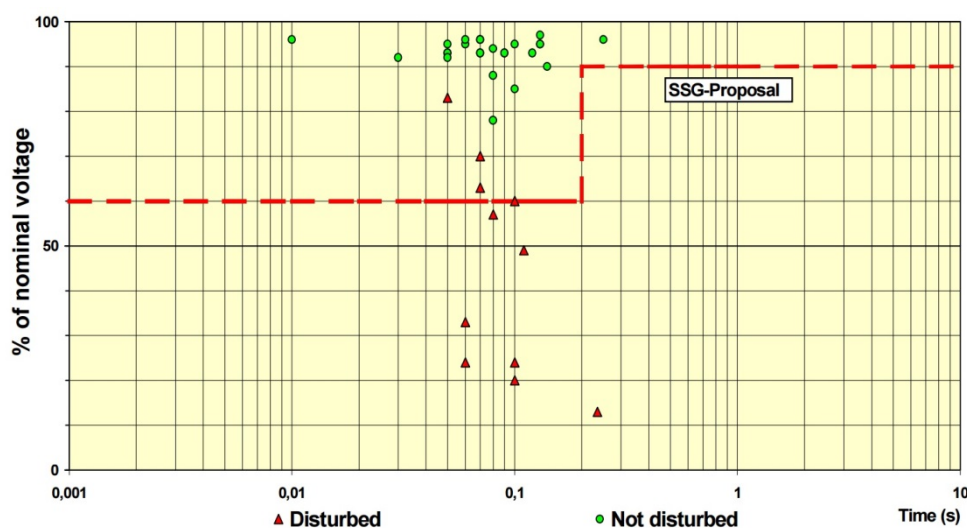
Figure 4.3. Recorded events (voltage dips) and the ability of the process to withstand the dip or not. [2]

In figure 4.3 the voltage dips are plotted in a voltage/duration graph. It can be seen that most of the dips have durations between 50 and 110 ms. The voltage level of the dips varies between 10 and 95% with the majority of the dips above 50%. As can be seen from the figure, deeper voltage dips result in more production stops.
