Increased fuel flexibility and performance for boilers with challenging fuels

KME conference 04.11.2020

Performance of cooled metallic parts

Refractories

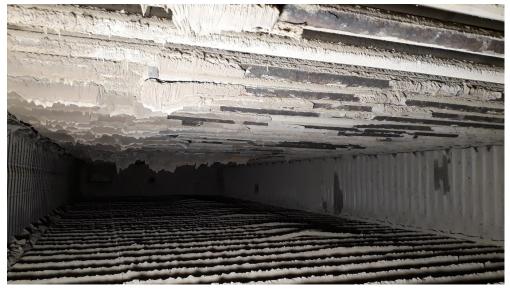
Exposure – Tube shield evaluation

Convection bank 0 floor		
Tube	6.	San 60
Tube	7.	Test alloy 2
Tube	8.	Test alloy 1
Tube	9.	APMT
Convection bank 1 roof		
Tube	12.	San 60
Tube	13.	Test alloy 1
Tube	18.	APMT
Tube	21.	Test alloy 2

180 cm

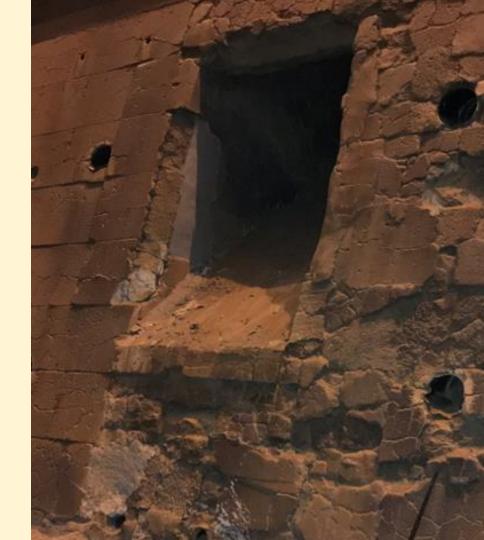
Example of challenges encountered

Calderys is acknowledged for providing the image

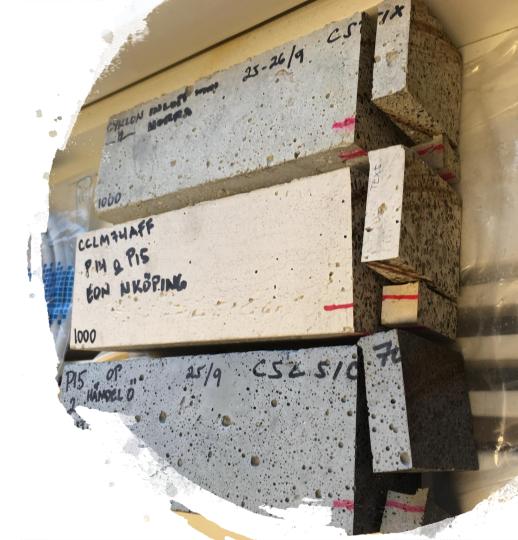
Test material

- Reference materials produced by Calderys (3 batches) installed in Händelö P14 & P15:
 - CALDE STIX PB 85 CG
 - CALDE CAST LM 74 A
 - CALDE SPRAYCAST SIC 70
- Bulk specimens prepared

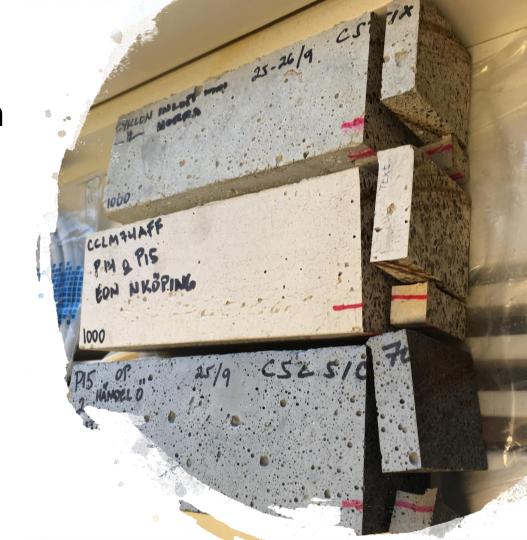
Specimen preparation

- Cutting method evaluated
- Mechanical grinding and polishing
- Final oxide polishing step (OPS) for EBSD
- Water cooling

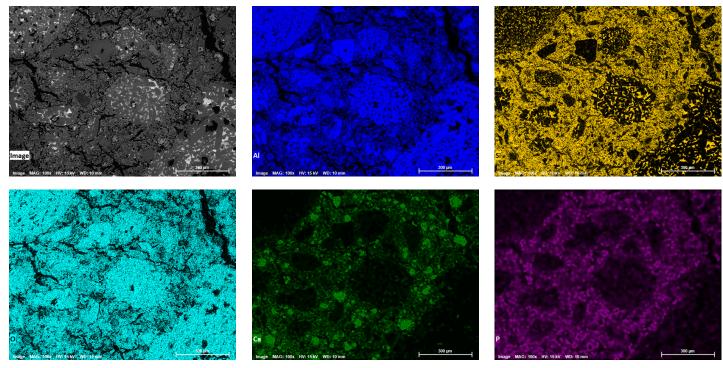
REF: CALDE STIX PB 85 CG – EDS mapping

Bulk specimen

- Microstructure of reference materials and exposed (+slag) material extracted after 6 months from Händelö P15 is characterized by SEM/EDS
- Composition results from EDS analysis are semi quantitative, and should primarily be evaluated <u>relative to each other</u> to determine trends (increasing/decreasing composition after exposure compared to reference)
- No obvious difference is observed in the microstructure images after exposure 6 months compared to reference materials
- Evaluation of exposed material in P15 shows that there is a **small increase in the concentration of:**
 - Na₂O and K₂O in CALDE STIX PB 85 CG (after 6 months)
