# Increased fuel flexibility and performance for boilers with challenging fuels

#### Background

# Performance of cooled metallic parts

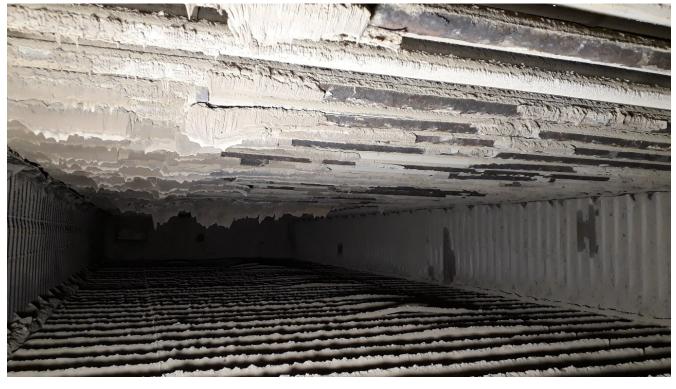
# Exposure – Tube shield evaluation

Collaboration with
 FeCrAlCLAD- project, which
 produced the test tube shields
 and carried out the exposures,
 as well as some evaluation

Convection bank 1, "roof"						
Tube	12.	San 60				
Tube	13.	EF101 (L197)				
Tube	18.	APMT				
Tube	21.	EF100 (L198)				
Convection bank 0, "floor"						
Tube	6.	San 60				
Tube	7.	EF100 (L198)				
Tube	8.	EF101 (L197)				
Tube	9.	APMT
