VIBRATION MEASUREMENT PITFALLS PROJECT KKU52450 at Energiforsk

Åsa Collet and Jessica Fromell 2021-11-10

VIBRATION MEASUREMENT PITFALLS

REPORT 2021:803

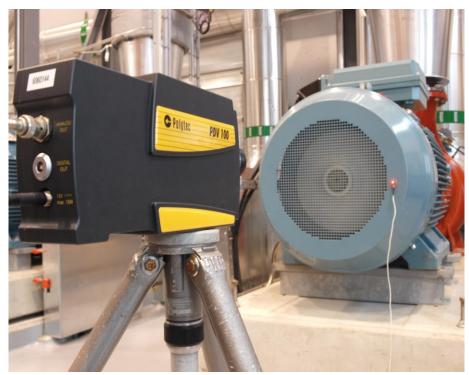
EXAMPLE PITFALL 2: LOW-FREQUENCY SKI-SLOPE

Laser Doppler Vibrometer, LDV Accelerometer ICP

- Transients from the pump
- The vibration must be "quicker" than the relaxation of the signal.

Found fault	Possible pitfall 1	Possible pitfall 2	Possible pifall 3	Possible pifall 4	Possible pifall 5	Possible pifall 6	Possible pifall 7
Unexpected DC component/ski- slope	ICP accelerometer, section 3.1.5- 3.1.6	High frequency overload, section 3.2.2	Steam pipe meas urement Section 5.1 and 2.3	Section 2.1.2, 2.3. Eg. Faulty cables, wrong sensors, temperature and radiation sensitivity	Integration issues section 2.4 and 3.1.5		
Unexpected 50 Hz component or other disturbances	Impact testing, section 3.1.4	Interfering potent ials, Section 5.2	2.2 impact testing during parallel work	2.3 and 5.2 Grounding issues. Transients due to cabling section 2.3	Not galvanically sepa rated channels section 2.6		
Unexpected vibration magnitude/ frequency	Sensor malfunctioning, section 3.2.1	Selection of measurement points, Section 4.3	Inconsistent alignment, Section 4.4	Section 2.1 Standards and Vibration criteria's, alarm levels	Section 2.1.1 Fixture points and resonances of fixtures	2.1.1 and 2.3 using filters and amplifiers. And attachment of sensors	Sensor sensitivity, section 2.3

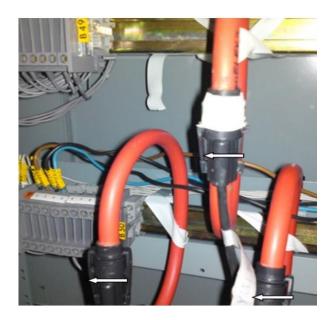
AmpFlex current sensors

After a complementary verification of the current sensor, the phase shift ended up to be 24° @ 2.4 A instead of the specified at data sheet 20° @ 10 A at f=50 Hz.

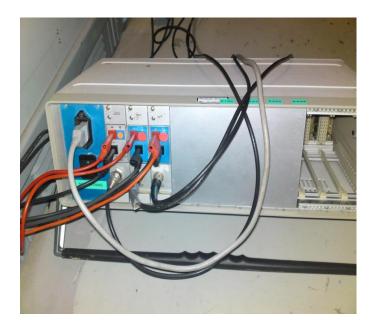
Analog isolation amplifier used to transform voltage 110.0 V on terminal to 5.47 V range suitable for measurement system

Upon phase verification it was verified that each input module of the isolator amplifier add a phase shift of approximately 17° @ 50 Hz during the prevailing circumstances

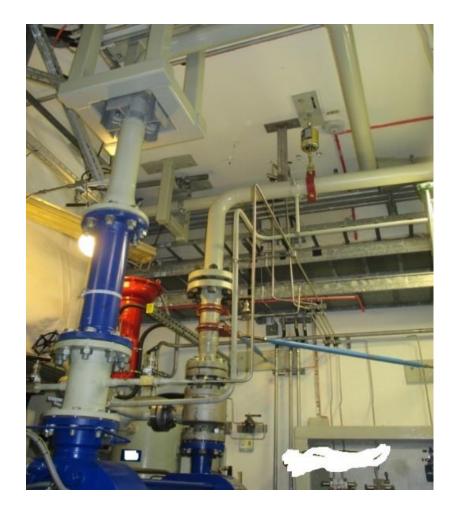
Example Pitfall 5: Missed and non-synchronized project information

Design of new pump foundation.

- Lack of communication between project experts pipe engineers and foundation design engineer.
- Missed the dynamic influence of strong constraints had on the discharge and suction pipes to the pump
