# NEW MATERIALS FOR IMPROVED COMPETITIVENESS OF FB PLANTS USING RENEWABLE FUELS

RAPPORT 2023:931

# New materials and Oxygen Carrier Aided Combustion for improved competitiveness of FB plants using renewable fuels

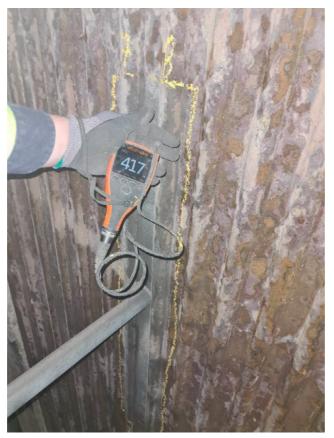
At the second inspection (2021-03-25), after about two years of exposure, there was no APMT coating left on the tubes number 3 and 4. For the CorEr coating on tubes number 7 and 8, the metallization was still visibile. The nominal layer thickness of material CorEr<sup>TM</sup> was approx.  $400 \pm 50 \, \mu m$ , see Figure 12. The variation depends primarily on manual application. Thus, there has been no appreciable stripping of the metallization on tubes number 7 and 8, after two operating seasons.

Figure 12. Thickness measurement of the HVOF sprayed CorEr coating at the 2021 revision in the P15 boiler in Händelö.

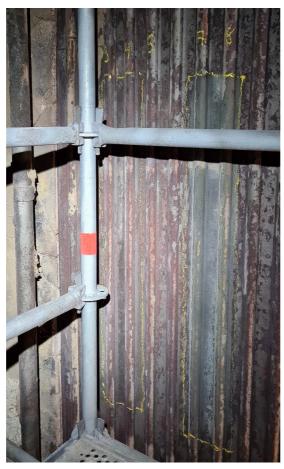
Two test areas, about 1.2 meter in height and about two tubes wide, were HVOF sprayed with APMT and CorEr, respectively. The number 3 and 4 tubes were metallized APMT and the number 7 and 8 tubes were metallized with material CorEr<sup>TM</sup>, see Figure 13. Both materials had been coated in the spring 2019.

Figure 11. The two areas HVOF sprayed. Tubes 3-4 are metallized with AMPT and tubes 7-8 are metallized with CorEr. The image is taken during the first revision, about 1 year of exposure.

Already at the time of the first inspection, on 2020-03-25, it was noted that only tubes number 7 and 8 (with CorEr) had any metallization left on the tubes. For tubes 3 and 4 (with APMT), only small remnants of metal left in the junction between the tube and the fin could be seen.
