Joint sealants and their ageing in nuclear power plants

Report's title Application of sealing pastes inside containments and their ageing	
Customer, contact person, address SAFIR2022	Order reference
Project name Safety criteria and improved ageing management research for polymer components exposed to thermal-radiative environments	Project number/Short name 129019/SAMPO
Author(s) Konsta Sipilä	Pages 13/7
Keywords Joint sealants, polymer, ageing, nuclear power plant	Report identification code VTT-R-00094
Summary <p>Joint sealants are polymer-based sealing solutions that are applied in between structures, such as floor and wall elements, thus joining them together and forming a gas-tight structure. Such sealants are widely applied in constructions, including nuclear power plants (NPPs). However, their ageing in the nuclear power plant environment is a less studied phenomenon. A wide range of polymers, such as acrylic, silicone, polybutene, latex, butyl, polysulphide and polyurethane, can be used as a base polymer in joint sealants. Each type of joint sealant will have slightly different properties and targets of application. The ageing stressors that the joint sealants experience in

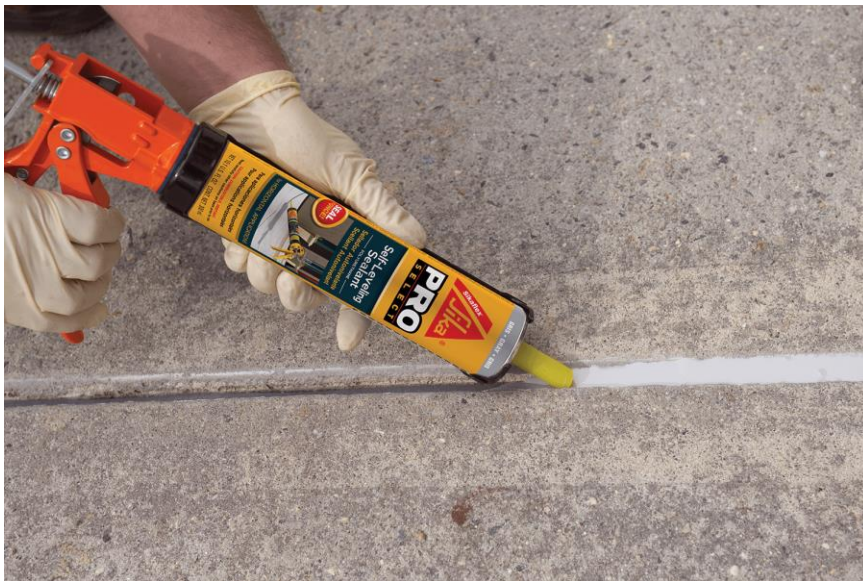
Figure 1. Application of a joint sealant between two concrete blocks. Picture was taken from [1].

Sealing solutions are an integral part of each building. The components (e.g. concrete blocks, wall and floor elements, glass structures etc.) of which buildings are constructed are often bonded or sealed to each other by joint sealants. Joint sealants are defined here as polymer-based materials that are applied in a groove between two structures and join tightly these components to each other preventing moisture or gases from penetrating through the sealed area. They are commonly used in various types of structures due to their ease of use, wide range of properties and applicability. An example of applying a joint sealant between two concrete elements is shown in Figure 1. Such joint sealants are widely applied in nuclear power plants but there is very little information available on their ageing and how to monitor their condition in the nuclear power plant environment.
