# Defining joint sealant condition in nuclear power plants

Authors: Konsta Sipilä, Isabella Björkvist, Harri Joki

The goal of this work is to assess the condition of sealants obtained earlier from the nuclear power plants by the means of tensile testing, DMTA and hardness measurements. Based on the results, suitability of each method to be used as a condition monitoring technique for such joint sealants is evaluated and using the measured material properties as acceptance criterion is assessed.

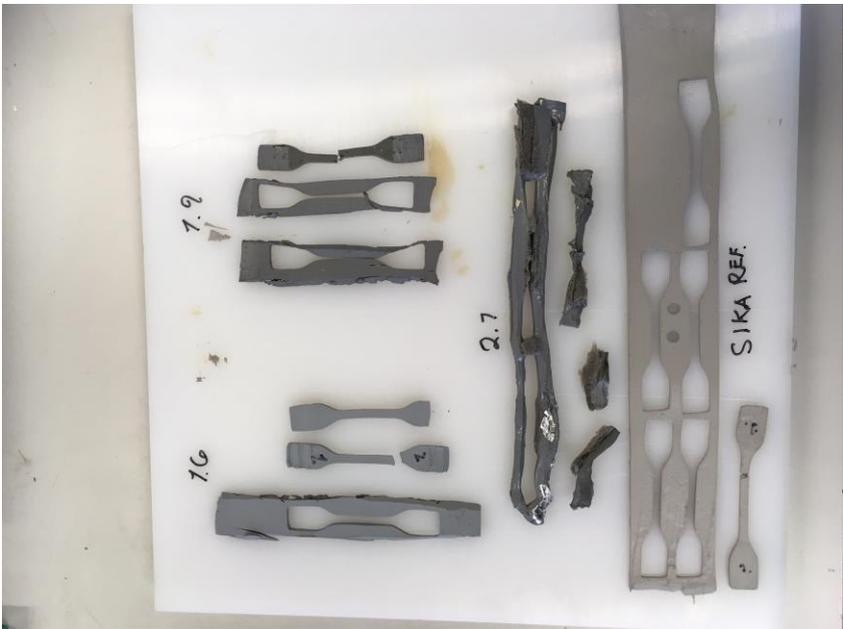
Figure 1. Samples prepared from TVO material and the reference Sikaflex materials.

Sample preparation from all aged samples was challenging. Their structure was soft and sticky and preparing a sample for DMTA or tensile test with homogenous dimensions was difficult. In case of some samples, the sample preparation was possible but attaching the sample between the tensile test machine grips was not possible as the sample was heavily deformed as it was pressed by the grip. In Figure 1 some of the prepared tensile samples can be seen. For example, it is clearly visible that sample 2.1 is deformed while prepared. Preparing a sample from the new Sikaflex material was clearly easier. The summary on the analyses that could be successfully performed to different samples are shown in Table 2.

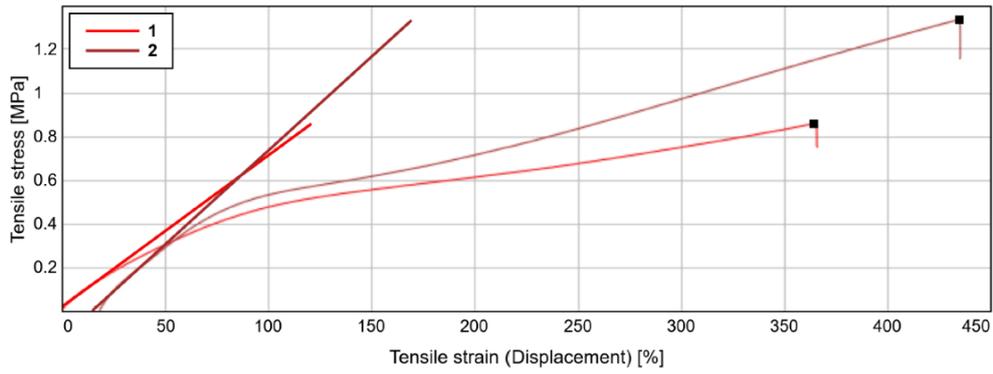
Figure 2. Tensile test curves for the two samples prepared from sealant TVO 1.6.

Figure 2 - Figure 5 show the stress-strain curves for the TVO samples and the commercial Sikaflex sample. Two tests per each TVO sealant were performed and average values of these two tests were used both for elongation and elastic modulus values in most cases. For the commercial sealant five tests were performed as there was more material available. The elastic modulus was defined based on the slopes of the linear part of the curves (see the two initial slopes in Figure 2 - Figure 5).

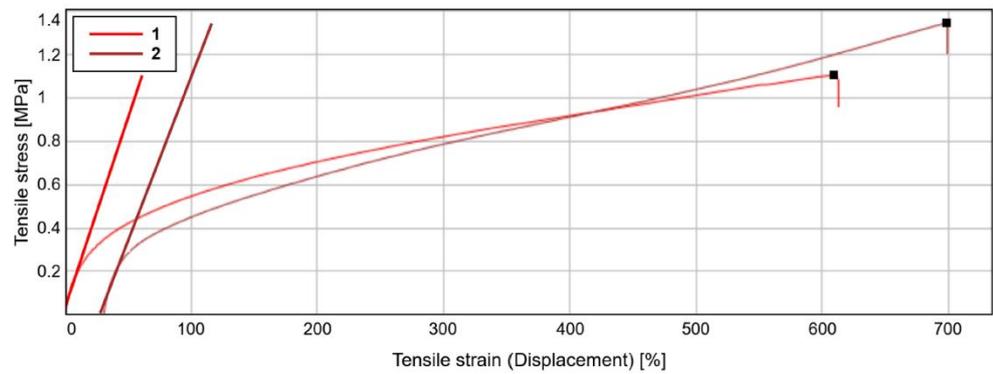
Figure 3. Tensile test curves for the two samples prepared from sealant TVO 1.9.

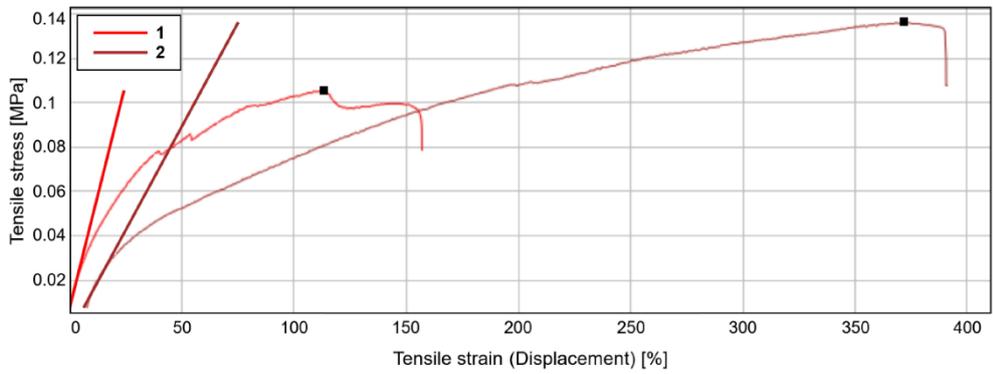
Figure 4. Tensile test curves for the two samples prepared from sealant TVO 2.1.

With TVO 2.1 samples, the two stress-strain curves deviate from each other. It is suspected that the first sample with shorter elongation had defects that have caused the smaller elongation. A likely source of the defects is the sample preparation phase as preparing a dumb bell-shaped sample was very challenging for this material. Thus, the first curve was not considered to represent the actual material condition and the elongation at break and elastic modulus values were extracted only from a single curve.

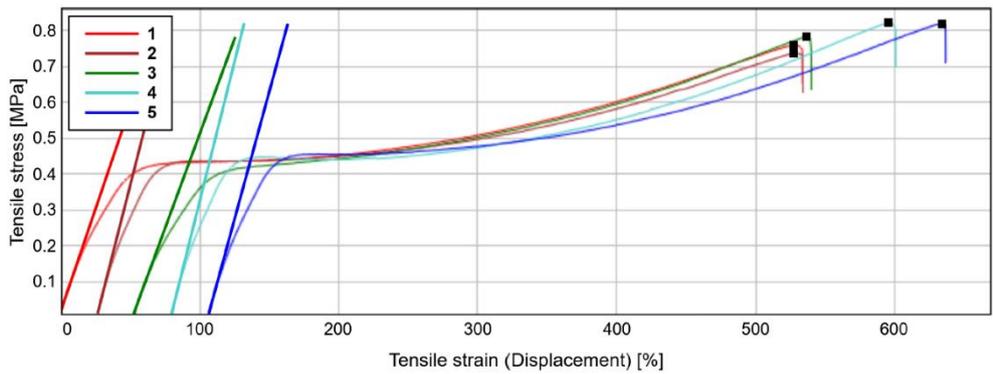
Figure 5. Tensile test curves for the five samples prepared from sealant Sikaflex® + Self Leveling Sealant.

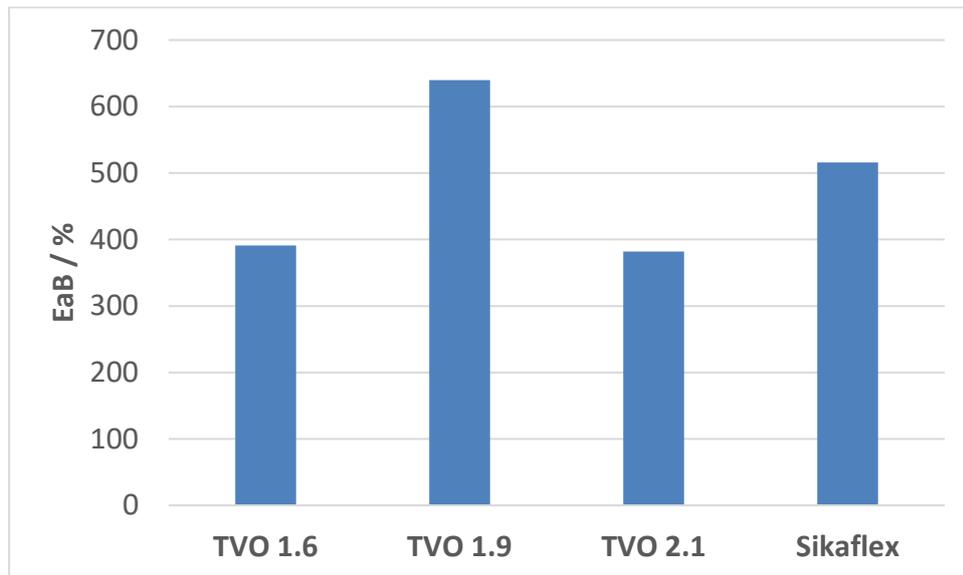
Figure 6. Elongation at break results.

Figure 6 and Figure 7 summarize the elongation at break and elastic modulus values extracted from the tensile tests. Interestingly one of the aged sealant materials has a higher elongation at break value than the new commercial material. It should be noted that the materials differ from each other by their composition affecting the comparison of the results. However, the result show that the aged sealant may still show significantly high elongation at break values, indicating that the material property in question is not necessarily the most representative property to describe the condition of the sealant. From the elastic modulus values the same trend can be observed as from the elongation at break results. TVO 1.9 sample shows larger elastic modulus value than the new commercial sealant.

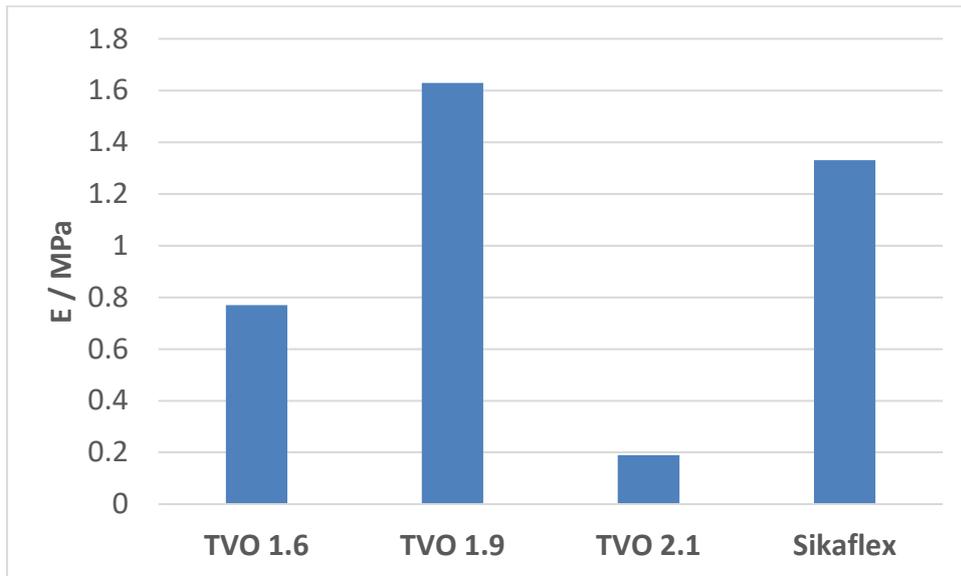
Figure 7. Elastic modulus values calculated from tensile test data.

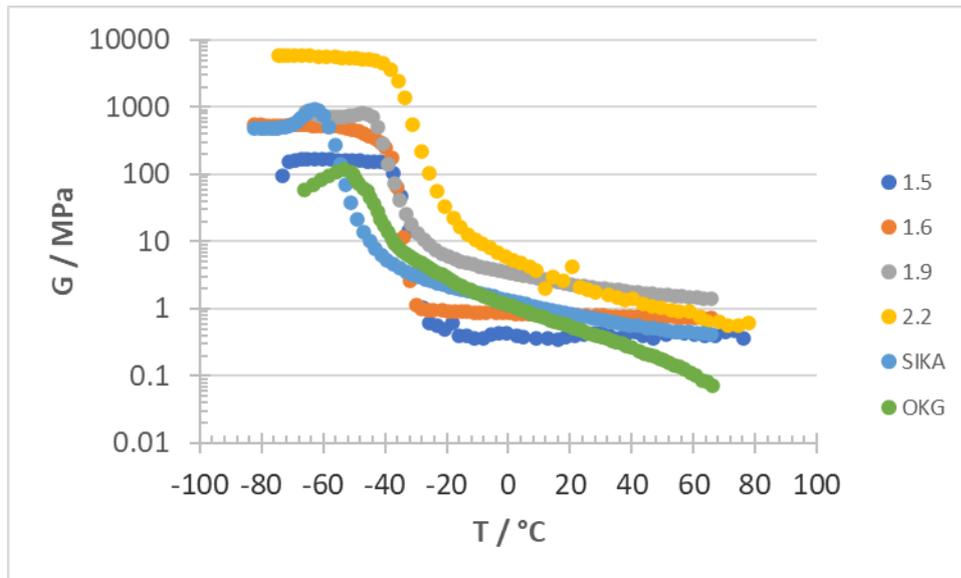
Figure 8 DMTA curves for the measured samples.

Figure 8 shows the DMTA curves for the measured samples. The storage modulus  $G$  was extracted around the temperature of 20 °C. The elastic modulus is known to be a function of  $G$  and Poisson's ratio  $\mu$ :

This equation was applied as the elastic modulus  $E$  was extracted from the DMTA data. The results are shown in **Error! Reference source not found.** TVO 1.9 and 2.2 sealant materials show clearly higher  $E$  values compared to other samples. The  $E$  value for TVO 1.9 material was roughly 4-times larger than was defined based on tensile tests, for TVO 1.6 material 3-times larger and for the commercial Sikaflex material roughly 2-times larger. The modulus values obtained for TVO 1.5 and OKG samples were the lowest. These were the two materials that could not be tested by the tensile test.

It is possible that the test samples were not representative enough for the DMTA tests, which may cause error in the  $E$  values. Also, the approximation of Poisson's ratio could contain some error, causing higher calculated  $E$  values. Furthermore, the measurements were performed only with a single sample and additional measurements should be performed to obtain more reliable estimations for  $E$  (this concerns the  $E$  values calculated from the tensile tests as well).

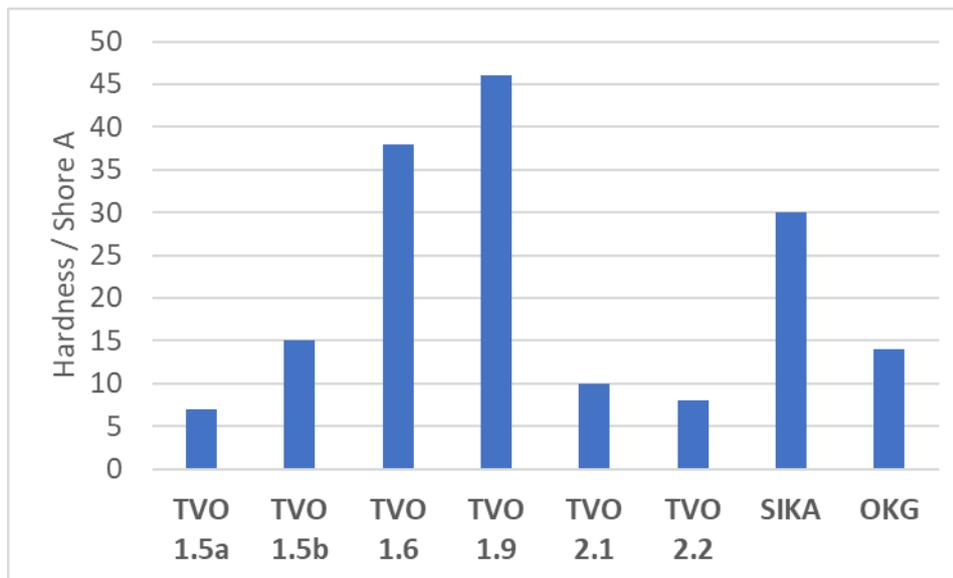
Figure 9. Hardness measurement results.

The hardness measurement results are shown in Figure 9. TVO 1.6, 1.9 and Sikaflex have higher hardness values compared to the other ones. TVO 1.6 and 1.9 have both higher hardness than the fresh Sikaflex sample. To define reason why some of the aged samples showed higher hardness than the fresh sample, additional composition analyses would be required. For TVO 1.5 two separate values are displayed as it was noticed that the sample contained two different areas with clearly different hardness value. TVO 2.1 and 2.2 as well as OKG material seem to have rather low hardness values compared to the new material, indicating severe ageing. This partly supported by the fact that no tensile test samples could be prepared from TVO 2.2 and OKG materials.

Based on the obtained results hardness result seems to be the most promising method to measure joint sealant condition. It is less laborious than tensile test and the hardness seemed to decrease more in aged samples than elongation at break (excluding TVO 1.9 sample). Hardness measurement can be considered as non-destructive which is an obvious benefit when sealant condition is tested onsite. Despite the fact that the DMTA method sample preparation and performing the test was somewhat easier than the tensile test, the obtained elastic modulus values deviated from those ones obtained from the stress-strain curves. Still, some of the most aged samples could be tested by DMTA but not with tensile test, indicating that DMTA could be suitable in testing severely aged samples.
